PRELIMINARY ACCIDENT REPORT

Accident and Incident Investigations Division

Accident
- Preliminary Report -
AIID Ref No: CA18/2/3/9939

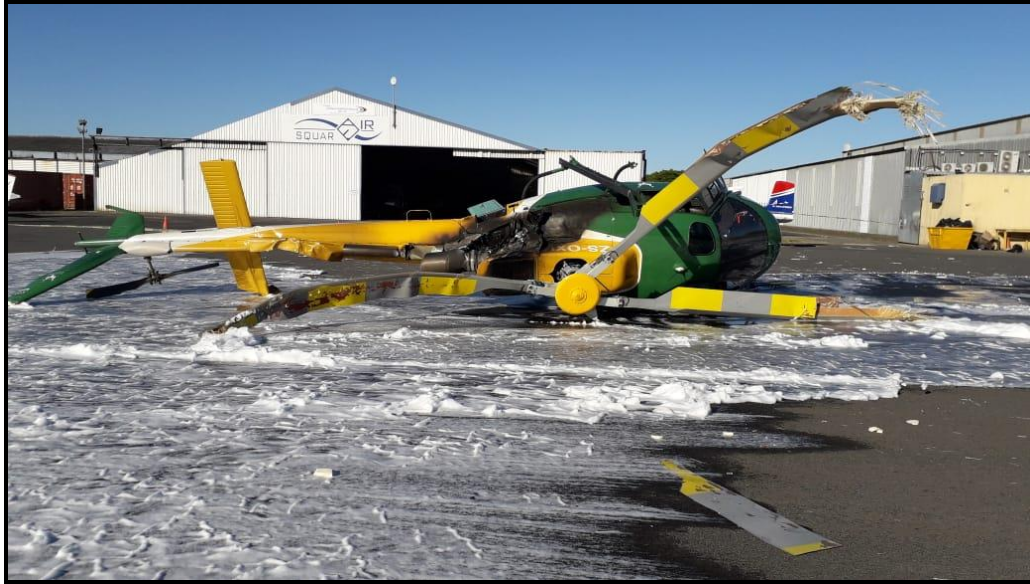
1.3.1 The helicopter was destroyed by impact forces and a post-impact fire during the accident sequence.

Figure 3: The helicopter at the scene post-accident. (Source: Operator)

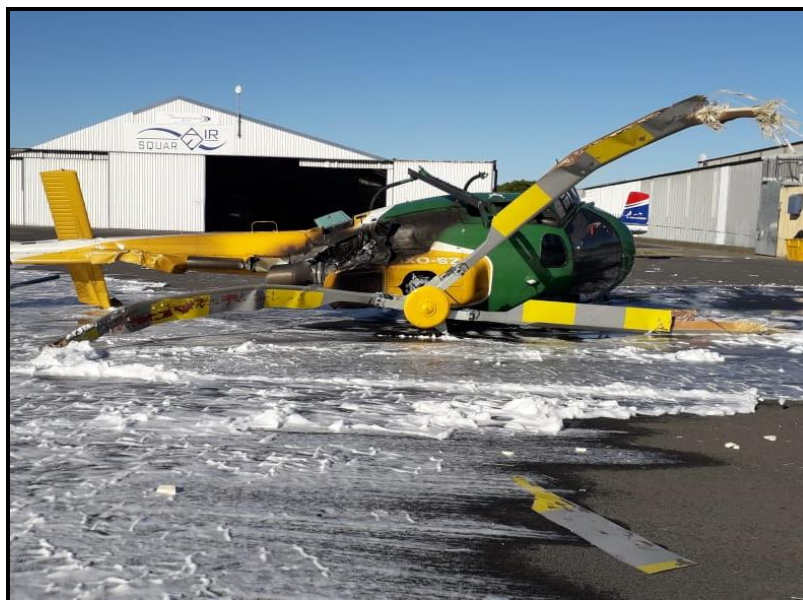
All main rotor blades showed signs of impact damage on the tips but were still attached to the hub via rigid sleeves. All three arms of the Starflex were severed due to the rotor blades impact with the ground. All three frequency adapters had cracks on them due to impact forces.

Figure 4: The main rotor blades post-accident.

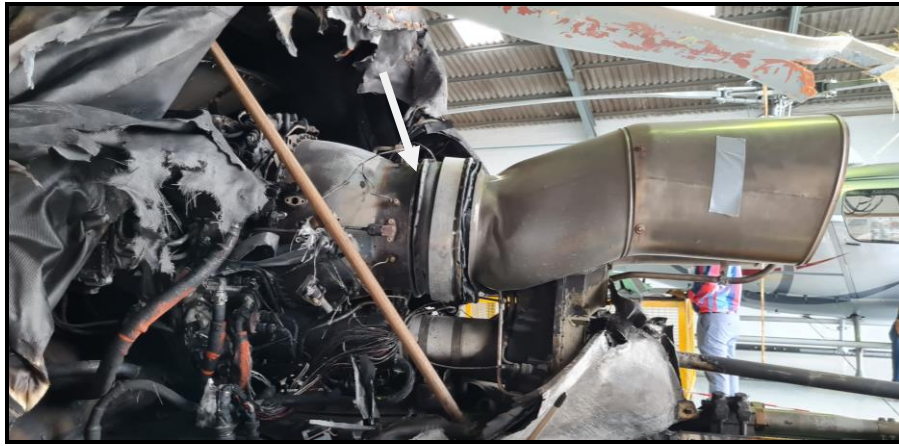
The engine was still attached to its mounts and showed signs of fire damage. The oil and fuel pipes were still intact and there were no visible ruptures or punctures. Some of the attachment bolts of the exhaust were severed due to impact forces. Most of the post-impact fire was contained within the engine bay.

Figure 5: The engine compartment after fire damage.

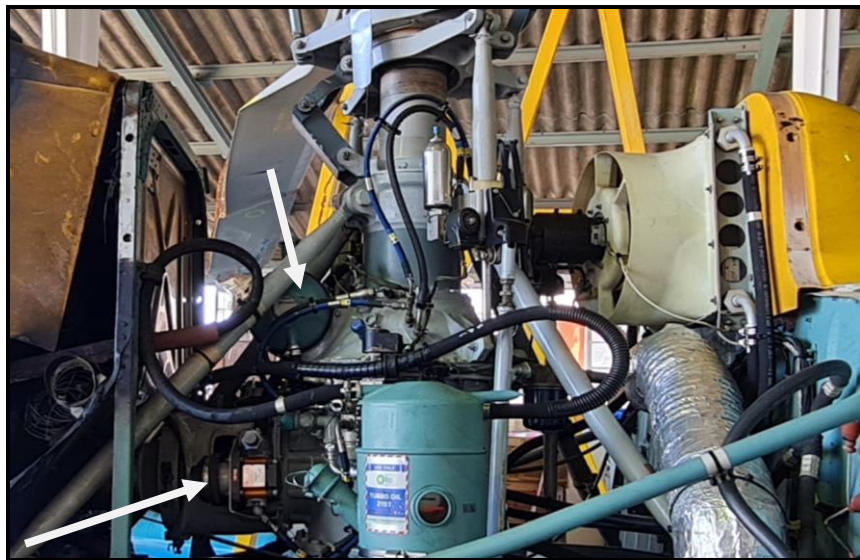
The hydraulic pump and reservoir were both found intact with no signs of impact damage. The hydraulic oil within the tank was 600 millilitres out of a total of 3 litres due to most of the oil seeping out of the tank when the helicopter was resting on its right side.

Figure 6: Hydraulic reservoir and pump found intact post-accident.

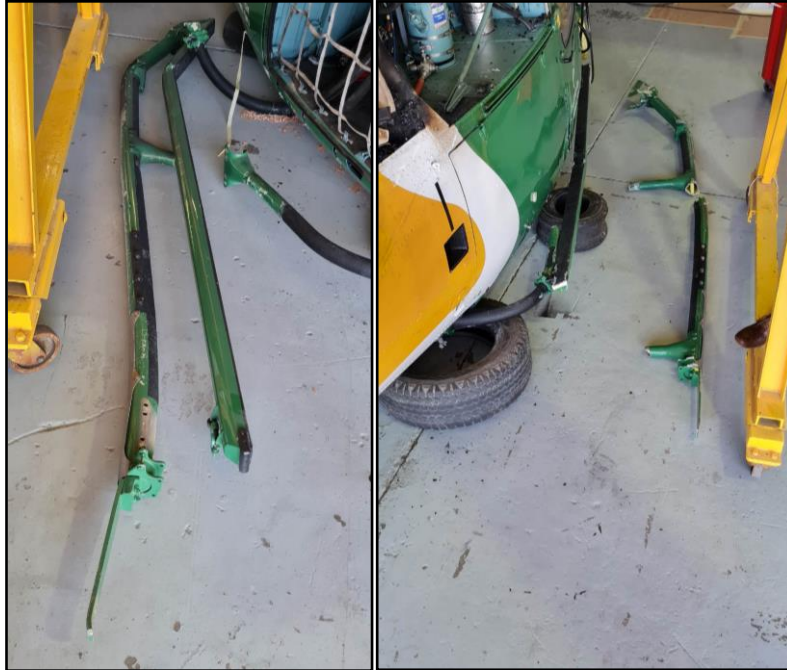
The entire left skid broke off from the attachments, but the right skid was still partially attached to the helicopter with the upper section bent upwards.

Figure 8: The left skid gear (left image) and the right skid gear (right image).

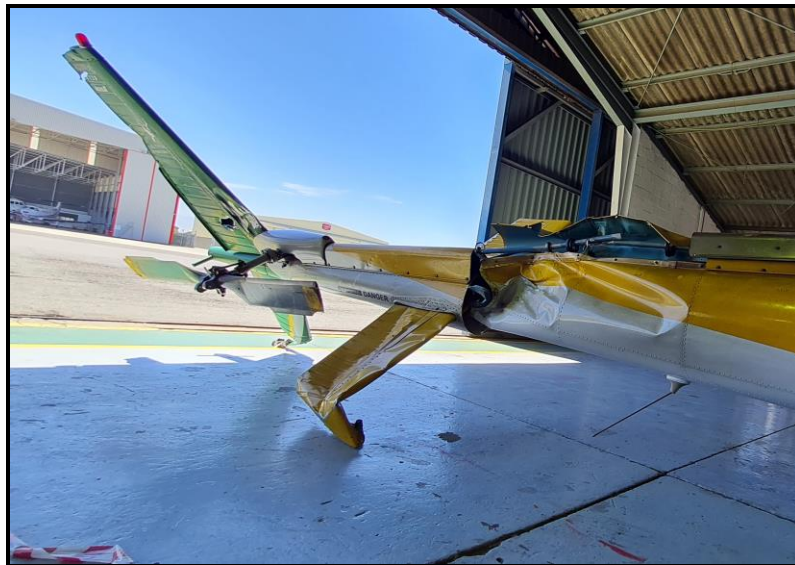
The tail drive shaft assembly was severed by the main rotor blade at its mid-section. The right horizontal stabiliser was bent during impact and the vertical stabiliser showed signs of impact damage by the main rotor blades. The tail rotor blades were still attached to the tail rotor output shaft but showed signs of impact with the ground on both tips.

Figure 9: Damaged tail boom and tail rotor.
