PRELIMINARY OCCURRENCE REPORT

Reference Number : CA18/2/3/9571
Name of Owner : S. J. Naude
Name of Operator : S. J. Naude
Manufacturer : Robinson Aircraft Corporation
Model : Robinson R44
Nationality : South African
Registration Marks : ZS-PWF
Place : Wagensboomkop farm. (GPS position: S 25° 42.156 E
026° 40.079)
Date : 13 October 2016
Time : 07:00 Z

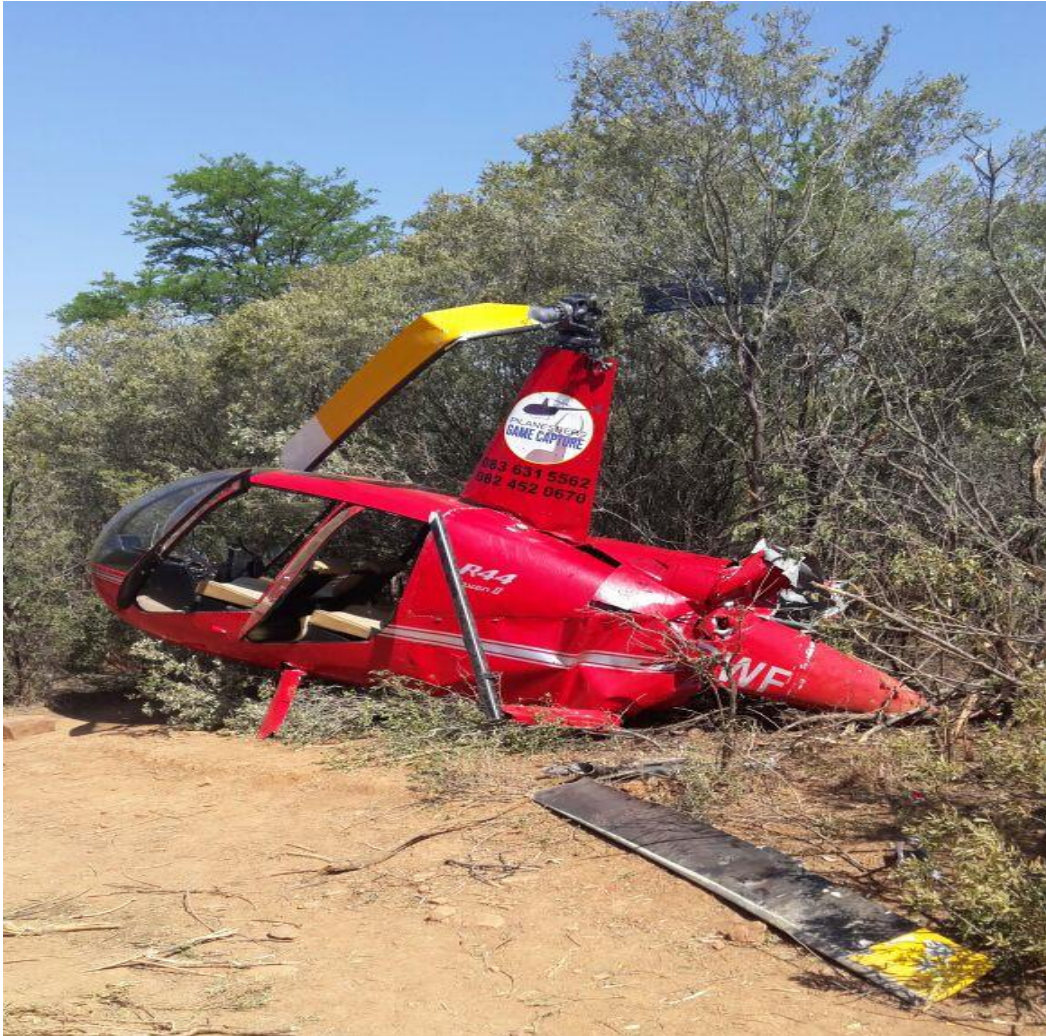
The pilot was not injured and the passenger was injured and rushed to the hospital for medical care. The aircraft sustained substantial damage. Power lines and two poles were damaged during the accident sequence.

FIGURE 1: Picture of the helicopter after the accident.
