PRELIMINARY ACCIDENT REPORT

Accident and Incident Investigations Division

Accident
- Preliminary Report -
AIID Ref No: CA18/2/3/10004

Reference Number : CA18/2/3/10004
Name of Owner/Operator : Gypsy Empire Properties (Pty) Ltd
Manufacturer : Robinson Helicopter
Model : R44 Raven II
Nationality : South African
Registration Marks : ZS-RSK
Place : Vaal Marina Dam, Gauteng province at GPS co-ordinates:
S 26° 54' 28.1", E 028° 12' 37.0"
Date : 14 May 2021
Time : 1610Z

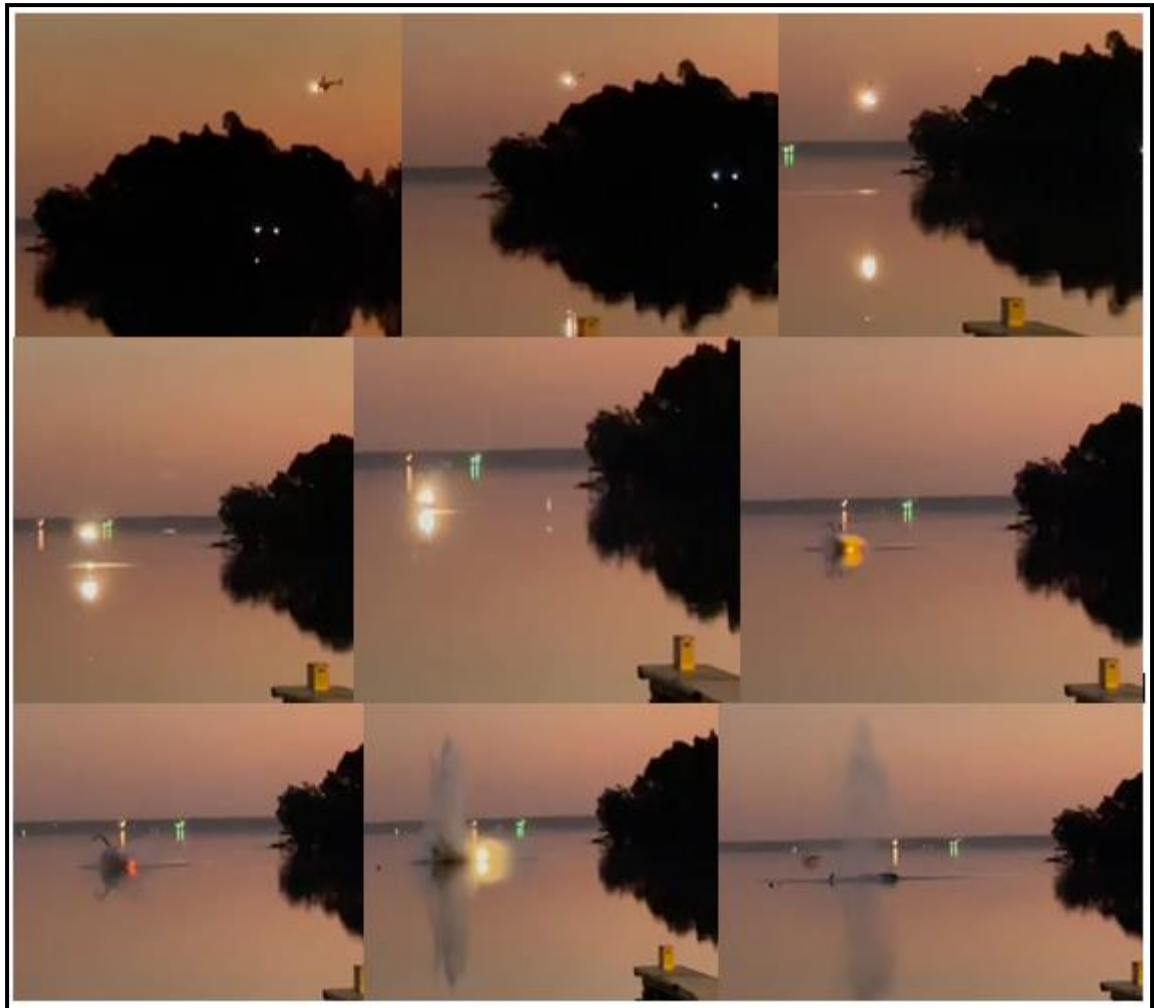
Figure 3: Stills of the video footage showing the helicopter's approach until the crash. (Source: Eyewitness)

1.1.6 The helicopter is then observed descending rapidly and very low towards the water surface while turning towards the landing site. It then struck the water surface, followed by a bright spark and a loud bang.

1.1.7 The loud bang audible from the video was attributed to the main rotor severing the tail boom section (the aft tail cone bulkhead, empennage, tail rotor gearbox and tail rotor assembly) which separated from the helicopter about a second before sinking. The helicopter lay on its right-side with the left skid gear on top before being completely submerged in water.

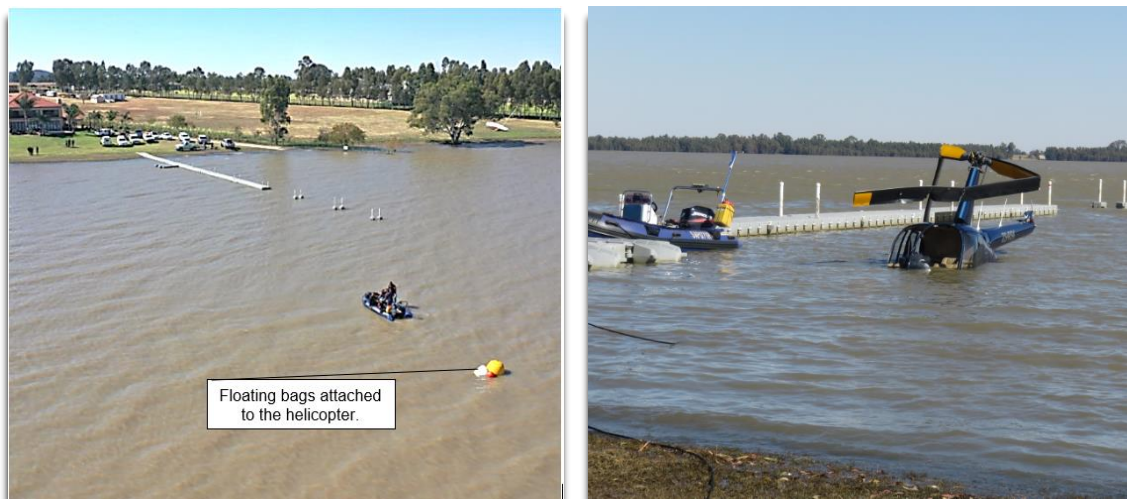
Figure 4: Left: Floating equipment attached to the helicopter; Right: The helicopter after being pulled ashore by the rescue boat.

- 1.1.9 The helicopter was recovered the next day (15 May 2021) in the same area where the pilot's body was found, about 200m from the edge of the shoreline. It was located 9.13m below the surface. Two floating lifting bags were attached to the helicopter to bring it up to the water surface and was then pulled to the shore using its skids.

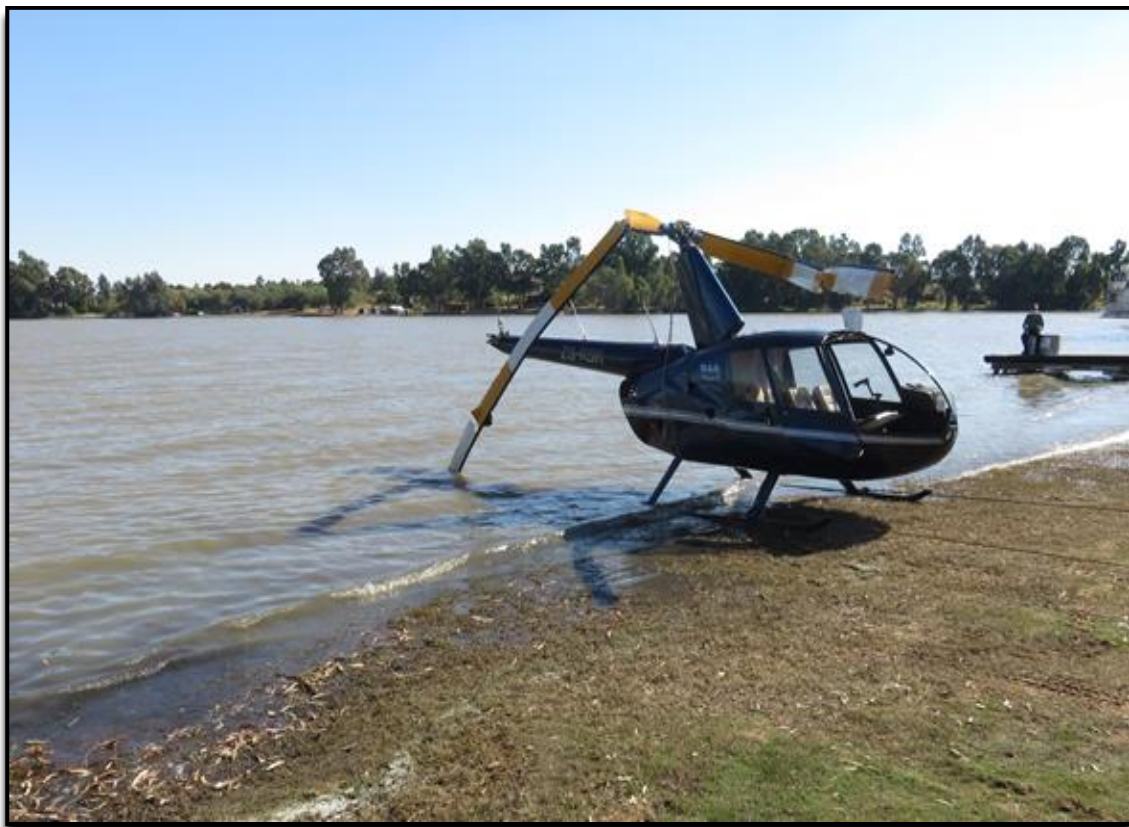
- 1.1.11 The helicopter sustained substantial damage to its fuselage structure. The main rotor blades were bent as a result of impact with water and, later, broke off after striking the aft tail-boom section. The right-side windshield had detached completely from its frame. The edges of the left-side windshield remained in the frame, with some shattered smaller pieces of the windshield glass found in the wreckage, while some larger pieces were recovered with multiple fractures.

1.3.1 The helicopter sustained substantial damage to the fuselage structure, the main rotor blades, aft tail-boom section which was severed, and the windshield during the accident sequence.

Figure 5: The accident helicopter after recovery.

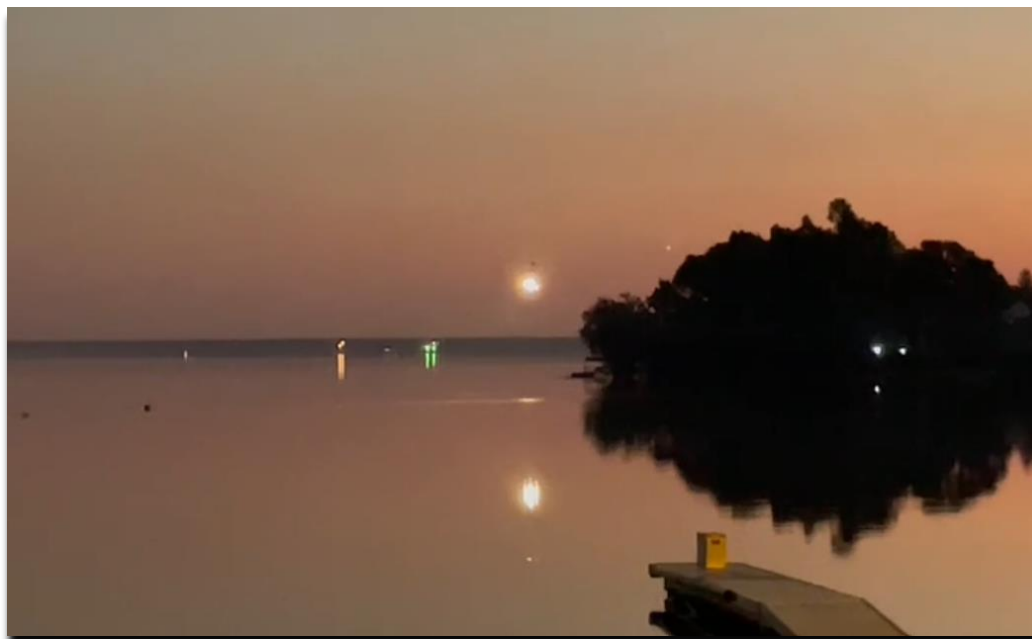
Figure 6: The image shows the calm weather conditions prevalent at the time of the accident.

1.12.1. The helicopter accident occurred at dusk during visual meteorological conditions by day over calm, glassy water surface in Vaal Marina Bay. Following impact with the water surface, the helicopter was completely submerged in water. It was only on the following day that the helicopter was recovered, oriented up-right (on its landing skid gears) from a depth of approximately 9.13m. It was attached to the floating equipment to bring it up to the water surface before being pulled out to the shoreline.

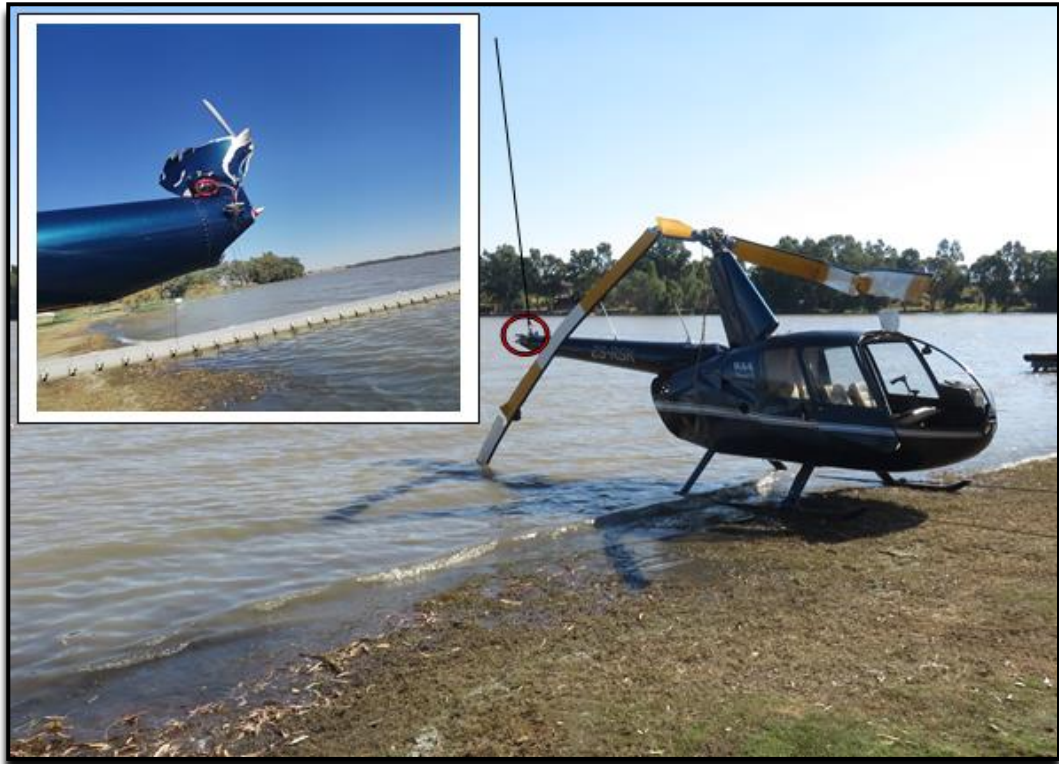
Figure 7: The severed aft tail-boom section.

- The main rotor hub and drive systems were bent towards the back, causing damage to the fire wall and the engine fuel divider. The main rotor blades were both destroyed. One of the two blades of the single main rotor severed the tail-boom aft-section near the tail navigation light. The video footage shows a high voltage spark which was concluded to have been caused by the main rotor blade's high rotation severing the strobe light on the tail cone.

- There was evidence of upward bending (coning) of the main rotor blades, indicating overpitching, which was exhibited by the compression (wrinkling) present on the main rotor blades and the backward bending caused by striking of the tail cone.

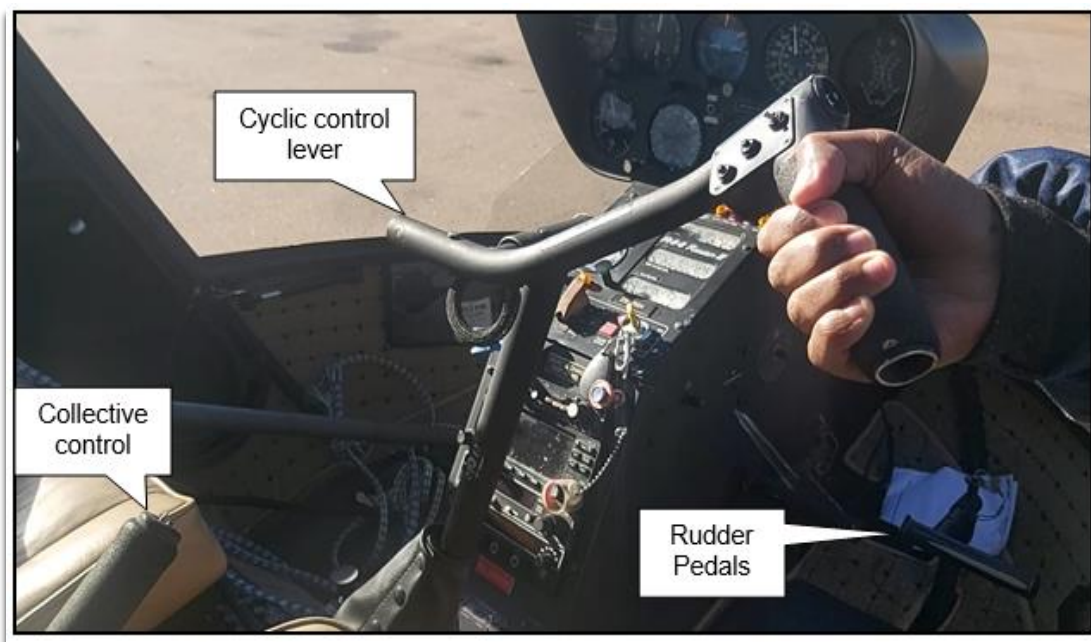
- The cyclic control lever and the two rudder pedals were only connected to the right-side of the control cockpit. This means that the pilot was flying the helicopter from the right-

side, which was expected. The extra collective lever, the cyclic and the two rudder pedals were found packed in the baggage compartment under the rear seat.

Figure 8: Controls on the right-side of the cockpit.

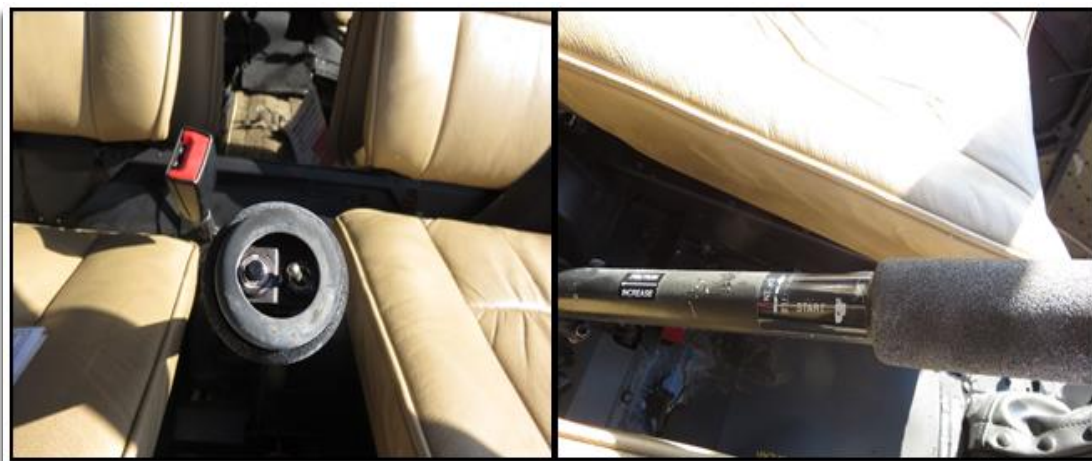
- The collective control lever was found in the full-up position. This shows that the pilot pulled the collective control lever up prior or during contact with water as it was in a descent transition.

Figure 9: The governor switch in ON position.

Figure 10: The collective controller raised at full-up position.

- The governor switch on the collective control lever was also found in ON position. The governor circuit breaker switch was found in a popped position; this could be because of impact with water.
- The engine was intact with little to no damage. There was visible damage to the fuel divider component. The third cylinder manifold outlet gasket seal was damaged due to impact forces. Following the recovery of the helicopter, the engine start-up attempt was conducted, however, the helicopter could not fully run because of the damage on the fuel divider. The damage on the engine components was due to impact forces.

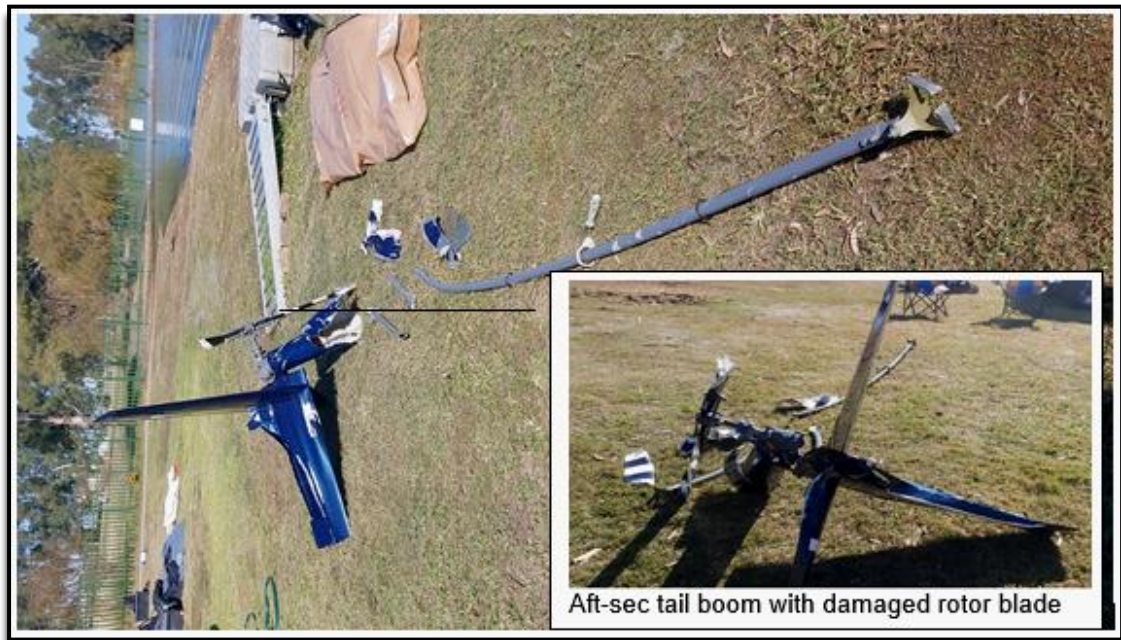
- The tail rotor shaft had detached from both the engine mounting and the tail rotor gear box attachment during impact; it got pulled through the tail-cone (tail-boom). Three pieces of the tail rotor drive shaft as well as the aft-tail boom section were distributed to the east of the main wreckage. They were recovered by the SAPS Diving Unit on Wednesday, 19 May 2021.

Figure 11: The aft-tail boom section, damaged tail rotor and the drive shaft.

- The break-up of the helicopter likely started with the main rotor blade striking and separating the tail cone from the airframe. The strike occurred while the tail rotor drive shaft was rotating; this is indicated by a section of the drive shaft with torsional failure.
- The tail rotor drive shaft had fractured into three sections between the intermediate and aft flex plate. Both flex plates had tension failure (pulled apart) and the drive shaft was pulled through the damper assembly. The separation points of the tail rotor drive shaft were examined; they displayed bending fracture failures.
- The failures of the tail rotor drive shaft in shearing indicated torsional damage towards the tail rotor. Moreover, the flex plates and rotational scoring to the drive shaft indicated that there was likely high engine power and rotor speed at the time the main rotor blades struck the tail cone.
