PRELIMINARY ACCIDENT REPORT

Accident
- Preliminary Report -
AIID Ref No: CA18/2/3/10130

Reference Number : CA18/2/3/10130
Occurrence Category : Category 1
Type of Operation : Private (Part 91)
Name of Operator : Blue Bird Aviation
Aircraft Registration : ZS-RVP
Aircraft Make and Model : Agusta Bell 206A
Nationality : South African
Place : Open grass area adjacent Runway 05 at Virginia Aerodrome
Date and Time : 2 March 2022 at 0743Z
Injuries : One of the passengers sustained minor injuries
Damage : Substantial

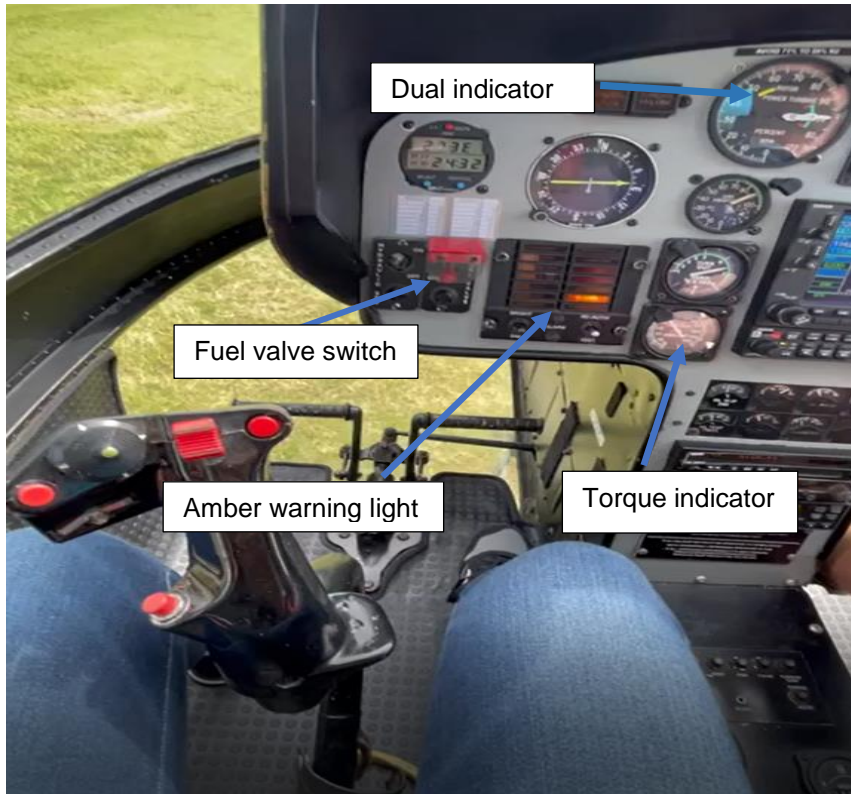
Figure 2: Arrows indicate positions of the fuel valve, torque indicator and dual gauge.
 (Source: Video footage from the passenger)

2.2.7 The passenger sitting on the front left seat was taking a video of the flight with her cellular phone. The footage showed fuel valve toggle switch in the off position, the torque indicator needle was at 50%, the dual (ERPM/RRPM) gauge indicator was in the green arch. There was an amber light in the central alerting auxiliary panel. The engine sound was clearly audible, and the engine was confirmed spooling down.

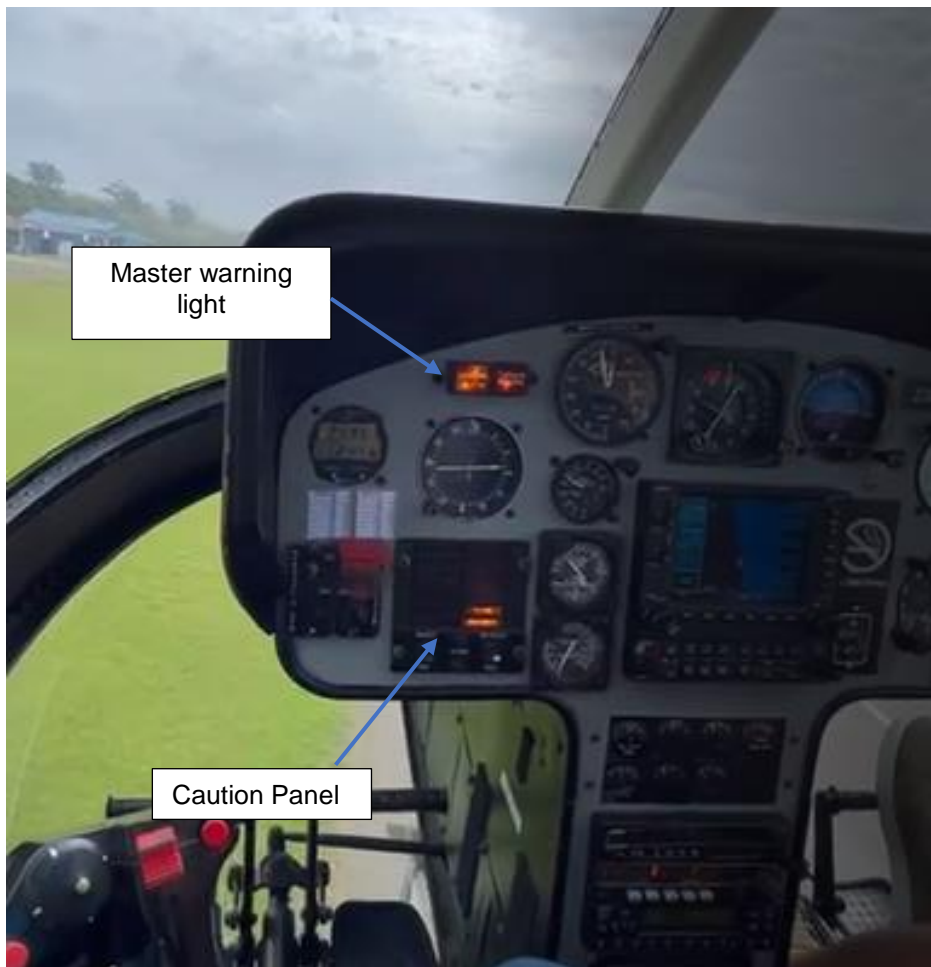
Figure 3: Master warning and caution as well as an additional caution message on the panel.
 (Source: Video footage from the passenger)

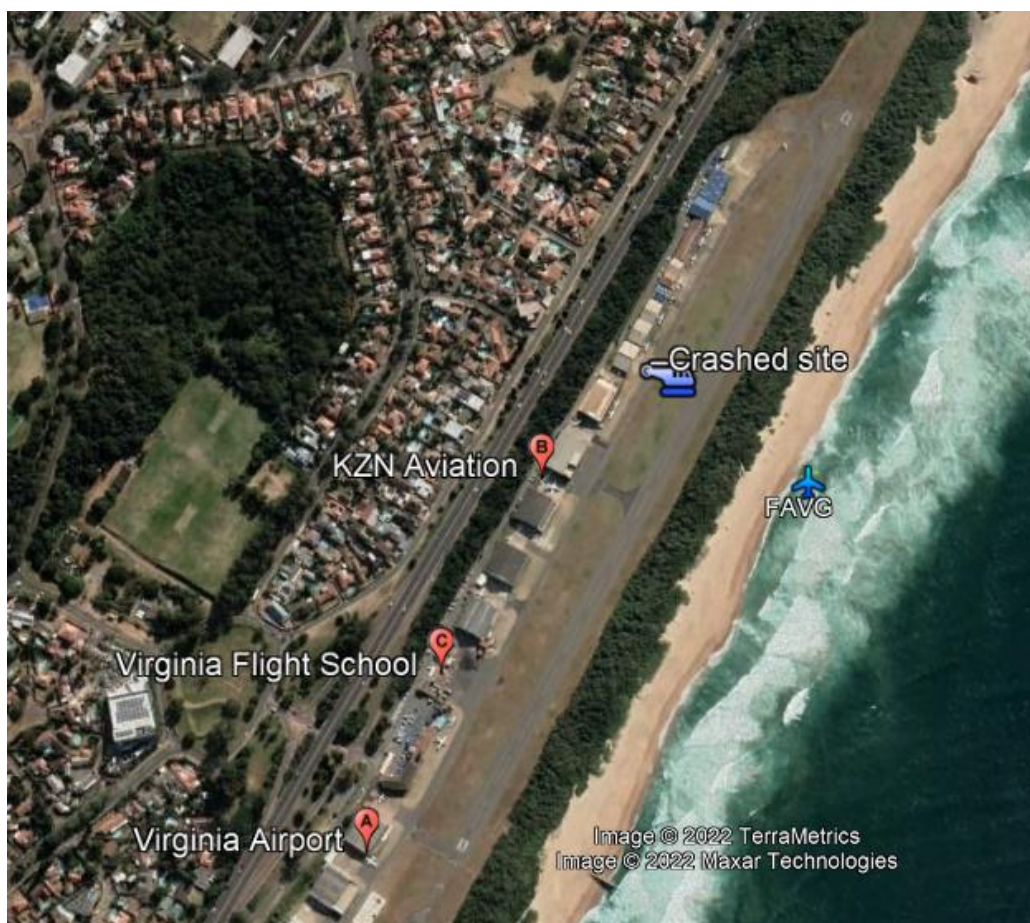
1.1.11 The accident occurred on the grass 3 metres (m) west of Runway 05 at FAVG in Durban, KwaZulu-Natal at Global Positioning System (GPS) coordinates determined to be 29° 46'14" South 031°03'30" East at elevation of 20 feet.

Figure 4: Overlay of the accident site. (Source: Google Earth)

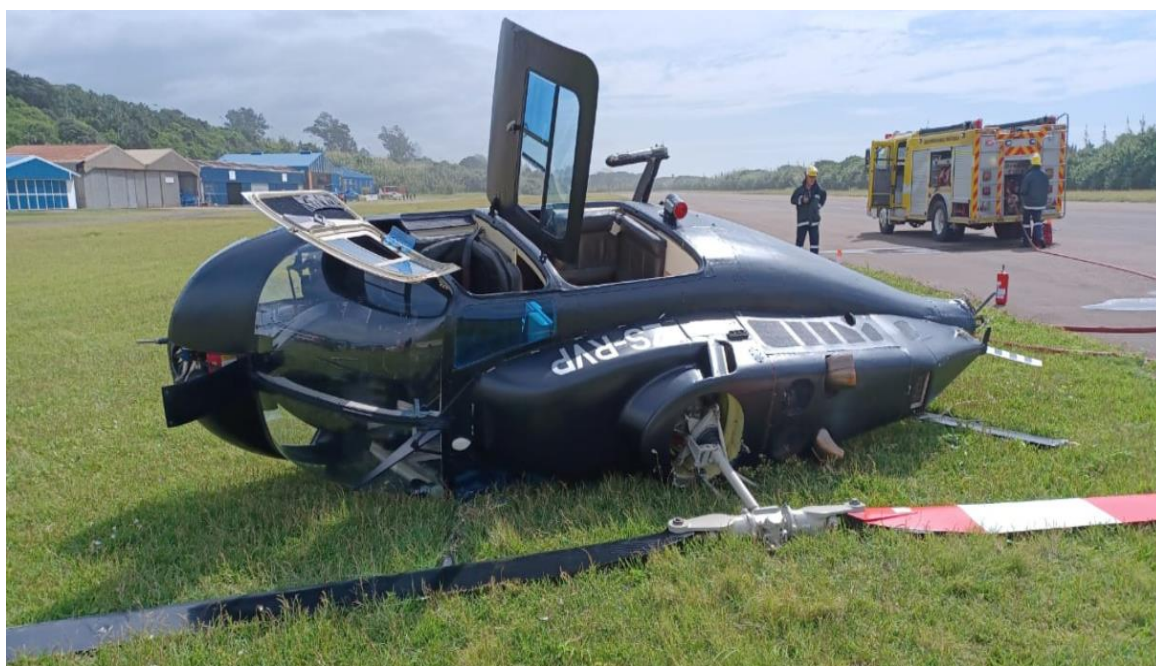
1.3.1. The helicopter was substantially damaged.

Figure 5: The helicopter as it came to rest. (Source: Johan Hattingh)

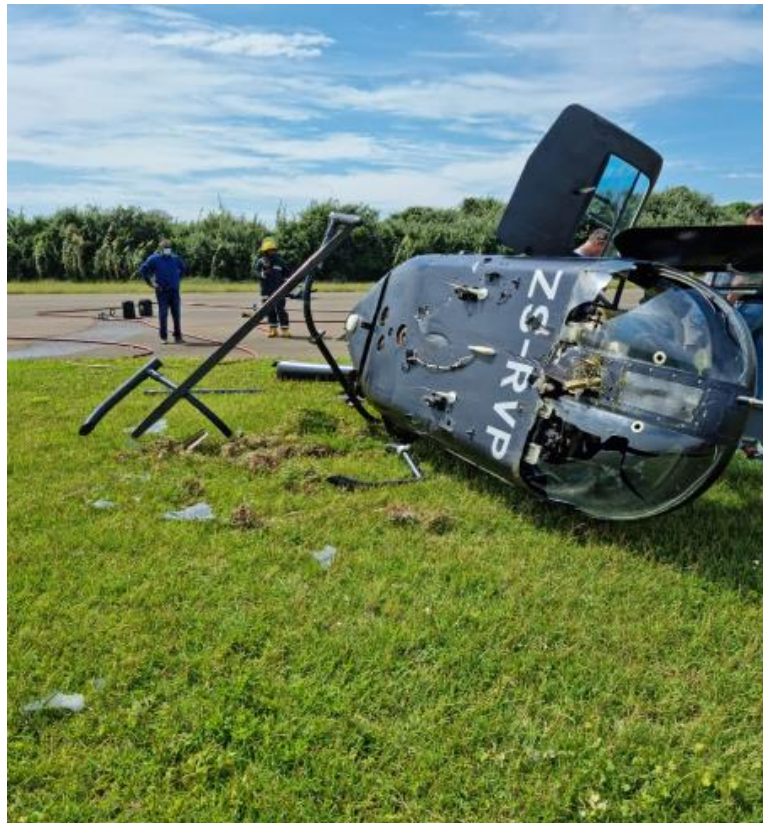
1.12.1 During transition, the pilot lost main rotor rpm and the helicopter lost height and crashed on the grass, 3m west of Runway 05. The helicopter touched down hard with the skid gears in a near level orientation. After impact, the helicopter rolled to the left with the nose on a heading of 260°. Both skid gears broke off and the front cross tube separated. The main rotor blades severed the tail boom in three parts and the tail boom separated from its attachment points. The tail cone, tail gearbox and tail rotor blades were still attached and were lying near the fuselage. The main rotor blades were still attached to the main rotor hub post-accident.

Figure 6: Main wreckage. (Source: Ronald Collyer)

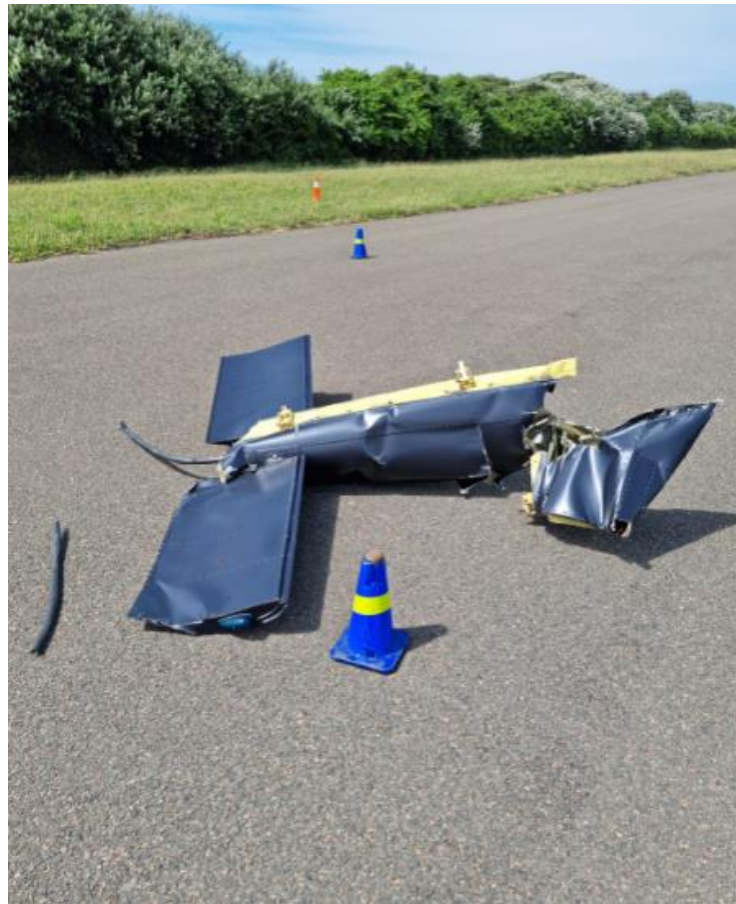
When the main rotor blades severed the tail boom, the tail drive shaft separated and broke into pieces which were scattered in different directions. The damage on the fractured skin indicated that the main rotor blades made contact with the tail boom before separating from the fuselage. The piece that was furthest was found approximately 20m east from the runway edge. The horizontal stabiliser and pieces of the control tail rotor tubes were found in the middle of the runway, east of the main wreckage.

Figure 7: Horizontal stabiliser and control tube. (Source: Ronald Collyer)

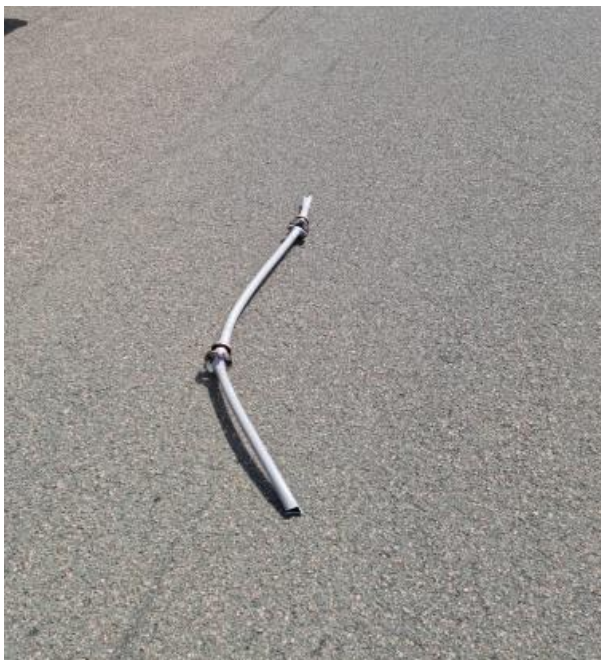
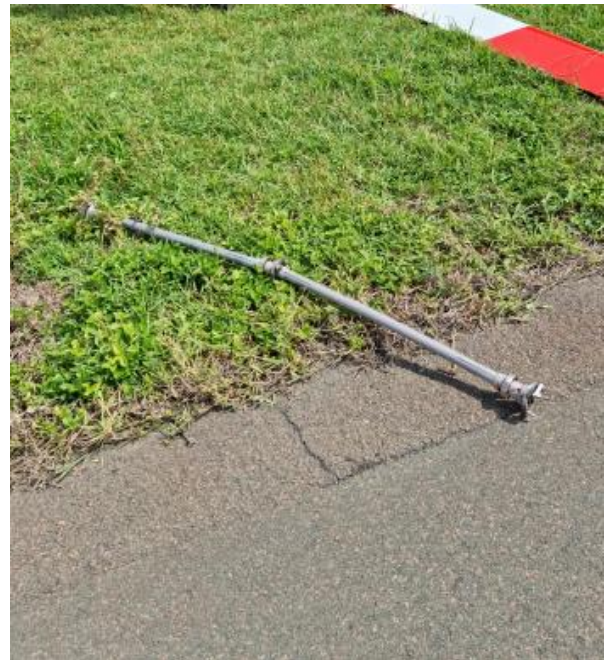
The front of the tail boom and front piece of the tail rotor drive shaft were found west of the main wreckage. The furthest part that was found east of the runway was a piece of the tail drive shaft. The tail rotor blades were still attached on the tail rotor hub and their condition was good. The control tube was severed into pieces, which were found in different locations. The continuity of the drive was confirmed between the tail gearbox and the output shaft.

Figures 8 and 9: Tail rotor shaft assemblies. (Source: Ronald Collyer)

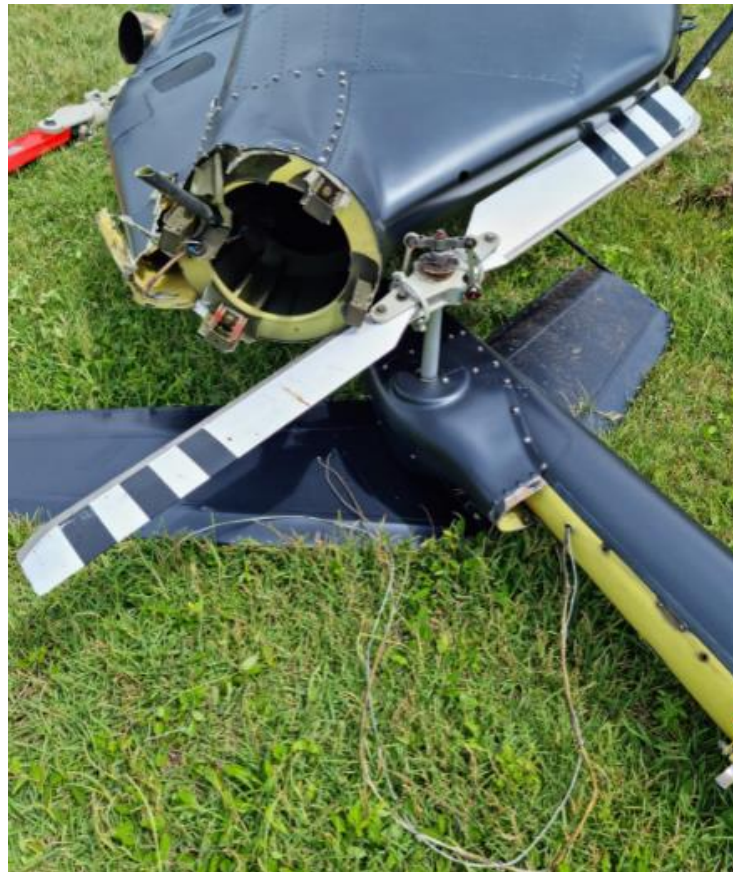
Figure 10: Tail cone with tail rotor blade attached. (Source: Ronald Collyer)
