**LIMITED INCIDENT INVESTIGATION REPORT**

<b>Reference Number</b>	CA18/3/2/1393						
<b>Classification</b>	Incident	<b>Date</b>	6 April 2022	<b>Time</b>	1752Z		
<b>Type of Operation</b>	Training (Part 141)						
<b>Location</b>							
<b>Place of Departure</b>	Wonderboom Aerodrome (FAWB), Gauteng Province			<b>Place of Intended Landing</b>	Wonderboom Aerodrome (FAWB), Gauteng Province		
<b>Place of Accident</b>	On Moloto Road, approximately 9km east of FAWB, Gauteng Province						
<b>GPS Co-ordinates</b>	<b>Latitude</b>	25°39'23.9" S	<b>Longitude</b>	28°18'06.4" E	<b>Elevation</b>	3464.6ft	
<b>Aircraft Information</b>							
<b>Registration</b>	ZS-SBN						
<b>Model/Make</b>	Cessna 172M Skyhawk (Serial Number:17266104)						
<b>Damage to Aircraft</b>	Minor	<b>Total Aircraft Hours</b>			8 898.7		
<b>Pilot-in-command</b>							
<b>Licence Valid</b>	Yes	<b>Gender</b>	Male	<b>Age</b>	23		
<b>Licence Type</b>	Commercial Pilot Licence (CPL) Aeroplane

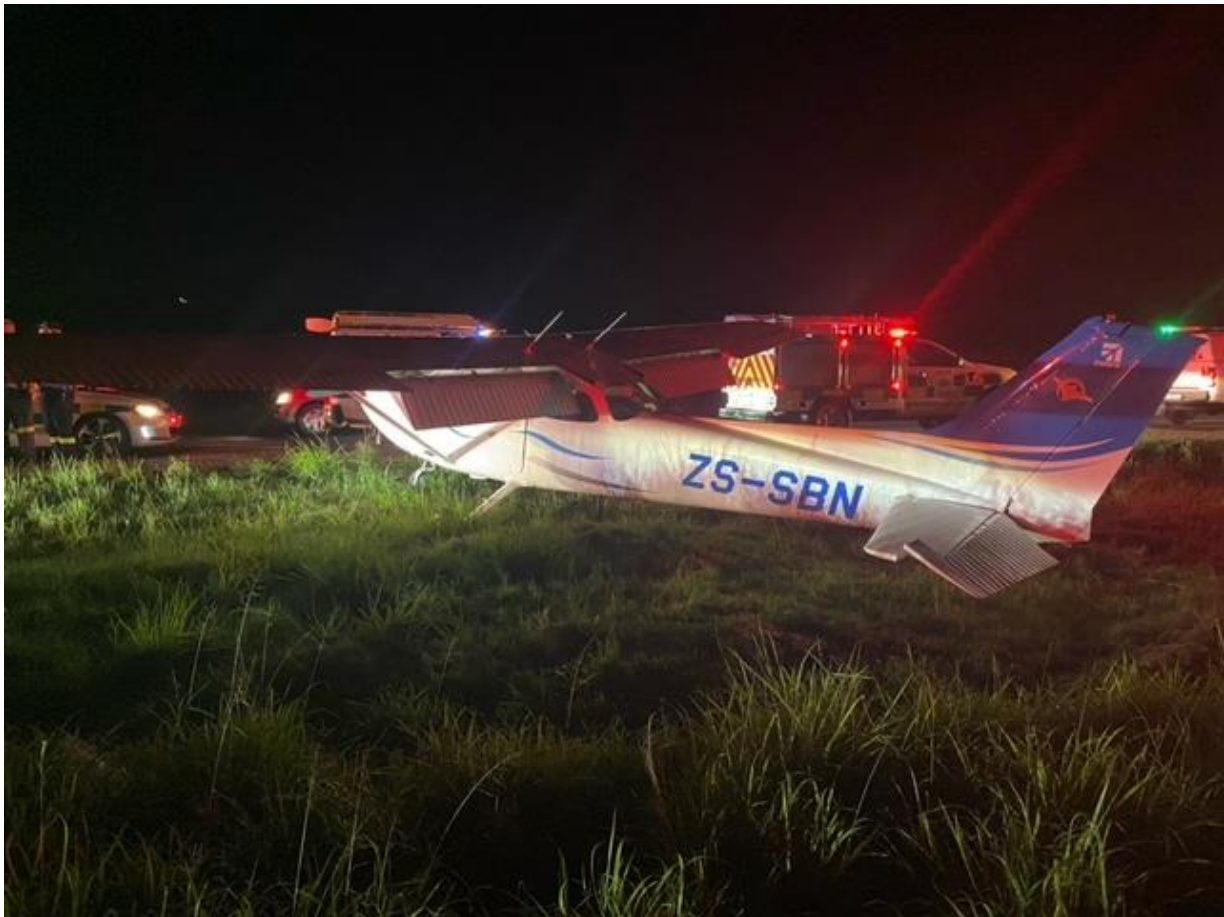
The aircraft sustained minor damage and both occupants were not injured.

**Figure 1:** The aircraft as found at the incident site.

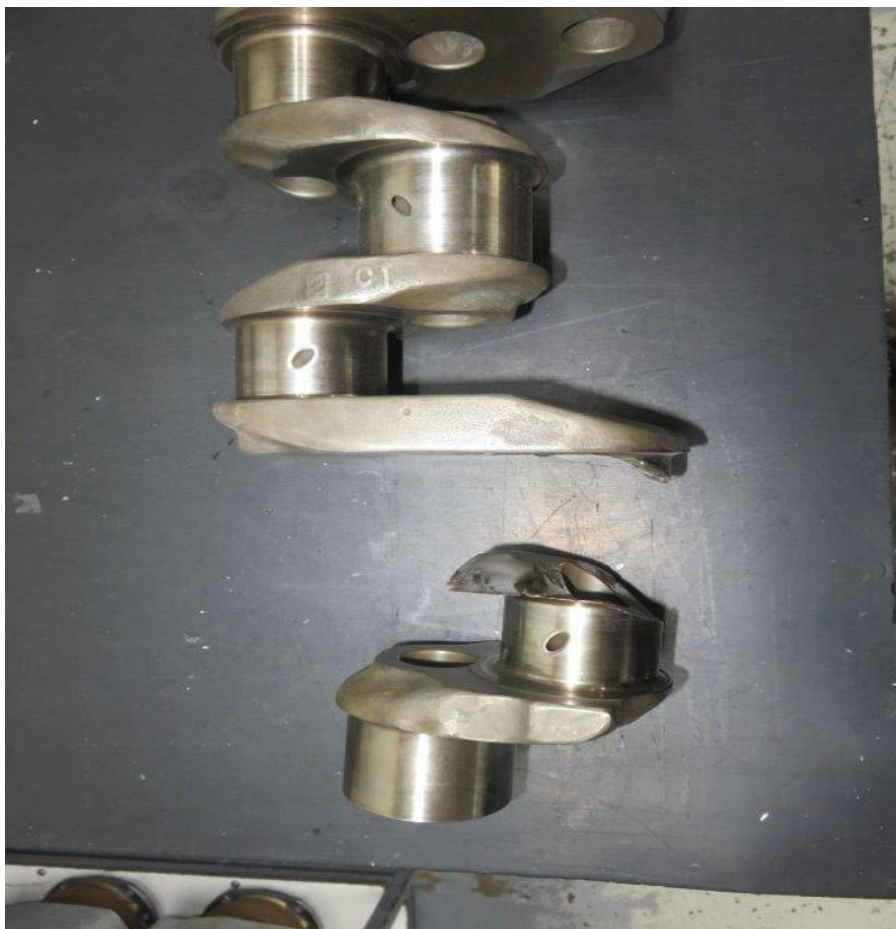
The investigation revealed that the engine crankshaft broke or failed at the No.4 connecting rod/cylinder journal area.

**Figure 2:** The crankshaft showing the area where the failure occurred.

- After the teardown inspection of the engine, the AMO reported that the crankshaft broke off at the connecting rod journal No.4; the broken crankshaft shifted to the rear of the engine and broke the idler gear between the camshaft and crankshaft. The AMO stated that they could not determine the cause of the breakage.

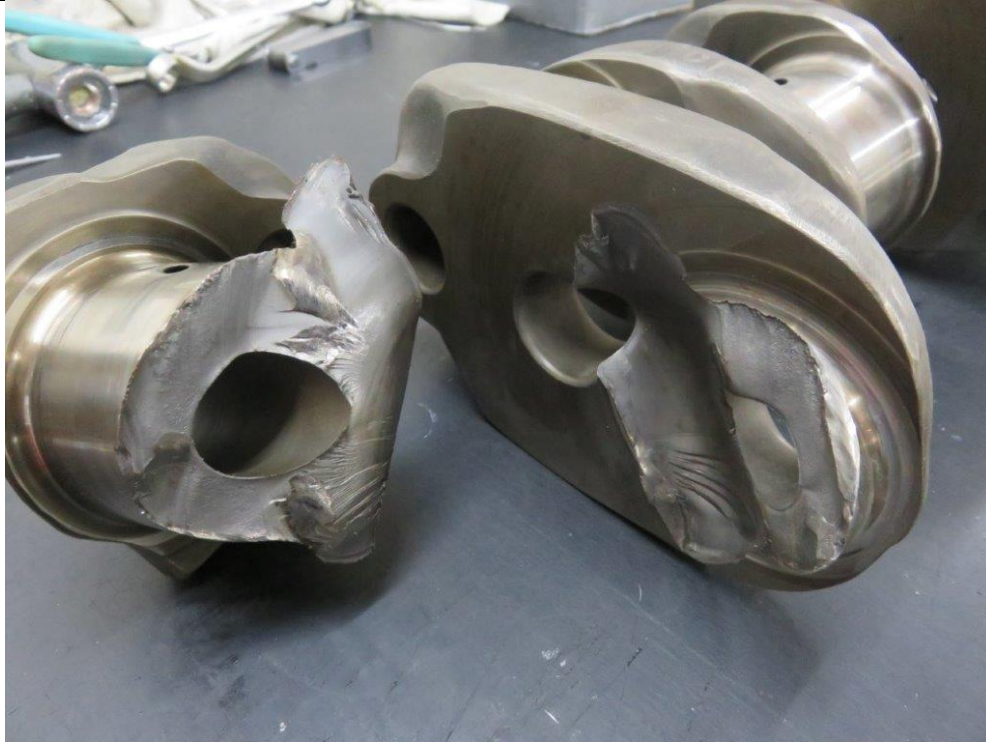
**Figure 3:** A closer view of the crankshaft showing the area where the failure occurred.

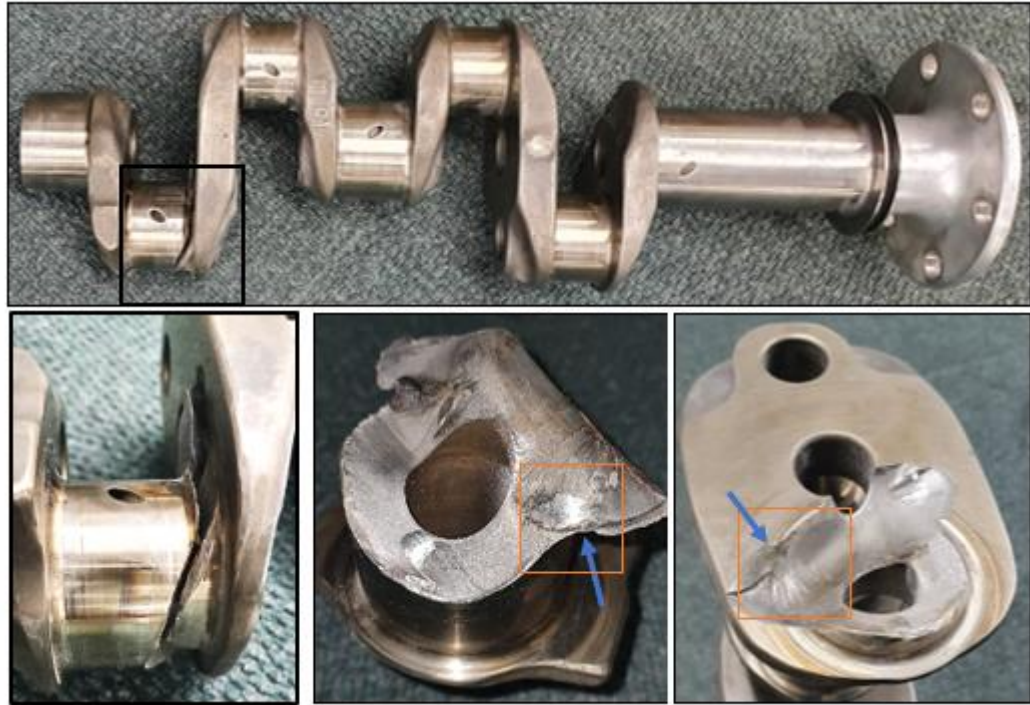
- Examination of the crankshaft revealed that it had fractured at the No.4 connecting rod journal because of fatigue cracking (see Figure 4).

**Figure 4:** The initiation site and progression marks associated with fatigue crack growth indicated by the blue arrow.

- Fatigue cracking initiated at the transition between the No.6 journal surface and the fillet of the crankarm between the No.6/No.5 connecting rod journals. The region of the fatigue fracture surface had localised deformations which are distinctive fatigue progression marks that are 'step-like', extending from the site of initiation to the surface. These marks are created by major changes in the alternating loading spectrum. Typically, for engine crankshafts, they are associated with engine start/stop cycles. The magnetic particle inspection was conducted on 3 May 2021 and there were no cracks detected. According to the information in the flight folio, the aircraft had approximately 51 start/stop cycles since the last magnetic particle inspection. It was estimated that fatigue crack growth had occurred over a period of at least 51 engine start/stop cycles.

The engine crankshaft failed due to fatigue, which resulted in engine stoppage and prompted the pilot to carry out a forced landing, which was successful.
