**PRELIMINARY ACCIDENT REPORT**

Accident  
- Preliminary Report -  
AIID Ref No: CA18/2/3/10041

**Reference Number** : CA18/2/3/10041  
**Name of Owner** : Impuma Group (PTY) LTD  
**Manufacturer** : Gates Learjet Corporation  
**Model** : 35A  
**Nationality** : South African  
**Registration Marks** : ZS-SFV  
**Place** : Lanseria International Airport (FALA), Gauteng Province  
**Date** : 20 September 2021  
**Time** : 1840Z

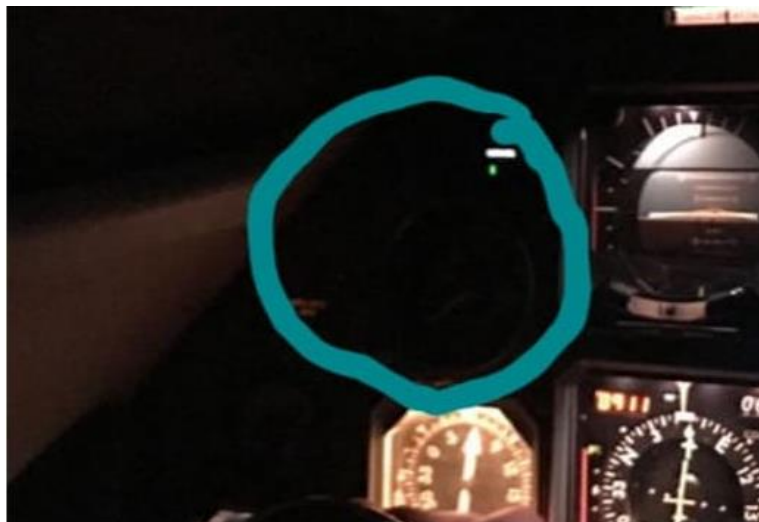
- 1.1.5 Because the PF's side air speed indicator backlight was not readable, the PF handed over control of the aircraft to the PM, who was then tasked with undertaking the landing of the aircraft. However, a further challenge was that the master warning light could not be reset from the PF's side and could only be reset from the PM's side. This meant that the PF was not able to reset the master warning indicator (which had illuminated) from his side of the cockpit nor was he able to reach the switch to reset it on the PM's side of the cockpit. The crew then took a decision to retain control of the aircraft at the PF's side and to undertake landing.

**Figure 2:** Air speed indicator backlight that was unserviceable.

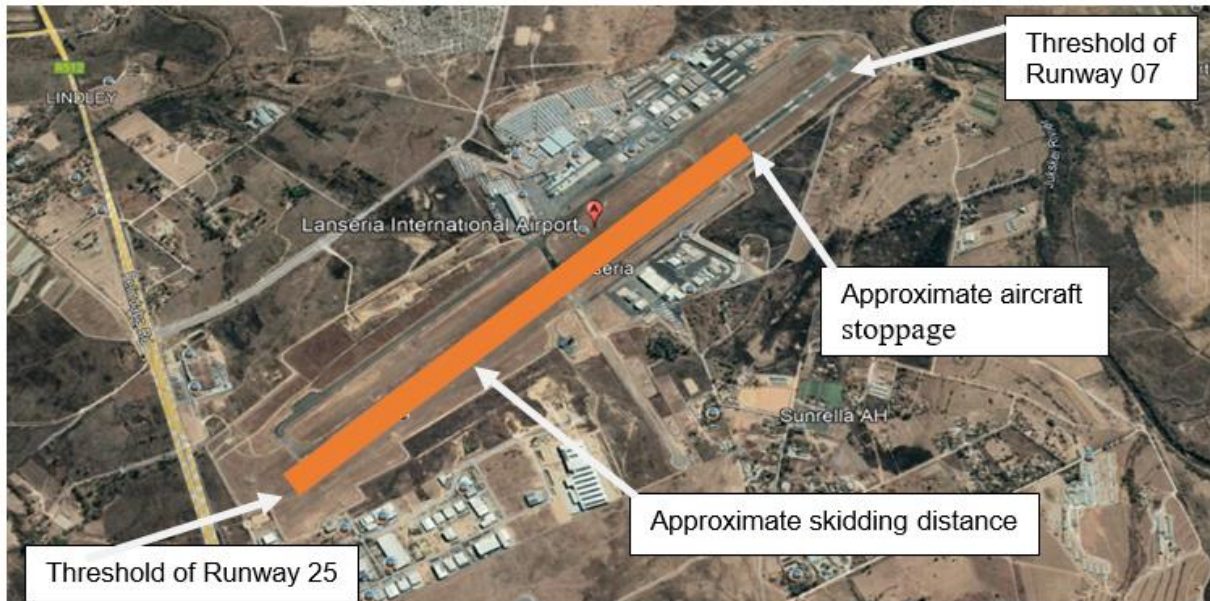
**Figure 3:** The approximate skidding distance of the aircraft during the accident.  
(Source: Google Earth).

1.12.1.1 The aircraft touched down on its belly with the landing gears retracted on the threshold of Runway 25; it skidded for approximately 2km in a nose-up attitude. There was no damage on the nose section. The accident was located on a heading of approximately 240 degrees (°) magnetic (MAG).

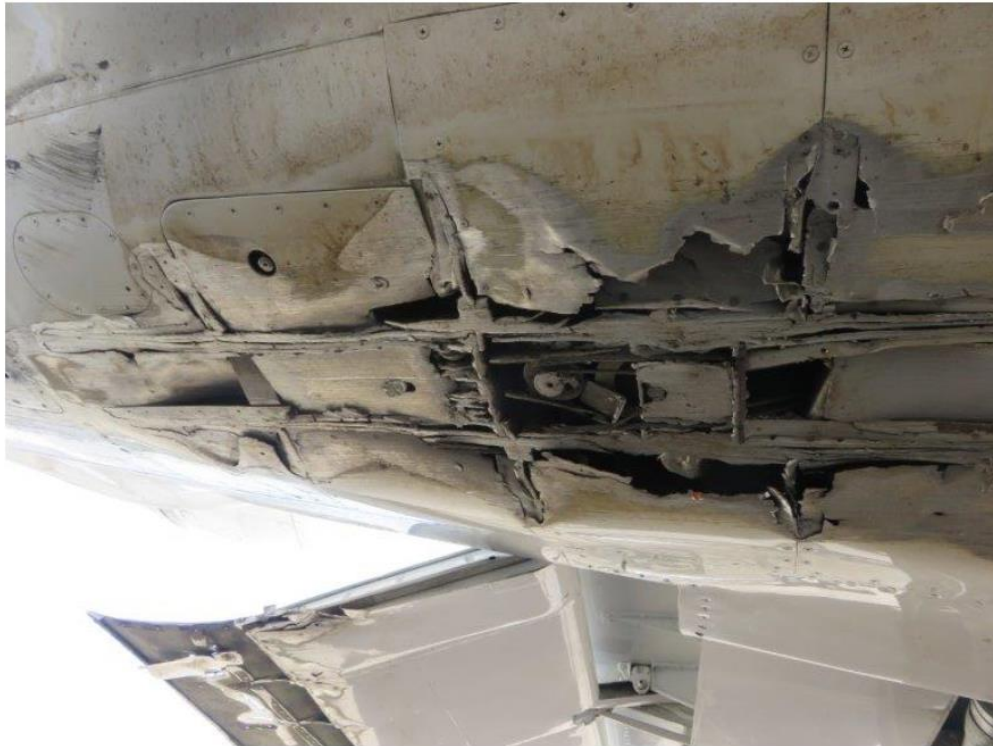
1.3.1 The aircraft was substantially damaged during the accident sequence.

**Figure 4:** The damage underbelly and flaps.

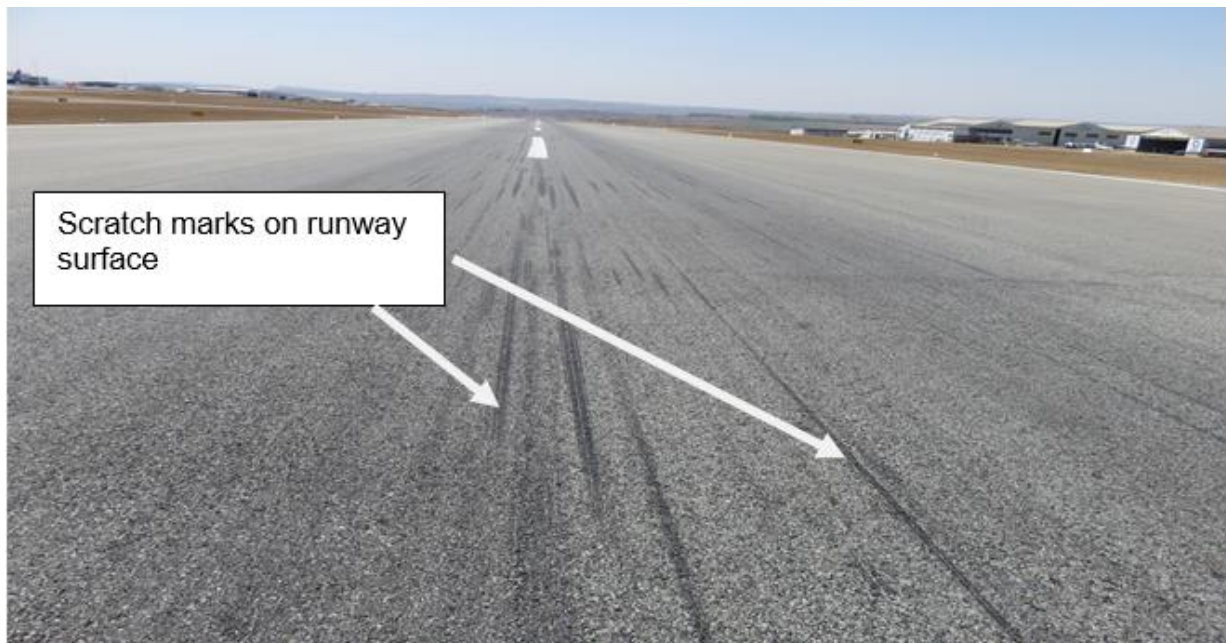
1.4.1 The runway surface was slightly damaged because of the accident.

**Figure 5:** Scratch marks on runway surface at FALA.

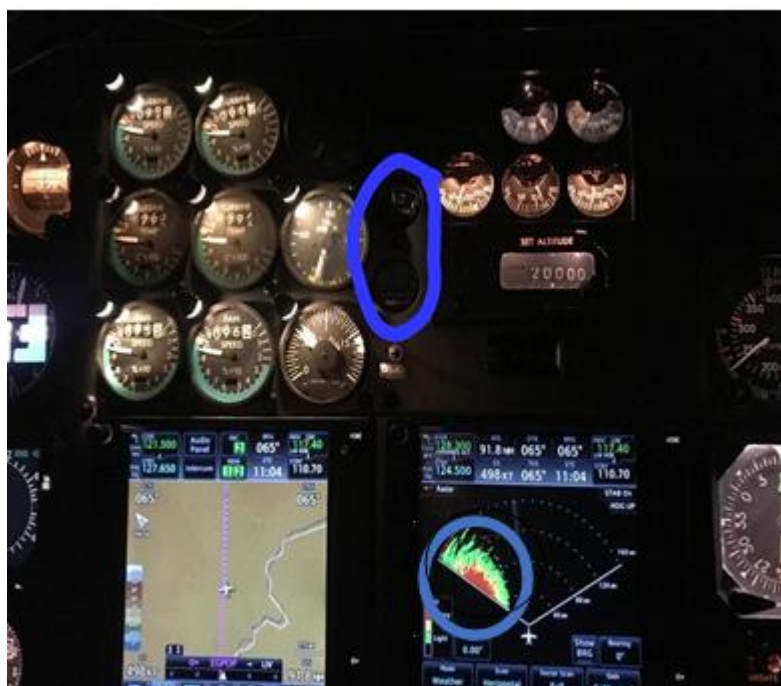
- On 20 September 2021 during the accident flight from FACT to FALA, the following major defects were recorded:
  - a) Augmentation aileron failed when the flaps were set at 45°.
  - b) Autopilot did not track Navigation.
  - c) Left-side stall master warning activated.
  - d) Left-side generator failed, amber caution illuminated.
  - e) Emergency air indicator light unserviceable (see Figure 6)
  - f) Radar paints left low.
  - g) Master landing gear warning unserviceable.

**Figure 6:** Emergency air unserviceable and radar paints left.

1.6.7 The aircraft had recurring safety defects which were not permanently rectified, and no records showed that the AMO tried to get assistance from the manufacturer regarding the defects. According to the AME statement, “*defects rectifying is done after troubleshooting has been carried out IAW Maintenance Manual. If defects are listed on Flight Folio, same principle would apply but at times rectification would be summarised because of space issues. Signing off on the work pack would be done in detail after work has been carried out in-house or by a subcontractor with their release documents referenced*”. See Annexure C.

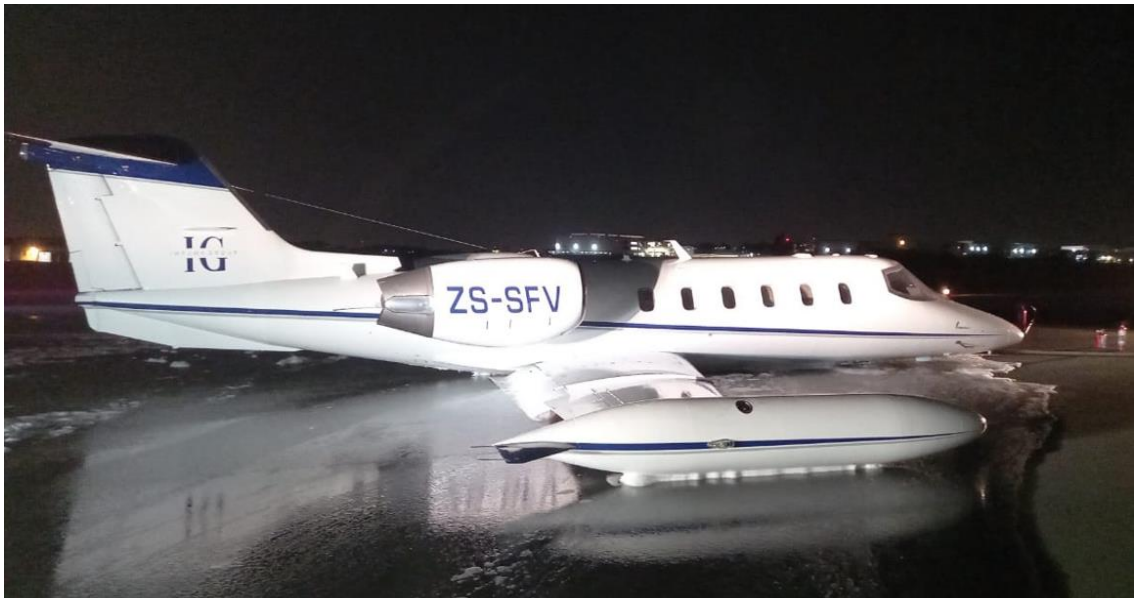
**Figure 7:** The ZS-SFV aircraft as it came to rest on its belly on the runway. (Source: AMO)

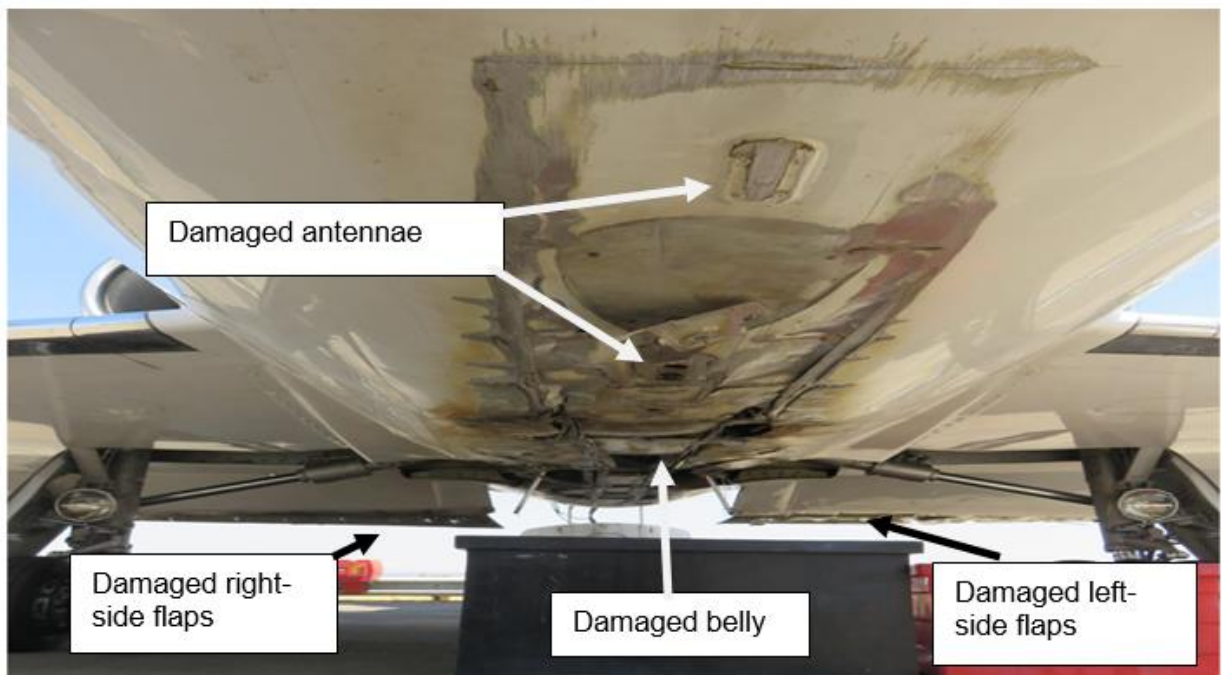
1.12.2 On-site investigation found that the aircraft sustained damages on the flaps, antennae and underbelly.

**Figure 8:** Aircraft damages post-accident.

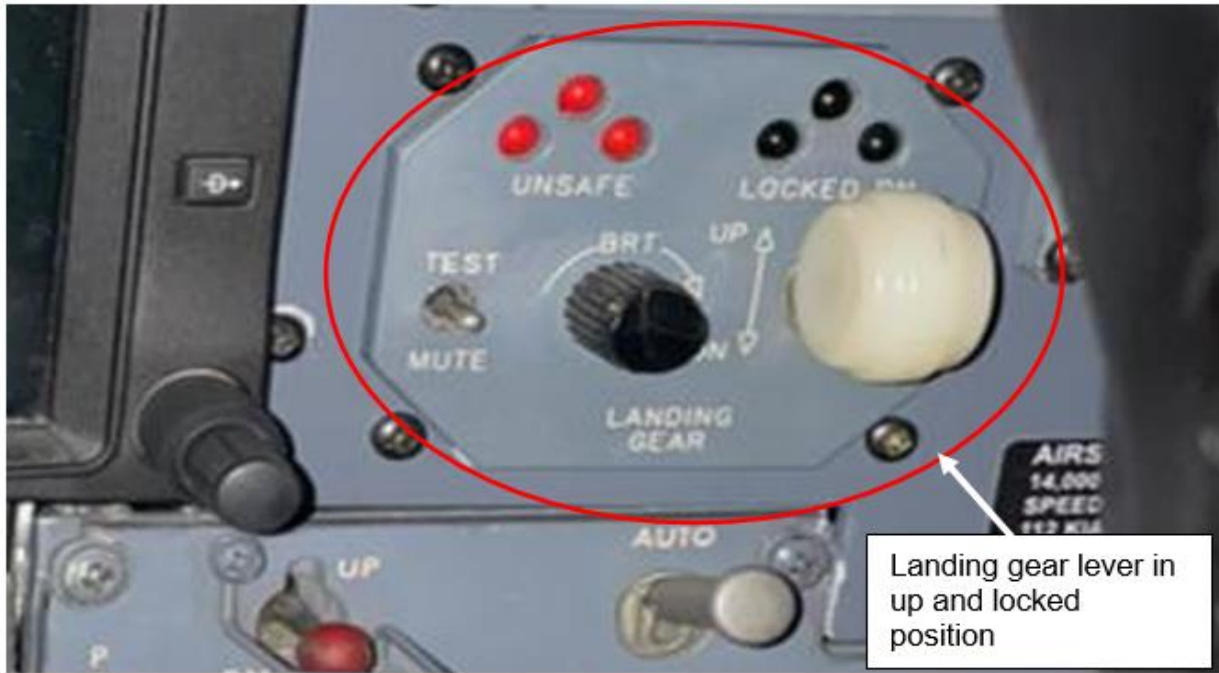
1.12.3 According to the AMO, the landing gear lever was found in up and locked position.

**Figure 9:** Landing gear lever in up and locked position. (Source: AMO)

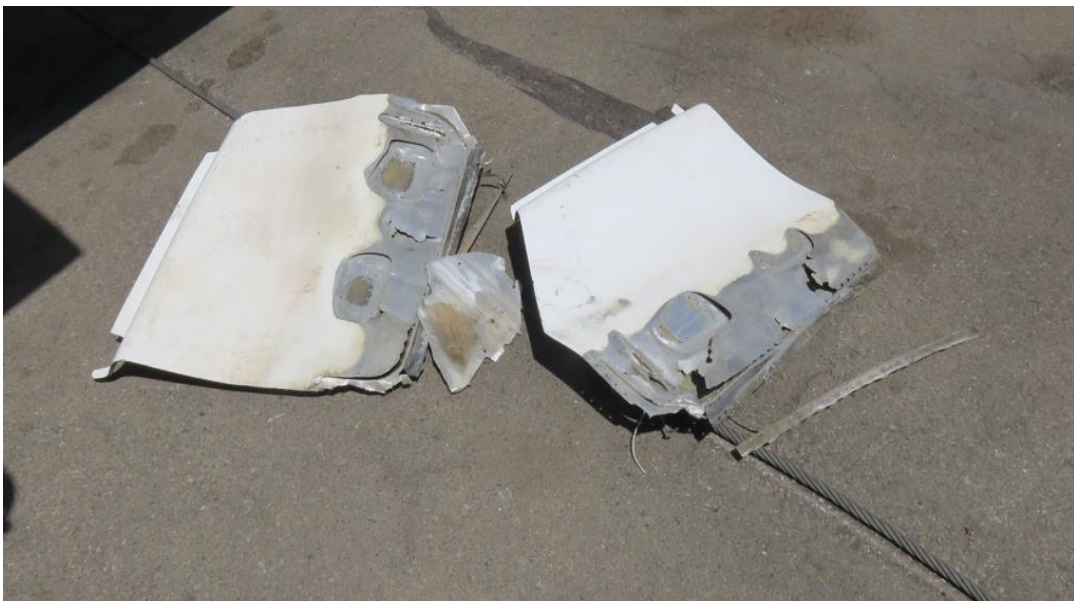
1.12.4 During an on-site investigation, it was found that the left-side and right-side main landing gear doors were damaged during the accident sequence.

**Figure 10:** Damaged main landing gear doors.

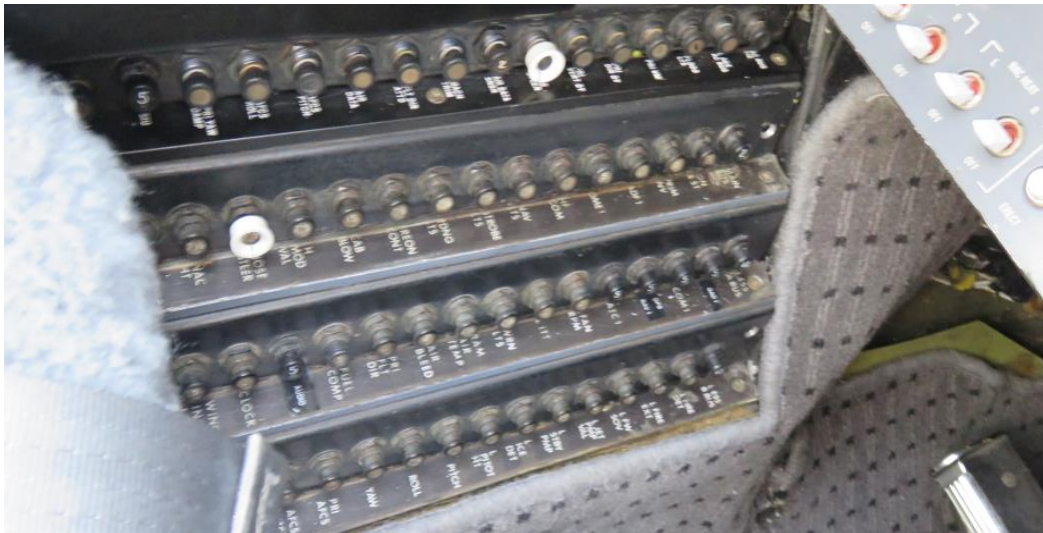
1.12.5 During an on-site investigation, it was also found that all circuit breakers (CBs) were in closed position.

**Figure 11:** All circuit breakers were in a closed position.

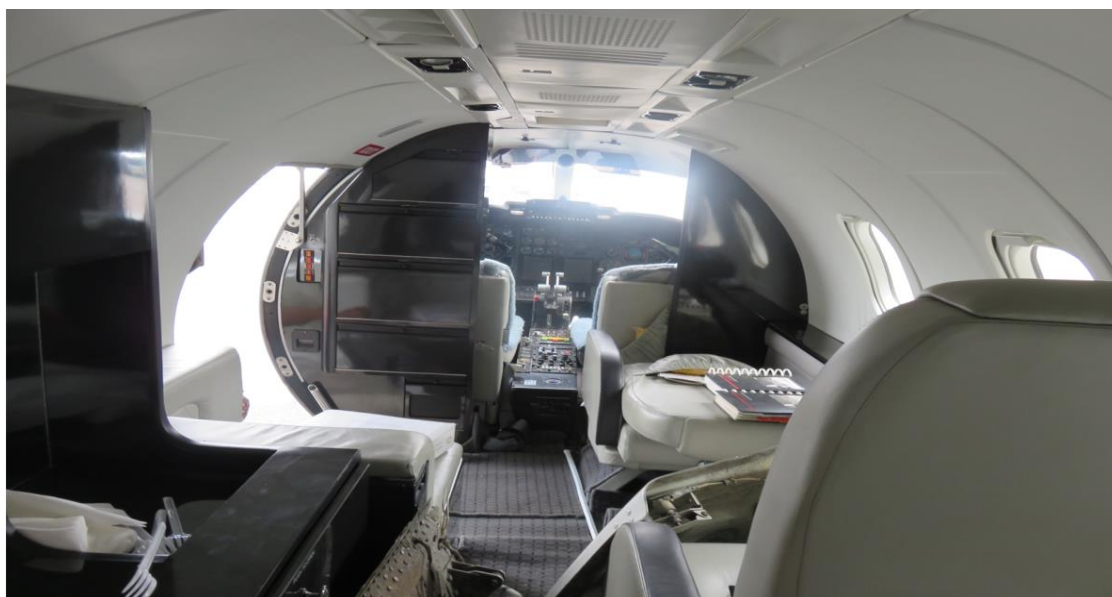
1.15.1 The accident was considered survivable as no damage was caused to the cockpit and cabin structure of the aircraft.

**Figure 12:** Cockpit and Cabin structure still intact.
