PRELIMINARY ACCIDENT REPORT

Accident
- Preliminary Report -
AIID Ref No: CA18/2/3/9946

Reference Number : CA18/2/3/ 9946
Name of Owner/Operator : Proman Lugbespruiting (PTY) LTD
Manufacturer : Air Tractor Inc
Model : AT-402B
Nationality : South African
Registration Marks : ZS-TCJ
Place : Private farm in Sardinia, Bultfontein, Free State Province at GPS co-ordinates: S 28° 04' 56", E 026° 05' 37" and at a field elevation of 4214ft
Date : 21 January 2021
Time : 1545Z

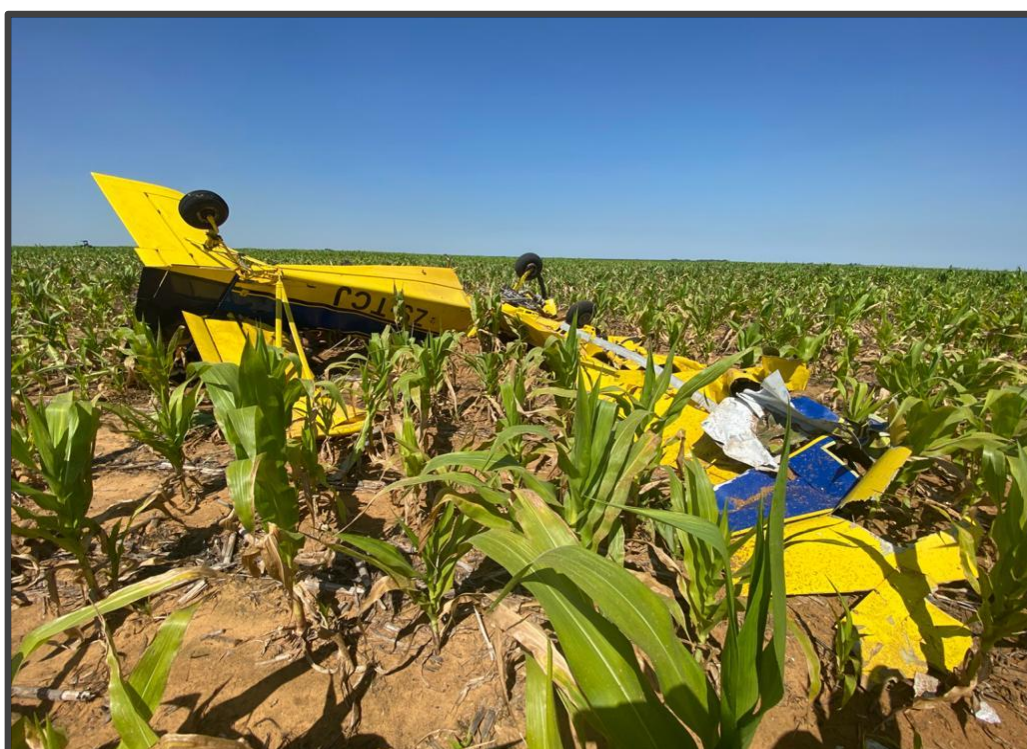
1.3.1 The aircraft was destroyed during the impact sequence.

Figure 3: The wreckage post-accident.

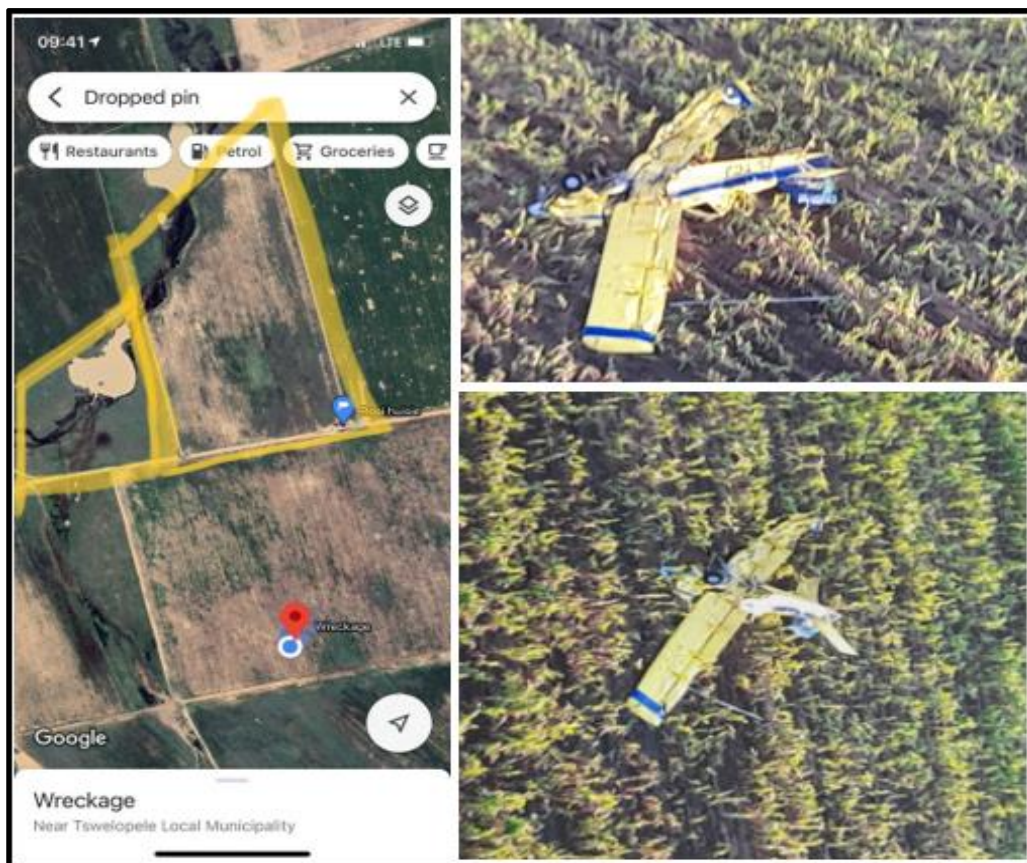
Figure 4: The area where the aircraft was operating (left); the wreckage as it was found at the accident site (right).

- The crater of the ground scars where the aircraft impacted the ground was limited to where the aircraft was found. This is indicative of an aircraft which was at a high angle of impact when it made contact with the ground with its left-wing tip and the nose at an inverted attitude.
- The aircraft impacted the ground with the top part of the left-wing leading-edge, the left top part of the nose section and the left fuselage part of the cockpit section. These damages are indicative of an aircraft that stalled while in a turn and impacted the ground in an inverted attitude.

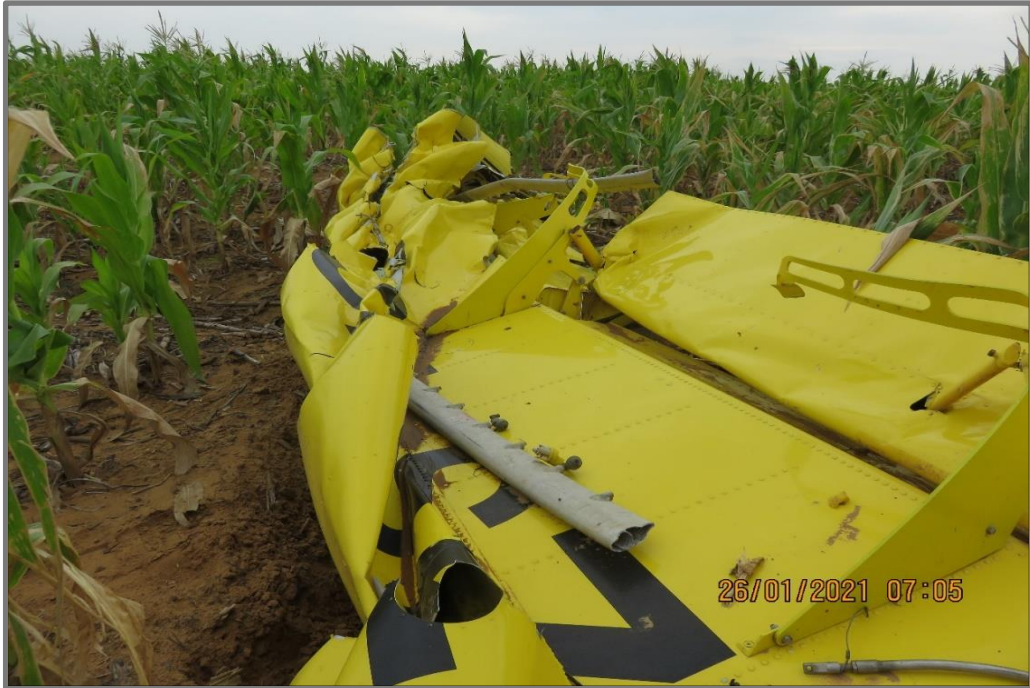
- The left-wing damage indicated a downward folding of the leading-edge with more damage on the wing tip. Impact with the ground was from the top front part of the wing.
- The left-side of the cockpit, towards the top of the nose section, was affected by impact forces. The top left-side of the nose section also showed damages caused by hard impact with the ground, creating a crater. The nose section had some downwards twist deformation.

Figure 5: The damaged left wing due to impact.

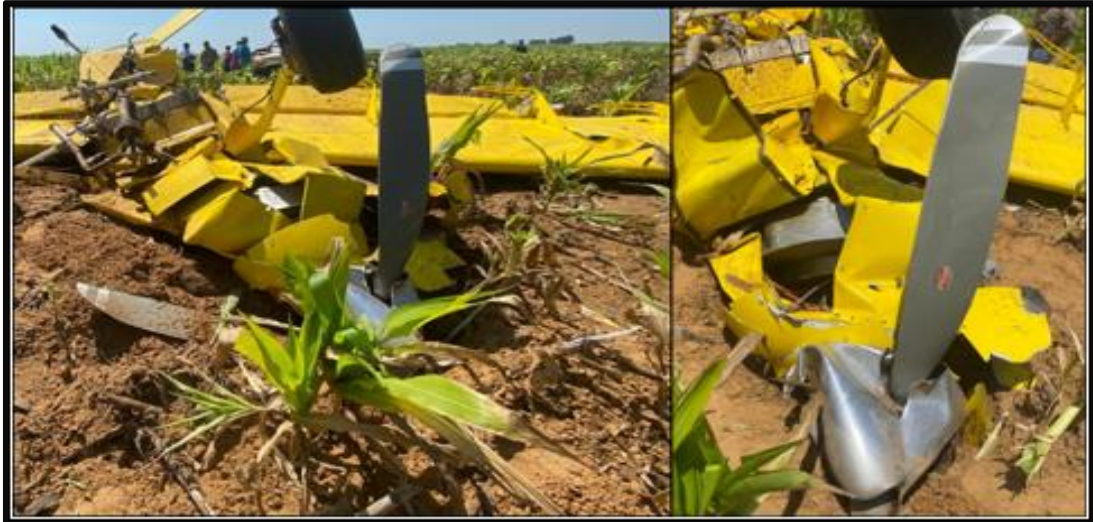
- The propeller hub was destroyed due to impact with the ground. One of the three propeller blades had broken off. The propeller hub and the blade that broke off were found lodged into the soil. The damage on the propeller indicated that the engine was turning with power at the time of impact.

Figure 6: The damaged propeller.

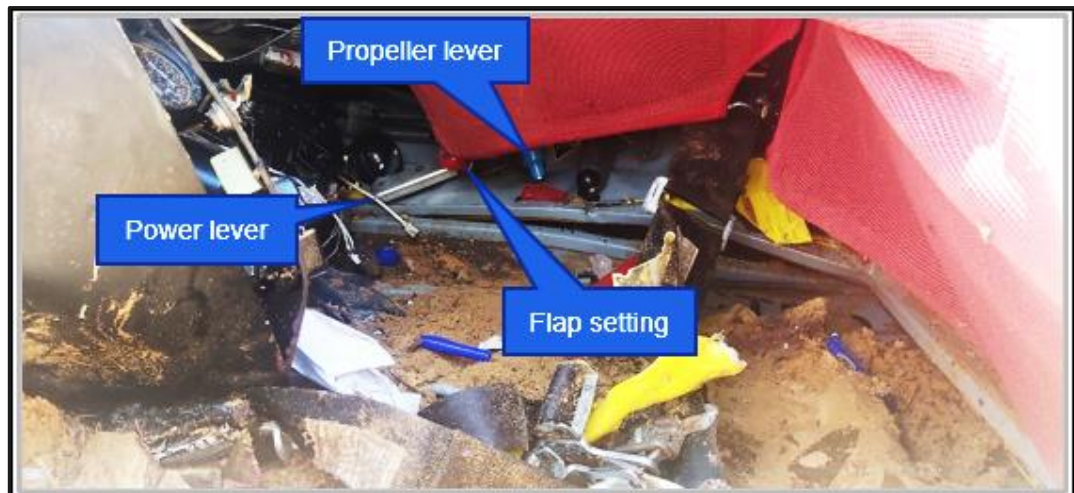
Figure 7: The aircraft's engine, propeller and flaps controls.

- All engine controls were still connected, and continuity was established. The throttle control was found in a full forward position. The propeller pitch control lever was found in a rear position and the propeller mechanism was found engaged in a flight mode position of the propeller settings.

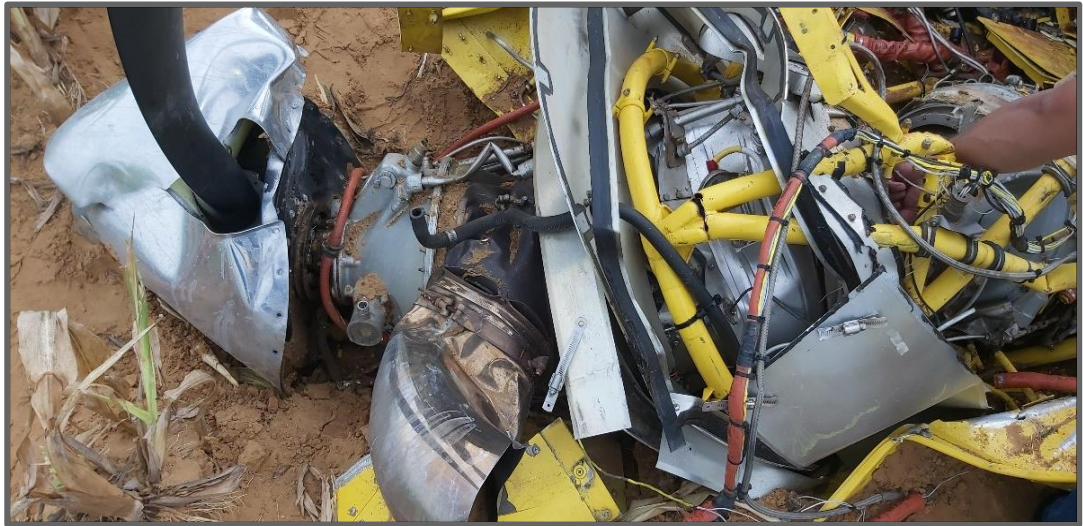
- The nose section was destroyed with damages extending to the engine. The engine was destroyed, with three separated sections. The damages were extensive on the nose section, which caused the compressor section to separate.

Figure 7: The engine damage post-accident.

- Turbine blades were found protruding from the exhaust pipes. Also, there was damage observed on the compressor blades in the compressor section that had separated from the engine due to impact sequence. Damages on both the compressor and the turbine blades were consistent with damages caused while the engine was turning with power during the impact sequence.

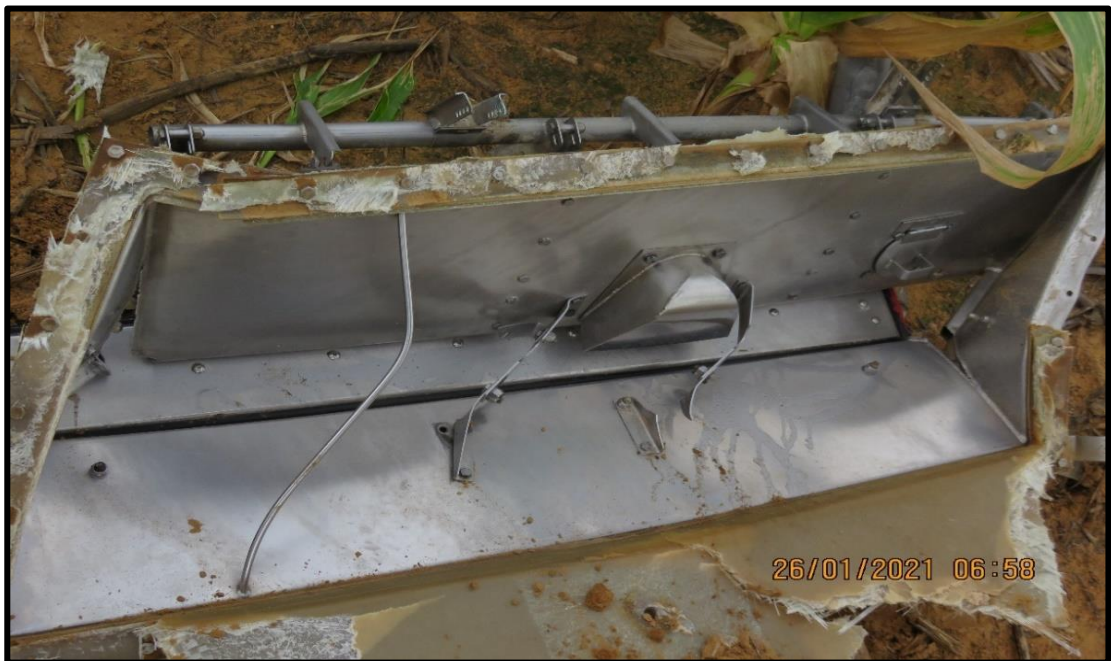
Figure 8: The hooper gate of the aircraft.

1.12.4 The hooper emergency dumb gate (door) was found in a “close” and “locked” position. This door is used in emergency situation/drills in case of an engine failure to help reduce the aircraft’s weight by dumping the crop-spraying solution.
