**PRELIMINARY ACCIDENT REPORT**

**Accident and Incident Investigations Division**

Accident  
- Preliminary Report -  
AIID Ref No: CA18/2/3/10167

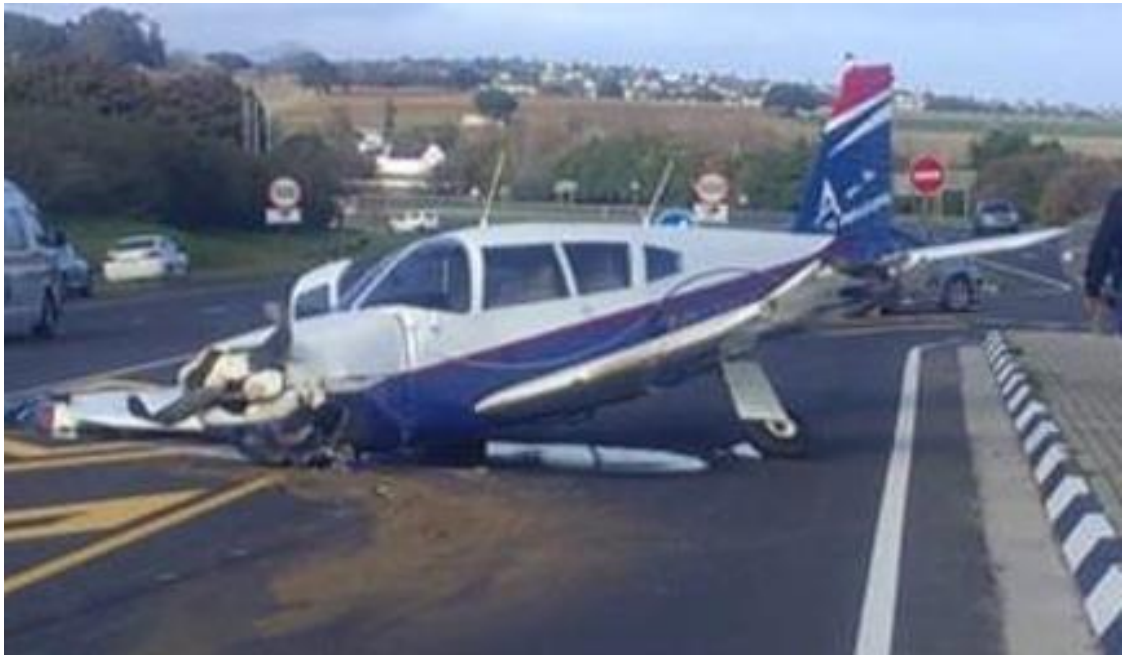
1.3.1. The aircraft was destroyed during the accident sequence.

**Figure 3:** The aircraft at the accident site.

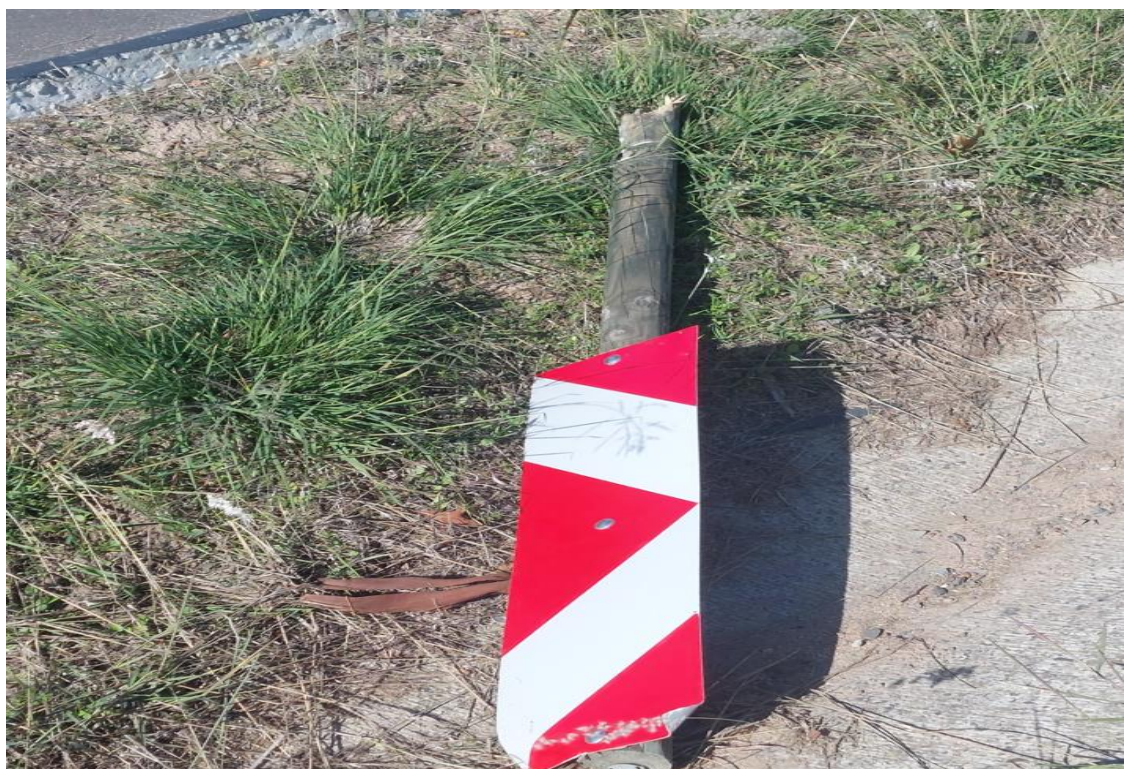
1.4.1. The aircraft impacted the road sign pole with its left wing.

**Figure 4:** The severed road sign pole.

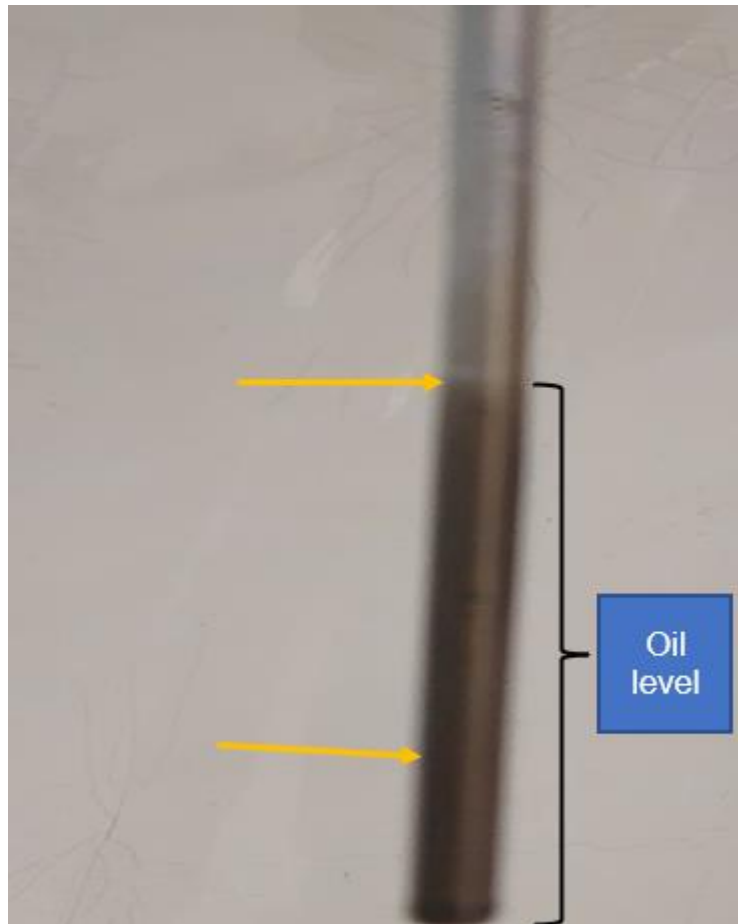
1.6.7 During the examination of the engine at the aircraft maintenance organisation's (AMO's) facility, the engine crankshaft was rotated by hand and it exhibited thumb compression on all four cylinders. Approximately 7 quarts of oil was found in the oil tank (see Figure 5), and the minimum safe quantity is 2 quarts, according to the POH.

**Figure 5:** A dipstick showing sufficient oil level in the tanks. The top arrow shows 7 quarts and the bottom arrow indicates 2 quarts.

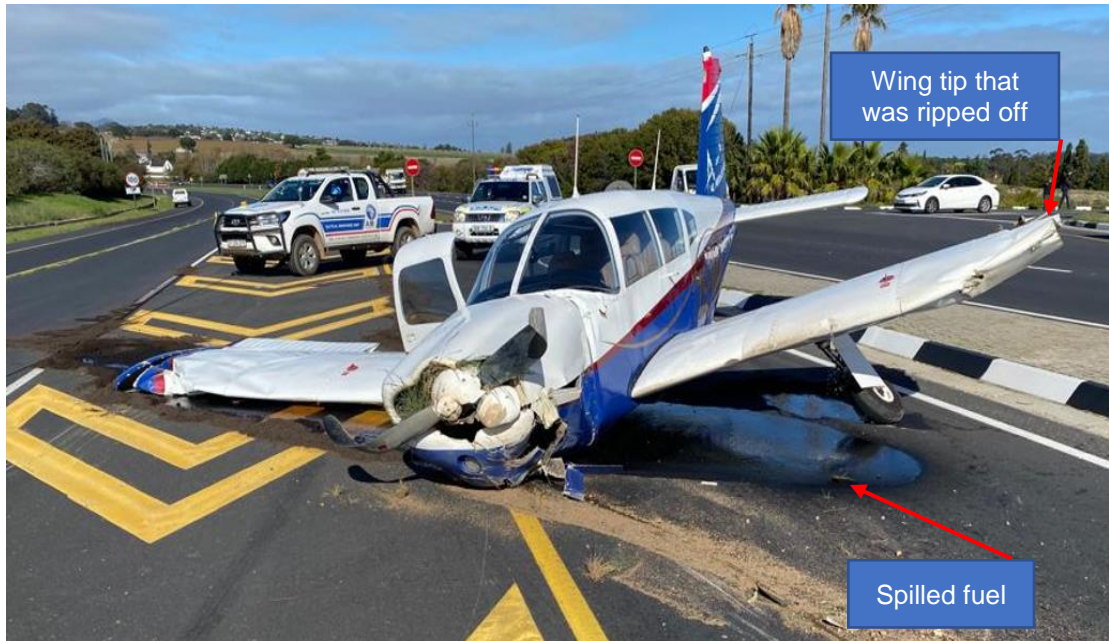
middle (centre island) of four lanes of the tarred R44 road, facing the opposite direction from which it had approached. The right wing exhibited damage. The left wing sustained damage on the leading edge, which was ripped off towards the end of the wing tip. Fuel was also leaking in the leading edge. The landing gear was found damaged.

**Figure 6:** The aircraft at the accident site. (Source: Operator)

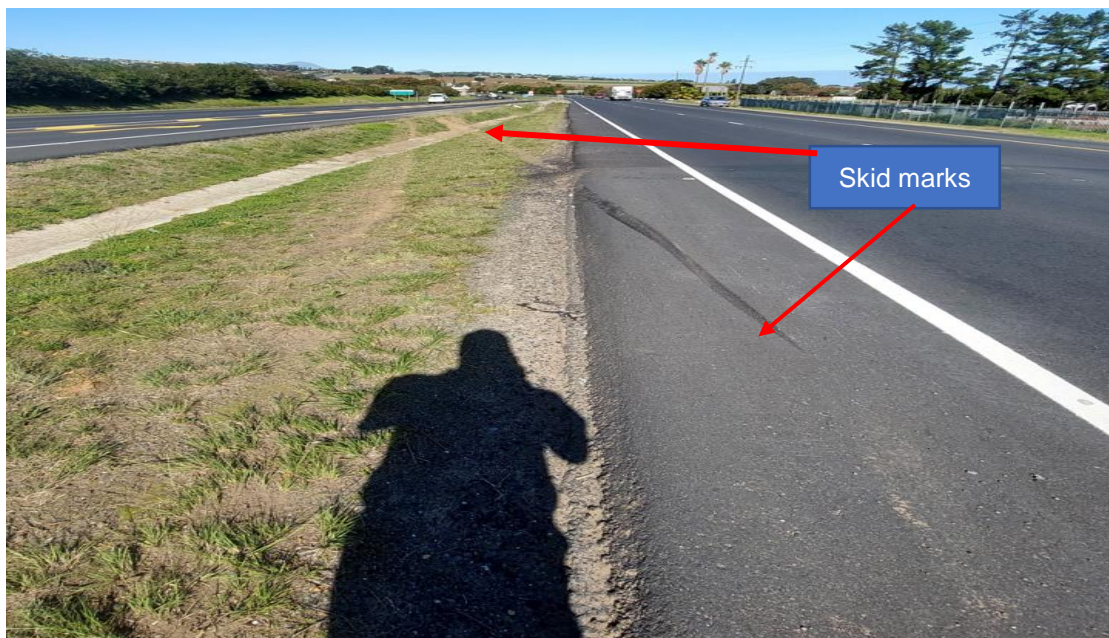
1.12.1. Examination of the accident scene revealed that upon touchdown, the aircraft skidded for approximately 30m (see Figure 7) before it came to rest in an upright position in the

**Figure 7:** Skid marks on the R44 road and on the dirt centre island.

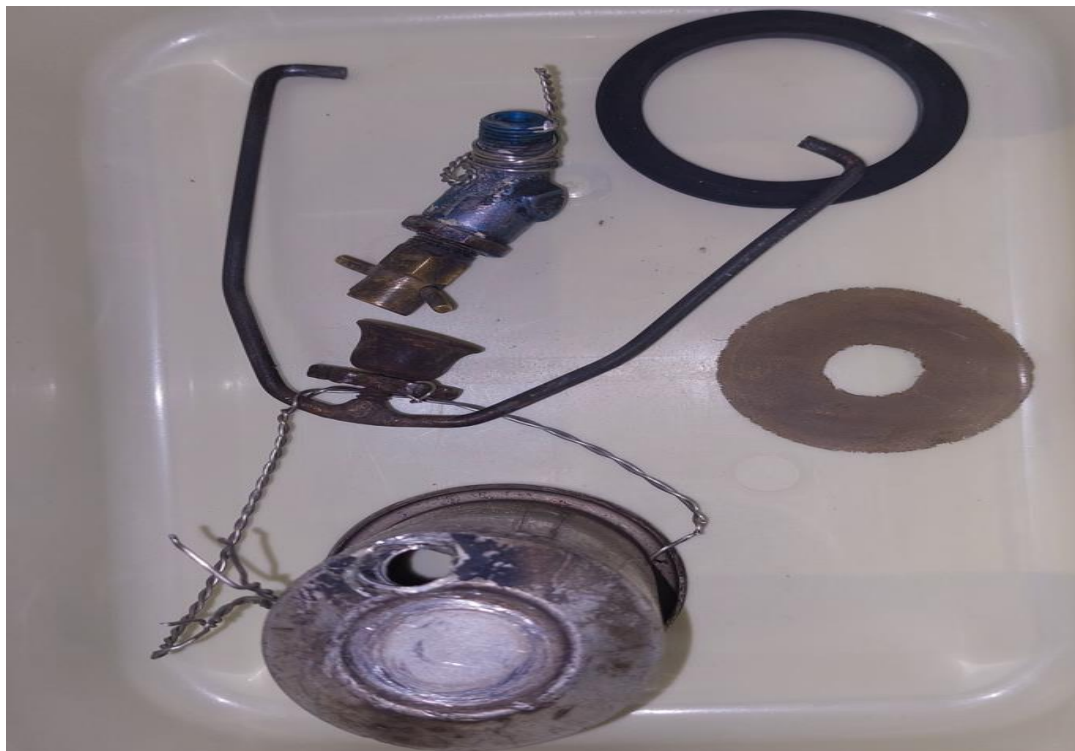
1.12.2. The aircraft was later examined at an AMO facility. The examination found that the engine and the nose section were displaced upward and aft of the aircraft. The gascolator did not contain fuel as it was damaged during impact.

**Figure 8:** Damaged gascolator.

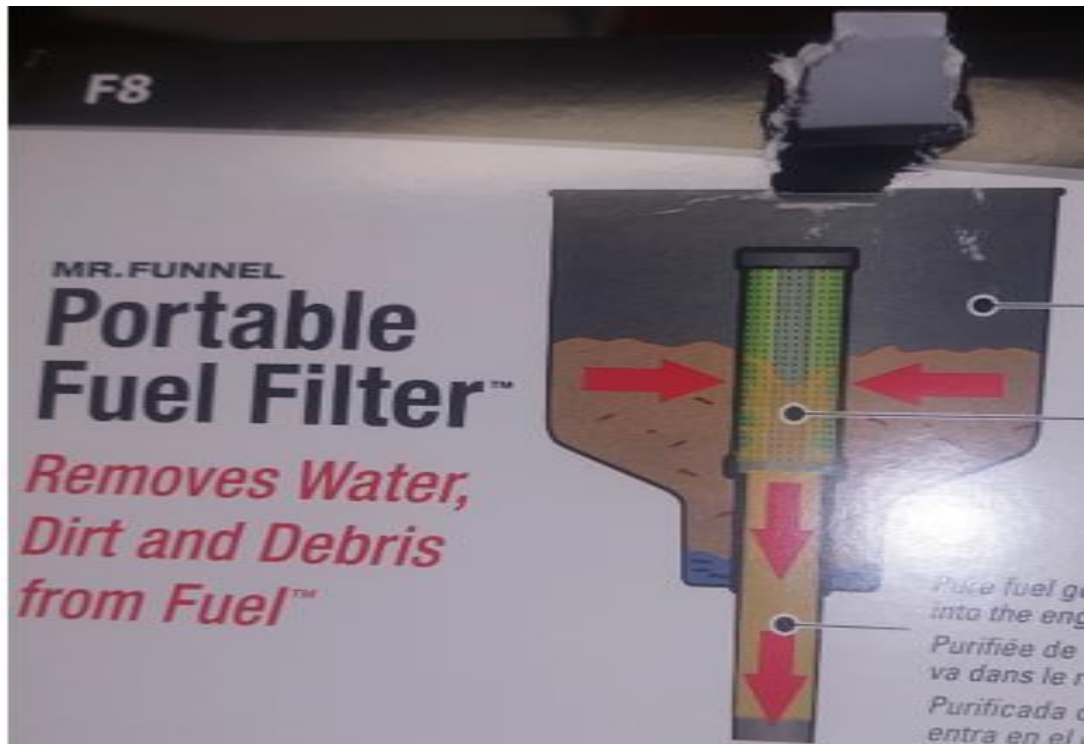
1.12.3. During fuel drainage, the AMO used a portable fuel filter that removes (separates) water, dirt and debris from the fuel. The 120L (32 gallons) of fuel that was drained from the aircraft was clear and free of water or visible contamination.

**Figure 9:** The Portable Fuel Filter that was used by the AMO.

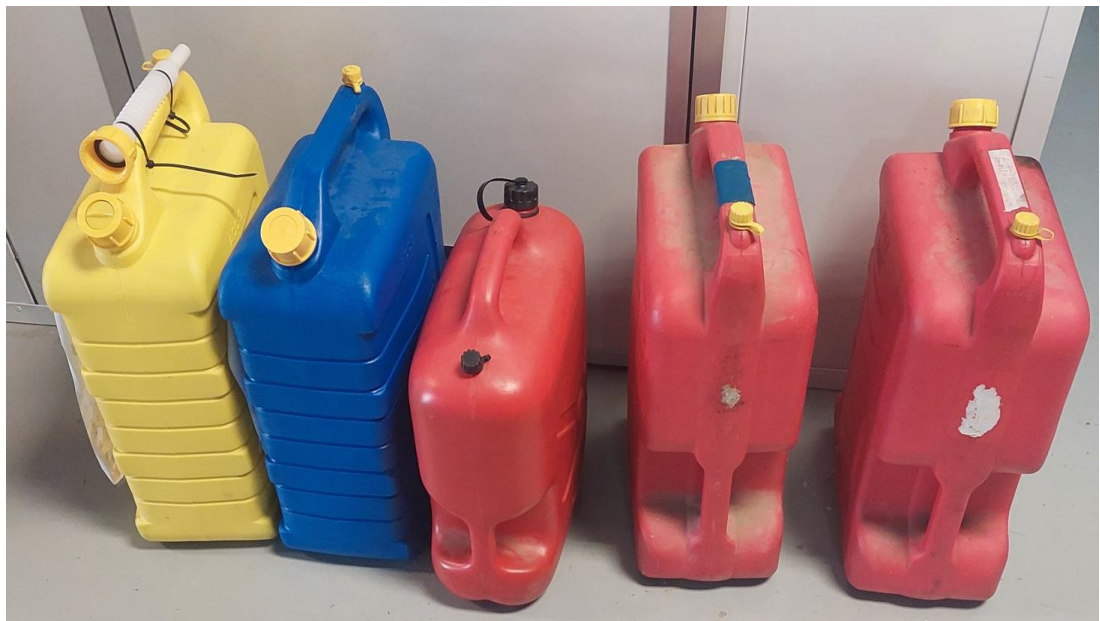
**Figure 10:** The 25-litre cannisters containing 120L of fuel that was drained.

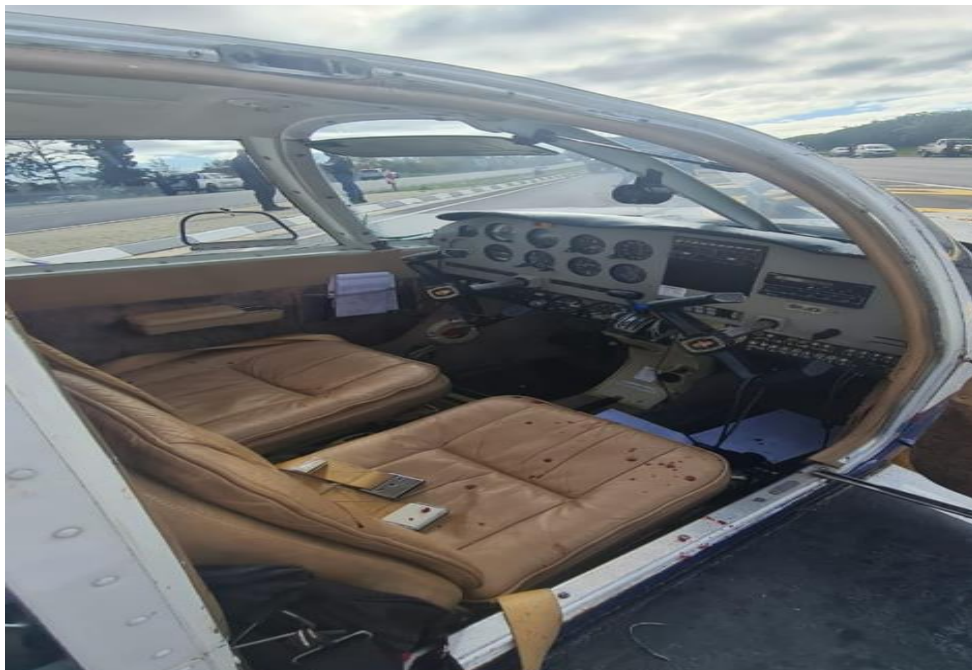
1.15.1. The accident was considered survivable as no damage was caused to the cockpit and cabin structure of the aircraft.

**Figure 11:** Cabin structure of the accident aircraft.
