PRELIMINARY ACCIDENT REPORT

Accident
- Preliminary Report -
AIID Ref No: CA18/2/3/9952

Reference Number : CA18/2/3/9952
Name of Owner/Operator : Xcalibur Resources (PTY) LTD
Manufacturer : Air Tractor Inc
Model : AT-502B
Nationality : South African
Registration Marks : ZS-XAT
Place : Millvale, North West province
Date : 4 February 2021
Time : 0932Z

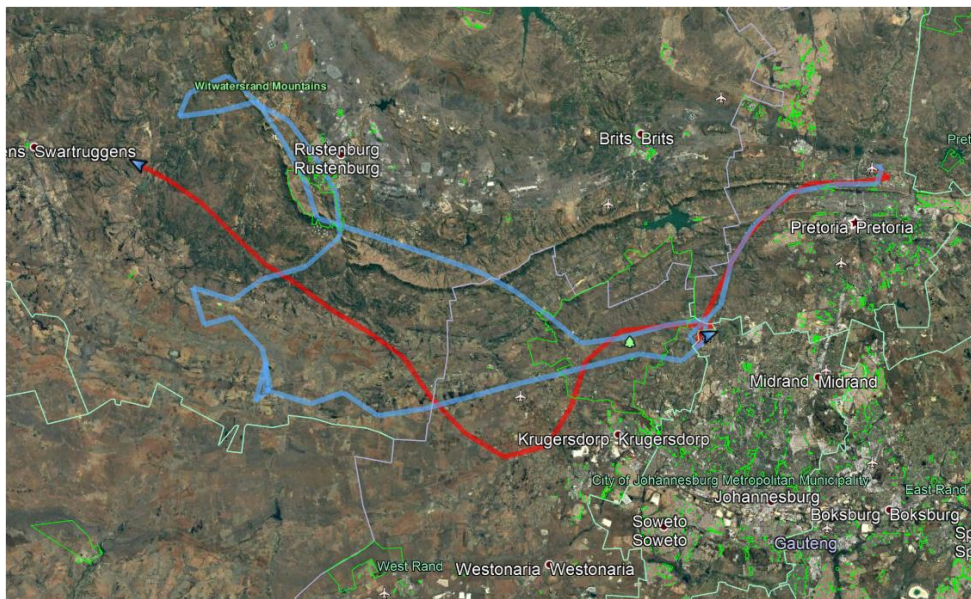
Figure 2: The flight path of both aircraft; red line, ZS-XAT and blue line, ZS-XAS.
(Source: Operator)

1.1.2 The pilot of ZS-XAS stated that he took off at 0858Z after ZS-XAT aircraft. The two pilots were communicating via very high frequency (VHF) radio during the flight. He (ZS-XAS pilot) then routed right (Figure 2, blue line) of the planned flight path due to low-hanging clouds; and climbed to flight level 055 (FL055). Thereafter, he contacted ZS-XAT pilot, who responded and notified him that he was climbing to FL100 and was flying to the left (Figure 2, red line) of the planned flight path. The pilot of ZS-XAS flew towards north of Rustenburg and turned in a south-westerly direction due to the deteriorating weather conditions. He tried to contact ZS-XAT pilot to no avail. He then contacted Johannesburg (JHB) Information to get an update on the weather conditions. JHB Information advised that the weather was becoming more unfavourable to fly; and the ZS-XAS pilot made a decision to fly back to FALA.

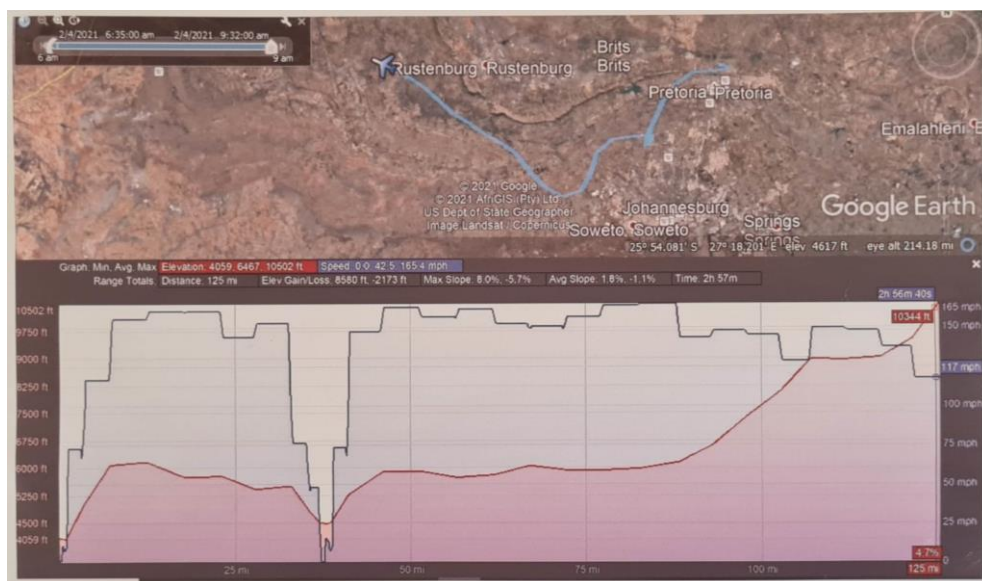
Figure 3: The flight path of ZS-XAT. (Source: Operator)

1.1.3.1 Figure 3 shows the flight path relating to ZS-XAT: The red shaded area relates to the altitude of the accident aircraft (ZS-XAT). The aircraft took off from FAWB and made a descent to FALA where it landed without event. The aircraft then took off again to FYWH and climbed to 6000 feet (ft) above mean sea level (AMSL) approximately 50

miles from FALA; it again climbed to a maximum altitude of 10 344ft AMSL at 0932Z when it disappeared from the tracking device.

1.1.3.2 The blue shaded area (in Figure 3) relates to the speed of the ZS-XAT aircraft. The aircraft took off from FAWB and made a descent to FALA. It then took off again and climbed, reaching a speed of 165 miles per hour (mph) or 143 knots (kts) approximately 50 miles from FALA. Thereafter, the speed started to decrease until it reached 117mph (101 kts) at 0932Z and then disappeared from the tracking device.

1.1.3.3 The place where the aircraft was seen disappearing from the operator's tracking device and radar control of JHB Information was determined to be 1 nautical mile (nm) north-east of Morningside Airfield (FAMS).

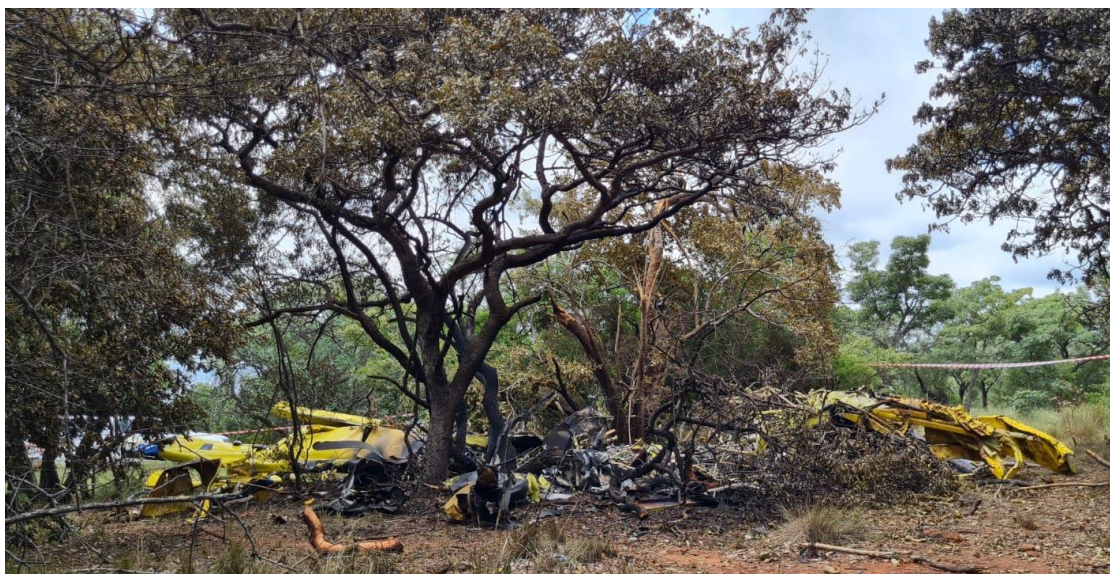
Figure 4: The aircraft at the accident site.

1.3.1 The aircraft was destroyed during the accident sequence and by post-impact fire.

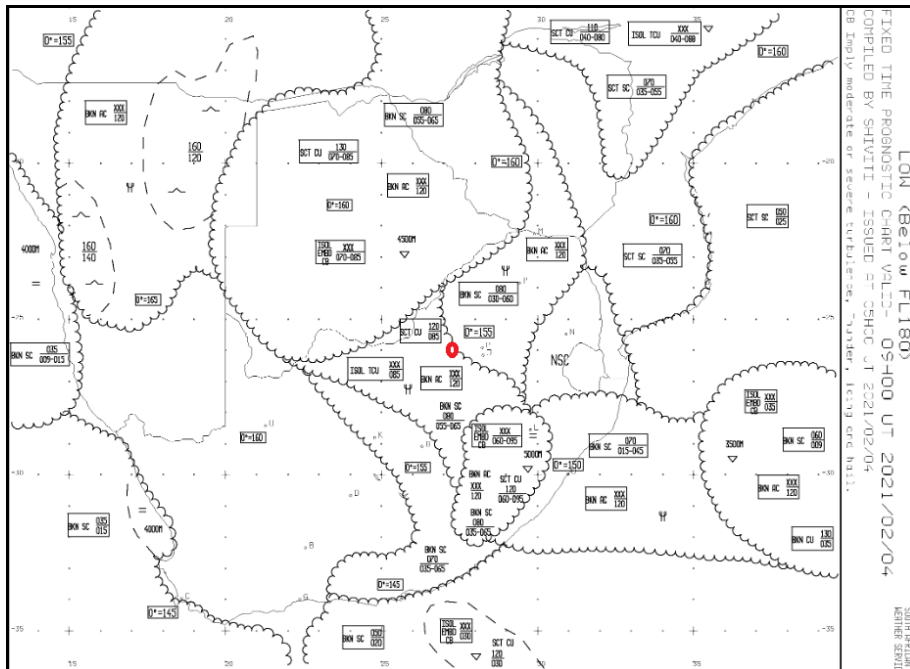
Figure 5: The cloud bases and tops at the time of accident.

Red area is roughly the accident site.

It shows generally cloudy area with low-level stratocumulus and cumulus clouds ranging from 1500-3000ft above ground with tops up to 12000ft and also towering cumulus clouds with some light showery rain.

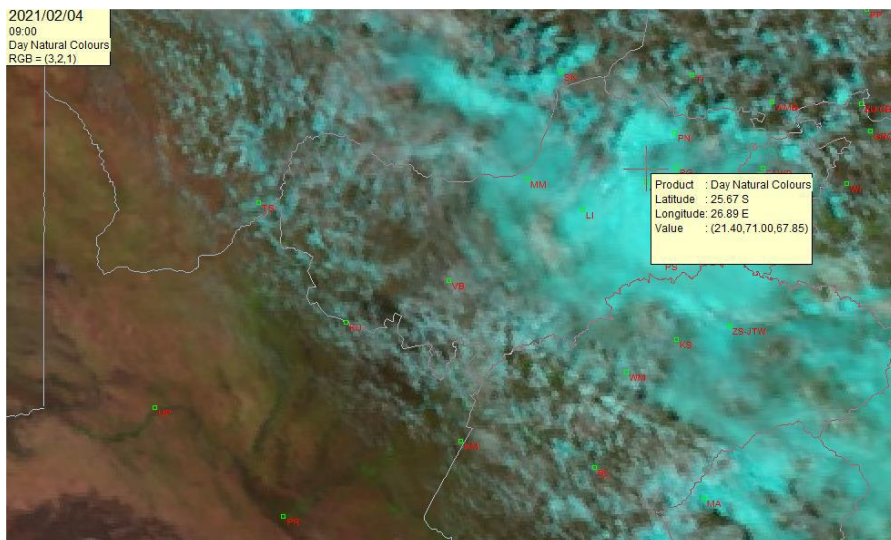
Figure 6: The cloud cover at the time of accident.

1.7.3 The weather report for 4 February 2021 shows that the weather stations along the planned route – FALA, Hartbeespoort, Buffelspoort, FARG and FAMM – recorded broken cumulus at 2000-4000ft above ground level (AGL) with cumulonimbus clouds, towering cumulus at 4500ft AGL and overcast at 6000ft AGL. The grey cross in Figure 6 (below) represents the accident site.

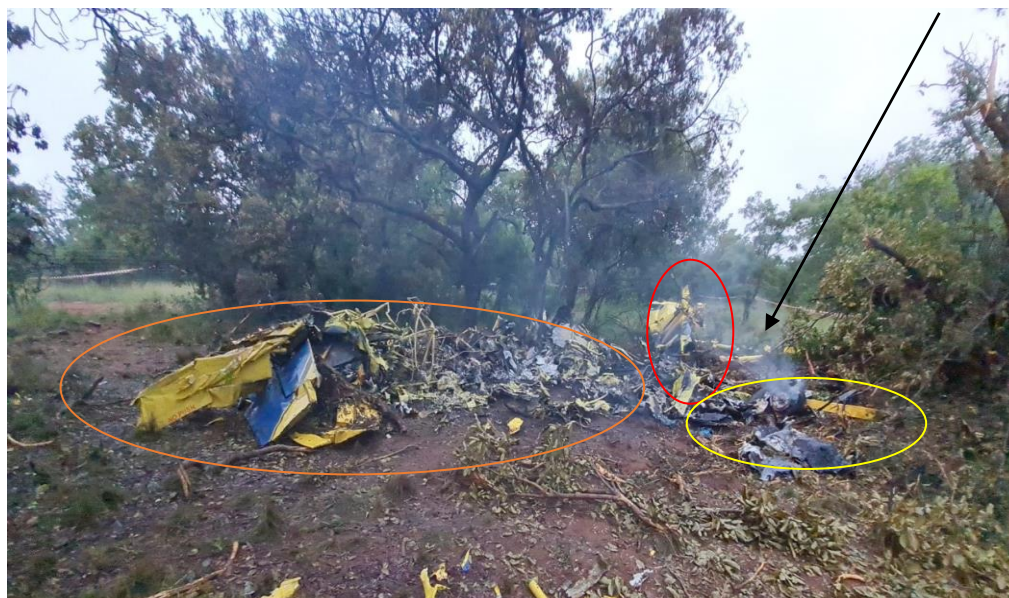
Figure 7: The wreckage layout post-accident.

1.12.2 On-site inspection showed signs that the aircraft was in a high rate of descent in a steep angle. It approached from a south-easterly direction and flew in a straight left

bank through the trees, severing the ones on its right-side path (Figure 7). On impact, the tail section folded onto the cabin section and the aircraft skidded to the left, leaving behind the severed right wing (at impact point). A post-impact fire ensued and burnt the cabin, some parts of the left wing, engine and the trees on its left-side path (Figure 7). The black arrow (Figure 7) shows the impact direction; the red circle indicates the severed right wing; the yellow circle shows the severed undercarriage; and the orange circle indicates the rest of the wreckage.

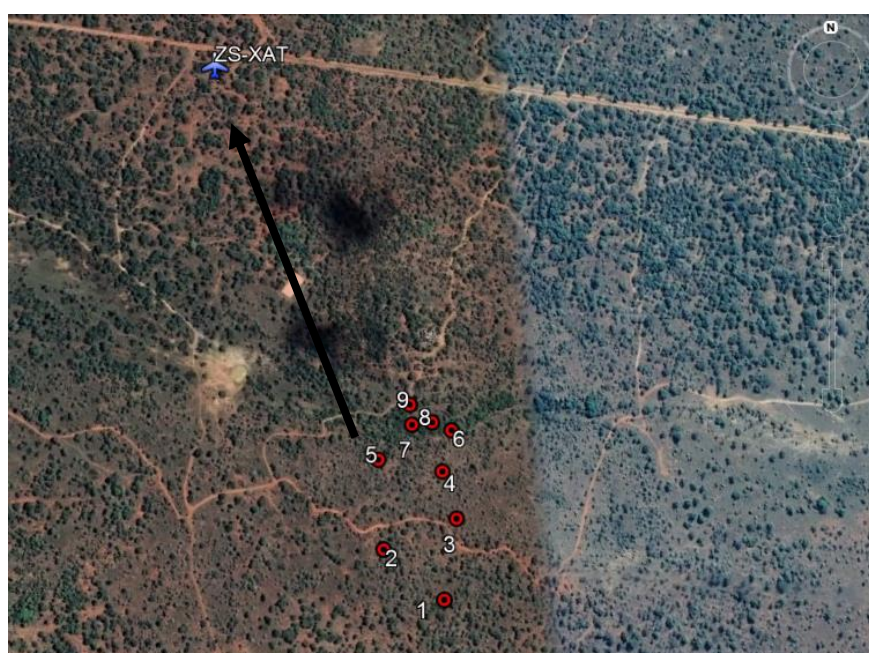
Figure 8: The wreckage distribution.

1.12.3 Parts of the left wing were found approximately 1km (behind) from the point of impact. Most of these parts were from the left-wing tip. The furthest part was found approximately 1km from the wreckage with the rest of the parts nearby. The red dots (1-9) in Figure 8 represent different locations where these parts were found. The black arrow indicates the flight path.

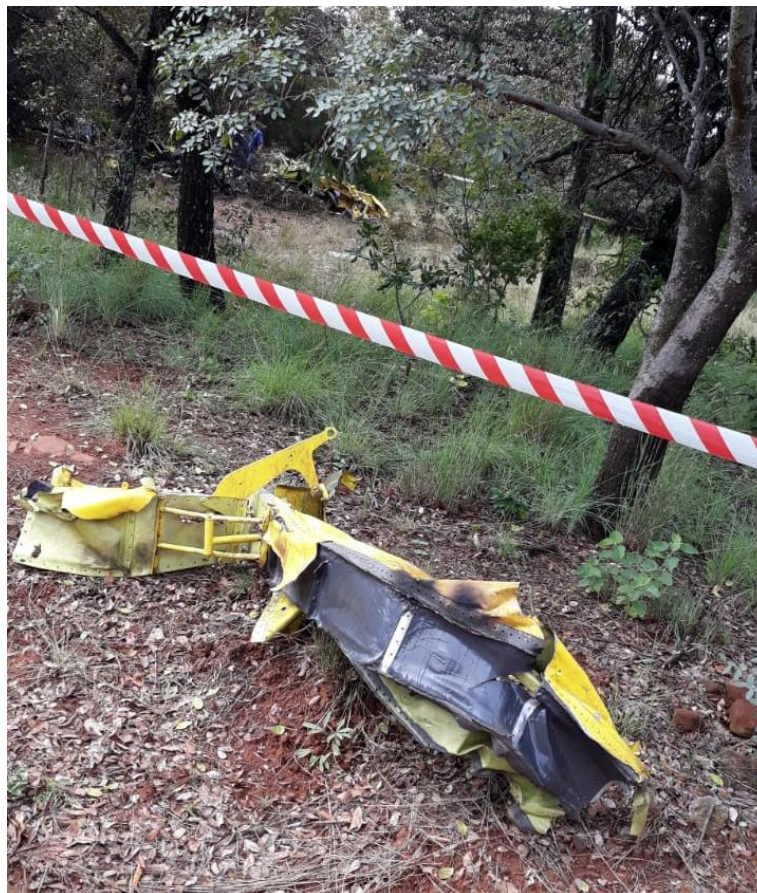
Figure 10: The left-wing aileron attachment.

1.12.4 One of the left-wing aileron attachment together with a piece of left-wing main tank projected 15 metres (m) ahead of the wreckage when the aircraft impacted the ground.

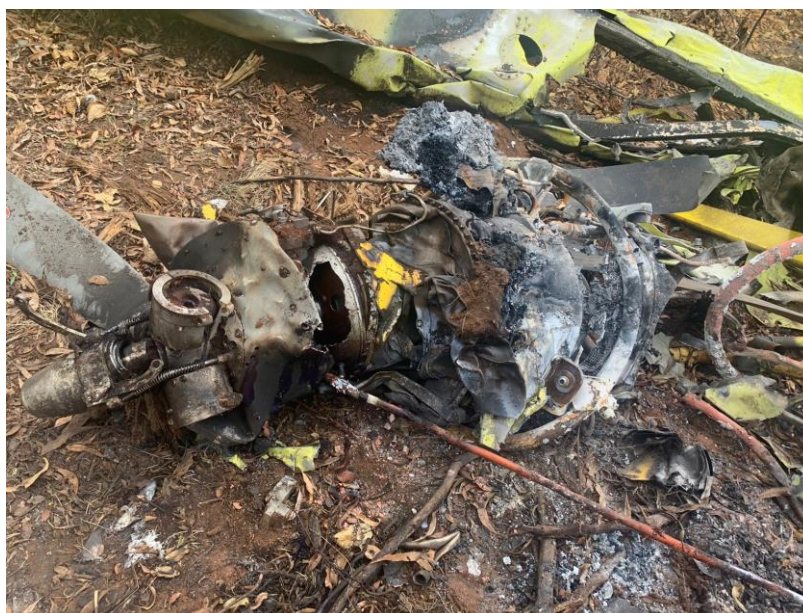
Figure 11: The engine post-accident.

1.12.5 The engine was burnt by post-impact fire and the damage to the engine was due to impact forces.

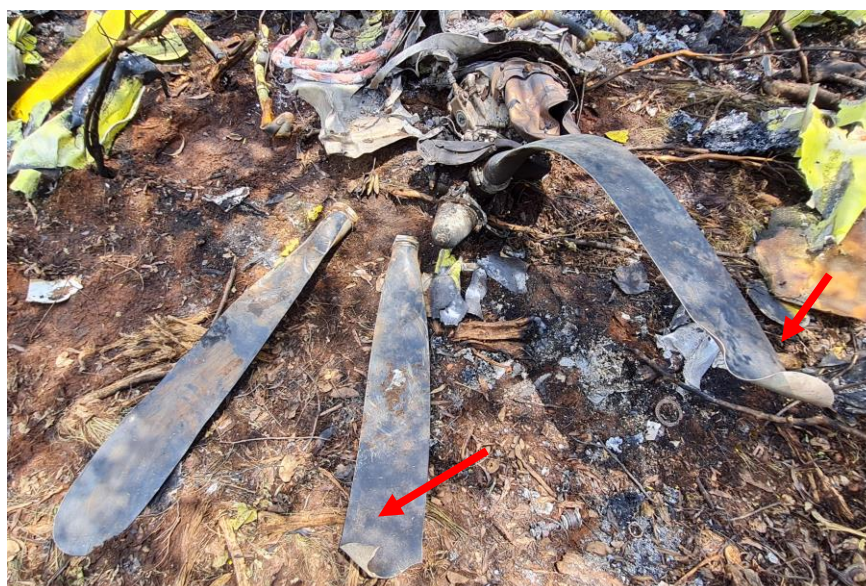
1.12.6 Two of the propeller blades were severed on impact and the third was still attached to the hub. All three blades showed signs of rotational signatures and damage caused on impact.

Figure 12: The propeller blades showing rotation signatures on the tips.
