PRELIMINARY ACCIDENT REPORT

Accident
- Preliminary Report -
AIID Ref No: CA18/2/3/9946

Reference Number : CA18/2/3/9946
Name of Owner/Operator : National Airways Corporation (Pty) Ltd
Manufacturer : Bell Corporation
Model : Bell 430
Nationality : South African
Registration Marks : ZT-RRT
Place : Colenso
Date : 21 January 2021
Time : 1135Z

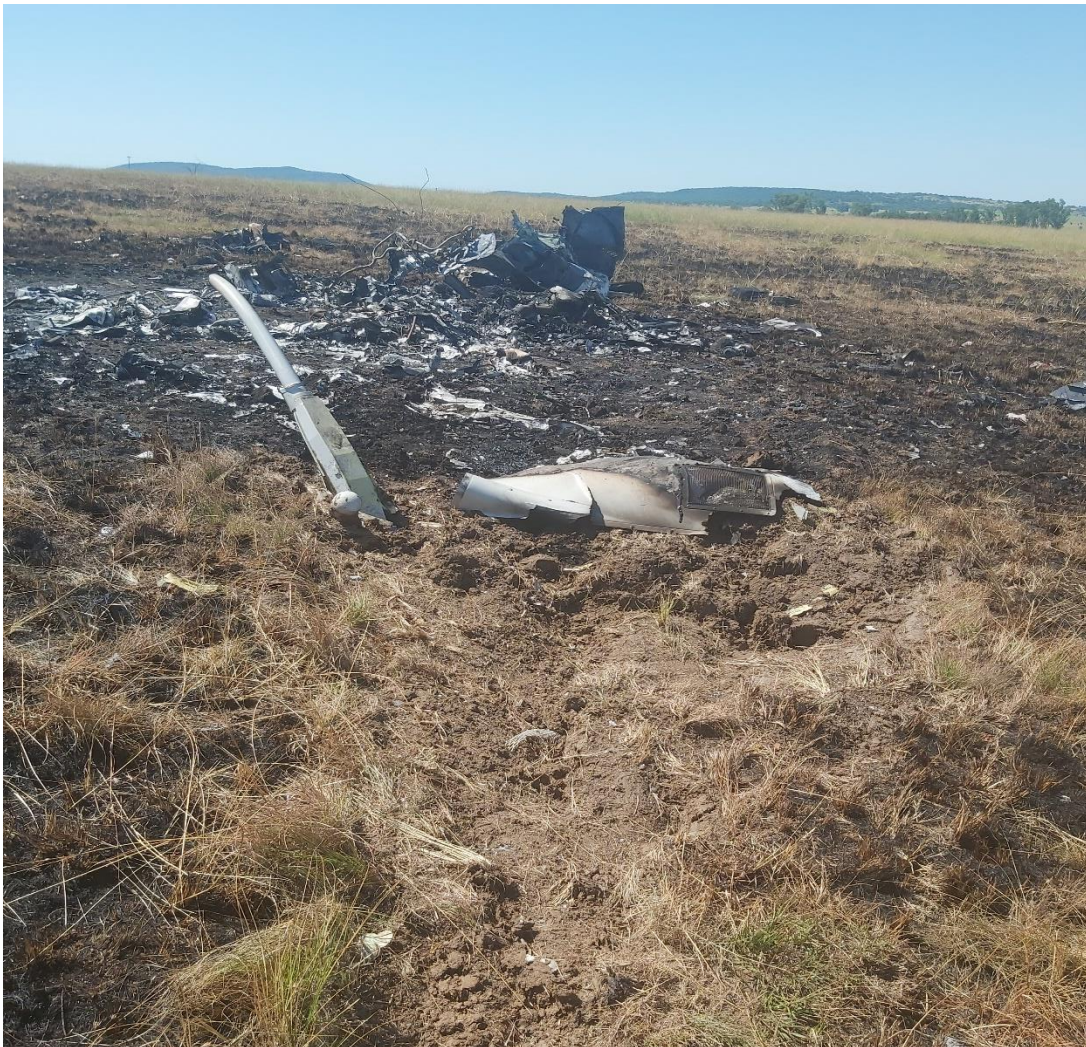
1.3.1 The helicopter was destroyed during the accident sequence.

Figure 3: Charred wreckage at the site.

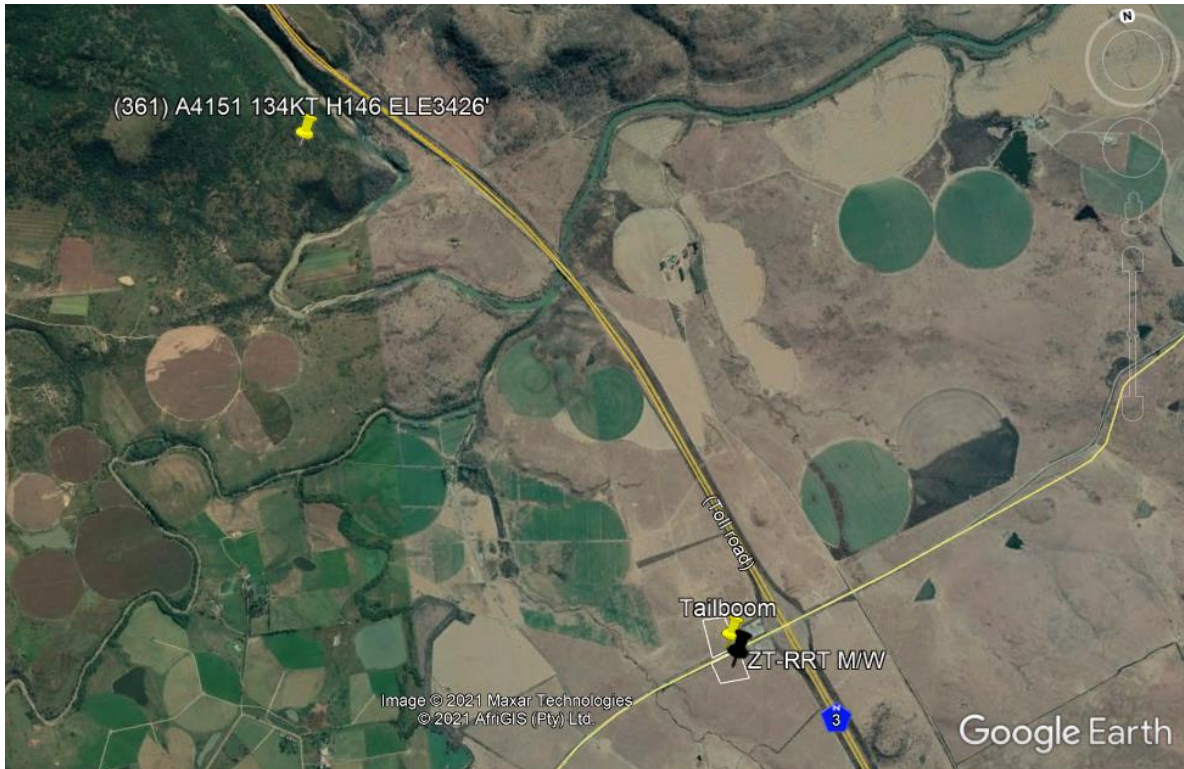
1.12.1 The helicopter's last known position from the Spidertracks device is 361 (Figure 6). The helicopter was cruising at 725ft AGL parallel to the N3 Highway in a south-easterly direction, tracking 146°. The witness (farmer) stated that he saw a red and white helicopter spinning around with objects being flung out of the helicopter. The helicopter maintained a south-easterly direction but started to lose height rapidly. The loss of control continued until the helicopter impacted the ground and burst into flames just after flying over the Main Road underpass which crosses the N3 Highway.

Figure 6: Point 361 is the last downloaded position of the helicopter. It is 2.4nm away from the main wreckage at a height of 725ft AGL. (Source: Google Earth)

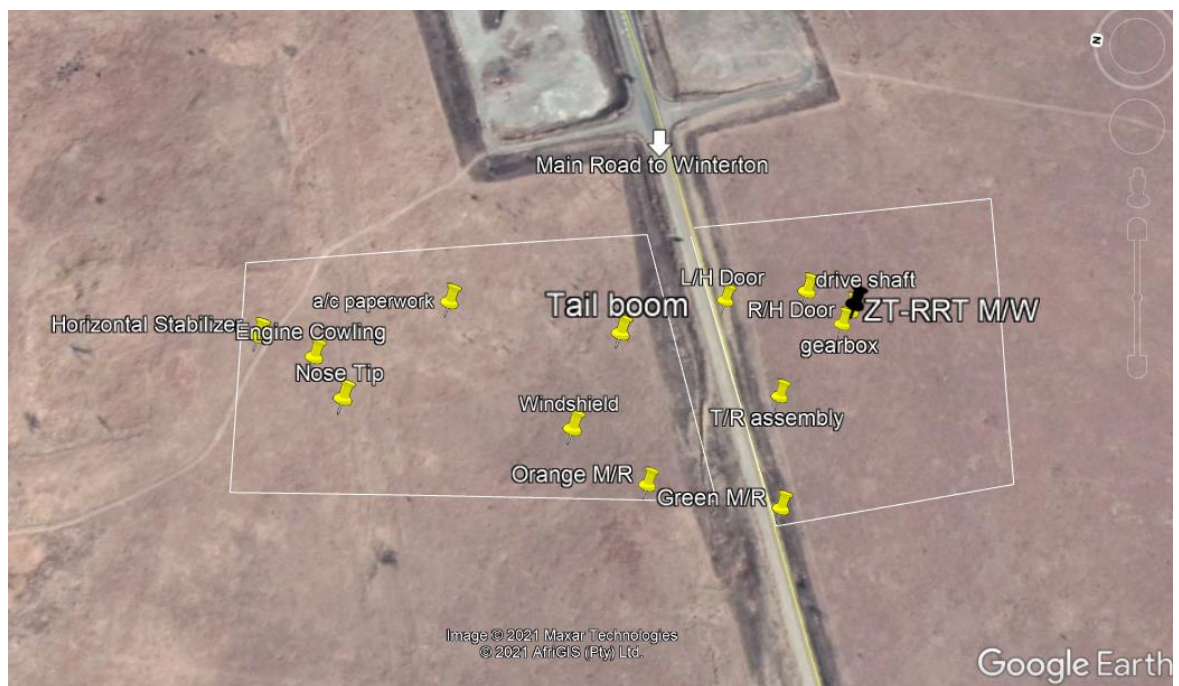
1.12.2 The objects that were flung out of the helicopter were some airframe parts that were severed by one or more of the helicopter's main rotor blade(s) whilst spinning out of control, as well as some airframe parts that broke off during the accident sequence. The accident site was divided into two sections; the first section was the tail boom site, and the second section was the main wreckage site. The accident site sections were divided (separated) by the Main Road leading to Winterton, south-west of the N3 Highway.

Figure 7: Schematic view of wreckage distribution. (Source: Google Earth)

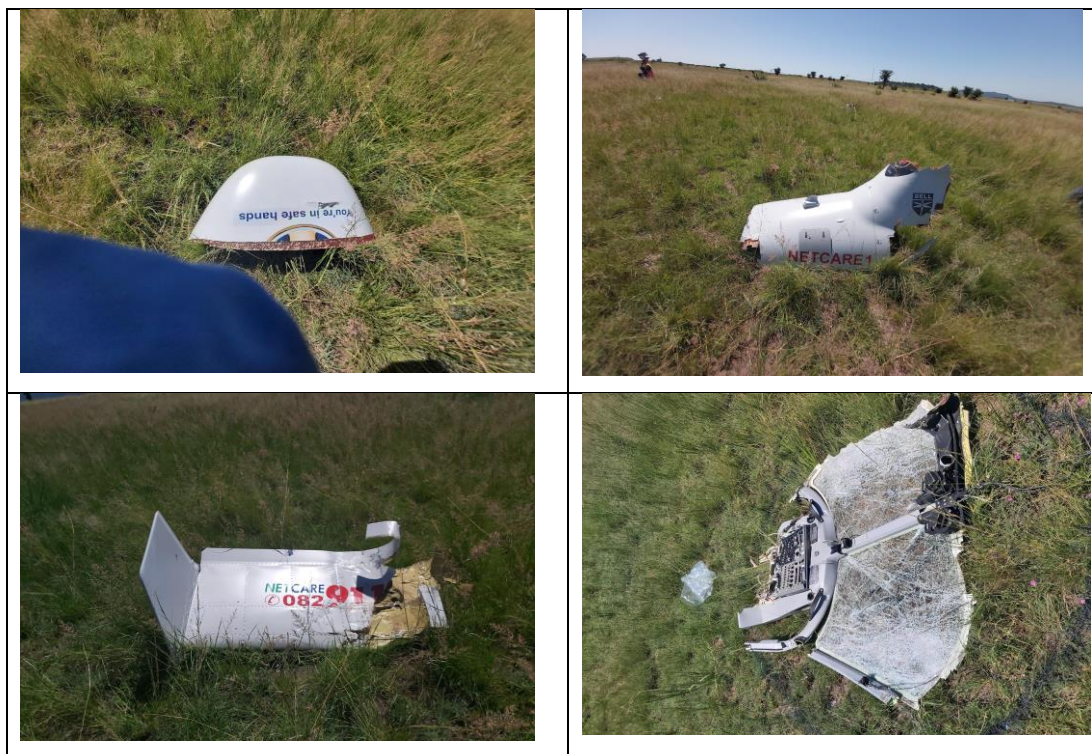
Figures 8, 9, 10, 11: Some helicopter parts that broke off in-flight before impact.

- The horizontal stabiliser, rear engine cowling and the nose cone were some of the airframe parts found furthest along the tail boom site. The investigating team also found helicopter paper work and the flight folio scattered in the tail boom site.
- Debris from the damaged main rotor blade(s), pieces of glass from the helicopter windows, instruments damaged beyond recognition and windshield still attached to the top instrument panel were found west of the tail boom.
- Two pitch link controls (one marked orange and the other blue) were also found closer to the tail boom.

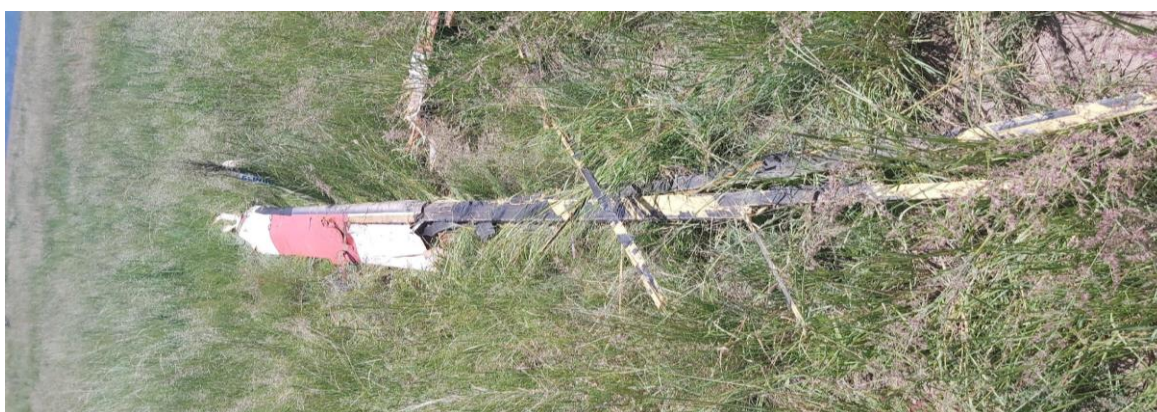
Figure 12: Orange main rotor blade landed 94m from the tail boom.

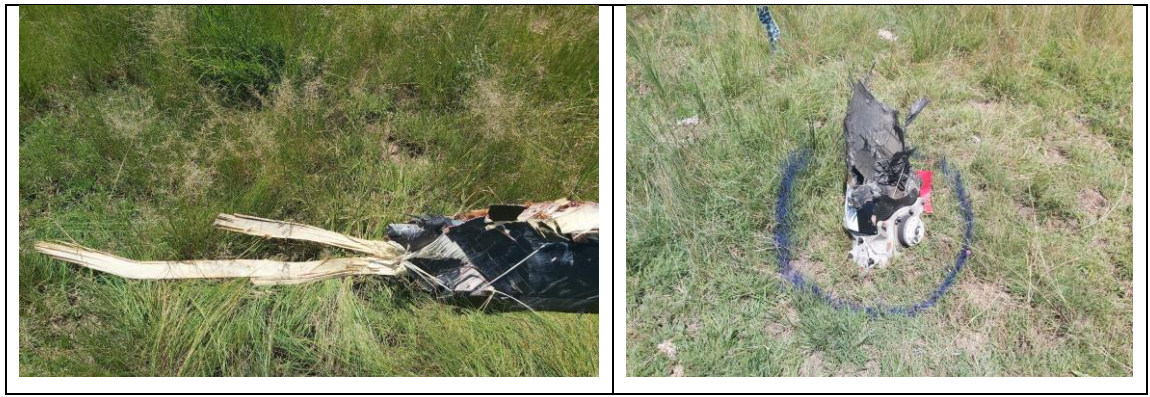
Figures 13, 14: The root of orange blade separated from the blade before impacting the ground.

- One of the most damaged main rotor blades marked orange was found further west of the tail boom.

1.16.2 The orange main rotor blade, four pitch link control (PLC) and four clevis and their universal bearings were sent for metallurgical testing and analysis.

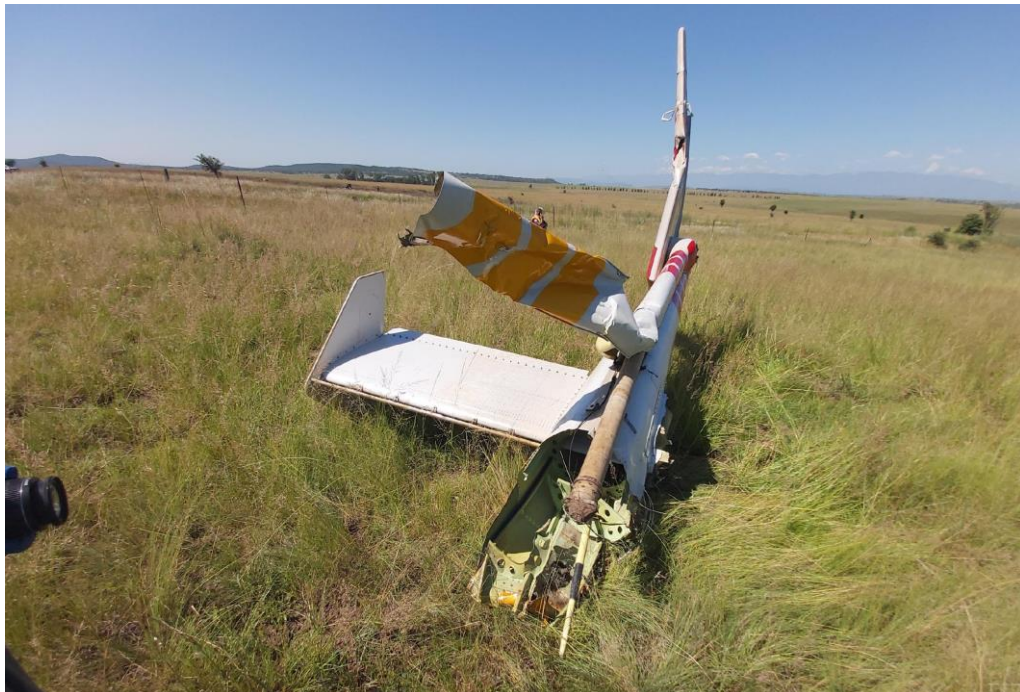
Figure 15: The tail boom was located 129.9m from the main wreckage.

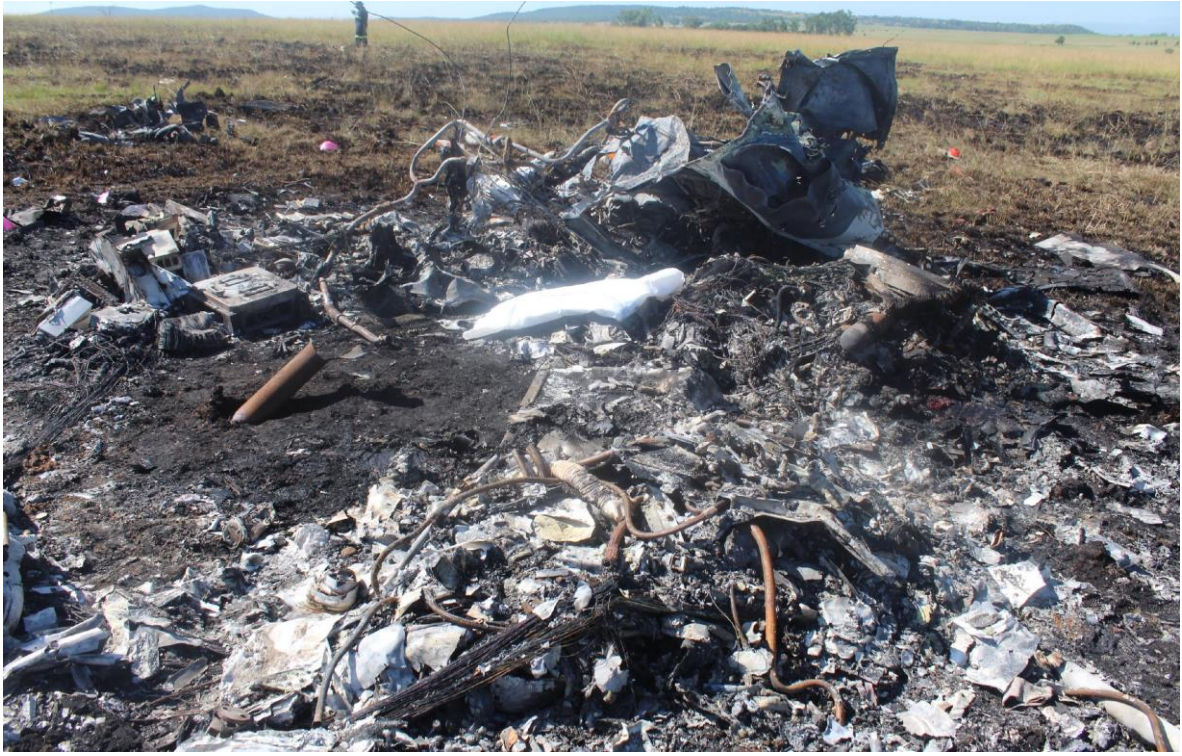
- The main wreckage was characterised by the remaining parts of the helicopter which had burst into flames after impacting the ground. The left-side fuel tank and gearbox with two blades still attached had broken off the airframe and were not burnt in the fire.
- The green main rotor blade, which is located directly opposite the orange main rotor blade, had also broken off and was found 148m from the main wreckage.
- There were 12 pressurised oxygen bottles, and one of them had exploded when the

Figure 16: The main wreckage post-accident.

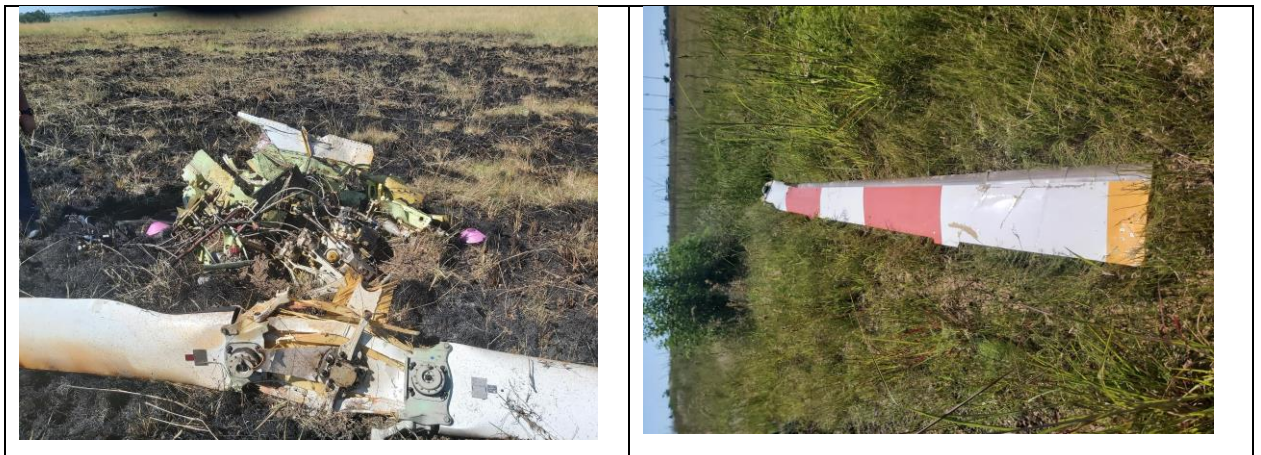
Figure 17: The gearbox that was not consumed by fire. **Figure 18:** The green main rotor blade.

1.14.1 Immediately after the helicopter had impacted the ground, it burst into flames and most of the helicopter's airframe parts were burnt beyond recognition. The gearbox with two main rotor blades (blue and red in Figure 17) still attached and the left-side fuel tank had broken off from the aircraft and were not burnt. Local fire services were called to extinguish the flames and they also assisted in locating most of the helicopter parts by marking them with visible flags.
