PRELIMINARY ACCIDENT REPORT

Accident
- Preliminary Report -
AIID Ref No: CA18/2/3/9864

The aircraft nosed over during landing on Runway 04 at Pietersgift private airstrip in Plot 40 near Klerksdorp in the Northwest Province. The aircraft was substantially damaged and the pilot reported no injuries.

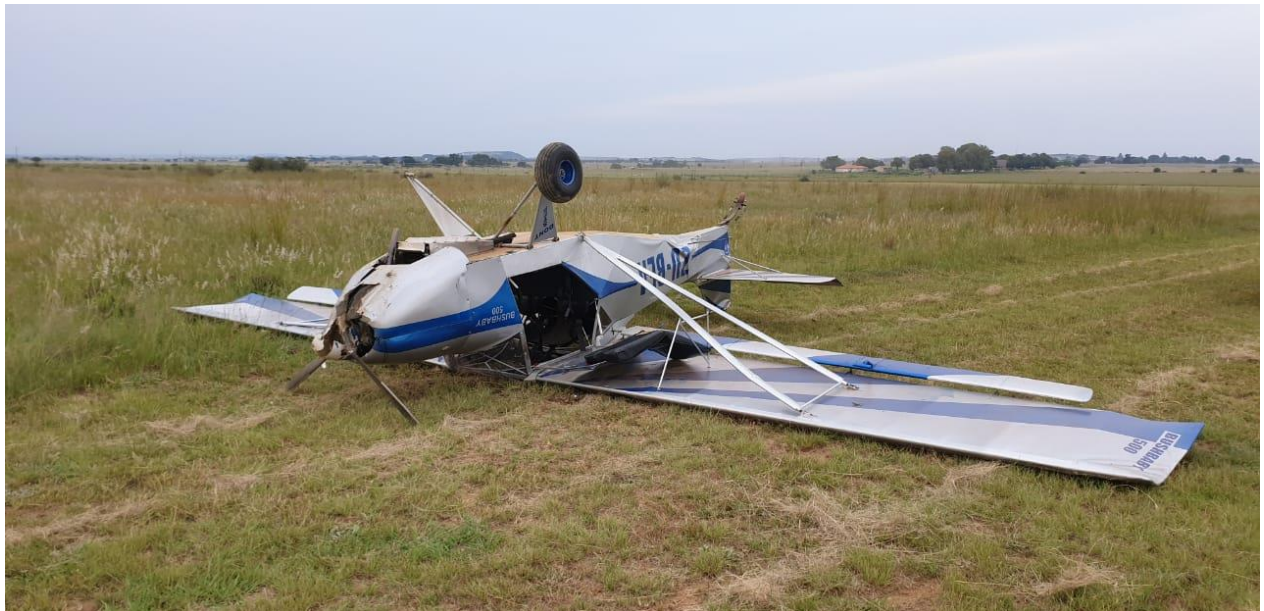
Figure 1: The Bush-baby as found at the accident site. (Photo courtesy of the pilot)

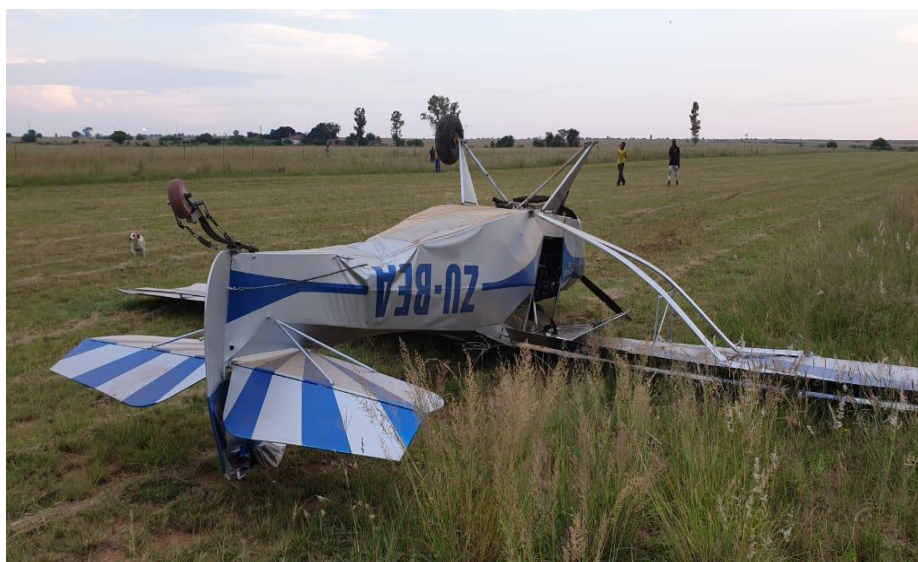
1.12.1 The left axle broke off during landing on Runway 04 resulting on the aircraft nosing over. The propeller struck the ground and one of the blades broke off before the aircraft nosing over. The tail gear assembly was bent, the tail section was buckled, and the vertical fin was bent as well as the he roof of the aircraft.

Figure 2: The Bush-baby after coming to rest

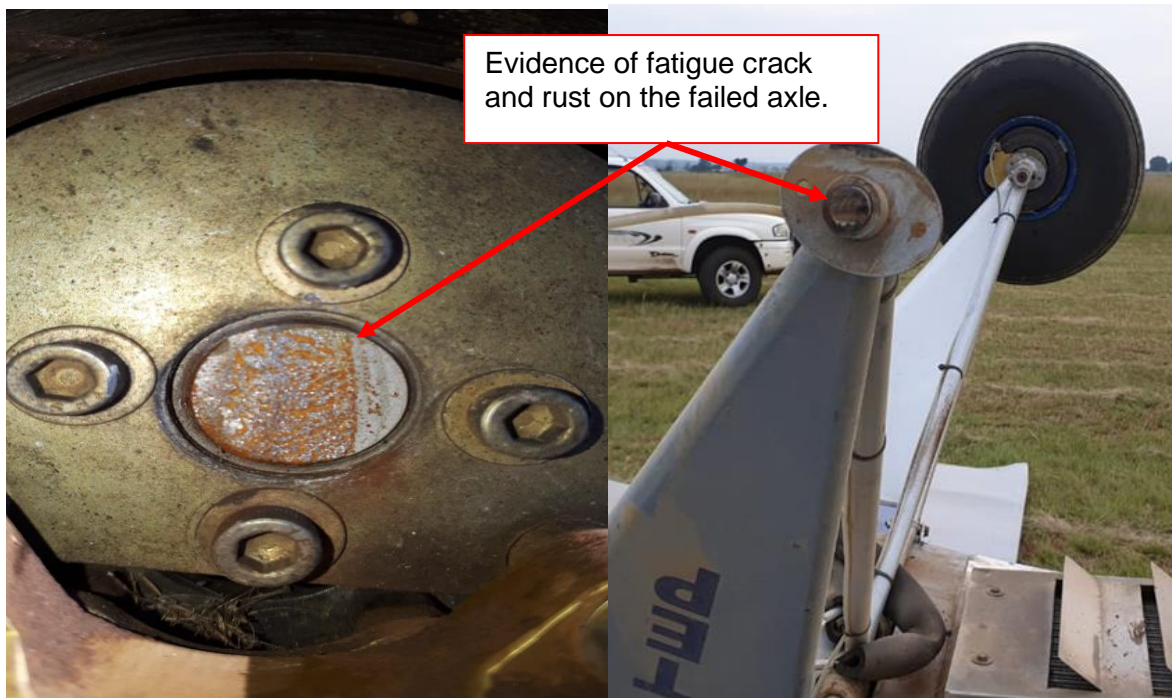
1.12.2 Figure 3 and 4 below shows some evidence of fatigue crack and rust on the failed axle.

Figure 3 and 4: Close view of the failed axle

- 2.1.2 The left axle broke off during landing on Runway 04 at Pietersgift private airstrip. Post-accident investigation photo showed evidence of a fatigue crack and rust on the majority surface of the axle.
