PRELIMINARY ACCIDENT REPORT

Accident and Incident Investigations Division

Accident
- Preliminary Report -
AIID Ref No: CA18/2/3/10070

Figure 1: Evektor SportStar, ZU-EIJ. (Source: Ben Snyman)

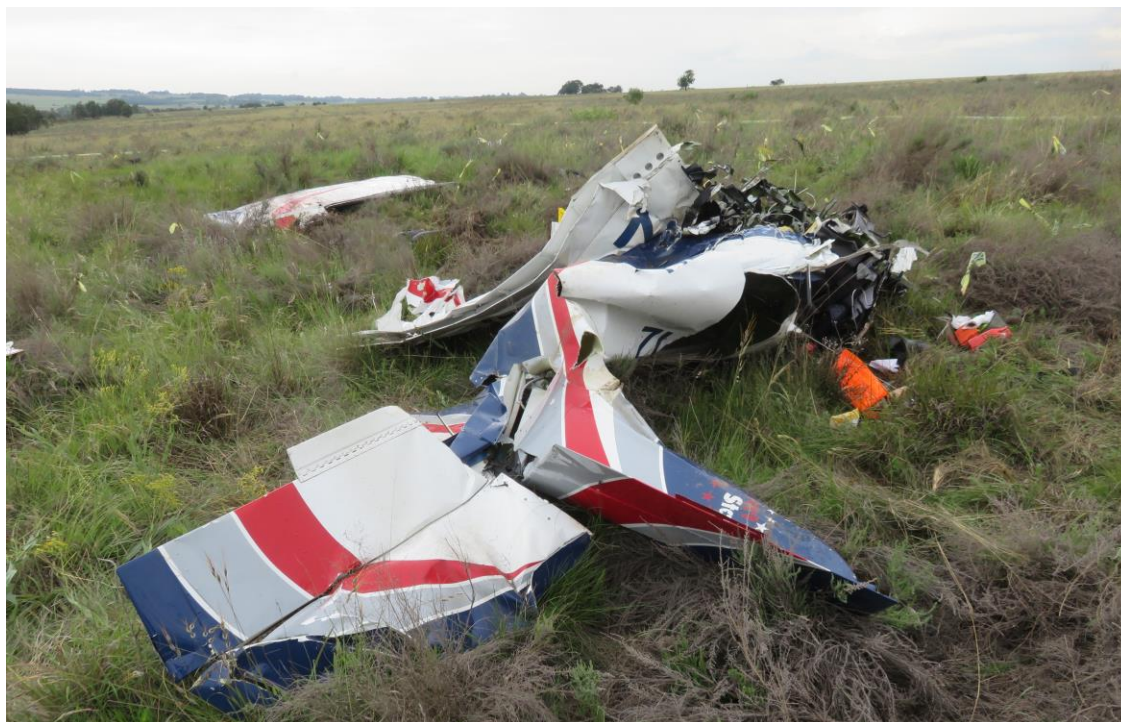
1.3.1 The aircraft was destroyed during the impact sequence.

Figure 3: The main wreckage as it came to rest.

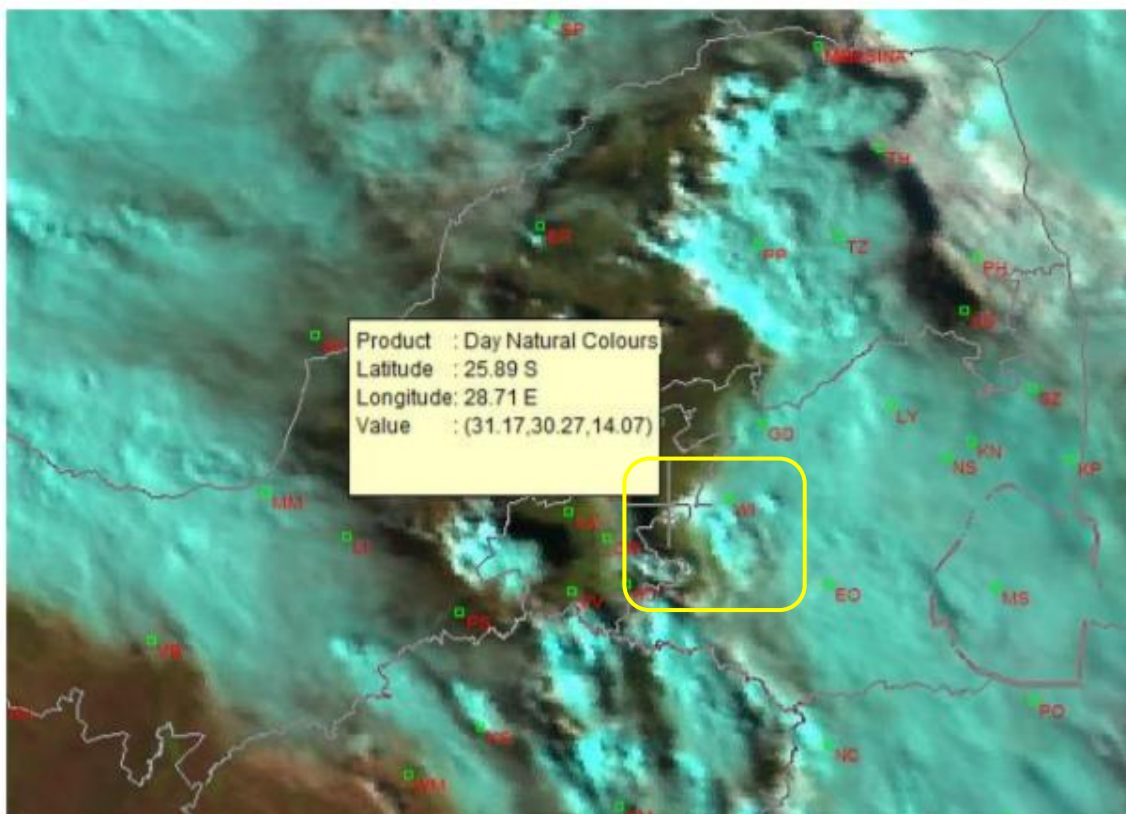
Figure 4: Satellite image of the accident site marked with a cross in the yellow frame.

The accident site (cross mark) is situated to the west of thunderstorms, which are visible in the Witbank (FAWI) area (overshooting tops can be seen). From this satellite image, it seems possible that cumulus/towering cumulus clouds were present in the area. The eyewitnesses report did not mention any significant clouds, so it is possible that this development might have been to the immediate east of the dam. It should also be noted that turbulence can be expected in any area where cumulus clouds are present.

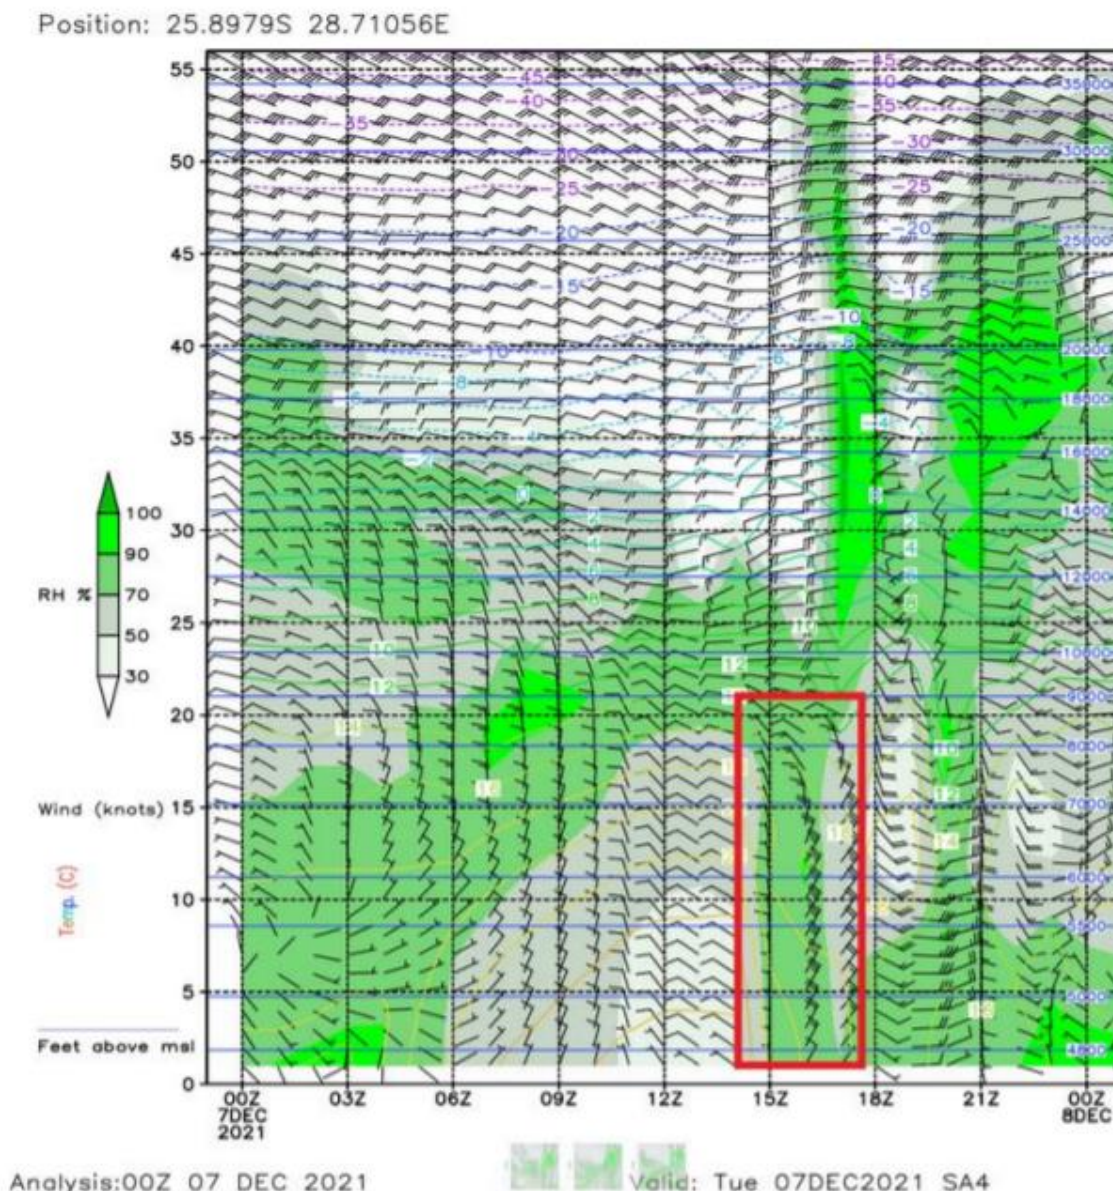
The above images represent Unified Model data on 7 December 2021. The accident occurred at roughly 1515Z (contained inside the red rectangle). From the wind charts, the winds above the surface were expected to pick up to about 25 knots after 1500Z.

It seems possible that cumulus/towering cumulus clouds were present in the area along with relatively strong winds in the lower levels, which could have caused turbulence.

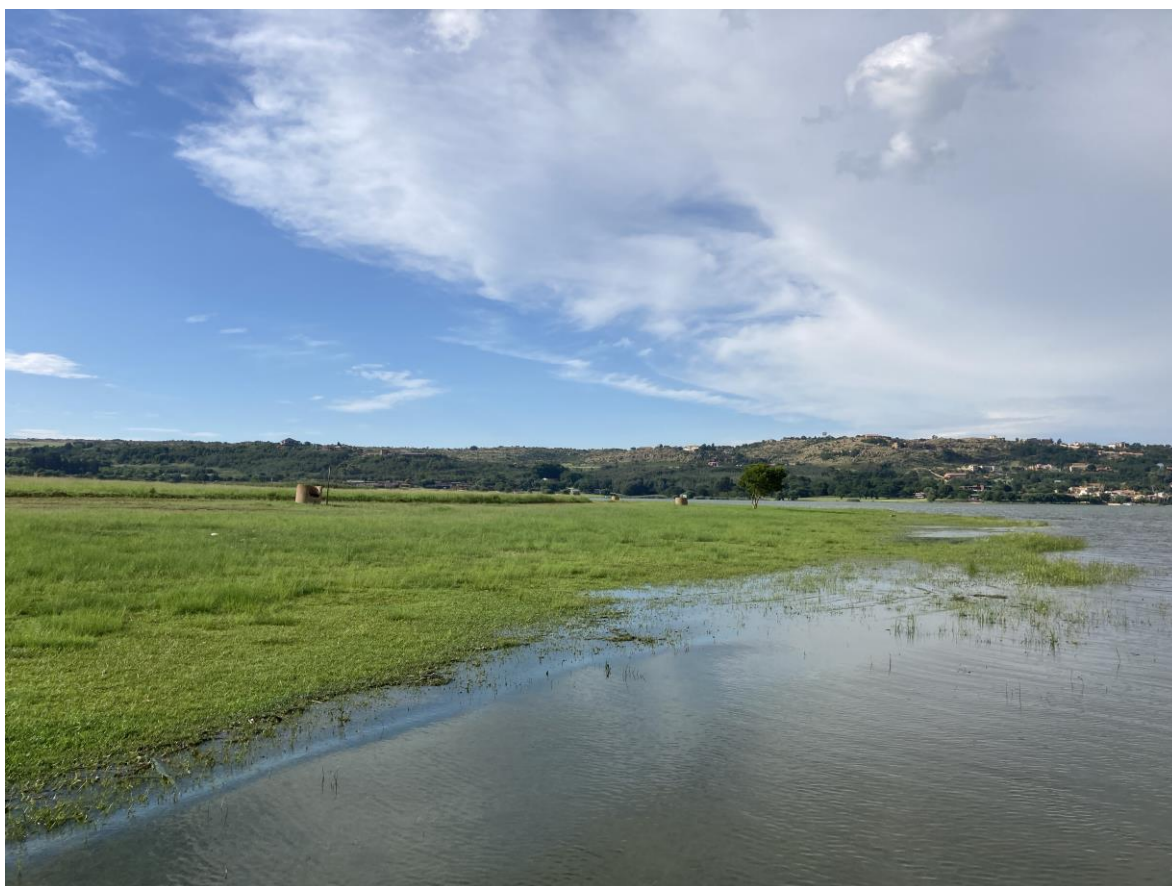
Figure 5: This photograph was taken at 1447Z in a northerly direction. (Source: Brian Kriedemann)

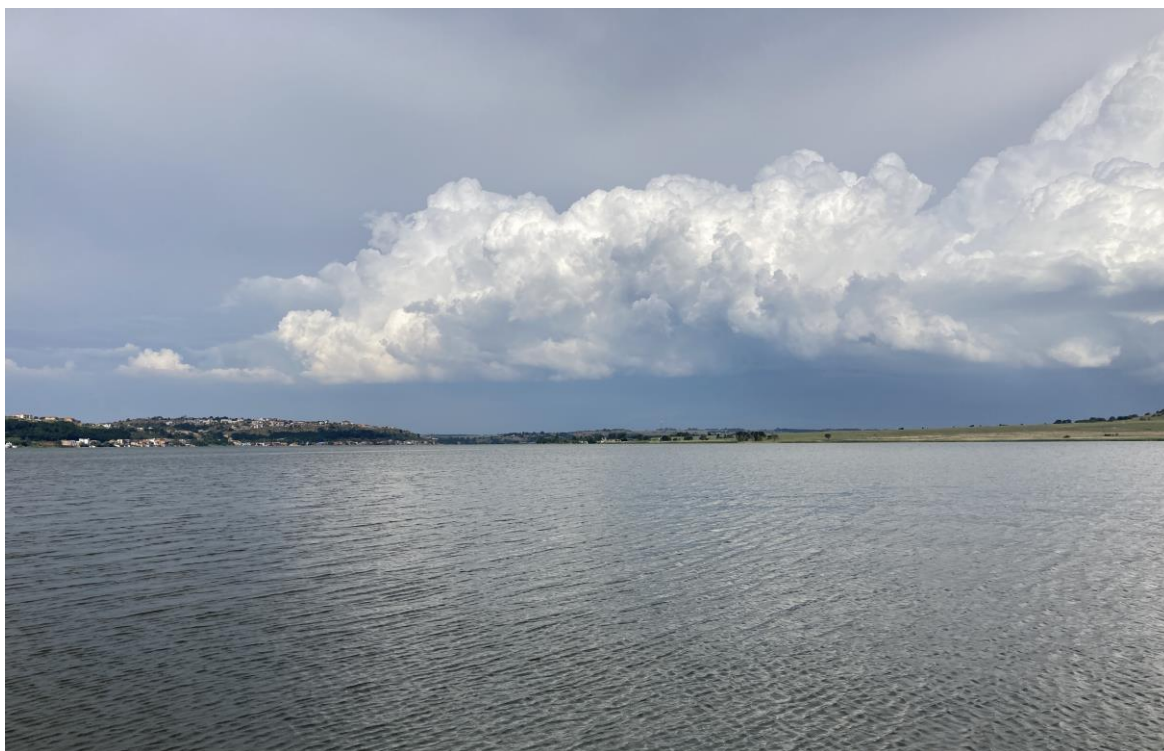
Figure 6: This photograph was taken at 1447Z in an easterly direction. (Source: Brian Kriedemann)

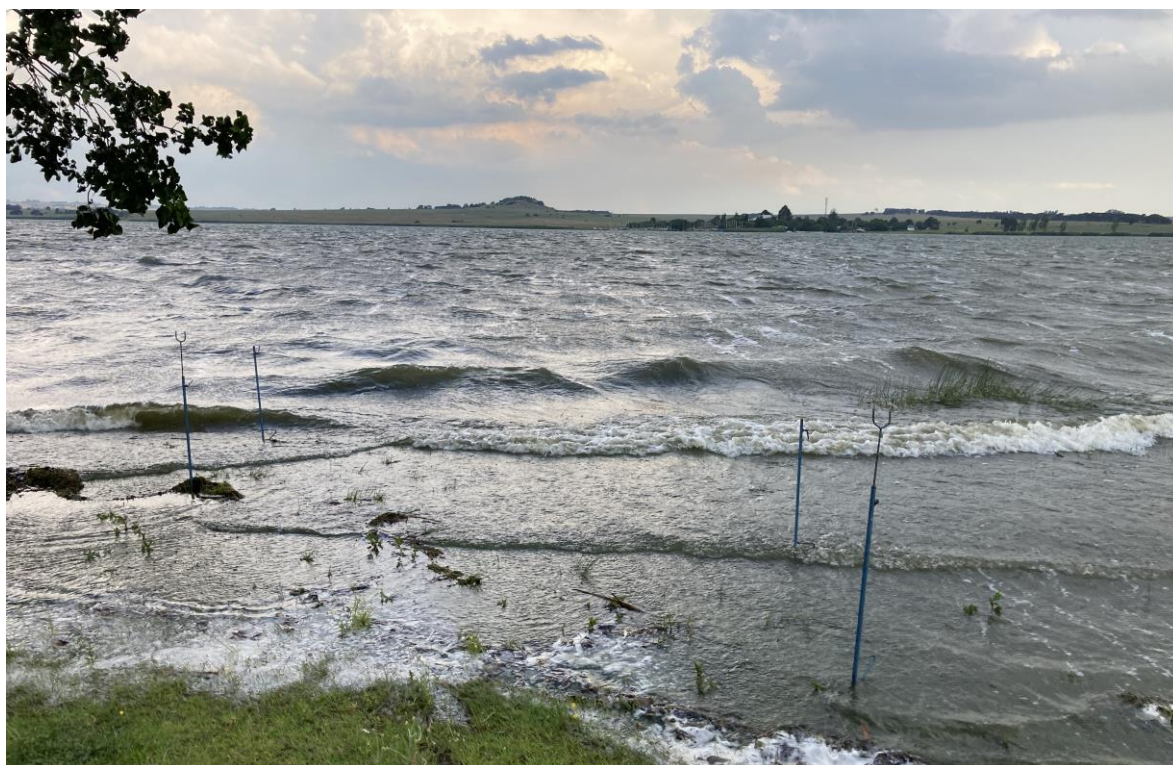
At 1538Z, he again took several photographs of the prevailing weather conditions. He stated that this was after a *gale force wind* had passed over the area. He further stated that the conditions went from basically no wind to gale force wind in about 5 minutes. The wind was so strong that he could not take any more photographs during that period.

Figure 7: This photograph was taken at 1538Z in an easterly direction. (Source: Brian Kriedemann)

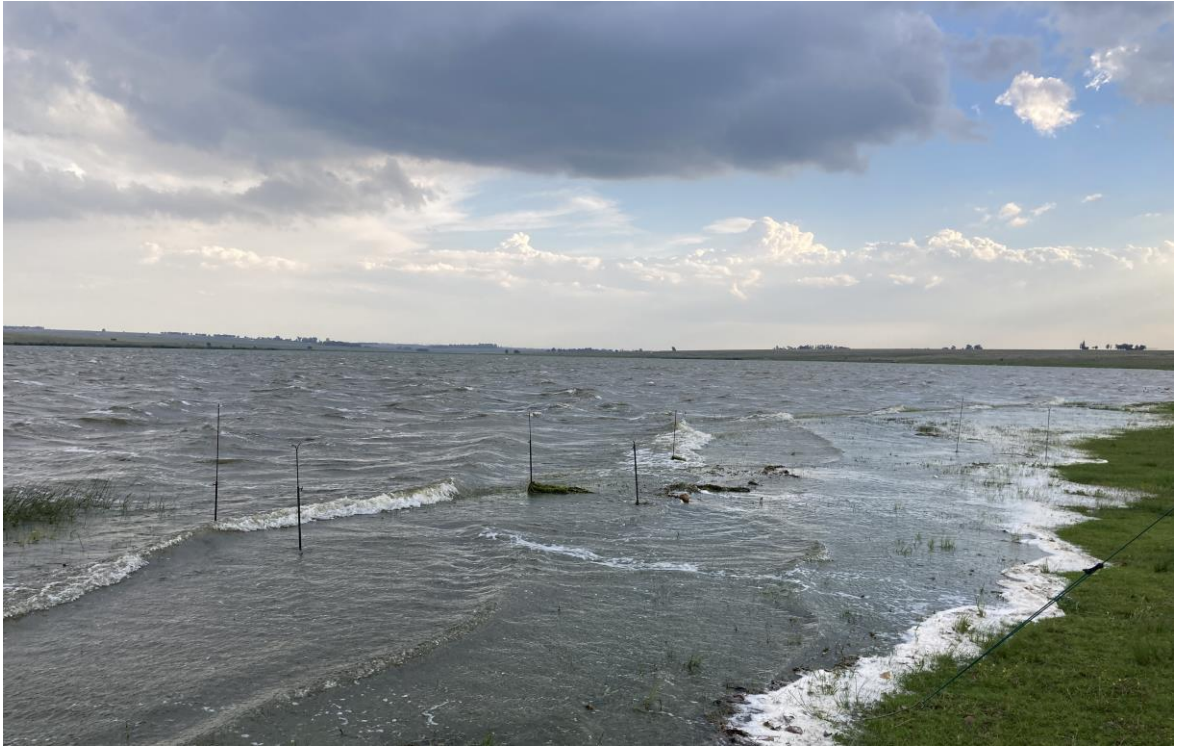
Figure 8: This photograph was taken at 1538Z in a southerly direction. (Source: Brian Kriedemann)

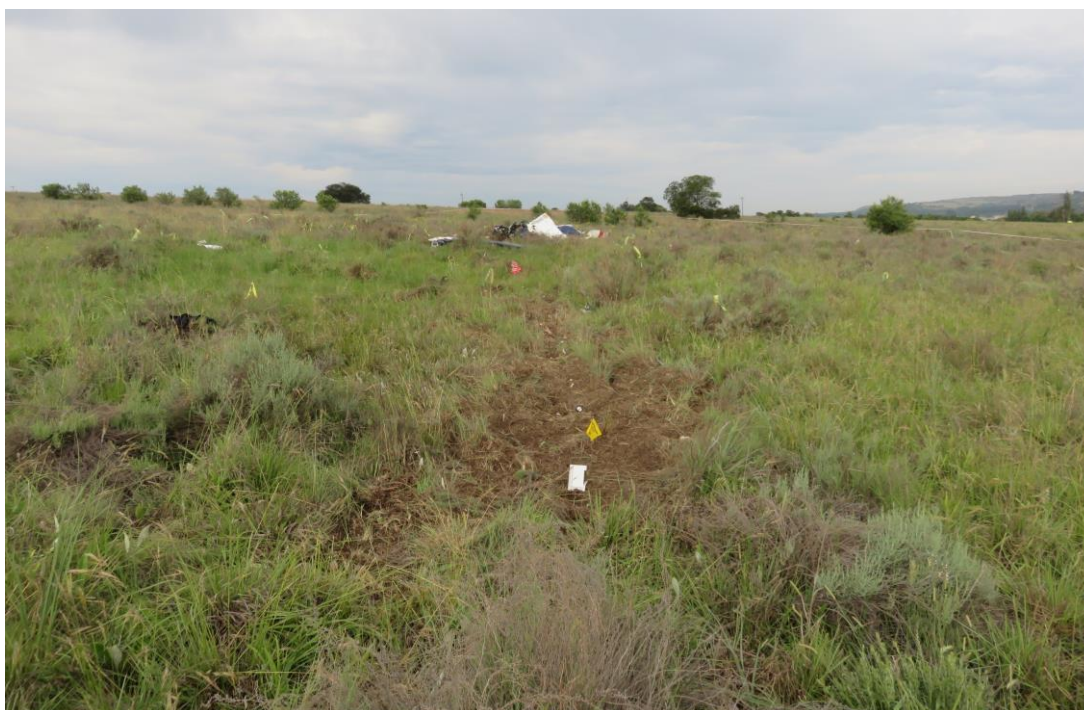
1.12.1 Following the failure of the outer section of the left wing in-flight, the aircraft was seen twirling towards the ground and impacted terrain (an open field) in a westerly direction. During the impact sequence, the right wing broke off whilst the inner section of the left wing remained attached to the fuselage. The entire propeller spinner assembly broke off from the the front section of the engine, all three propeller blades were severed at their respective roots and were accounted for along the impact line. This was indicative of an engine that was producing power on impact. The wreckage was severely disrupted during the impact sequence and most of the cockpit instruments ejected from the instrument panel. The empennage remained attached to the aft fuselage, and all control surfaces were accounted for. The main wreckage came to rest approximately 20m after the initial impact, with the right wing located to the left of the impact line. The left-wing outer section was located approximately 100m from the main wreckage.

Figure 9: The first point of impact with the main wreckage visible along the impact line.

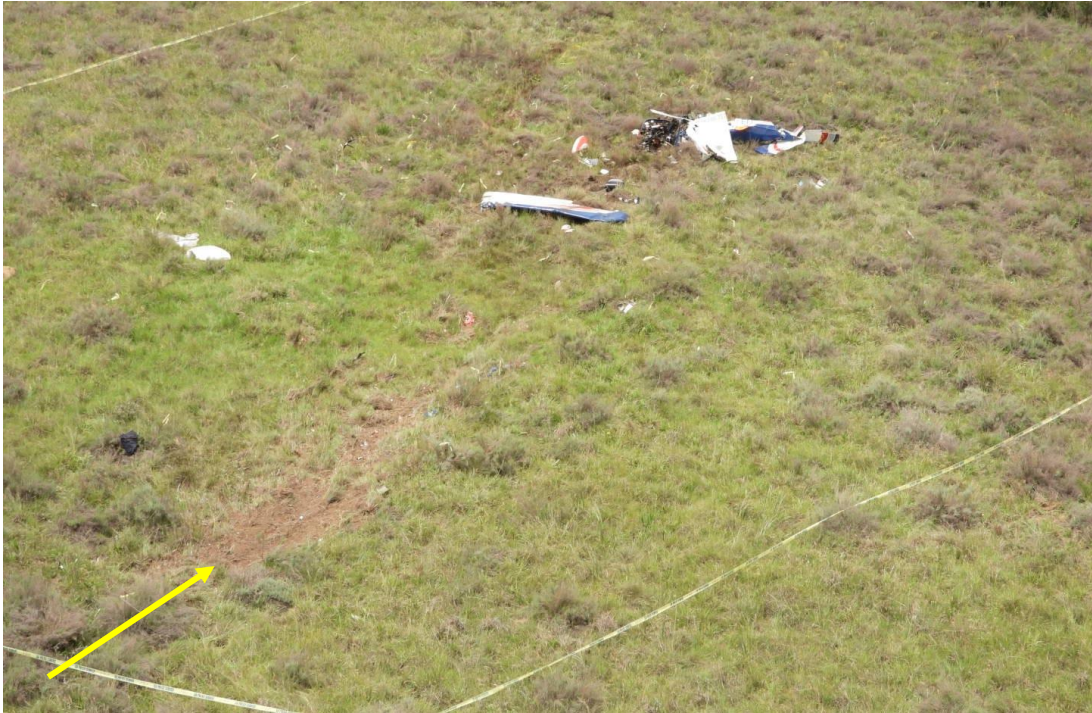
Figure 10: An Aerial photograph of the impact point, the right wing and the main wreckage.

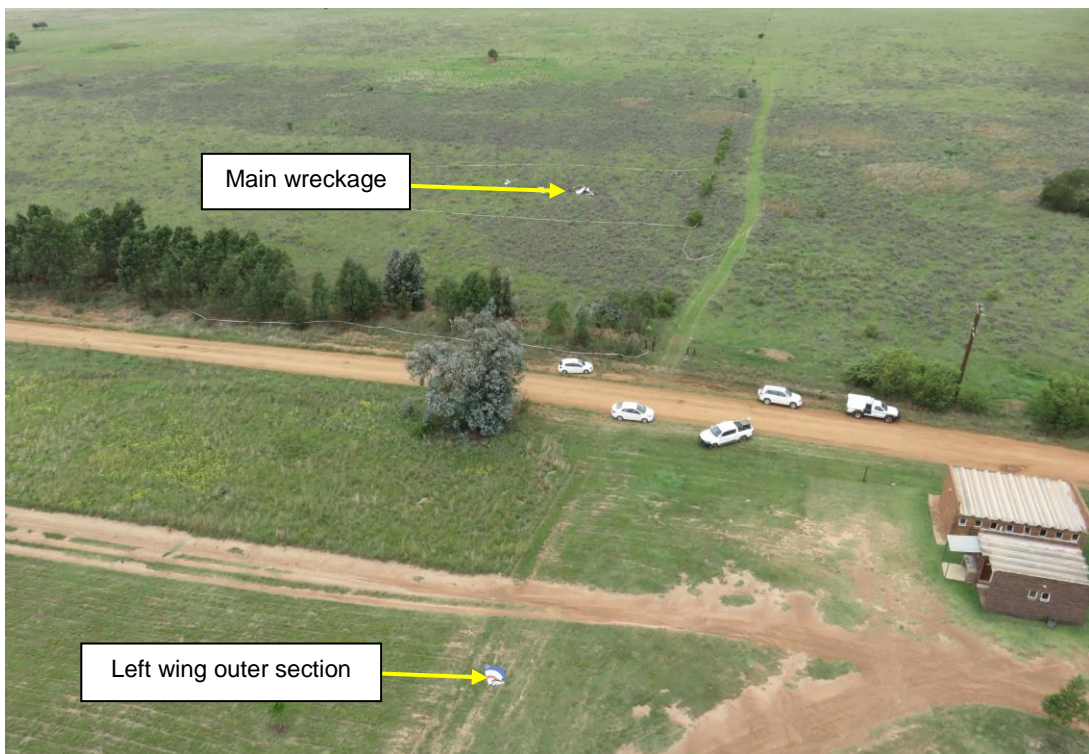
Figure 11: An aerial photograph of the main wreckage and the left-wing outer section.

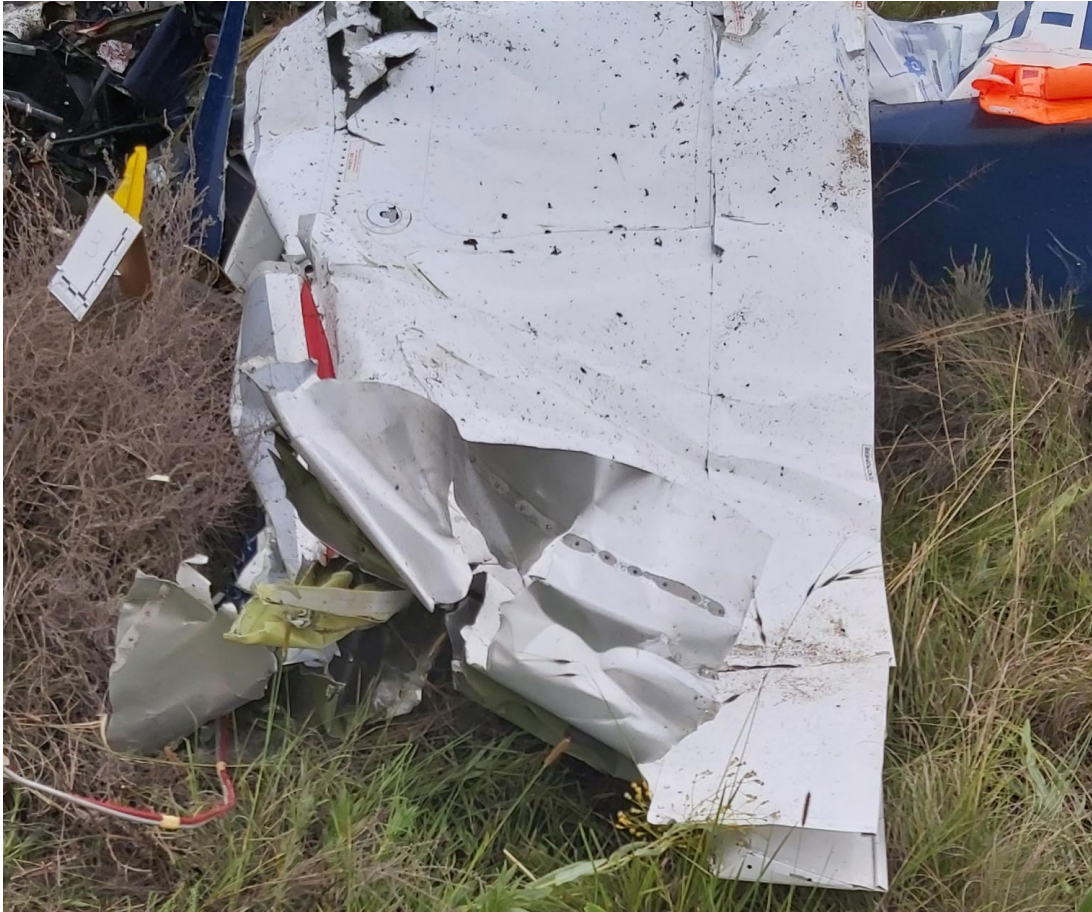
Figure 12: The left wing, which was found still attached to the main wreckage.

1.16.1 The entire left wing (both sections) as well as the main wing spar centre section were recovered from the accident site and were sent for metallurgical examination, which the results would be discussed in the final report.

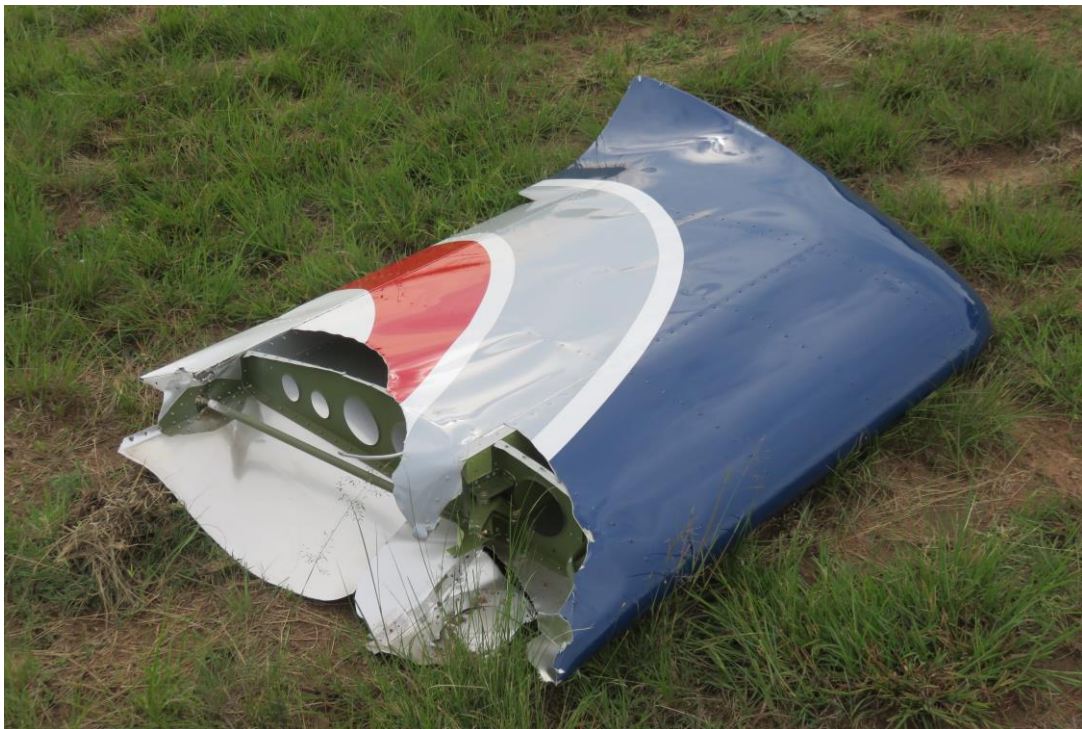
Figure 13: The left-wing outer section.

- 2.2.7 A Certificate of Release to Service was issued on 7 June 2021, which would lapse at a total of 615.4 hours of flight time or on 7 June 2022, whichever occurs first.
- 2.2.8 The outer section of the left wing failed in-flight and broke off the aircraft.
- 2.2.9 The entire left wing (both sections) was recovered from the accident site and was sent for metallurgical examination.
