PRELIMINARY ACCIDENT REPORT

Accident
- Preliminary Report -
AIID Ref No: CA18/2/3/9963

On Thursday 4 March 2021, a pilot on-board a Fokker E.III with registration ZU-FOK took off on a private flight from the Coves Airfield. The pilot reported that during the flight, he experienced a rough running engine. A few seconds later, the engine stopped. The pilot decided to execute a forced landing on a ploughed field. The aircraft was substantially damaged during the accident and the pilot sustained minor injuries.

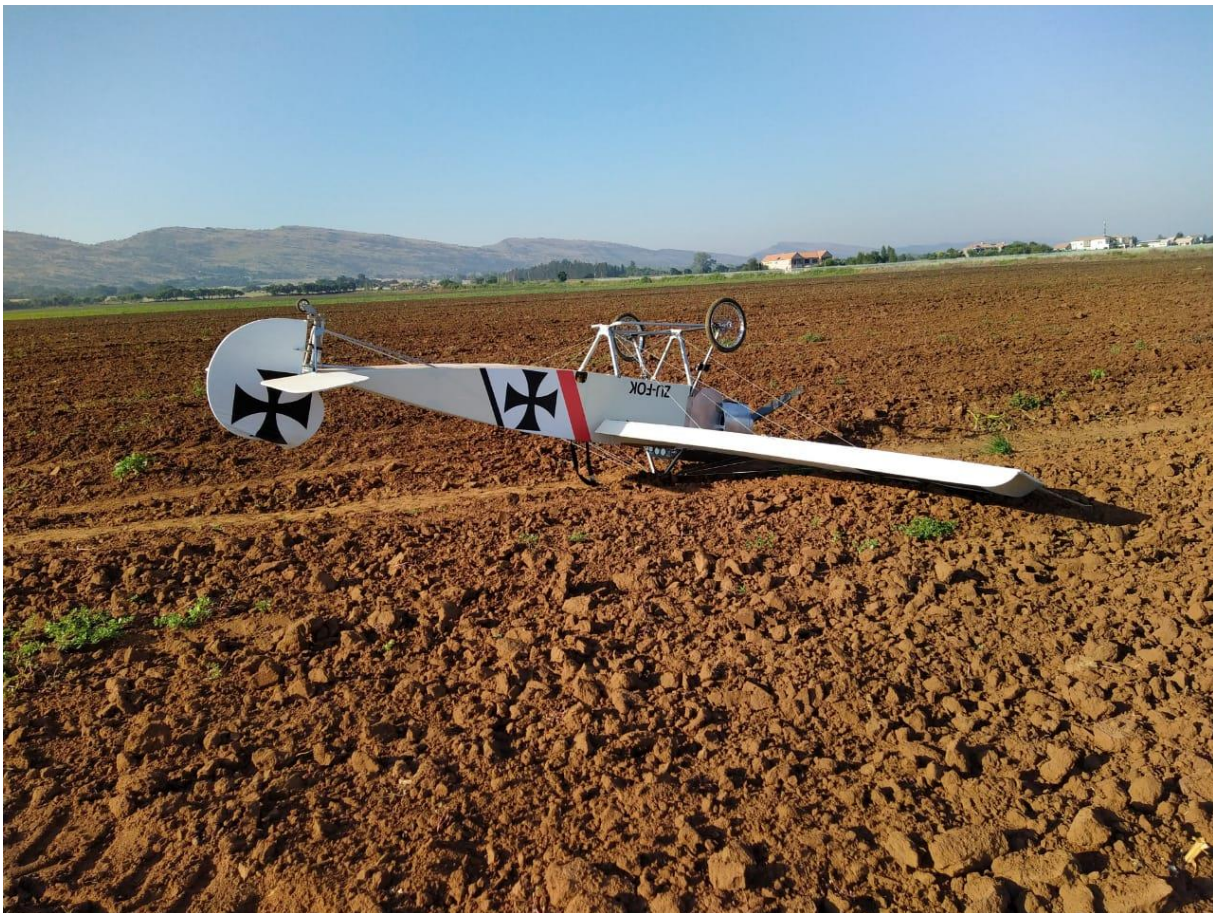
Figure 1: The aircraft as it came to rest post-accident. (Source: Owner)

1.1.2 The pilot reported that approximately 30 minutes into the flight, he experienced a rough running engine, and about five seconds later, the engine stopped. The pilot elected to execute a forced landing on a ploughed field. The aircraft touched down and came to rest in an inverted position.

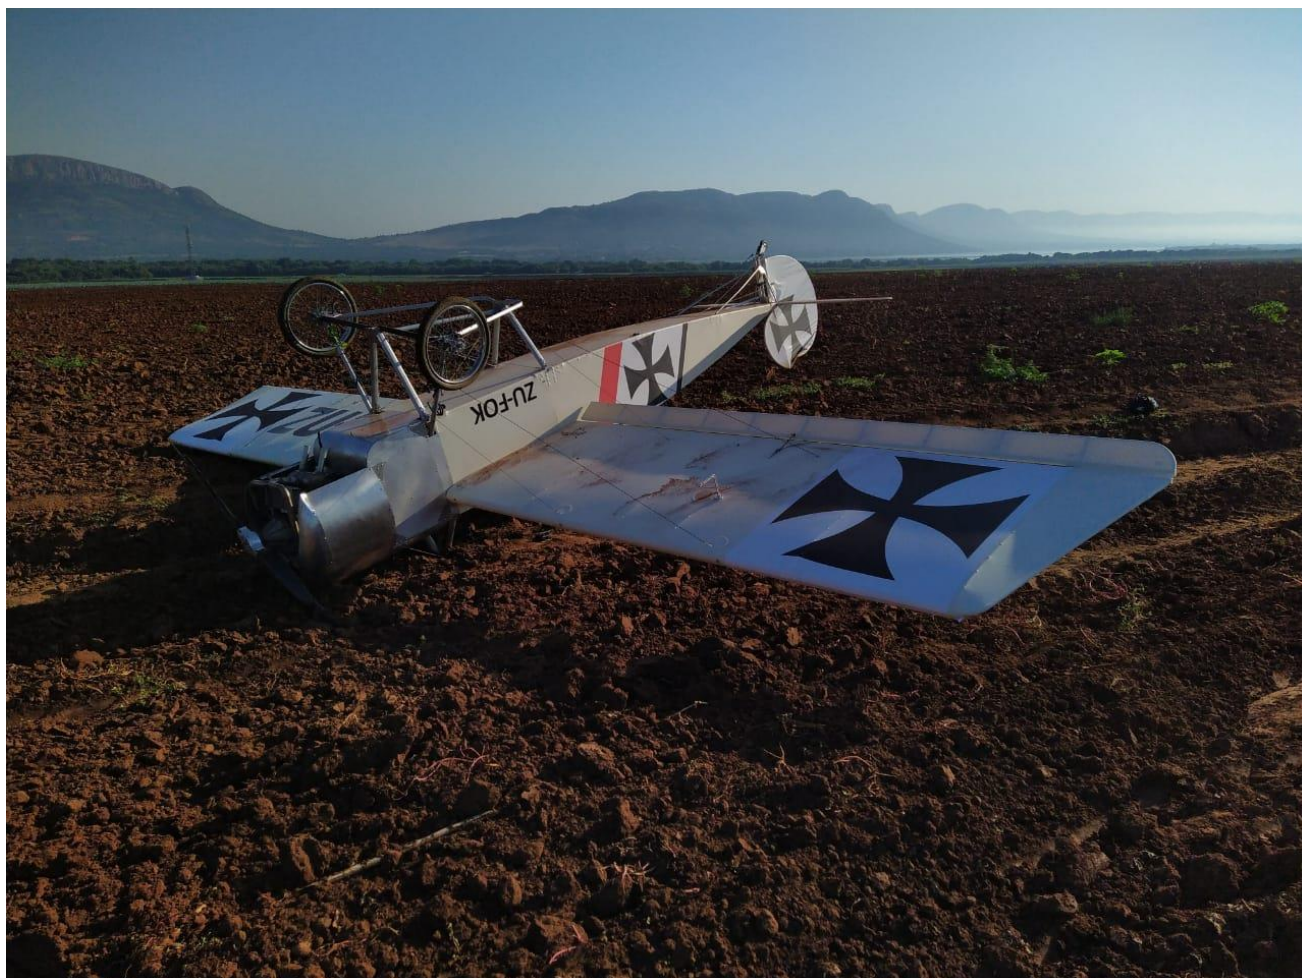
1.3.1 The aircraft sustained substantial damage during the accident sequence.

1.12.1 The pilot experienced a rough running engine, and about five seconds later, the engine stopped. The pilot elected to execute a forced landing on a ploughed field. After touch down, the aircraft came to rest in an inverted position. The accident occurred approximately 1nm from the take-off airfield.

Figure 3: The aircraft with damage to the wing. (Source: pilot)
