**PRELIMINARY ACCIDENT REPORT**

**Accident and Incident Investigations Division**

Accident  
- Preliminary Report -  
AIID Ref No: CA18/2/3/10007

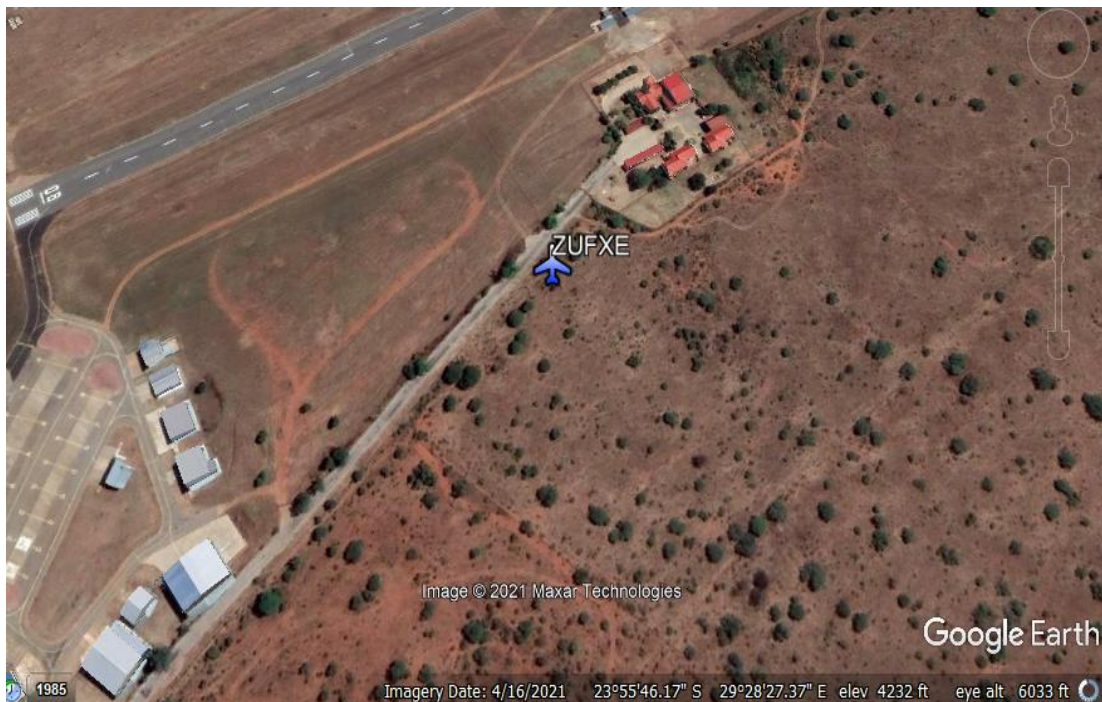
- 1.1.6 The aircraft accident occurred during daylight on a bushy terrain with obstacles (trees, electrical power lines and perimeter fence) and near FAPI at Global Positioning System (GPS) readings: S 23°55'54.19" E 029°28'40.86" and at a field elevation of 4250 feet (ft).

**Figure 3:** An aerial view of the accident site. (Source: Google Earth)

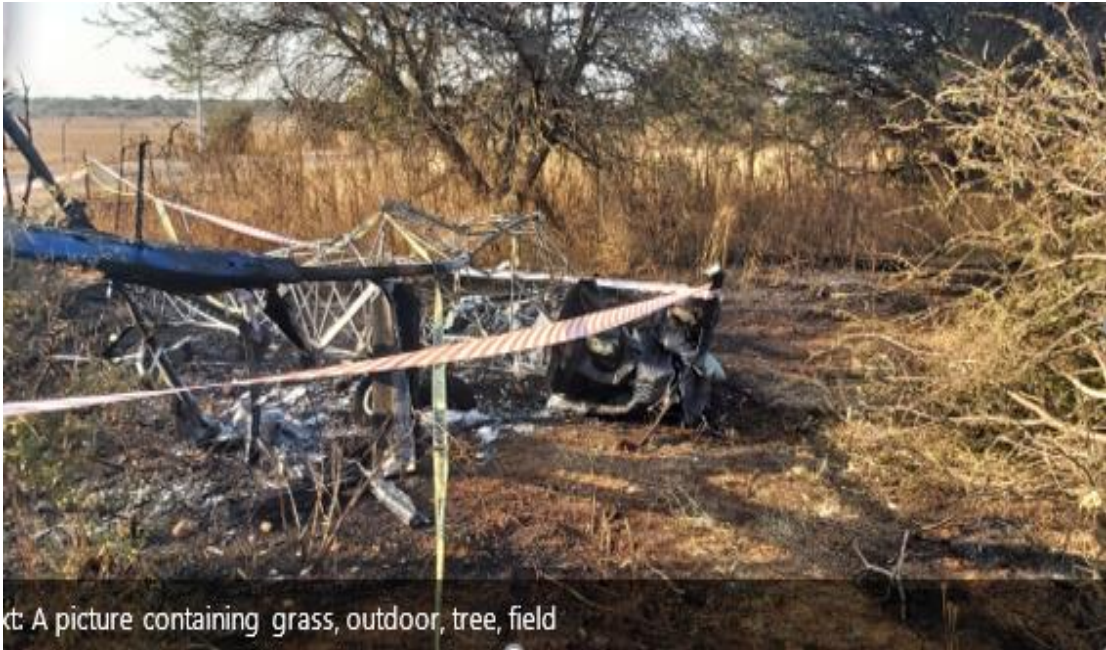
- 1.3.1 The aircraft was destroyed and consumed by post-impact fire.

**Figure 4:** The burnt wreckage after the fire was put out.

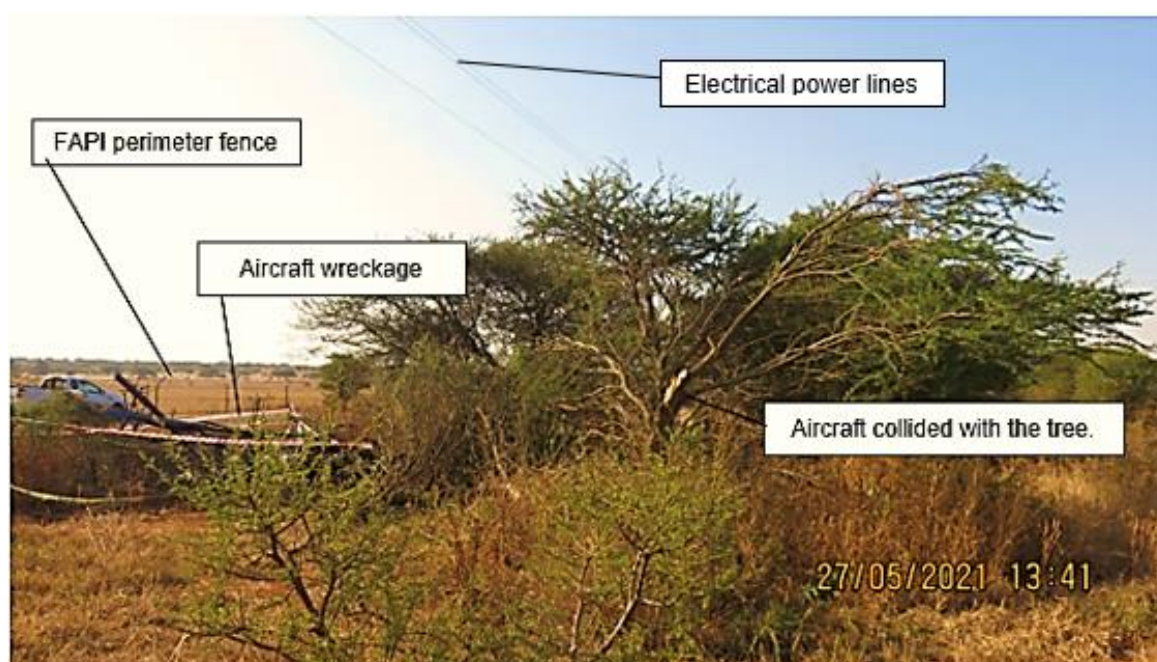
1.12.1 The aircraft accident occurred 30m from FAPI's perimeter fence on the eastern side. The aircraft crashed on a bushy terrain close to electrical power lines. The aircraft collided with a thorny tree and swung around approximately 180 degrees to face the opposite direction of approach before coming to rest; thereafter, a post-impact fire ensued.

**Figure 5:** The accident site and obstacles in the area.

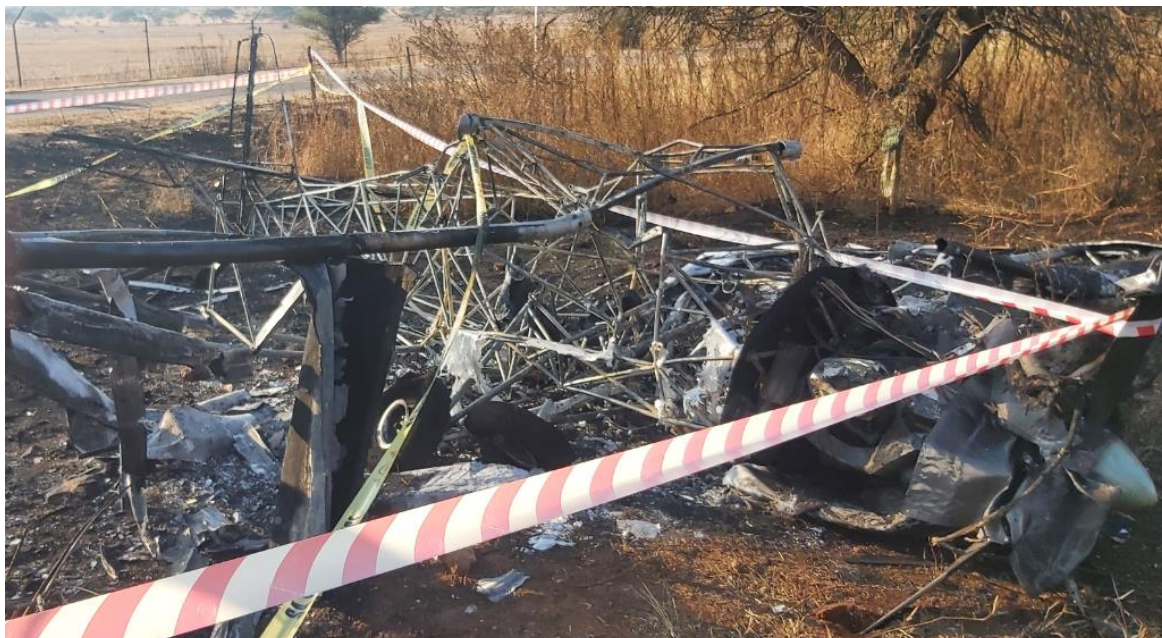
1.12.2 The left-side main gear was found near the right-side main landing gear. The left-side landing gear strut was bent towards the right-side main landing gear.

**Figure 6:** Both landing gears were found on the right-side of the wreckage.

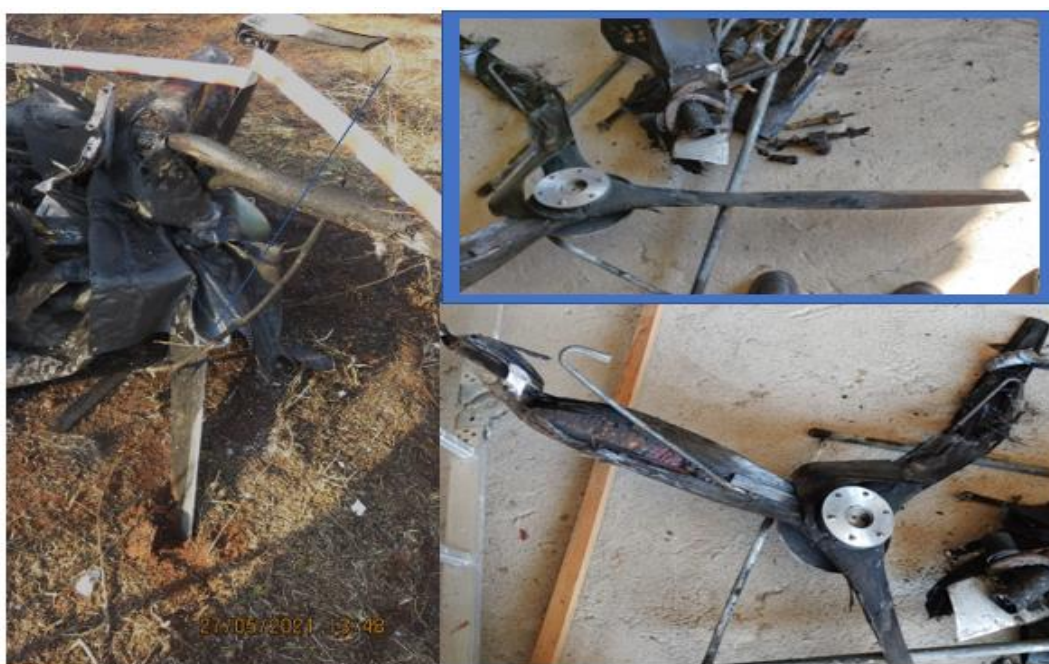
1.12.3 The aircraft was equipped with a three-bladed propeller and two of the propeller blades were damaged by post-impact fire. One of the propeller blades was found with no damages. The damage to the composite propeller blades was indicative of an engine that was not turning during collision with the tree and impact with the ground.

**Figure 7:** The damage on the propeller blades.
