PRELIMINARY ACCIDENT REPORT

Accident
- Preliminary Report -
AIID Ref No: CA18/2/3/10022

Reference Number : CA18/2/3/10022
Name of Owner/Operator : Johannesburg Flying Academy
Manufacturer : Sling Aircraft
Model : Sling 2
Nationality : South African
Registration Marks : ZU-FZZ
Place : Panorama Airfield, Gauteng Province
Date : 9 July 2021
Time : 0720Z

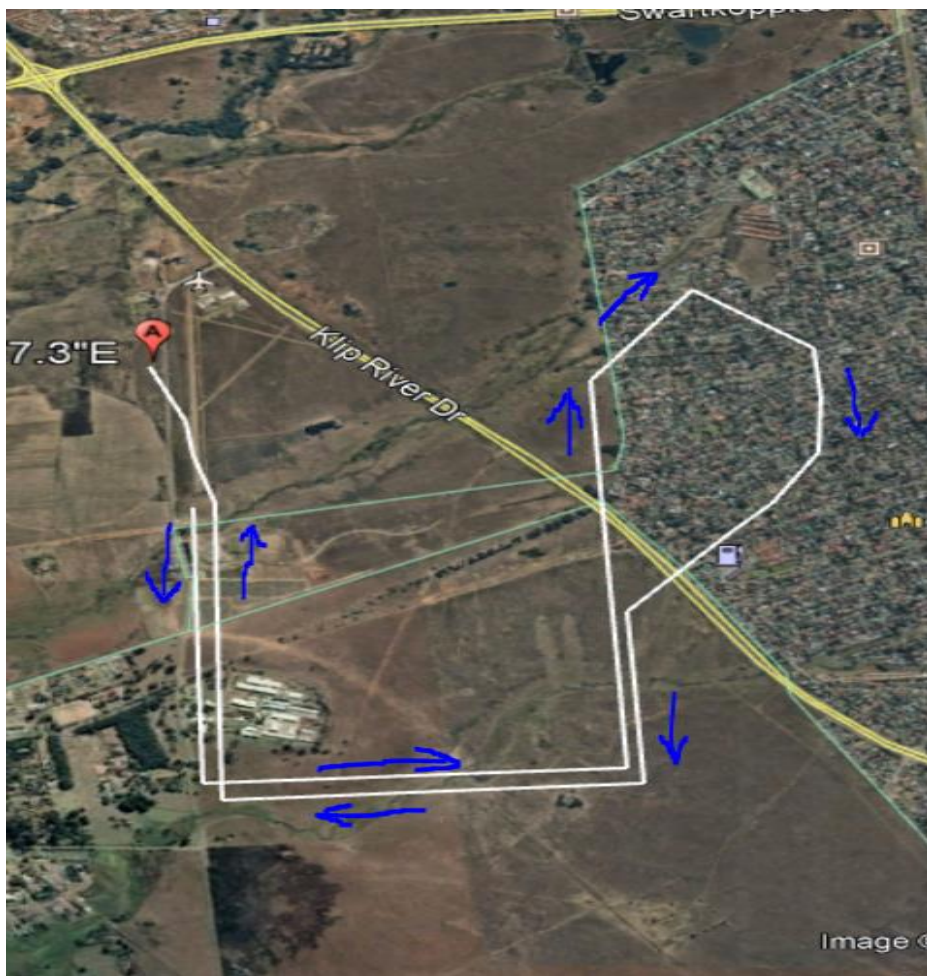
Figure 3: Pilot changed circuit to land from RWY 20 to RWY 02. (Source: Google Earth)

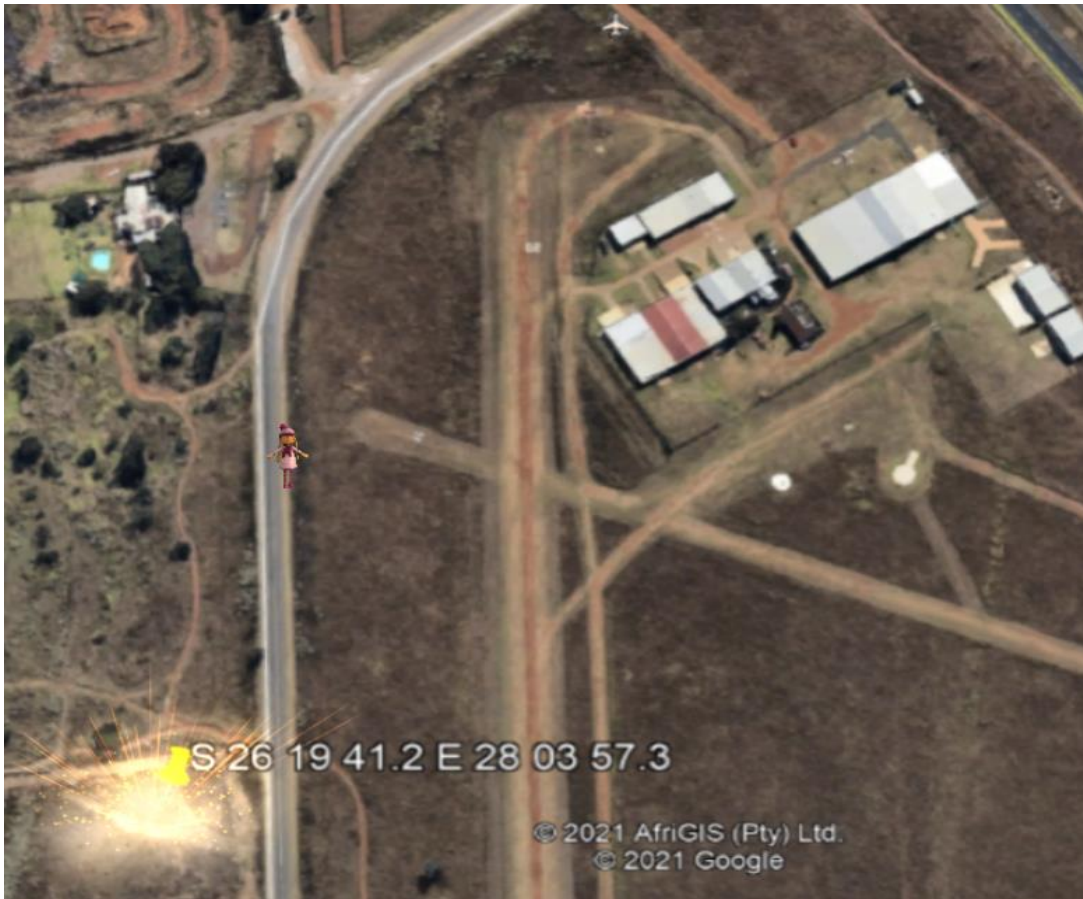
- 1.1.3 An eyewitness (see position of eyewitness in Figure 4) stated that he observed the aircraft lift-off, then it made a descent, flying low over the road with the left-wing low. He then observed the aircraft striking the ground with the left-wing first, thereafter, the aircraft rolled over and the propellor struck the ground and came to rest in an inverted position. Moments later, the aircraft caught fire. The student pilot was fatally injured during the accident. The aircraft was destroyed by impact forces and a post-impact fire.

Figure 4: GPS location of the accident site. The human figure depicts the position of the witness.
(Source: Google Earth)

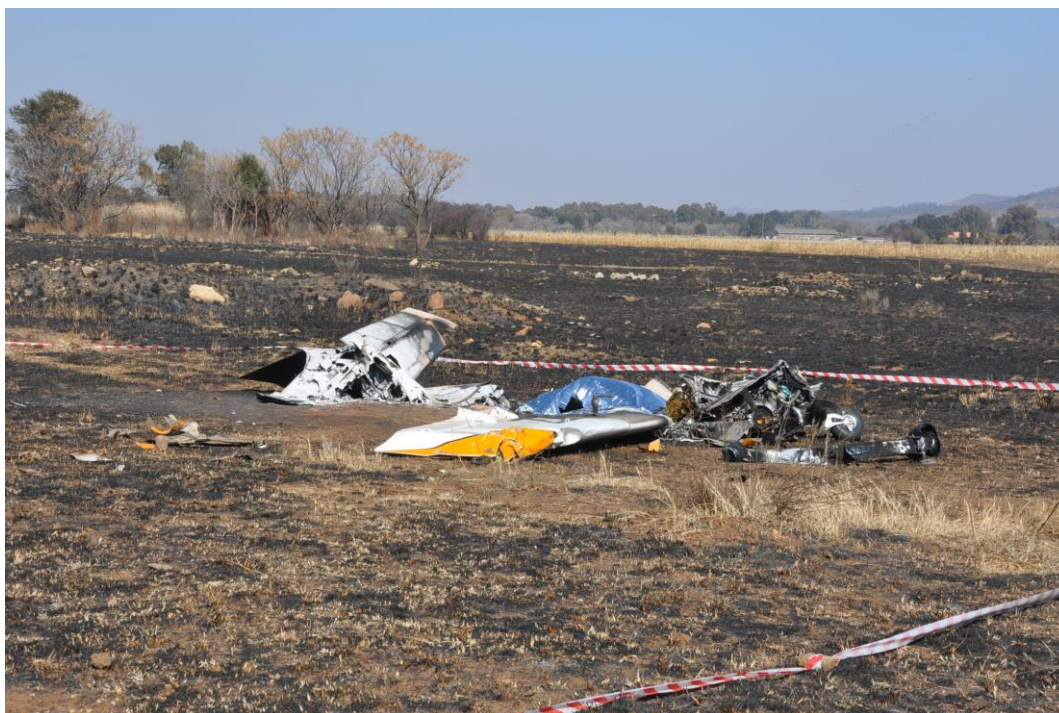
1.3.1. The aircraft was destroyed during the accident sequence.

Figure 5: The aircraft at the accident scene post-accident.

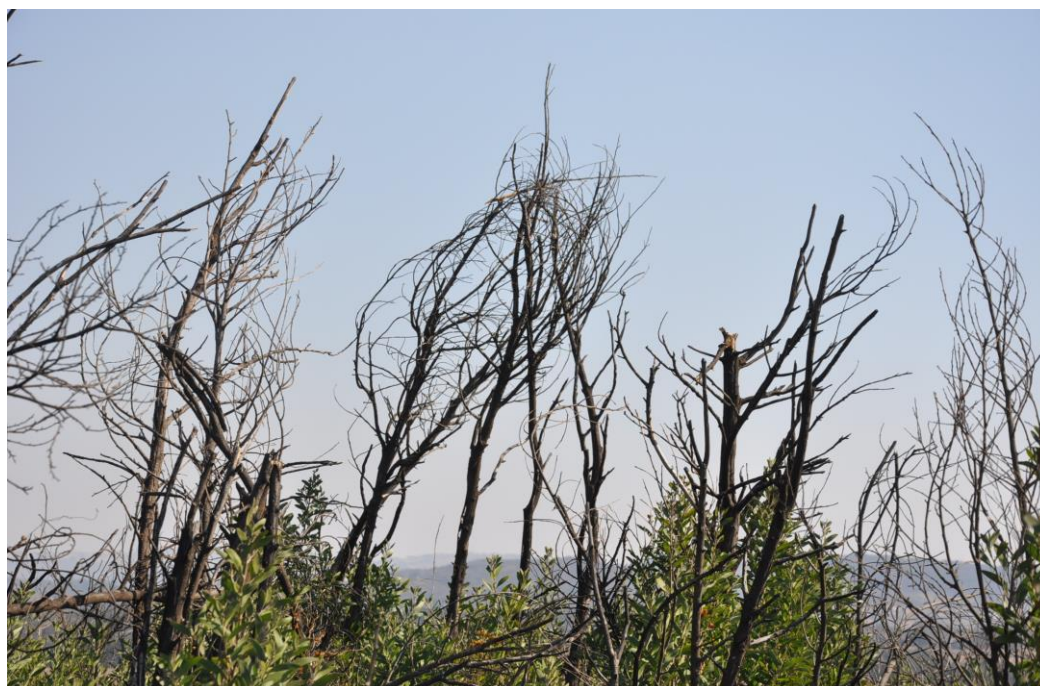
1.4.1. Some trees were clipped by the aircraft during the accident sequence (see Figure 6).

Figure 6: Trees on the left-side of Runway 02 that were clipped by the aircraft.

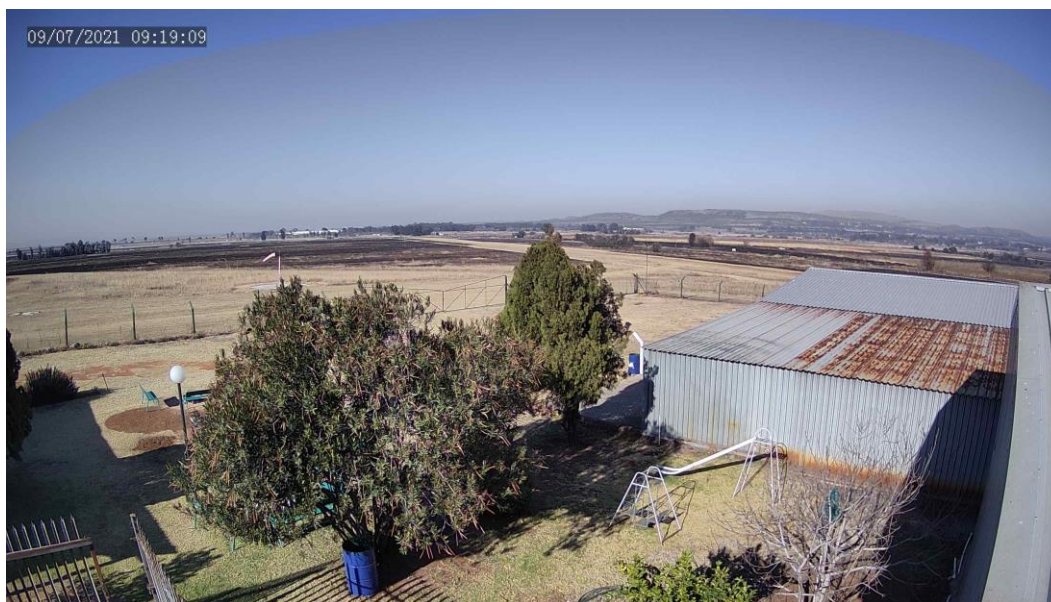
Figure 7: The windsock showing an approximate 11 knot northerly wind at 0919LT (0719Z).
(Source: Aviation Webcams)

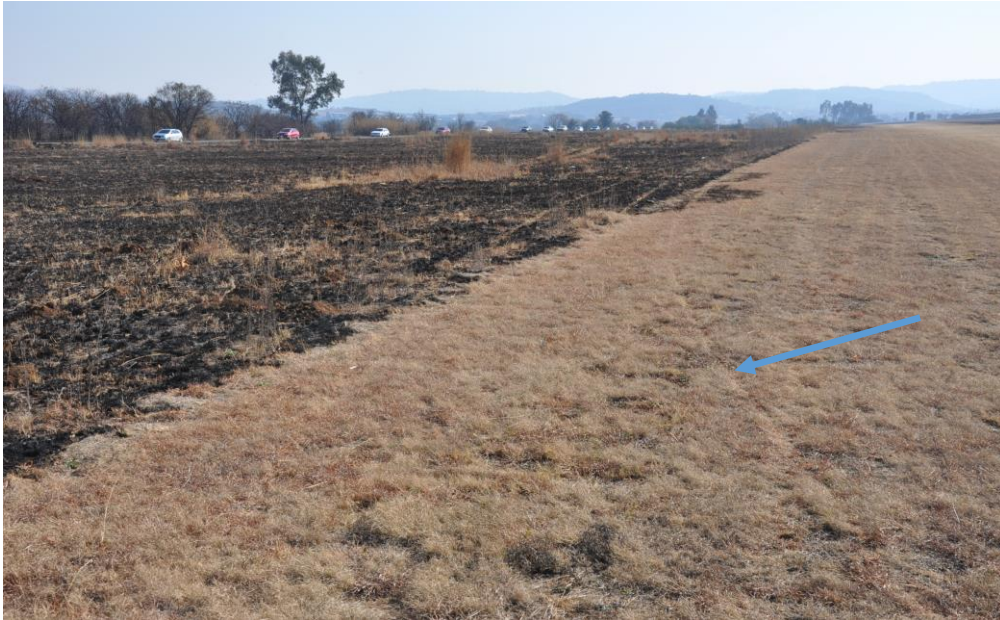
1.12.1 The first set of ground scars were observed towards the left of RWY 02, indicating that the aircraft had veered off to the left of RWY 02 (see Figure 9). The ground scars (landing gear lines) stopped (ended) a few metres before the trees, while the tops of trees were severed, indicating that the aircraft had been airborne at this phase (see Figure 6 and Figure 10. Red aircraft is for illustrative purposes only).

Figure 9: The first ground scar shows that the aircraft had veered off to the left after touchdown before taking power for next circuit.

- 2.1.10 During inspection of the runway (RWY 02), it was noted that the pilot had an unstable take-off because of the ground scars (see Figures 9 and 10).

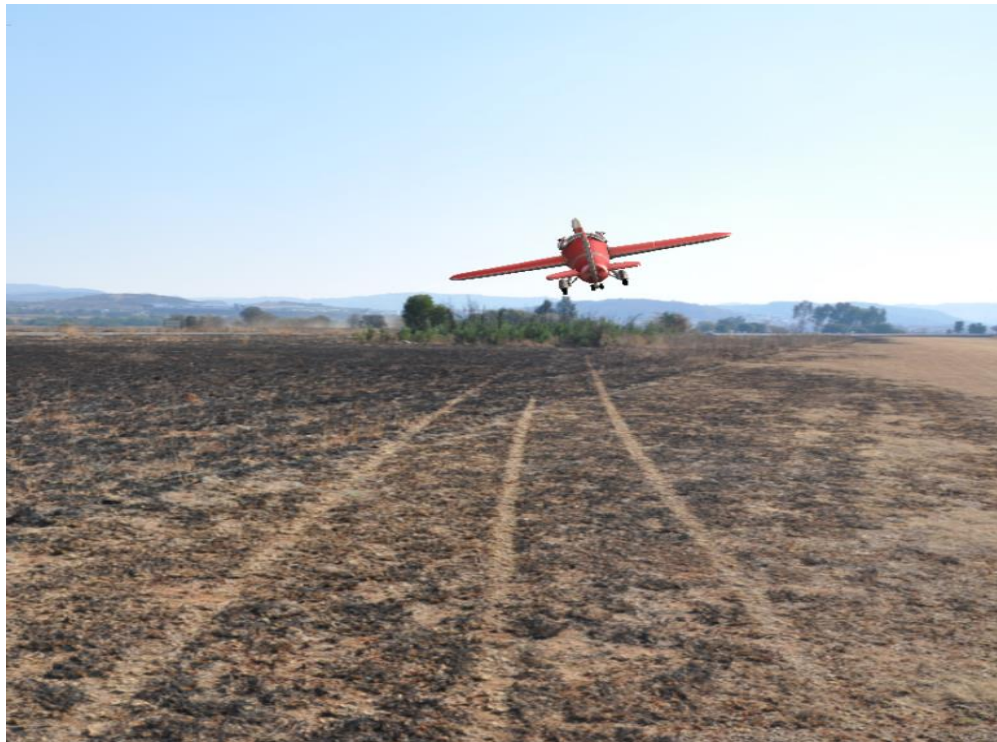
Figure 10: The second ground scars show the aircraft rolling before lift-off, with the student pilot attempting to avoid collision with the trees. (Aircraft figure source: 3D library)

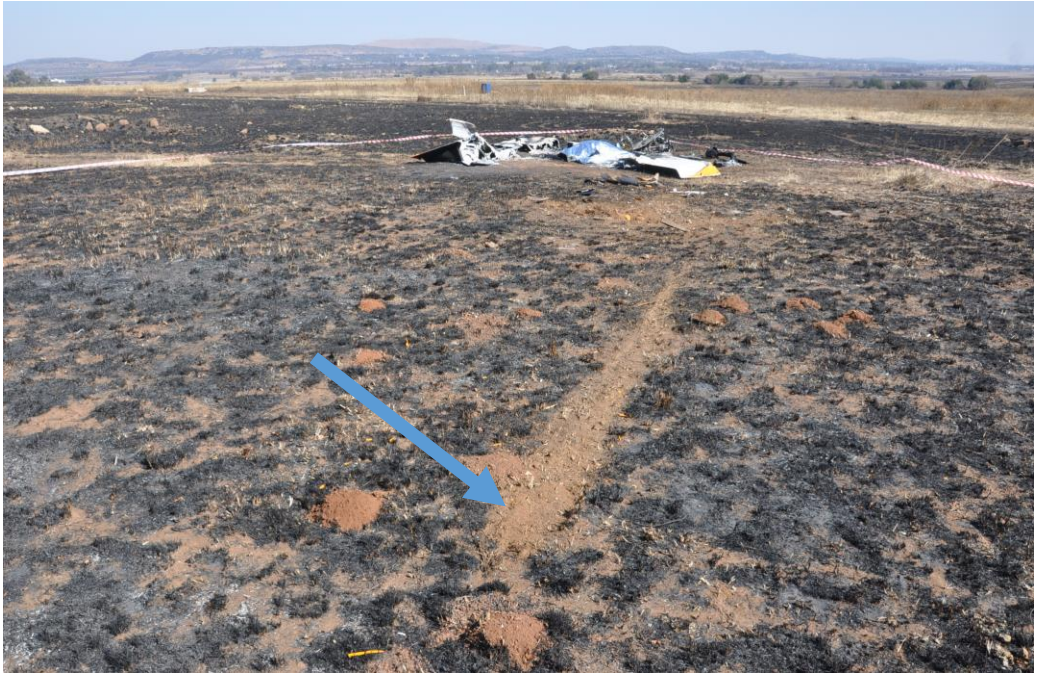
1.12.2 Further ground scars were observed 120m west of RWY 02. The aircraft first made impact with the ground with its left wing. The second ground scar was made by the propeller 8m away. The aircraft finally came to rest in an inverted position before it caught fire (see Figure 11).

Figure 11: The first ground scar made by the left wing.

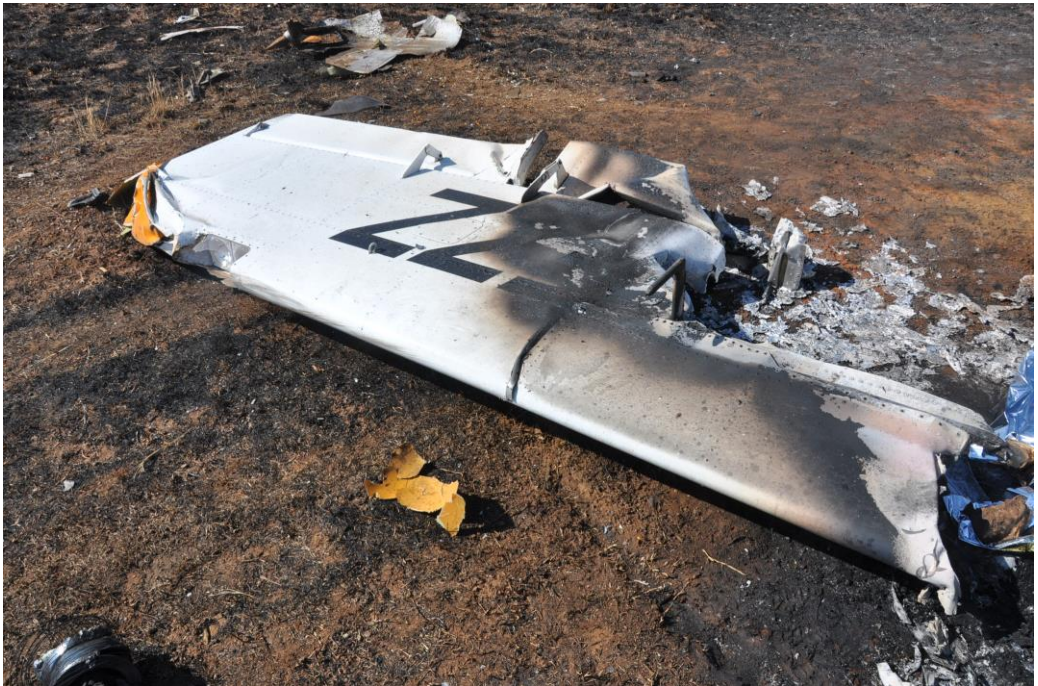
Figure 12: The left-wing that made contact with the ground first shows signs of impact damage on the wing tip.

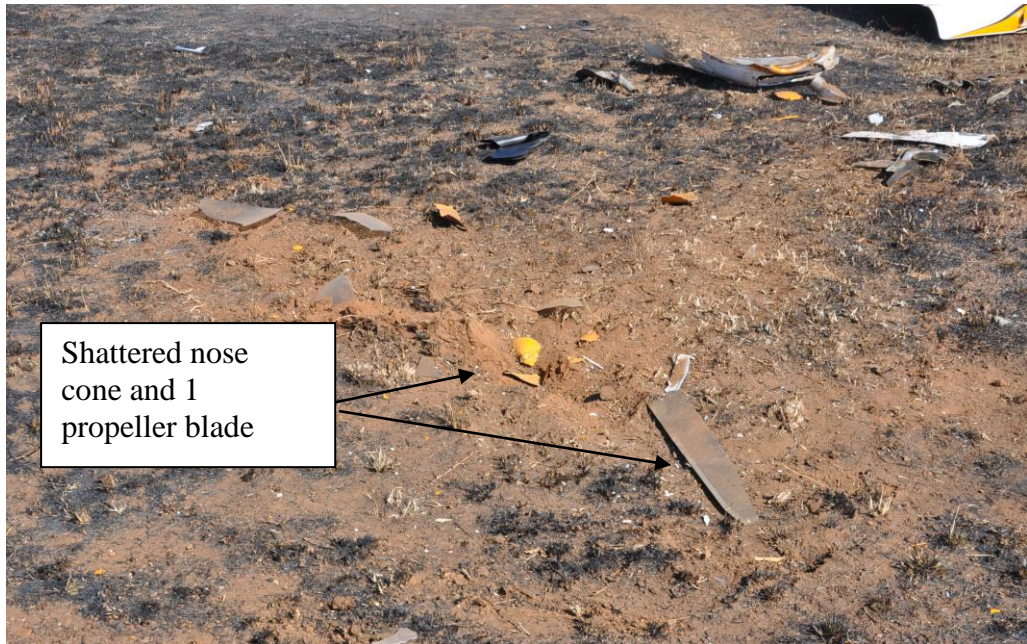
Figure 13: The second ground scar caused by the engine propeller blades.
