PRELIMINARY ACCIDENT REPORT

Accident
- Preliminary Report -
AIID Ref No: CA18/2/3/10110

Reference Number : CA18/2/3/10110
Name of Owner/Operator : AJ Crook
Manufacturer : Jabiru
Model : Jabiru 430 (S/N:912)
Nationality : South African
Registration Marks : ZU-IKI
Place : Cape Point Nature Reserve
Date : 10 February 2022
Time : 1110Z

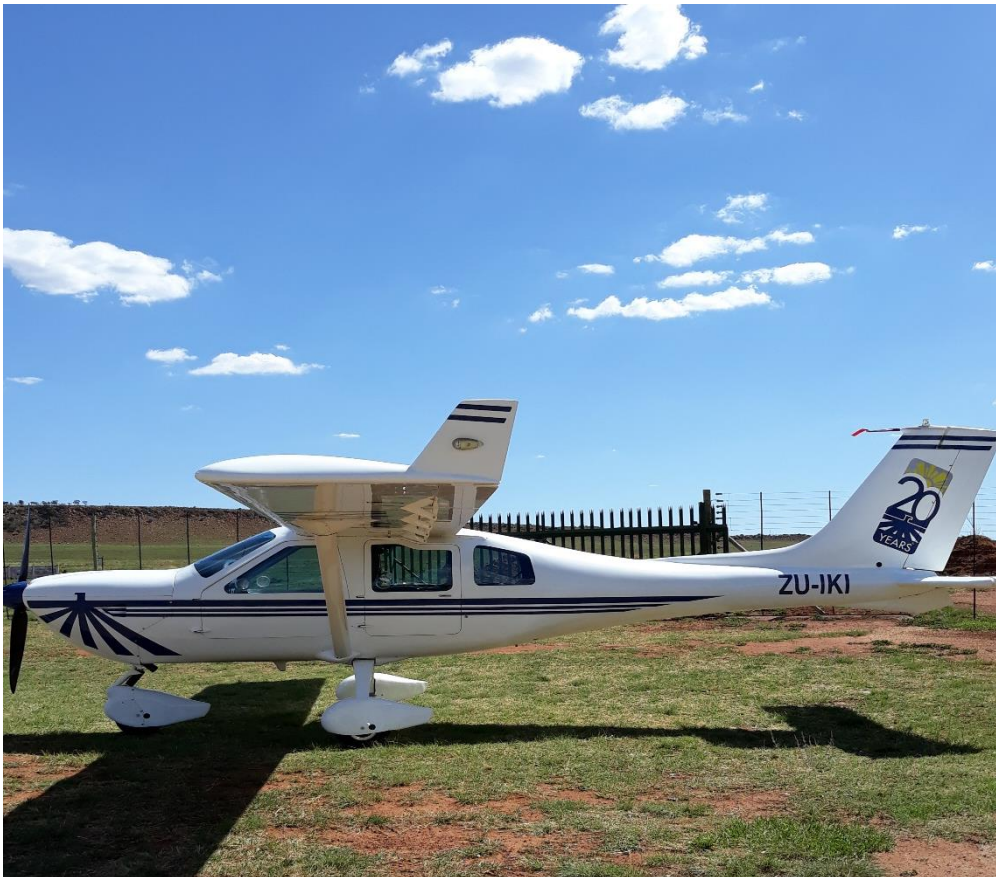
Figure 1: ZU-IKI after landing (Source: Aircraft file).

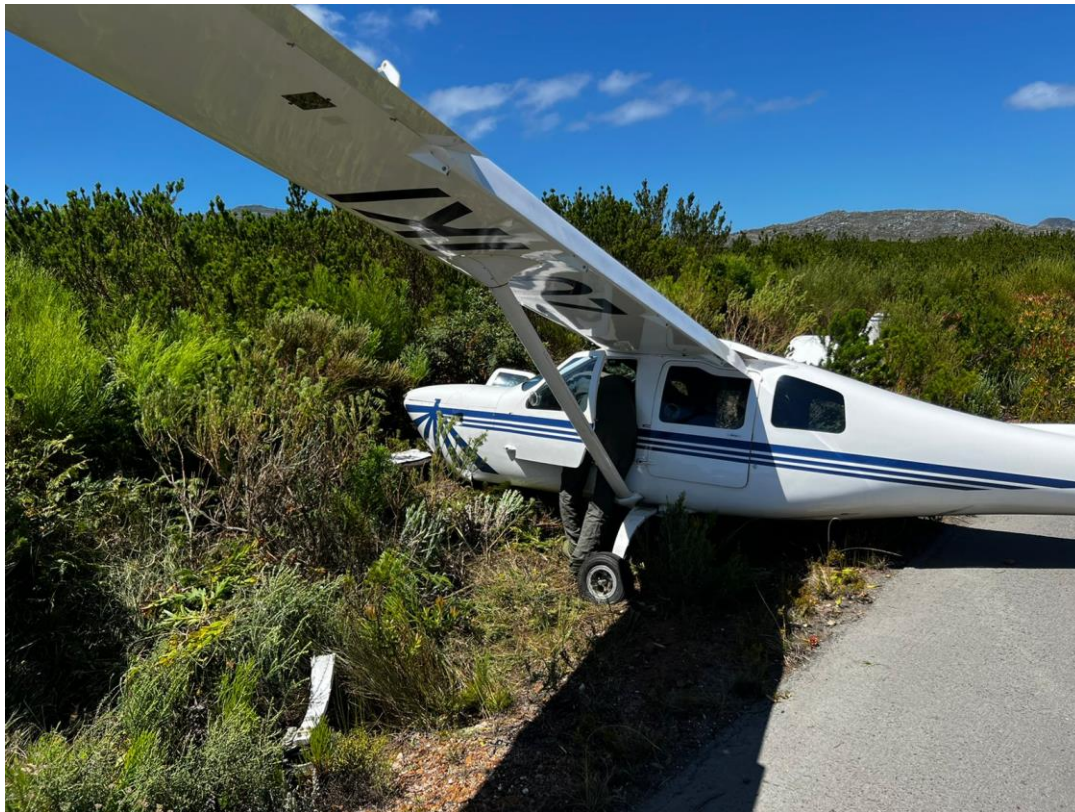
- 1.1.4 The pilot then executed a forced landing on a road in the Cape Point Nature Reserve. During the landing roll, the left wing clipped the fynbos which was on the left of the road, and the aircraft ground looped (to the left) and came to rest with the nose in the fynbos. The SAAF helicopter pilot flew towards the direction given by the pilot of ZU-IKI and spotted the aircraft from the air.

Figure 3:The aircraft as it came to rest in the fynbos. (Source: EMS)

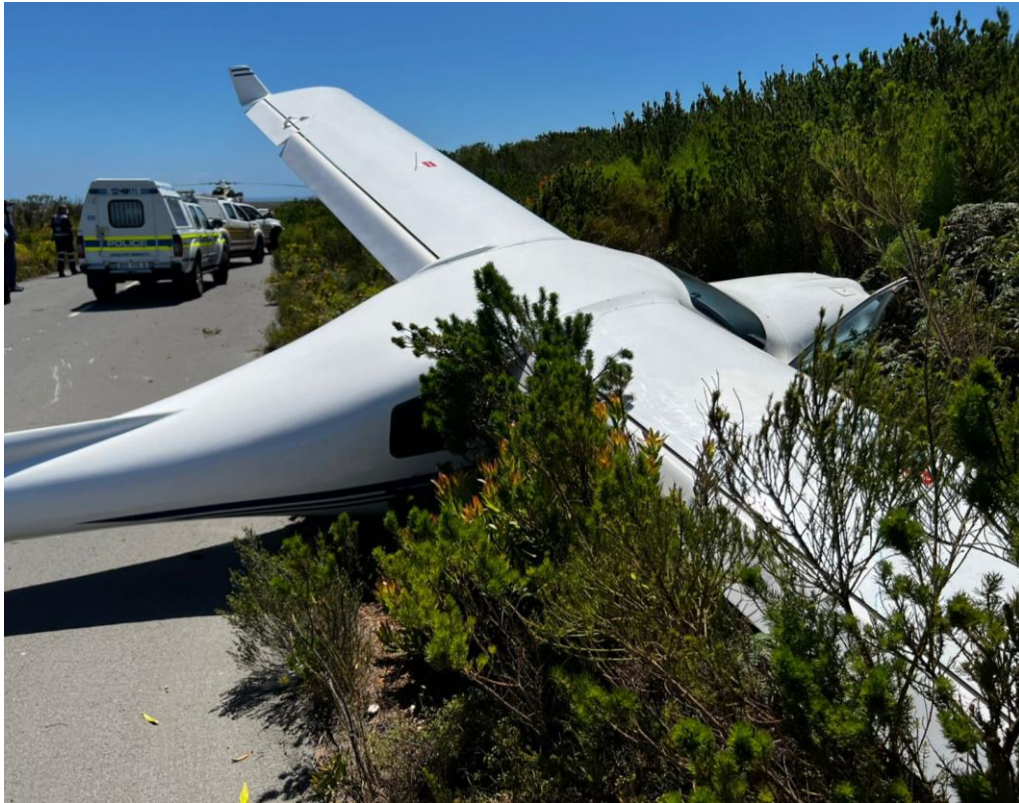
1.12.1 The aircraft landed on a road in the Cape Point Nature Reserve. The left wing made contact with the fynbos on the left-side of the road and ground looped counter-clockwise. The aircraft came to rest 90° across the road, sustaining damage to the right wing, horizontal stabiliser, undercarriage, nose wheel, propeller and fuselage.

Figure 4: The aircraft post-accident. (Source: EMS)
