PRELIMINARY ACCIDENT REPORT

Accident and Incident Investigations Division

Accident
- Preliminary Report -
AIID Ref No: CA18/2/3/10164

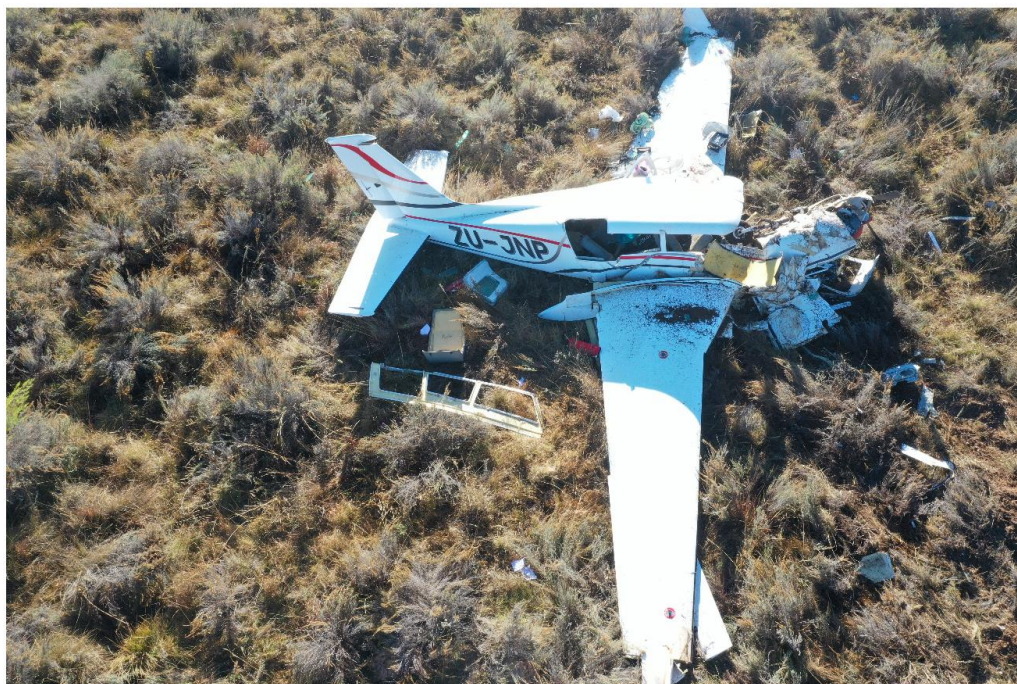
1.3.1. The aircraft was destroyed during the accident sequence.

Figure 3: The aircraft in its resting position post-accident. (Source: Operator)

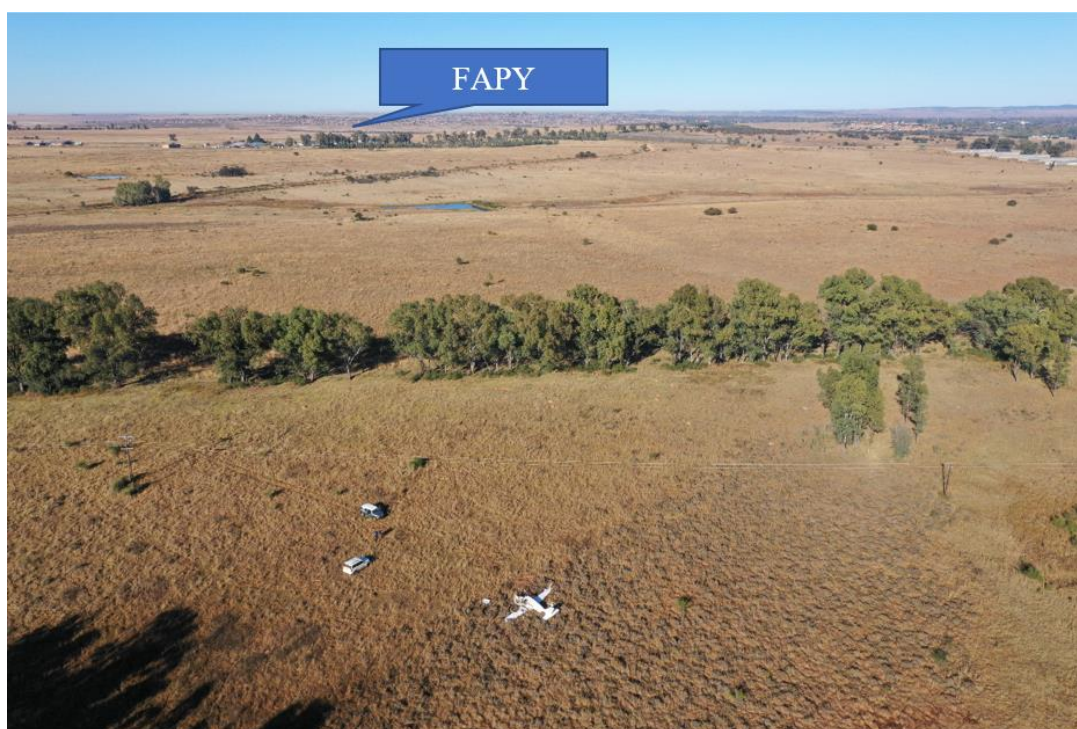
1.12.1 The aircraft took off in a northerly direction. According to the first eyewitness, a few seconds after take-off the aircraft was seen losing height before it disappeared behind the trees and from the eyewitness' view. The aircraft crashed approximately 1 664m from FAPY.

Figure 4: Aircraft's final position. (Source: Operator)

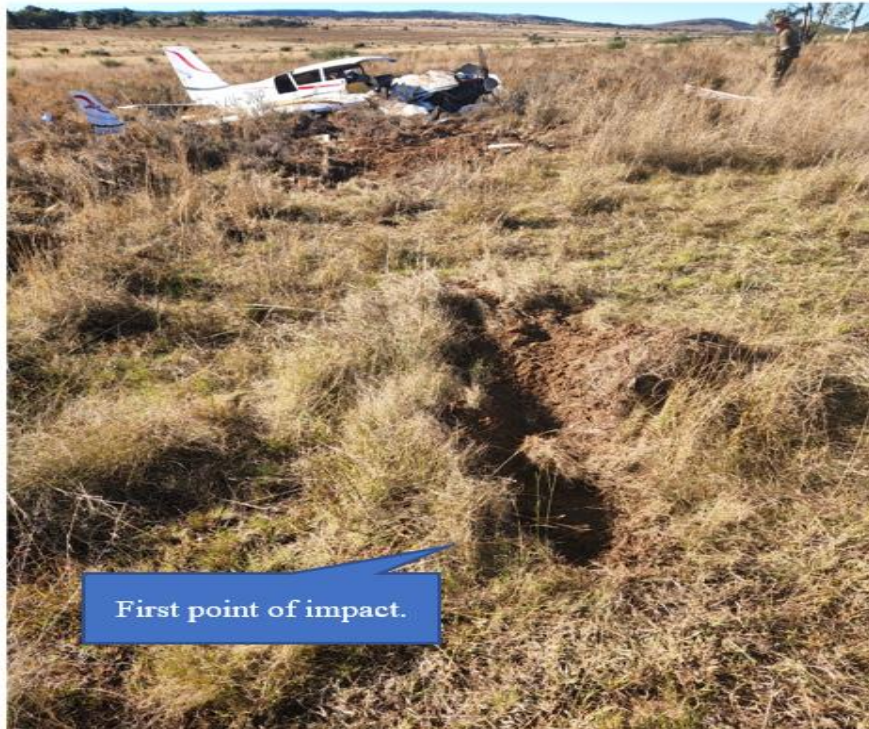
1.12.2 The aircraft impacted the ground with its right-side wing first and spun clockwise; this was followed by the nose hitting the ground and, subsequently, the aircraft came to rest facing south.

Figure 5: The first point of impact and the aircraft's resting position.

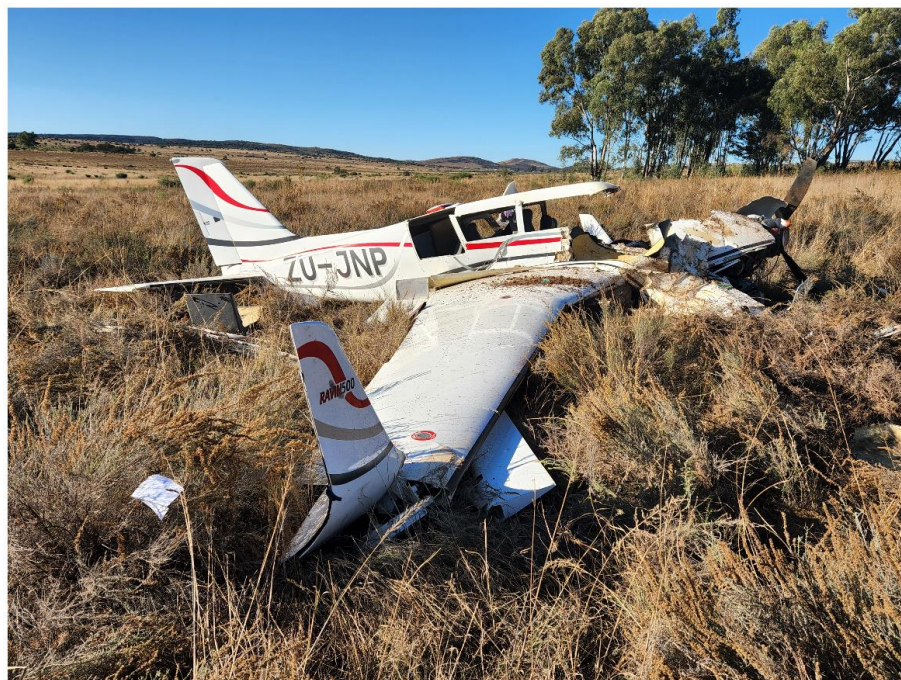
1.12.3 The right-side wing tip was damaged on impact, and it partly detached from the root.

Figure 6: Damage on the right-wing tip.

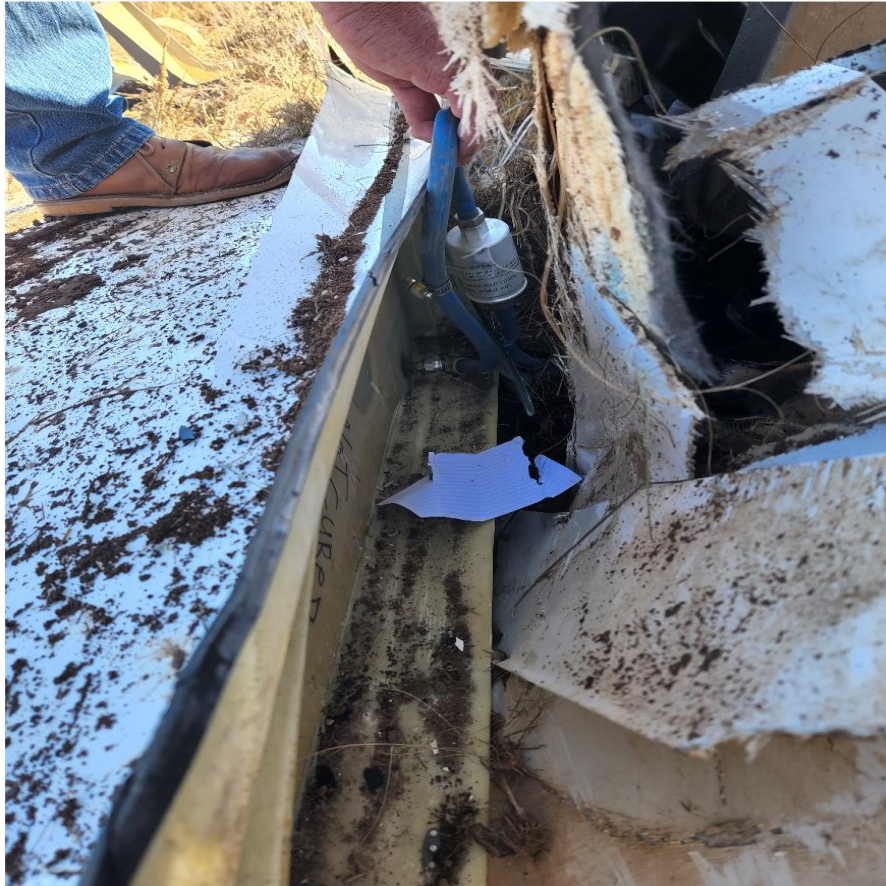
Figure 7: The separated wing from the root.

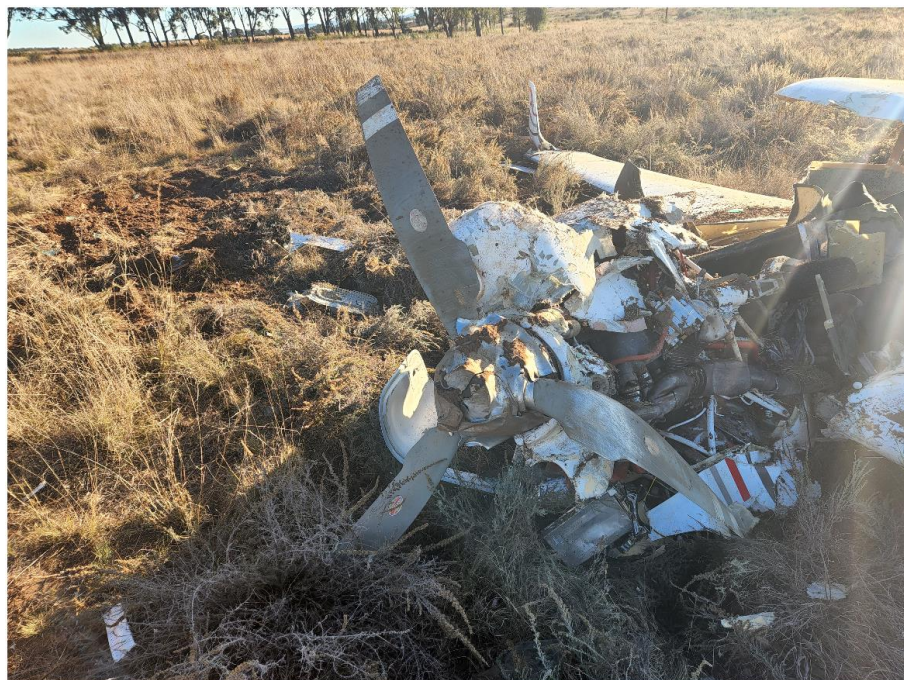
1.12.4 The nose section of the aircraft impacted the ground and the aircraft skidded on one of the propeller blades. The aircraft sustained damage to the spinner and one of the three propeller blades, an indication that the engine was not turning when the aircraft impacted the ground. The vertical stabiliser split in half due to impact force.

Figure 8: The damaged spinner and the propeller blade.

- 2.2.8 The condition of the propeller blades indicated that the engine had stopped prior to impact with the ground.
- 2.2.9 The first eyewitness who was stationed outside the hangar and to the right of Runway 06 reported that he witnessed the aircraft's take-off and, when it was at a height of approximately 500 feet (ft) above ground level (AGL), it spun to the right and disappeared from his view behind the trees. The second eyewitness who was working on a nearby farm stated that he saw the aircraft with its right-side wing low and losing height, before it impacted the ground.

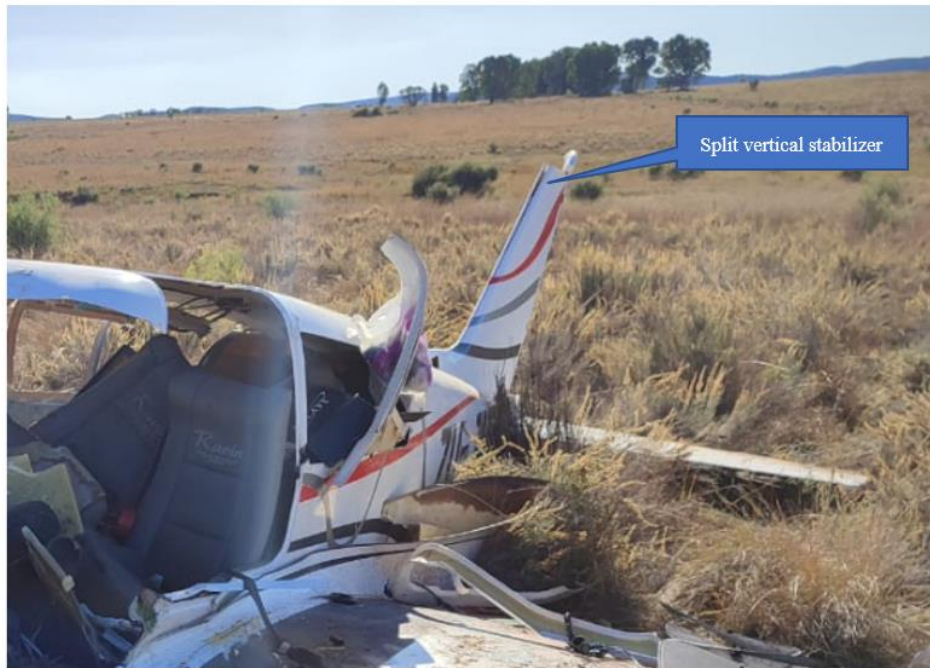
Figure 9: The split vertical stabiliser.

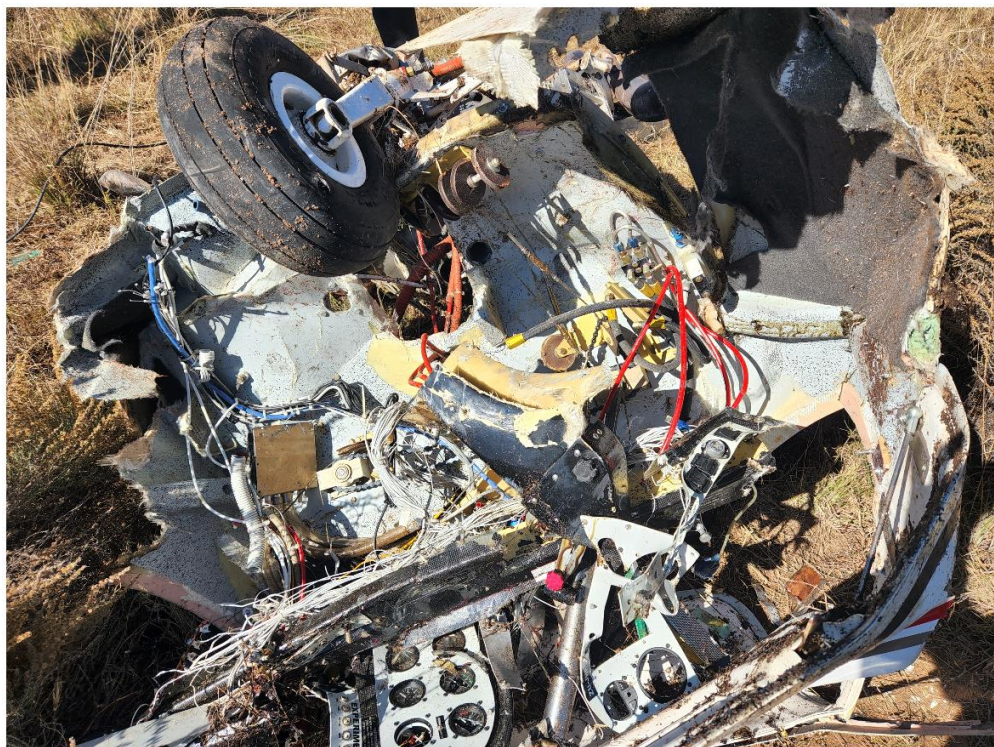
1.12.5 The instrument panel was destroyed during the accident sequence.

Figure 10: The destroyed instrument panel and the nose gear in the cockpit.

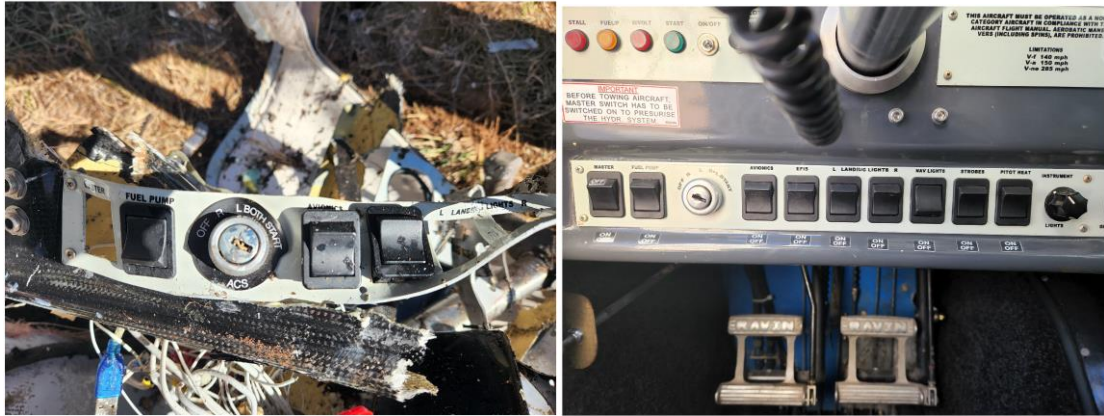
1.12.6 The ignition key was found broken and in “off” position. The fuel pump was found in “on” position.

Figure 11 and 12: Position of the switches after the accident (left); and the position of switches in a stationary aircraft that is similar to the accident aircraft (right).
