PRELIMINARY ACCIDENT REPORT

Accident
- Preliminary Report -
AIID Ref No: CA18/2/3/10111

Reference Number : CA18/2/3/10111
Name of Owner : DG 808B Partnership
Name of Operator : Private (Part 94)
Manufacturer : DG Flugzeugbau G.m.b.H.
Model : DG 808B
Nationality : South African
Registration Marks : ZU-KDP
Place : Langeberg Mountain, Suurbraak area, Western Cape
Date : 1 February 2022
Time : 1350Z

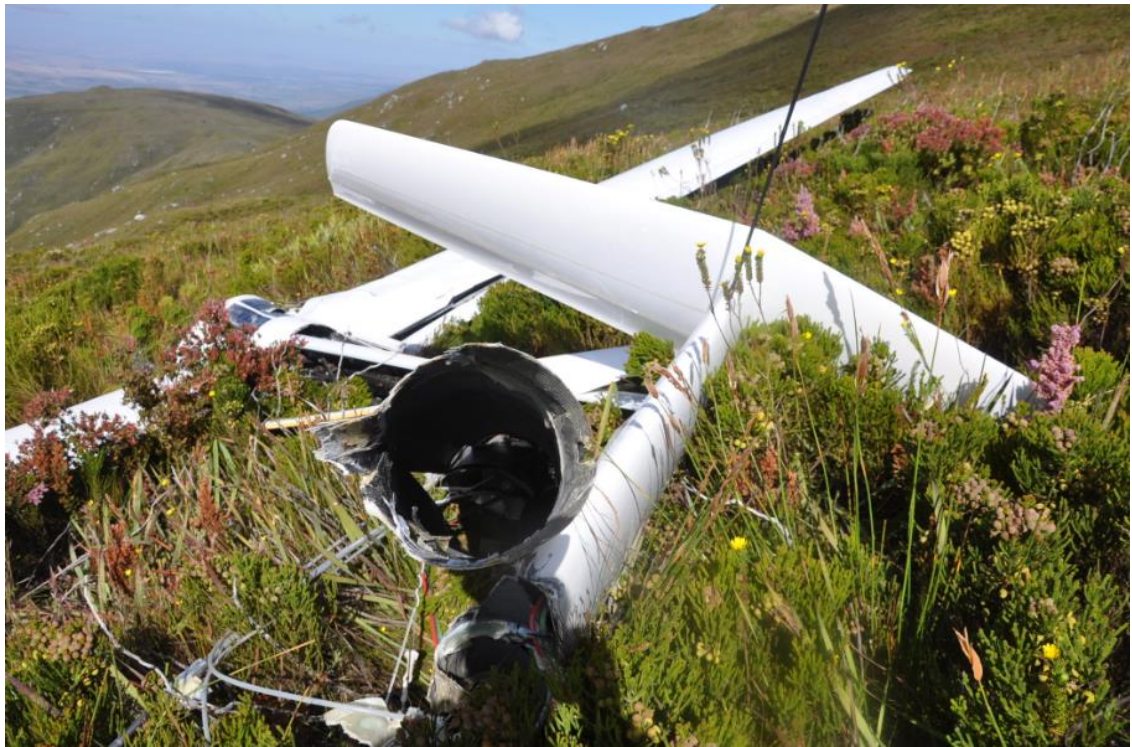
1.3.1 The glider was substantially damaged during the accident sequence.

Figure 3: Damage to the glider.

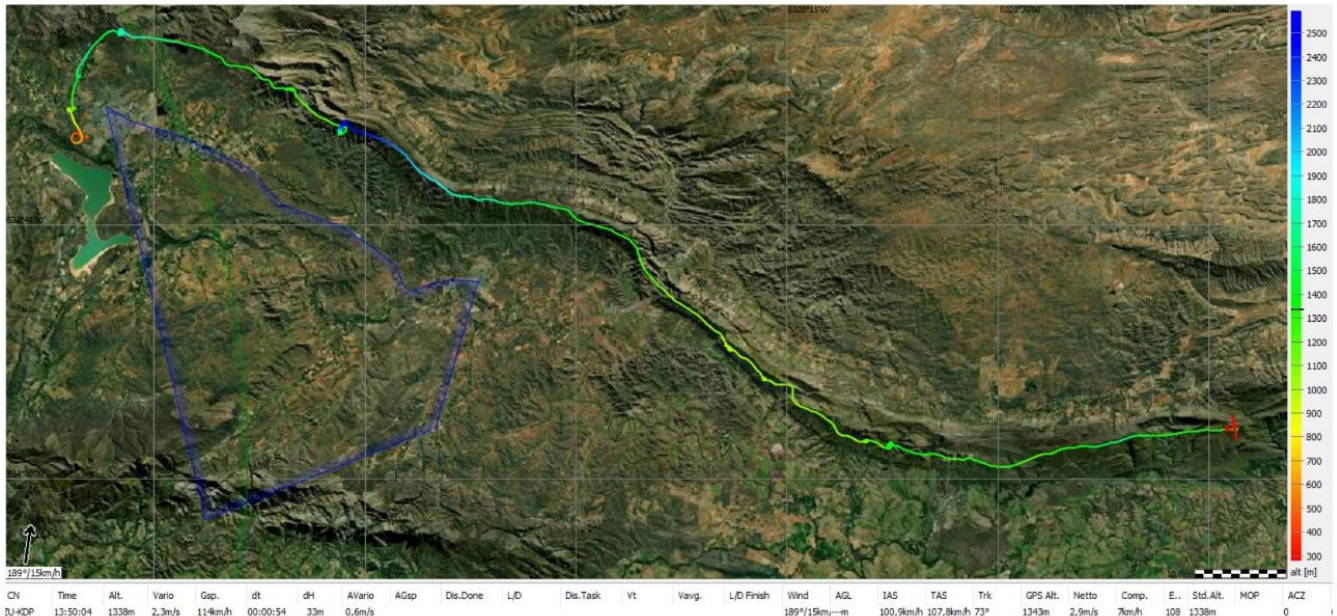
Figure 5: Flight log file data depicting the flight path and wind direction. (Source: Cambridge system)

1.11.3 According to the flight path (Figure 5), the glider is seen taking off from FAWC Runway 12, it then commences with a spiral climb to the left before setting north bound heading towards the mountain ridge. The glider then makes a right turn along the windward side of the mountain ridge in the south-easterly direction (see Figure 6). The recorded wind direction is from the south (see the arrow at the bottom left corner indicating that the glider was in windward side). The flight path appears to be uniform throughout with spiralling ascends (see Figure 5). The glider flies along the ridge until the end of the recording (see Figure 6). The height that the glider was flying at was 4 429ft AMSL. The elevation of the accident site was 4 389ft. The total distance covered from take-off to the accident site was 151km.

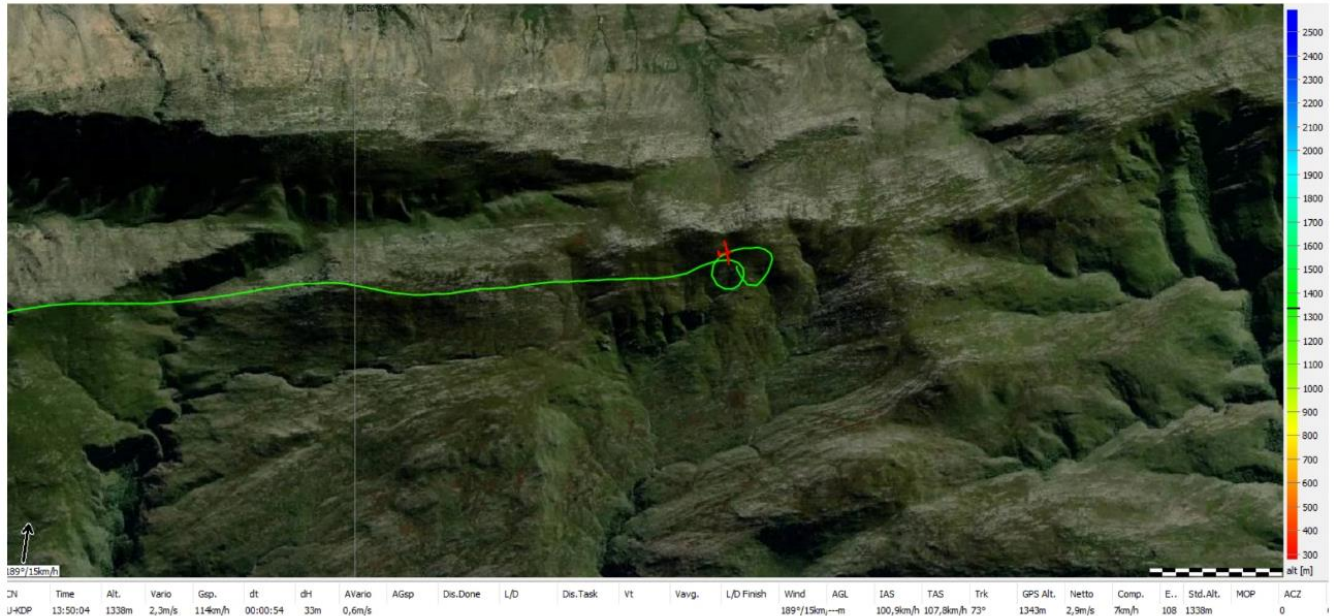
Figure 6: Overlay depicts moments before the crash. (Source: Cambridge system/Google Earth)

1.11.4 The green line in Figure 6 depicts the final moments before the crash. The pilot was flying straight and level along the windward side of the ridge which suggested normal operation; this does not show any evidence of unusual behaviour or loss of control by the pilot. The pilot then initiated a right turn which was a full 360° (i.e. away from the mountain and then back towards the mountain) followed by a second turn (which was 270°). The glider impacted the side of the mountain during the second turn, which correlates with the direction in which he struck the ground.

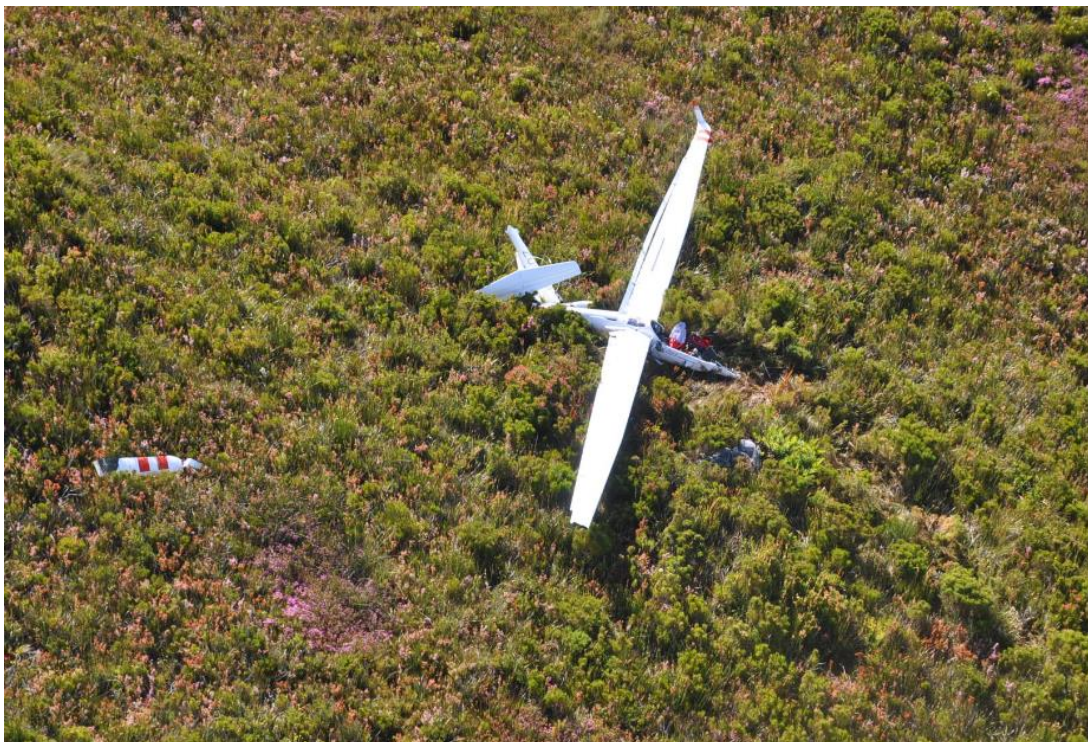
1.12.1 The motorised glider was flying in an easterly direction along the Langeberg Mountain catchment, thereafter, commenced a spiralling turn to the right before impacting the mountain on the windward side. The glider was found lying upright and facing a south-easterly direction. The ground scar was located 2 metres from the nose of the glider, it was approximately 300mm in depth and fitted the profile of the nose tip section, which was evidenced by dirt marks. The retractable mainwheel was still in its bay, which suggested that the motor glider was in a flying configuration at the time of impact.

Figure 7: Aerial footage of the accident site.

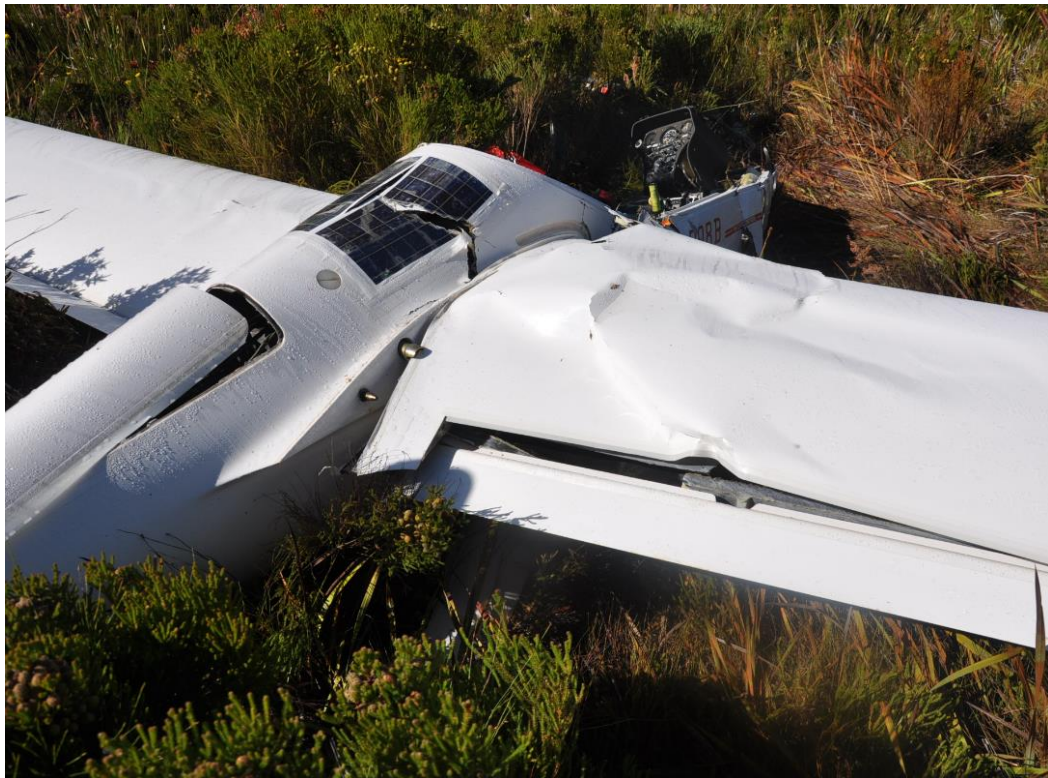
1.12.2 The motor glider wings were fairly intact, the damage observed on the right-side wing was the separation of the winglet as a result of impact, found lying 8m from the wing's outboard. The right-side inboard upper surface skin exhibited signs of buckling and deformation as a result of impact damage. The left-side winglet tip had fractured in the root but was still attached to the wing. The left-side airbrake was slightly deployed. The left-side flaps were damaged in the middle attachment points, whereas the right-side appeared to be damaged near the inboard of the wing. Both ailerons were still attached and no apparent damage was observed. Continuation of the ailerons was not achieved due to the control stick that was jammed as a result of impact. However, all control surfaces were accounted for.

Figure 8: Buckling and deformation of the skin surface.

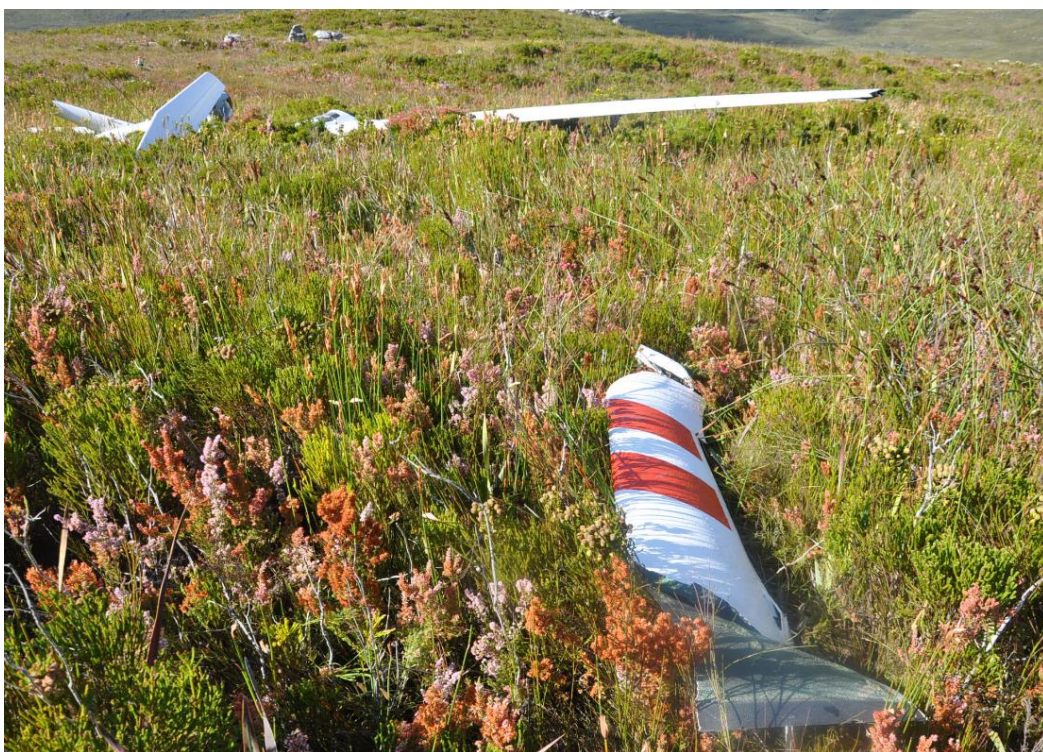
Figure 9: Detached right-side winglet.

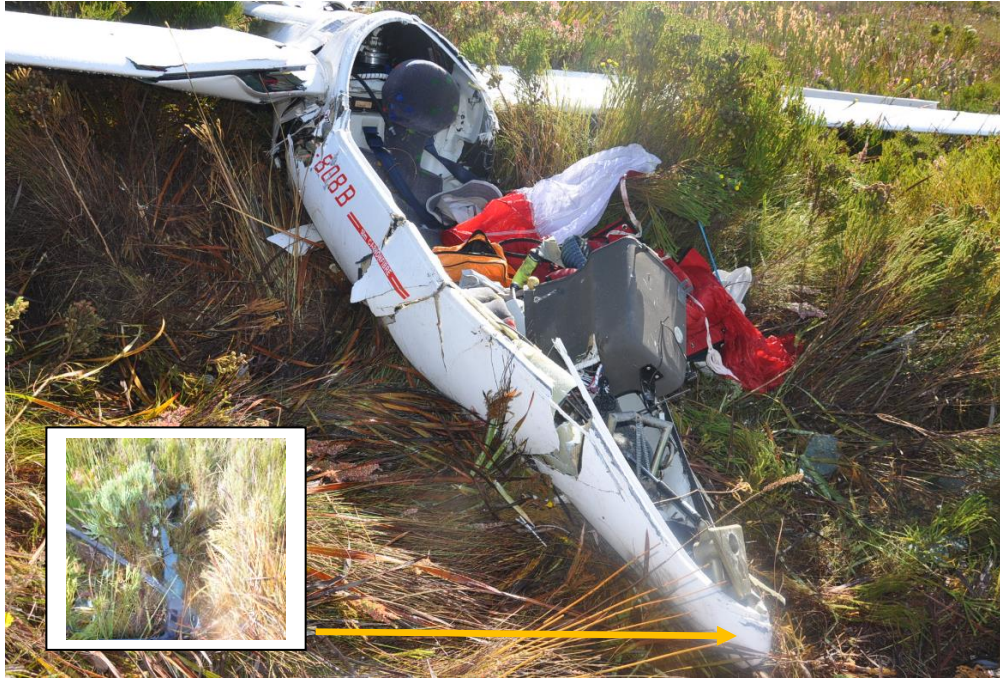
1.12.3 The cabin section exhibited structural fracture in four places on the right-side. The canopy had separated and pieces of the frame and Perspex were found scattered at the front of the nose section. The tip of the nose was damaged; dirt and grass was visible around the tip, indicative of a high angle contact with the ground. The rudder pedals appeared to be damaged.

Figure 10: The damaged cabin section. The inset shows an indentation on the ground caused by the nose during impact.

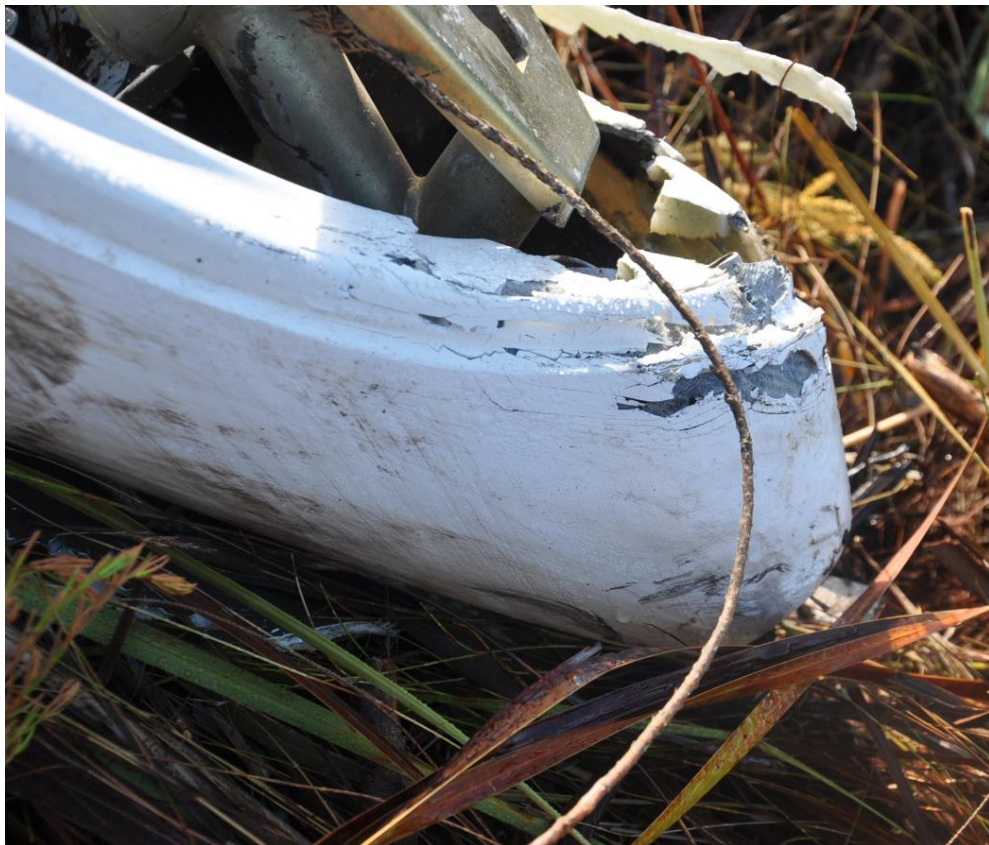
Figure 11: The nose section post-accident.

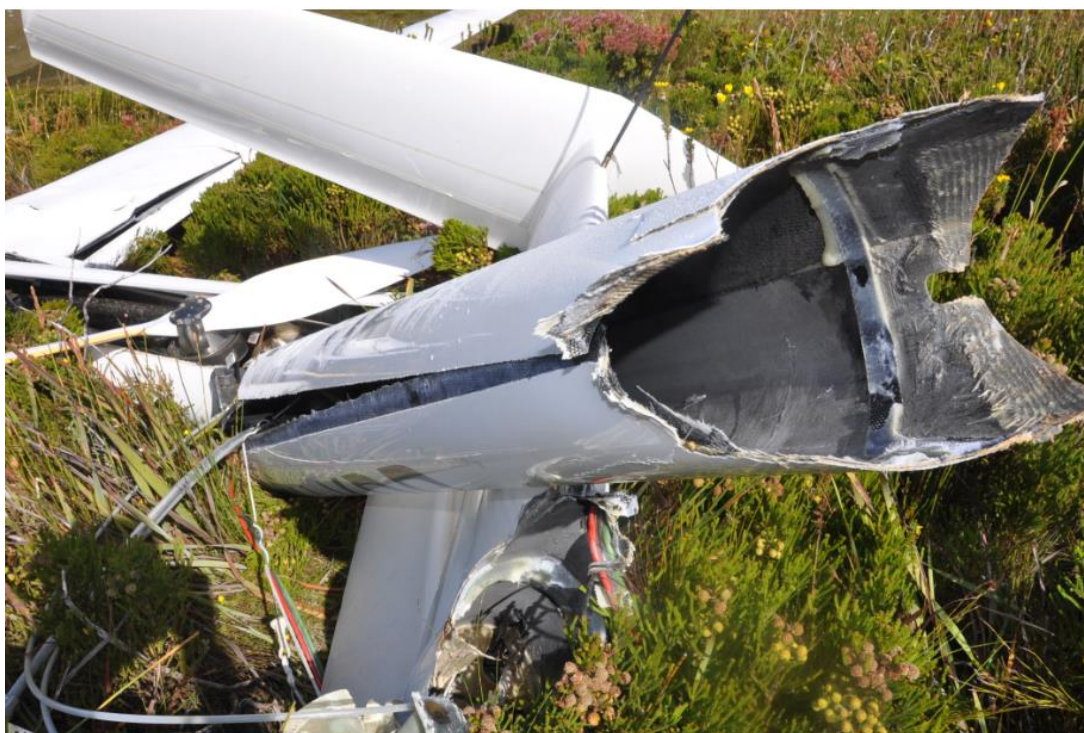
1.12.4 The empennage was heavily damaged. It was fractured and had separated in three different places; broken sections were kept in place by control cables. The vertical stabiliser had broken off from where it attaches on the tail. The elevator appeared to

have not been damaged. A piece of composite was missing from the top of the rudder pedal as a result of impact. The tail wheel broke off and was kept in place by the control cables. The top part of the empennage that houses the engine had split open, exposing the engine. The engine and propeller appeared to be in a stored position (deployed from the empennage); however, one of the propeller blades was damaged on the tip. The damage on the blade could be attributed to impact during the accident sequence. No evidence was found in the cabin of an attempt to (re)start the engine prior to impact. Engine control and switches as found at the scene were in the off position.

Figure 12: Damage sustained by the empennage.

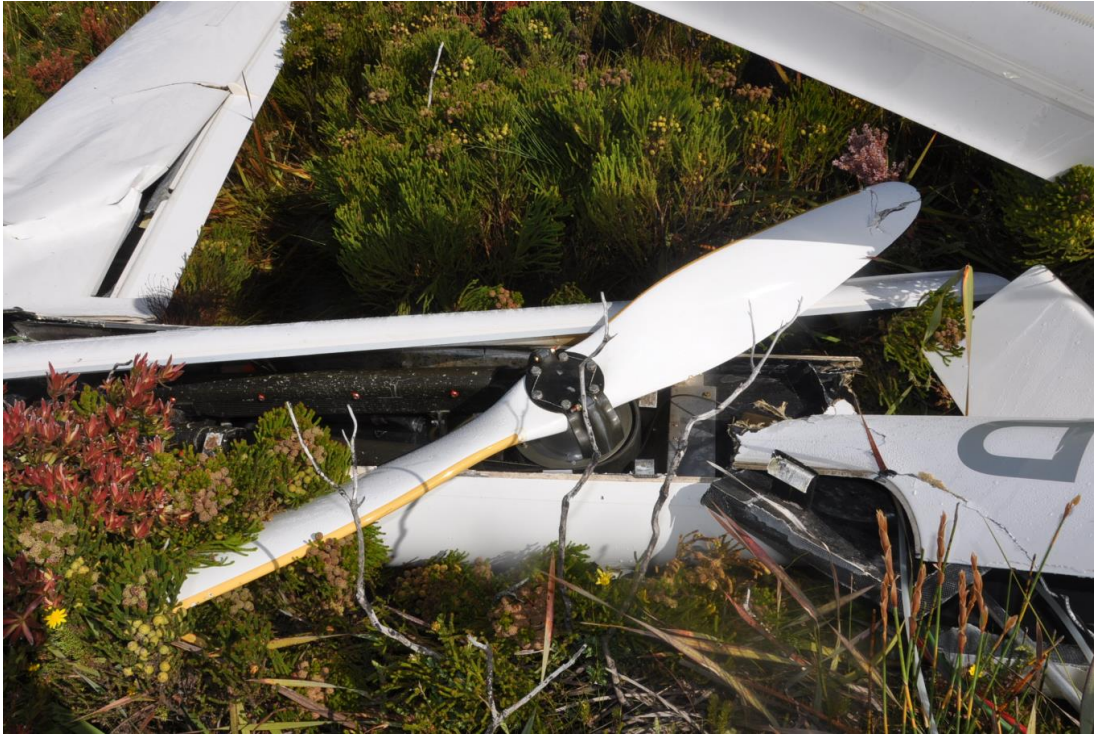
Figure 13: Propeller blades as found at the accident site.
