PRELIMINARY ACCIDENT REPORT

Accident
- Preliminary Report -
AIID Ref No: CA18/2/3/10051

Reference Number : CA18/2/3/10051
Name of Owner : G J Bingham
Manufacturer : RotorWay International
Model : Executive 162F
Nationality : South African
Registration Marks : ZU-RDX
Place : Morning Star Airfield, Western Cape province
Date : 9 October 2021
Time : 1150Z

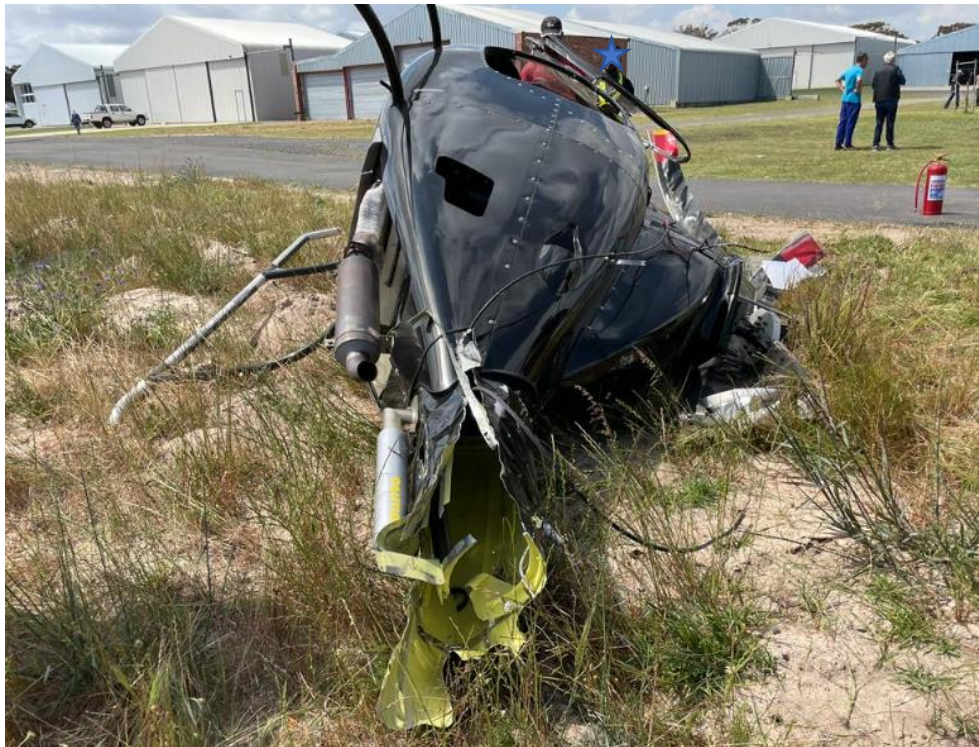
1.3.1 The helicopter was substantially damaged during the accident sequence.

Figure 3: The helicopter as it came to rest. (Source: Pilot)

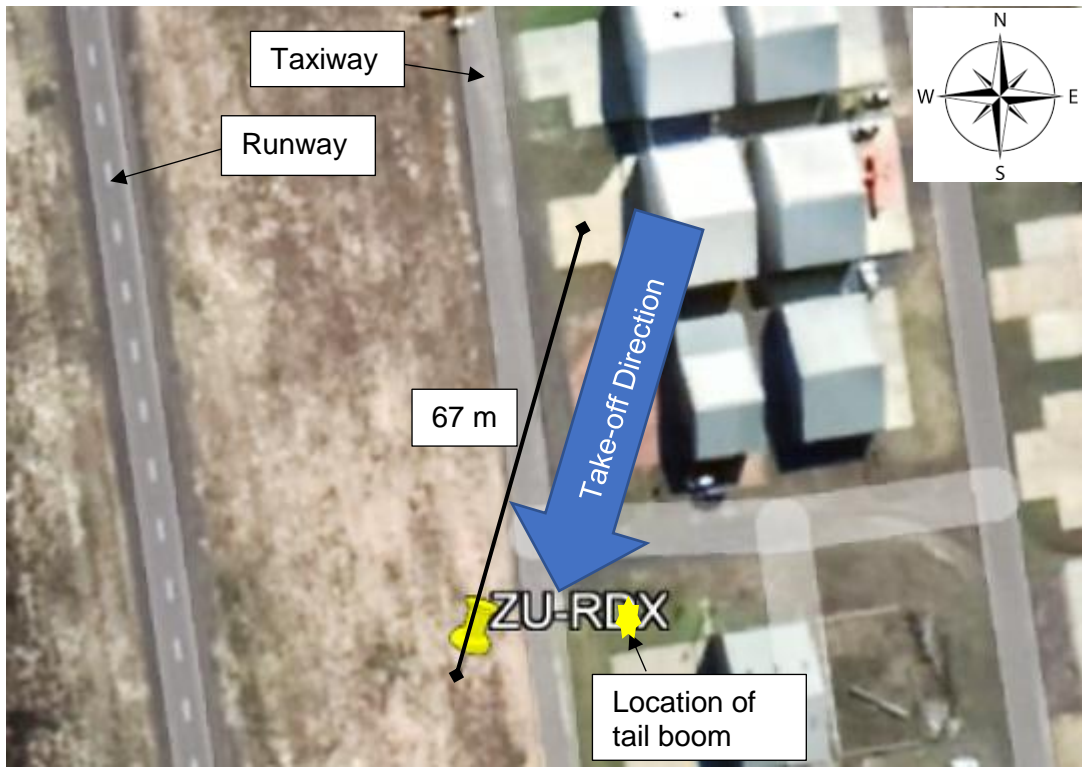
1.12.3. The main wreckage was lying approximately 67m from the point of take-off and the tail boom was located approximately 12m east of the main wreckage.

Figure 5: Wreckage location and information. (Source: Google Earth)

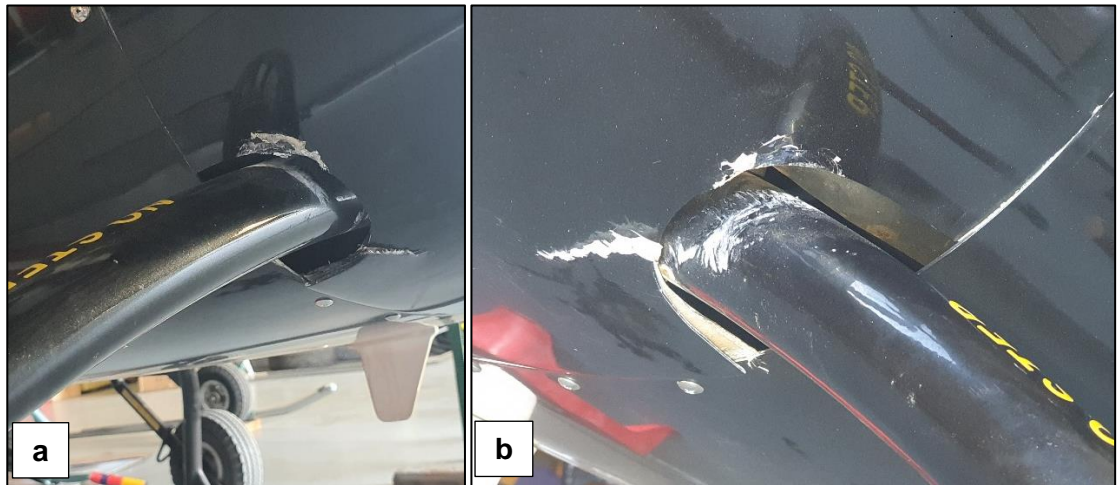
1.12.4. Examination of the helicopter's skids and fuselage indicated that the helicopter first contacted the soft sand with its left skid. This is an indication that the helicopter yawed to the left during loss of control.

Figure 6: Damaged on the fuselage and skids (a shows right-side skid, b shows left-side skid).

2.1.11 Post-accident on-site investigation revealed that the helicopter impacted the soft sand with its left-side skid first before entering a dynamic rollover, coming to rest on its right-side. The observations made were consistent with one of the witness' account of events. According to the witness, a loud metal noise drew her attention to the direction of the helicopter, after which she saw the helicopter hit the ground on its left-side before it got into a rolling motion and coming to rest on its right-side.

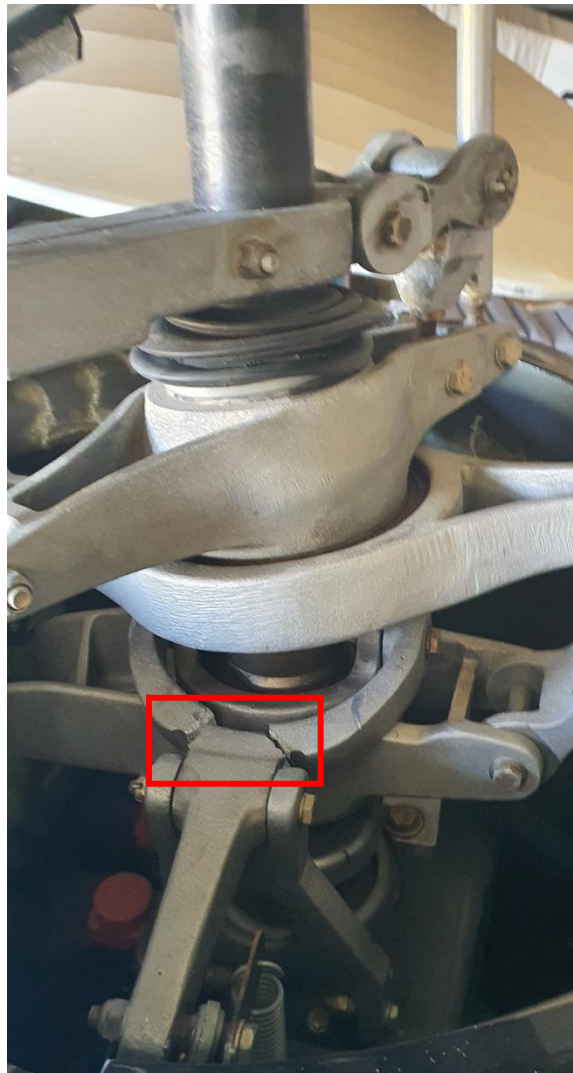
Figure 7: Red block shows fractured joint component of the main rotor hub's non-rotating swashplate.

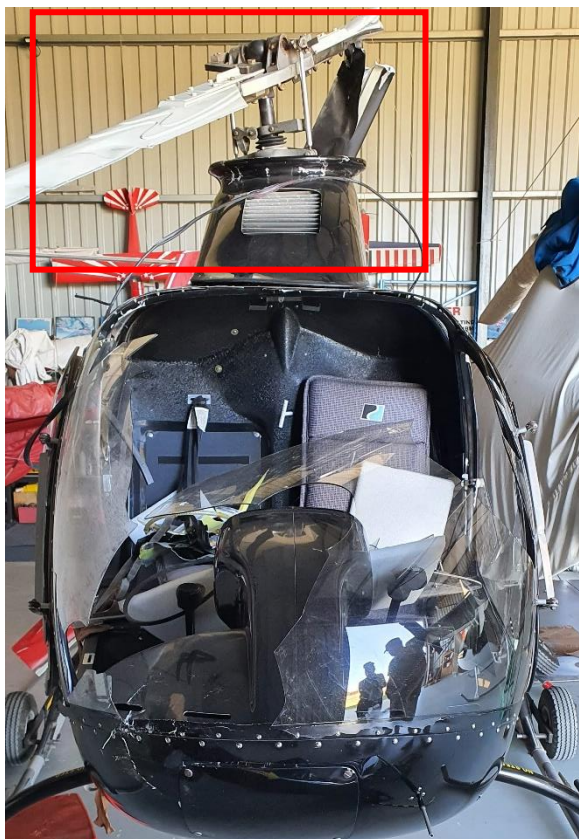
1.12.5 Both main rotor blades and pitch links were still attached; the main rotor hub had a slight bent to the left (when viewed from the rear of the helicopter). The windshield was found shattered in the cabin, which is consistent with the pilot's description of how he kicked the windshield for them to exit the wreckage while the helicopter was lying on its right-side.

Figure 8: The red block shows the condition of the main rotor hub assembly and rotor blades post-accident.

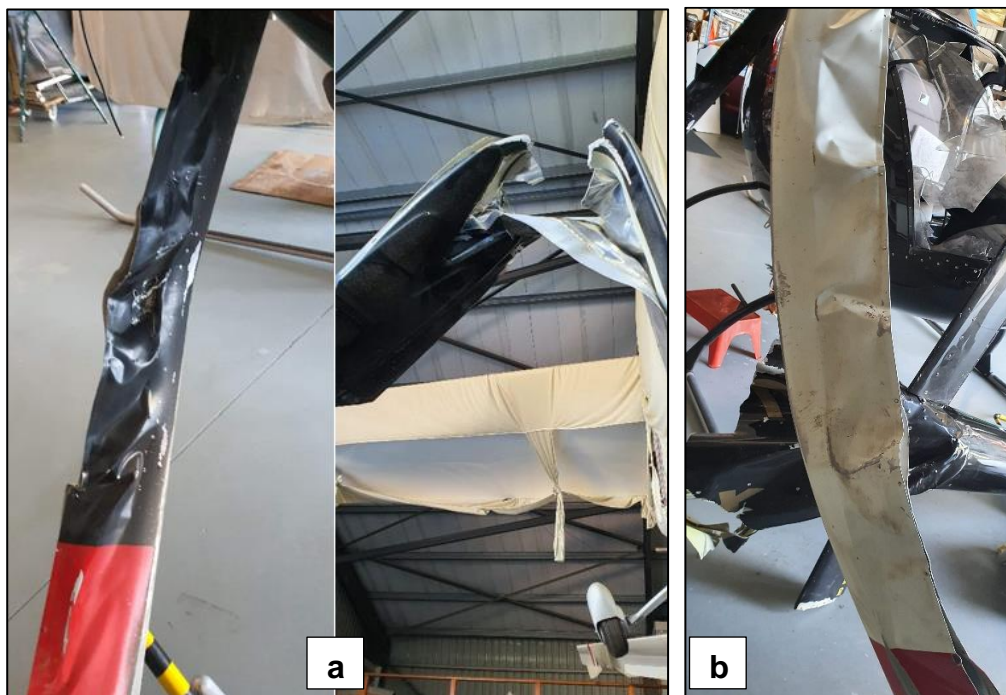
- 1.12.6 Continuity of the flight controls (collective and cyclic) was established, and the controls moved freely with no obstruction. The engine compartment was free from visible damage, except for the torn drive belt.
- 1.12.7 One of the blades broke off near the root and had deformation damage in the centre of its leading edge (Figure 9a). The other blade showed no distortion near the root section, however, it exhibited deformation damage in the centre of its trailing edge. This blade also had separated near its tip section of the trailing edge (Figure 9b). The deformations are indicative of metal-to-metal contact at low rotation speed. The blades' fractures are indicative of slow separation exhibited by its tensile nature, this overload occurred while the helicopter rolled on its right-side.

Figure 9: a) The deformed leading edge and the broken rotor blade. b) The deformed trailing edge blade which separated at the blade tip.

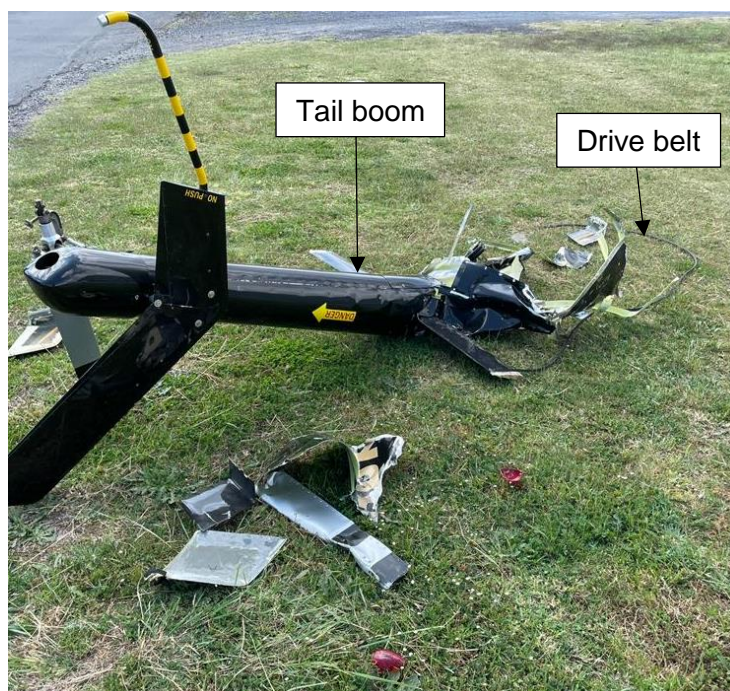
1.12.8 A section of the drive belt was found near the tail boom. The tail boom assembly had impact damage consistent with the bent main rotor hub and main rotor deformation, which is an indication of mast bumping during impact. One of the tail rotor blades separated from the hub due to impact with the ground. The tail gearbox was still intact on its attachment points. Continuity check between the gearbox and the output shaft was carried out and the drive was positive.

Figure 10: Location of the tail boom after the accident. (Source: Owner/pilot)

2.1.12 Damage observed on the wreckage indicated that the main rotor blades severed the tail boom during the accident, and this could also be attributed to the severed drive belt (SN: E18-1150).

2.1.13 The tail boom assembly had impact damage which is consistent with the bent main rotor hub and deformed main rotor blades.
