PRELIMINARY ACCIDENT REPORT

Accident  
- Preliminary Report -  
AIID Ref No: CA18/2/3/10156

Figure 1: RAF2000 GTX SE FI, ZU-RHL. (Source: Owner)

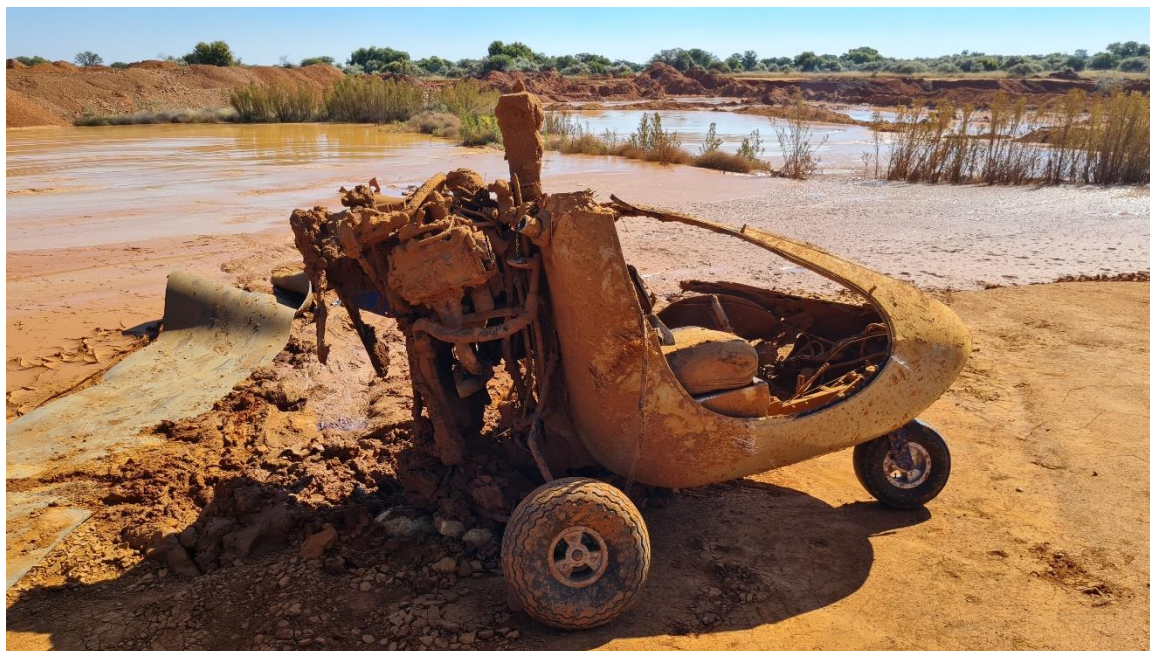
**Figure 2:** The gyrocopter after the eyewitnesses had moved it to stable ground.

1.12.12. The gyrocopter crashed a few metres from where the eyewitnesses were positioned. The eyewitnesses had run to the accident site and dragged the gyrocopter out of the unstable muddy terrain. The witnesses had cut off the pilot's safety harness to remove him from the wreckage, but later realised that the pilot had succumbed to his injuries.

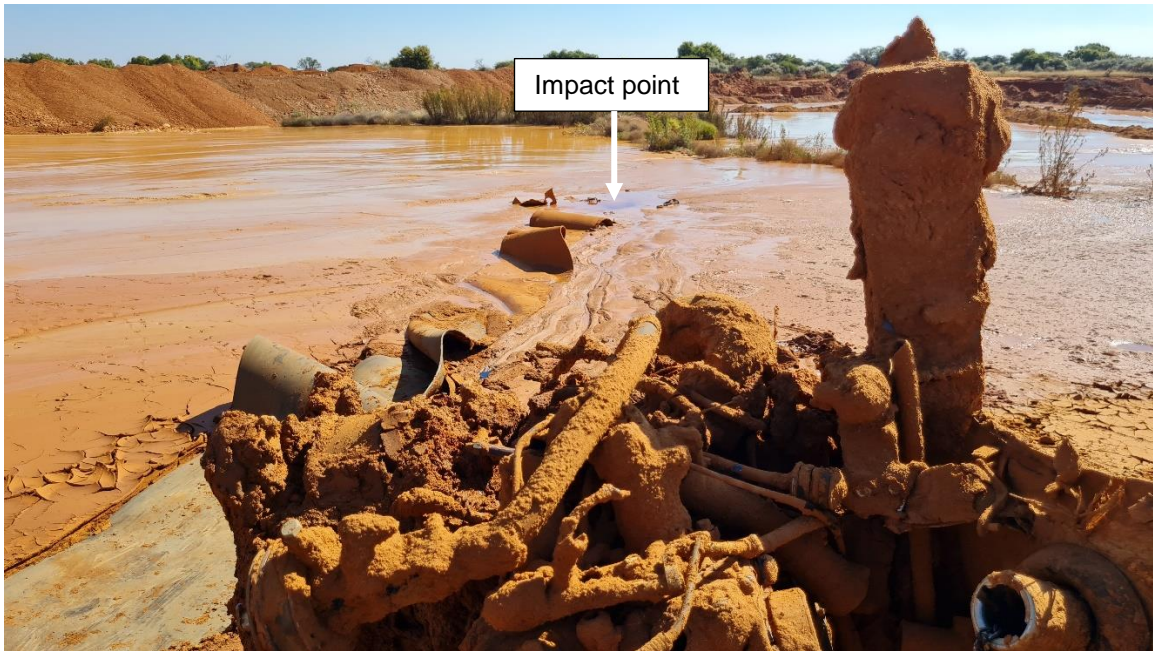
**Figure 3:** Distance from where the aircraft was dragged.

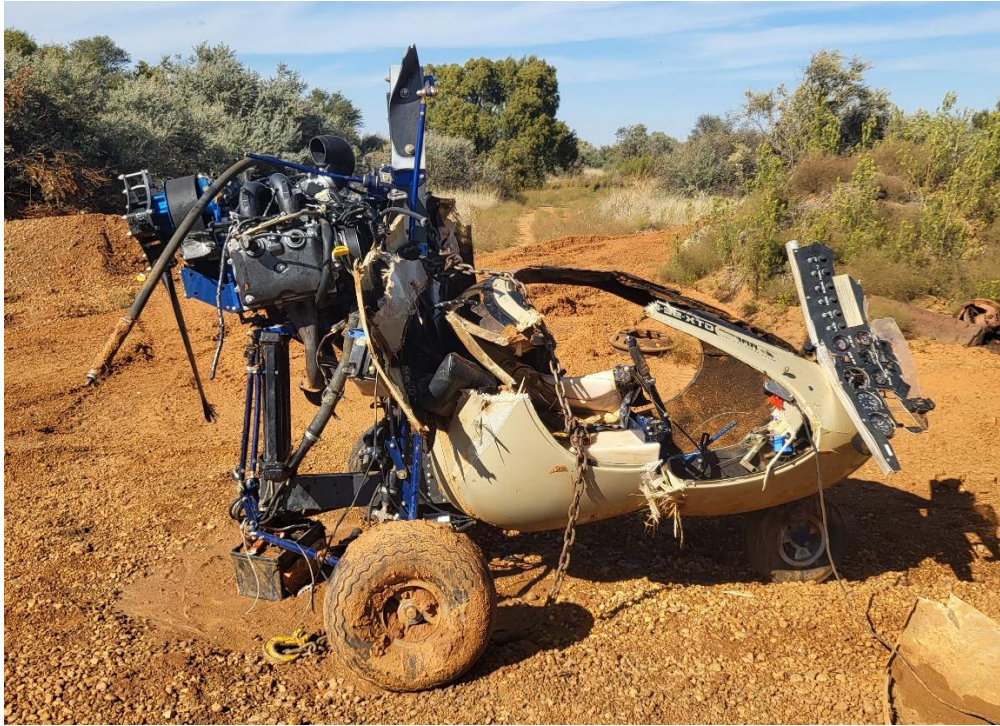
1.3.1. The gyrocopter was destroyed.

**Figure 4:** The gyrocopter after the mud (dirt) was washed off.

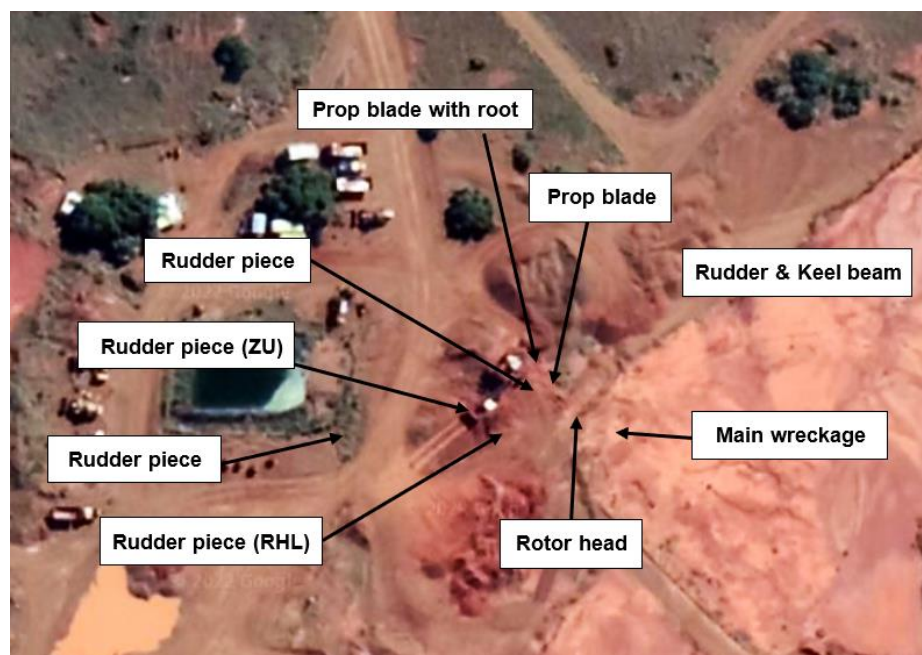
1.12.2. Damage to the gyrocopter's structure revealed that it impacted the soft, muddy ground while in a left steep nose-down attitude (high angle of impact) and at high speed. The wreckage distribution of the ZU-RHL gyrocopter consisted of numerous fragments that were scattered over a radius of approximately 100 metres (m), indicative of an in-flight break-up.

Figure 5: Wreckage distribution of the ZU-RHL gyrocopter. (Source: Google Earth)

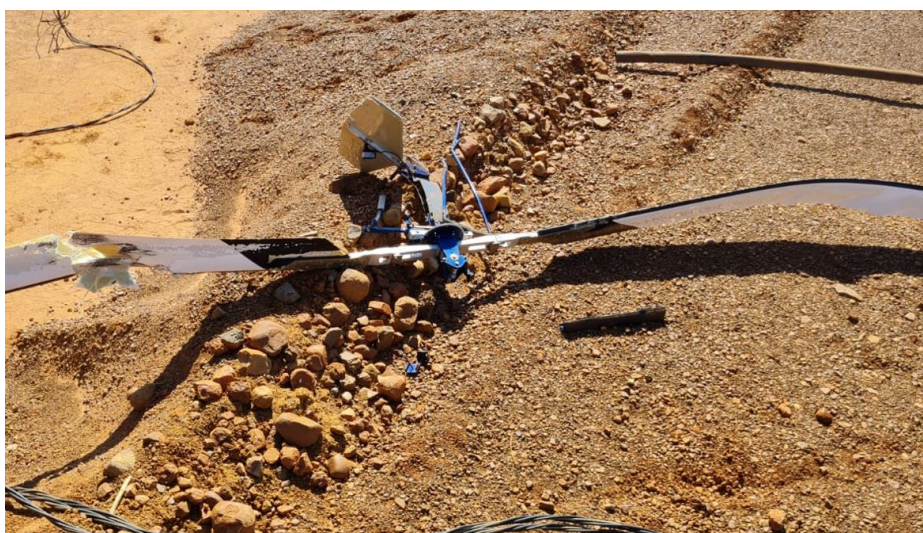
1.12.4. The rotor mast and blade assembly detached from the gyrocopter and were found approximately 7 metres (m) from the main wreckage. The location of the rotor assembly indicated that it could have been catapulted while the gyrocopter was airborne due to forces produced as the gyrocopter nose-dived steeply. One of the rotor blades showed evidence of contact marks with a moving object along its shank section at a distance equivalent to the propeller blades position, as well as paint marks from impact with the rudder.

**Figure 6:** Rotor mast and blade assembly.

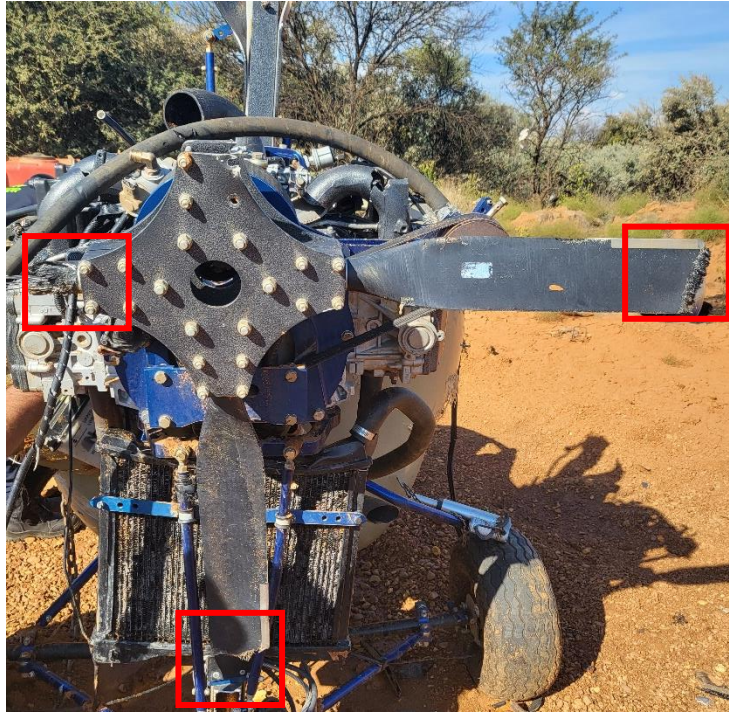
1.12.5. All four propeller blades were accounted for and exhibited impact damage on their tips, consistent with impact caused by contacting the rotor blade during flight. Two of the propeller blades had separated from the assembly, while the other two remained attached. The propeller blades showed evidence of rotation and impact with the rotor blades. The subsequent examination of the engine revealed no pre-impact mechanical damage.

**Figure 7:** Propeller hub with damaged blades.

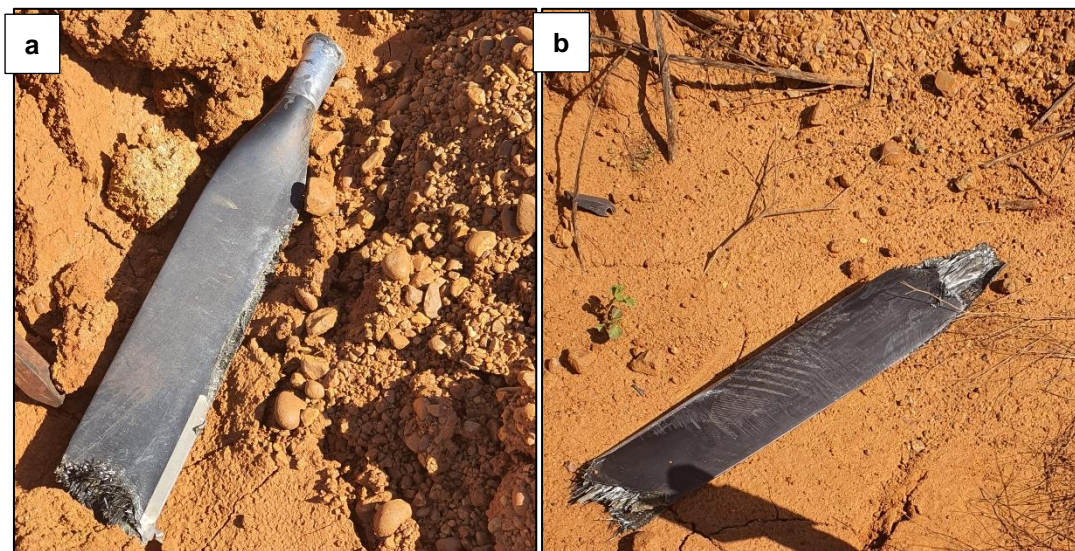
1.12.6. One propeller blade was found approximately 20m west of the gyrocopter's flight path. The blade had completely detached (from its root) from the propeller hub and was damaged on its leading-edge tip. The other propeller blade was found approximately 8m west from the first blade and had broken off along its blade shank. The damage on all four propeller blades was consistent with the damage that would occur when coming into contact with the rotor blades and whilst the engine was turning at high power.

**Figure 8:** (a) The propeller blade that detached from the root with damage on the leading-edge and tip. (b) The propeller blade that broke off along the blank shank with damage on the tip.

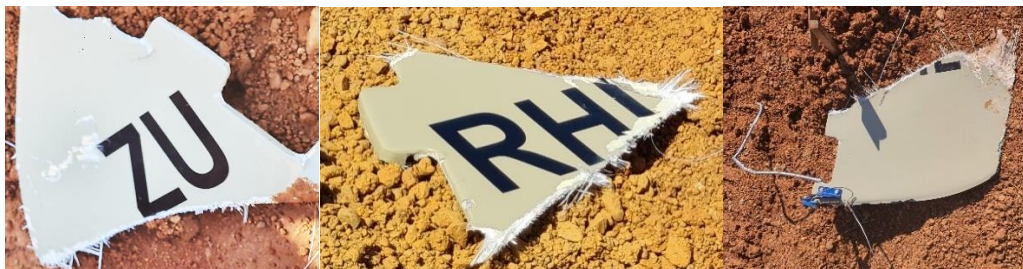
1.12.7. The rudder and rear keel beam were found approximately 10m to the west (to the left, in relation to the flight path) of the main wreckage. More wreckage debris comprising the remainder of the rudder section was spread along the path in a southerly direction from the main wreckage and within a radius of up to 20m.

**Figure 9:** Rudder pieces of the gyrocopter.

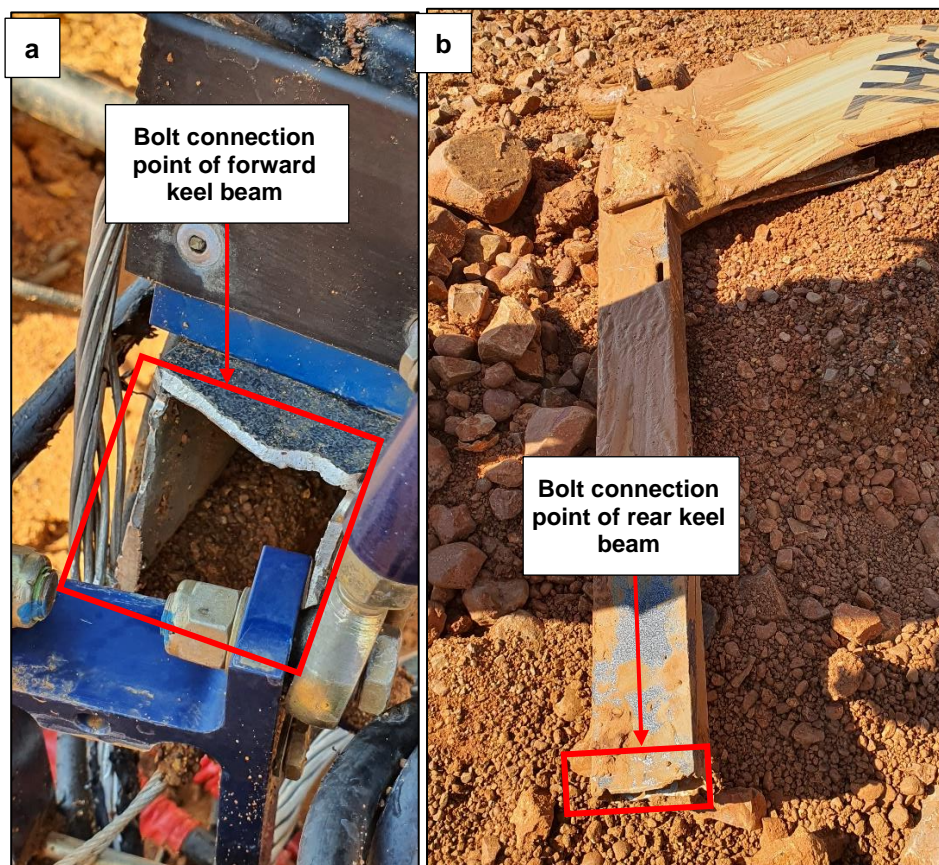
1.12.8. The rear keel beam section had broken off along its bolted attachment joint that joins it to the forward section (under the cabin).

**Figure 10:** The broken keel beam showing location of failure across the bolt connection point.
