**PRELIMINARY ACCIDENT REPORT**

Accident  
- Preliminary Report -  
AIID Ref No: CA18/2/3/10178

On 25 June 2022, a pilot and a passenger on-board a Sling 2 aircraft with registration ZU-WCG were engaged on a private night navigation flight. The aircraft took off from Gqeberha International Airport (FAPE), Eastern Cape province, to Buyskloof general flying area, towards the north-east of the aerodrome, with the intention to land back at FAPE.

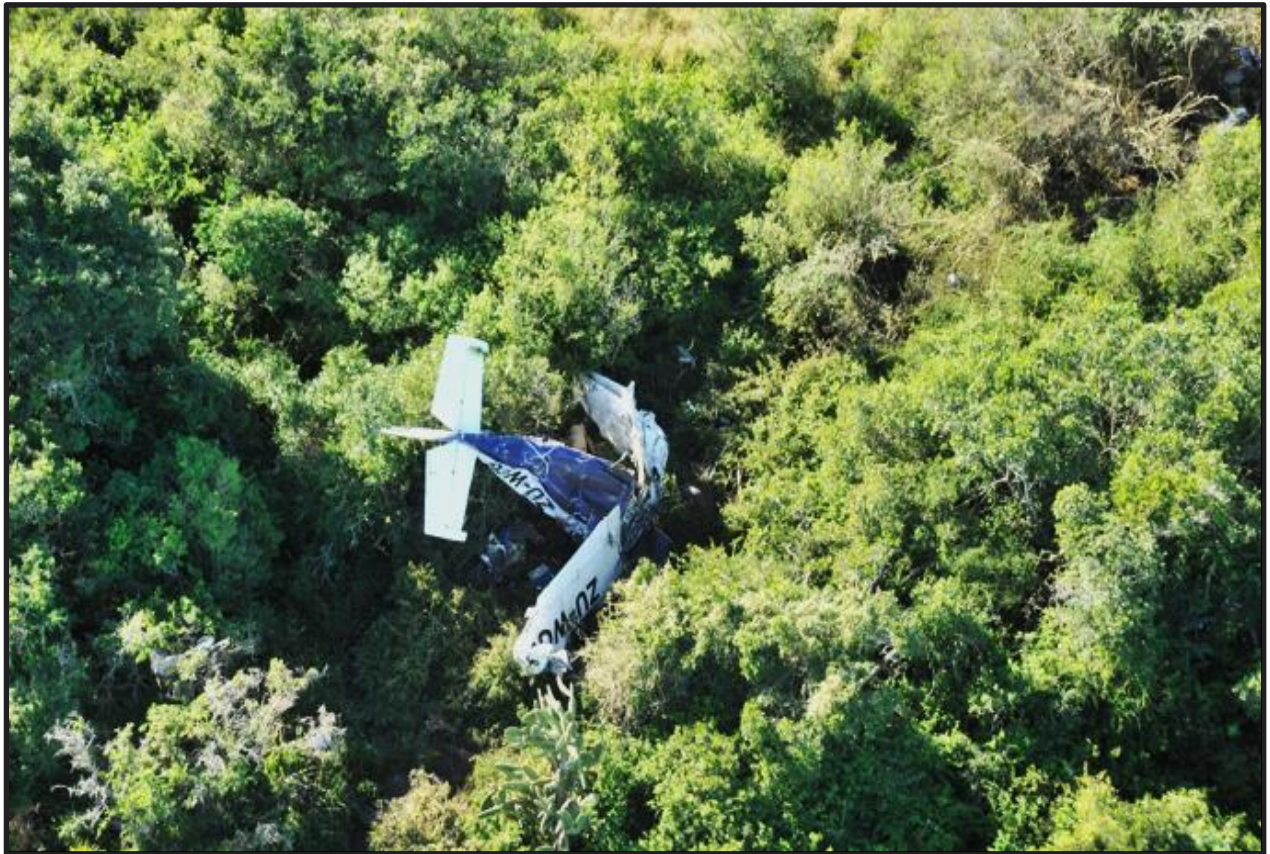
1.3.1 The aircraft was destroyed during the accident sequence.

**Figure 3:** Aerial view of the aircraft wreckage at the accident site. (Source: SAPS)

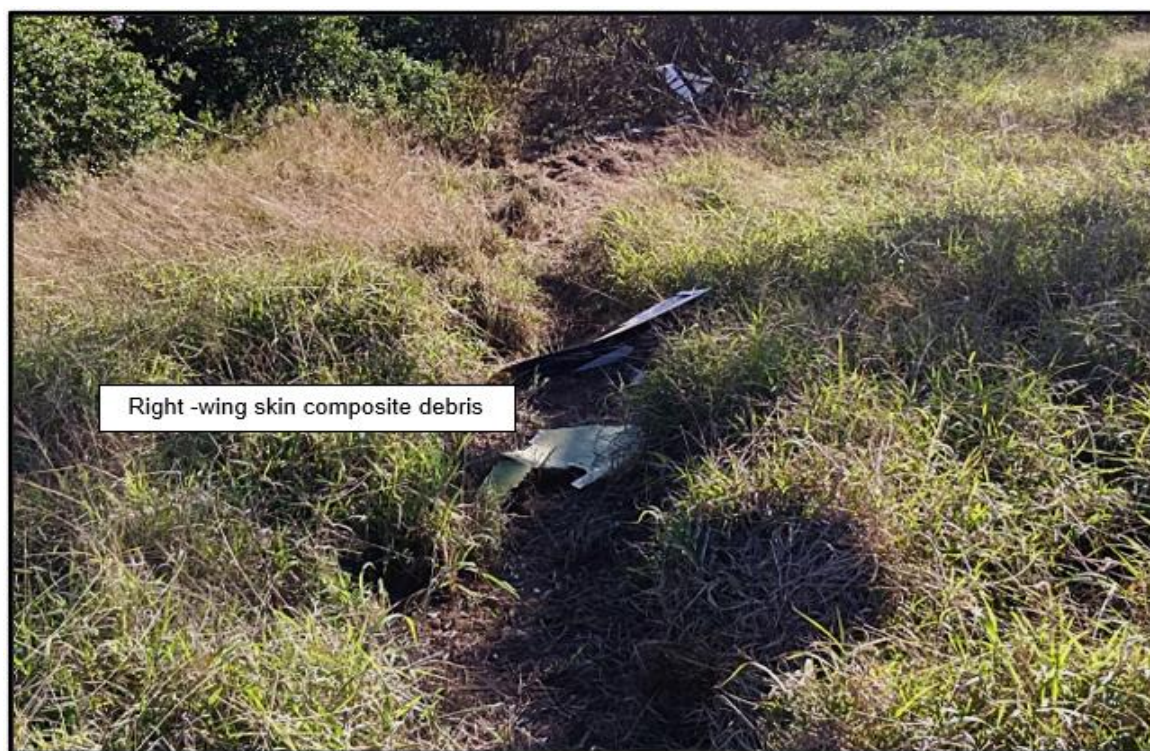
- The accident site had a ground mark – the single line that extended approximately 45m towards the position where the main wreckage was located.
- Along the ground mark line, there was evidence of composite material with paint colour markings that were consistent with the colours on the right-wing tip. Two large pieces of composite skin material were found along the same line, about 10m from the first point of impact towards the position of the main wreckage.

**Figure 4:** The ground mark of the right wing and the composite material.

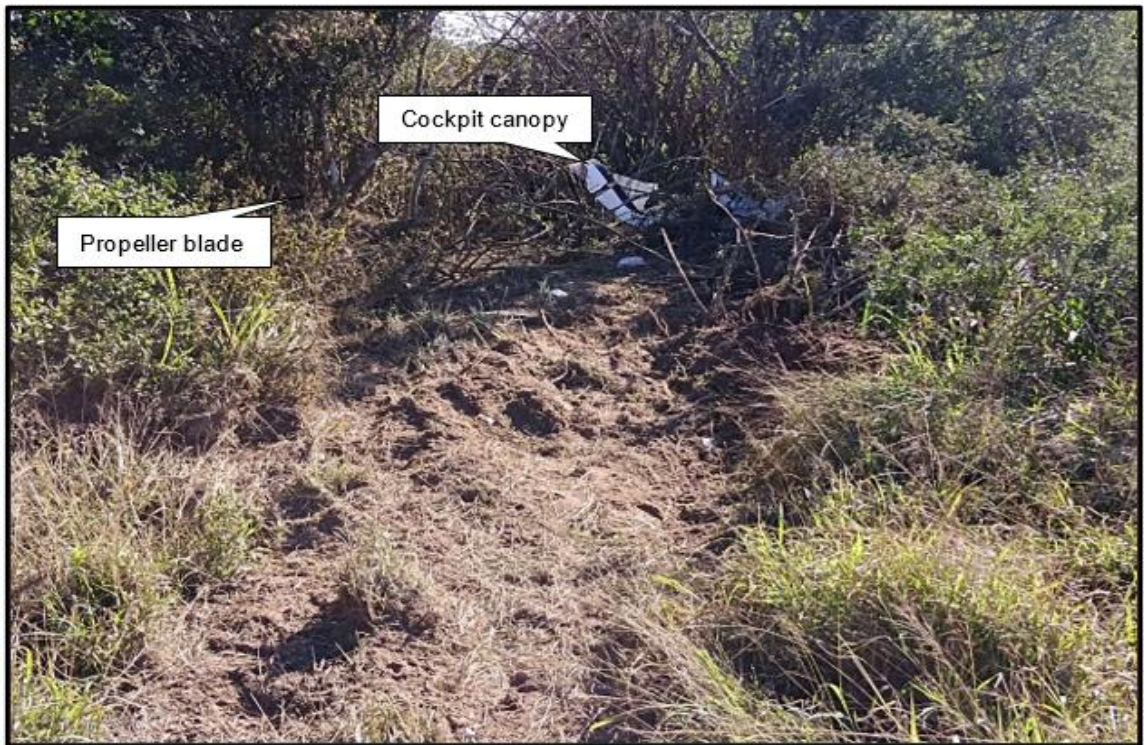
1.12.3 The second impact point was with the nose section at a high forward speed and in the much denser terrain. The aircraft's cockpit door was found in this area, as well as the propeller and some cockpit debris.

**Figure 5:** The second impact point as well as some cockpit debris.

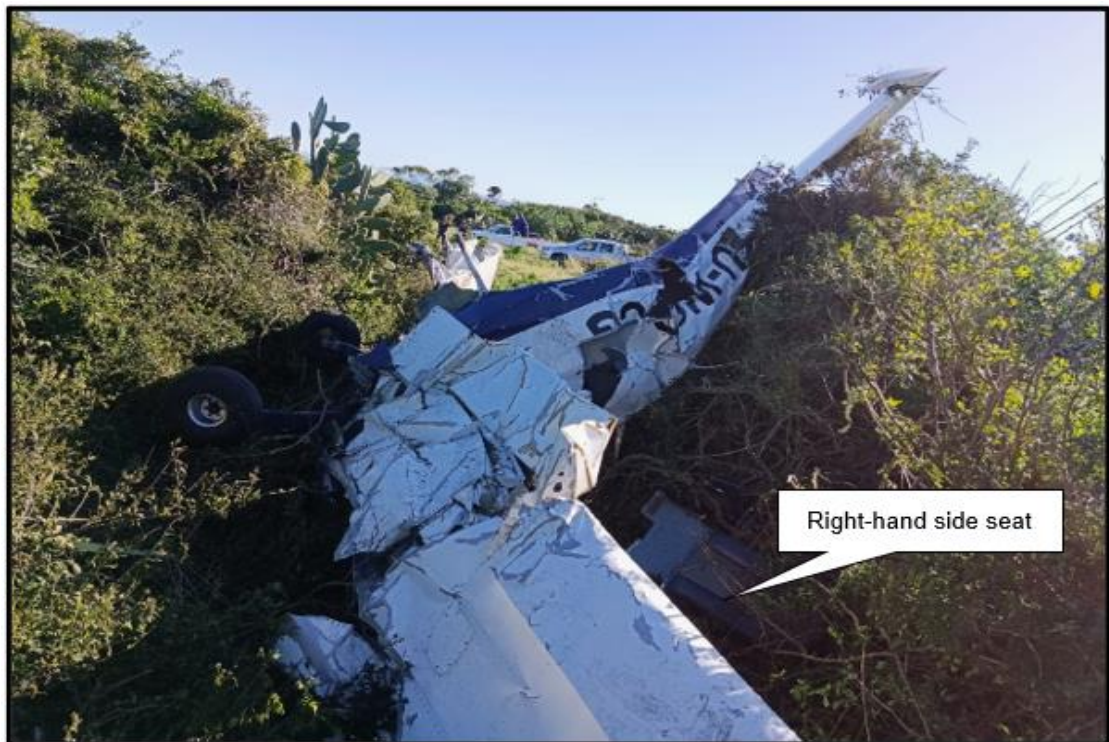
1.12.4 After the second impact, the aircraft tumbled over before it came to a full stop; it was found resting on thick vegetation in a tail-high attitude.

**Figure 6:** The wreckage at the accident site.

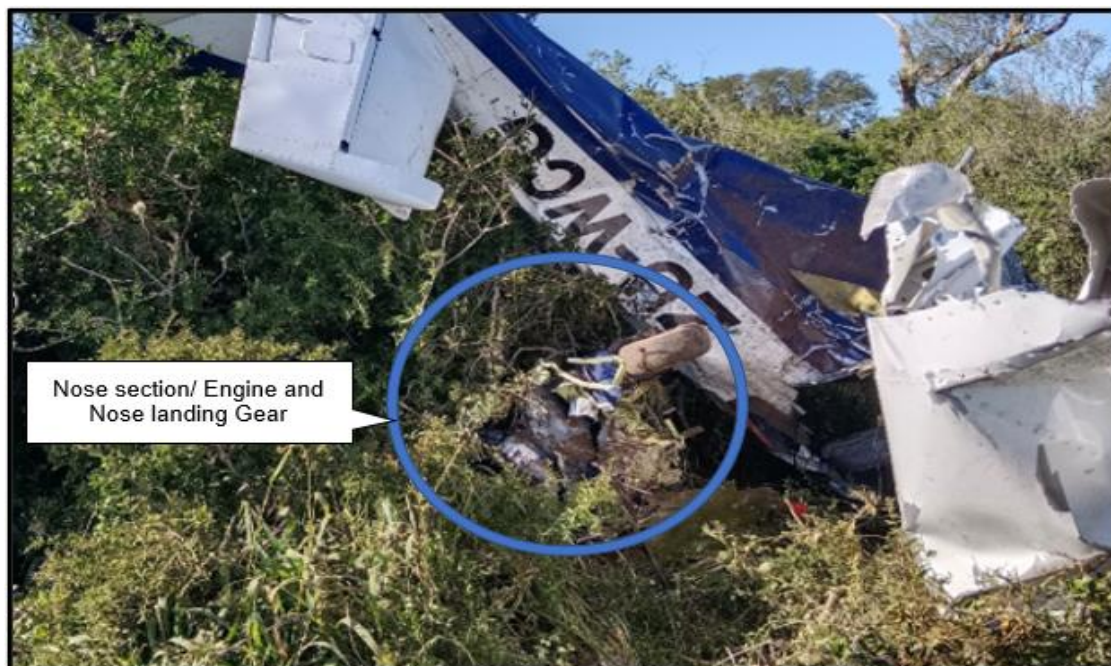
1.12.5 The aircraft's nose section and the cockpit were disintegrated. The right-side cockpit seat was uprooted (pulled out) from its anchor in the aircraft due to impact and was found a few metres away from the wreckage, with the passenger's body close-by. The right-side seat belt and harness were found still latched on the seat. The pilot was trapped on his

seat on the left-side of the wreckage with the seat belt still strapped on. The nose landing gear and the engine were located just behind the aircraft's left wing.

**Figure 7:** The left-side view of the aircraft wreckage.

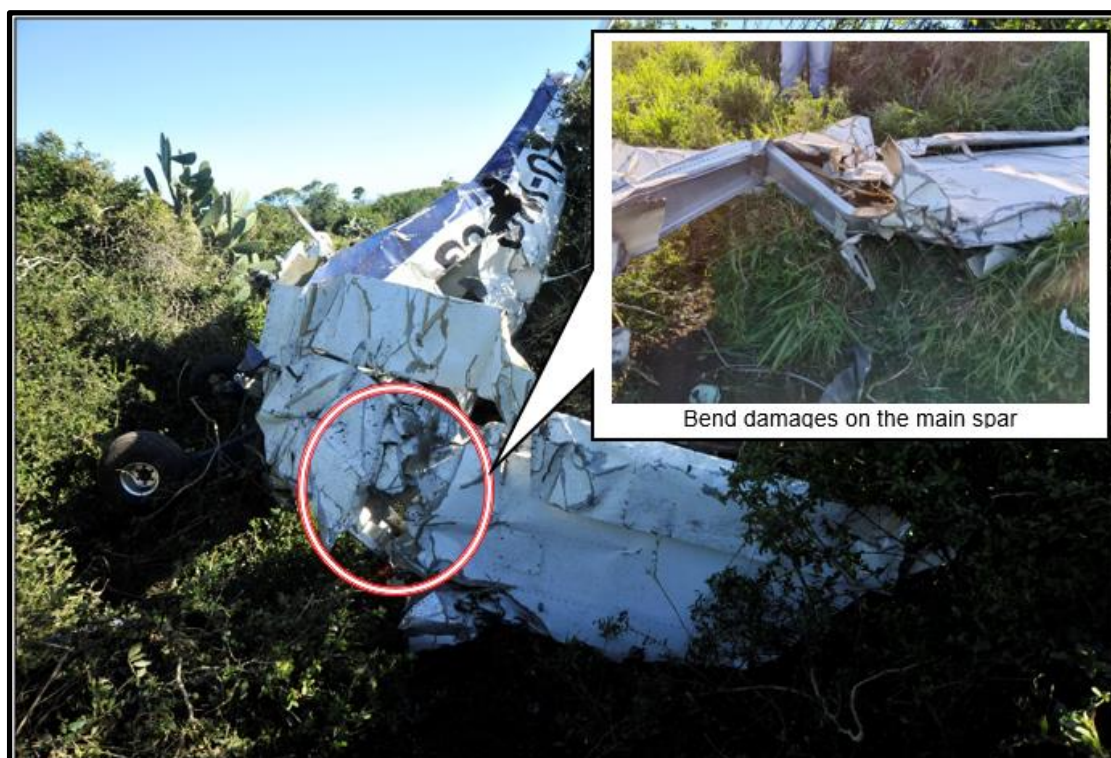
1.12.6 Both wings sustained extensive damage during the accident sequence. The right-side wing exhibited damage on the tip and the leading-edge, which extended to the trailing edge. The damage was consistent with a collision at a high forward speed. The right-side wing's main spar was bent in the middle section towards the fuselage.

**Figure 8:** The damage on the right-side wing.

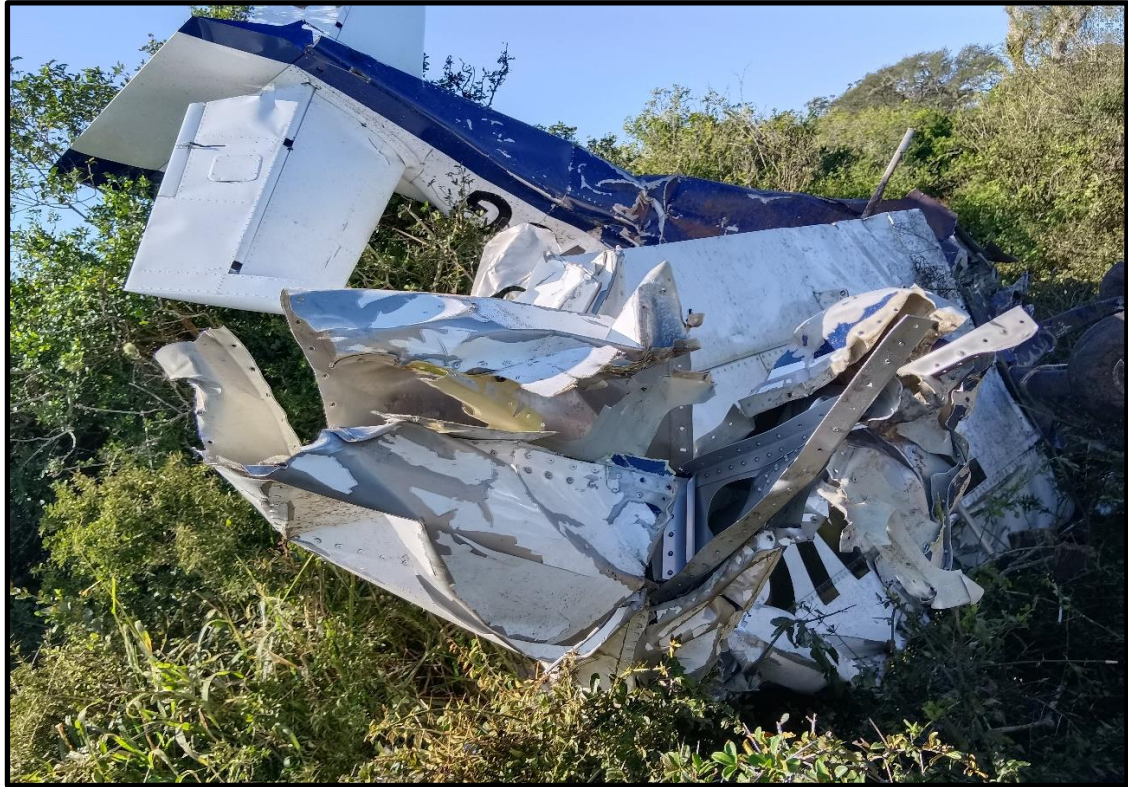
**Figure 9:** Damage on the outer part of the left-side wing.

1.12.7 The left-side wing exhibited damage which was consistent with collision with the outer part of the wing's leading edge. The damage was mostly on the outer part of the wing.
