**CIVIL AVIATION
AUTHORITY**

AIRWORTHINESS DIRECTIVES

SUBJECT INDEX

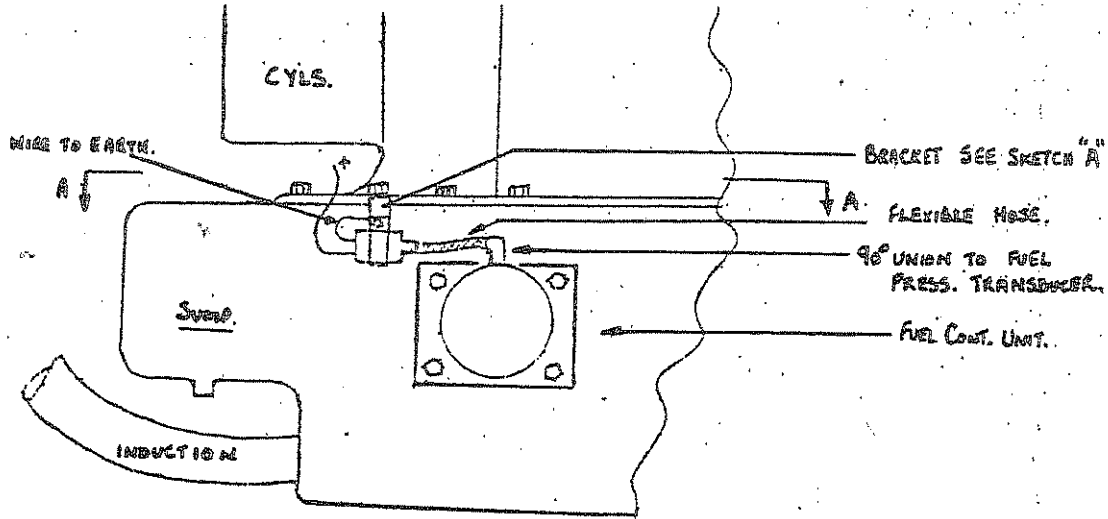
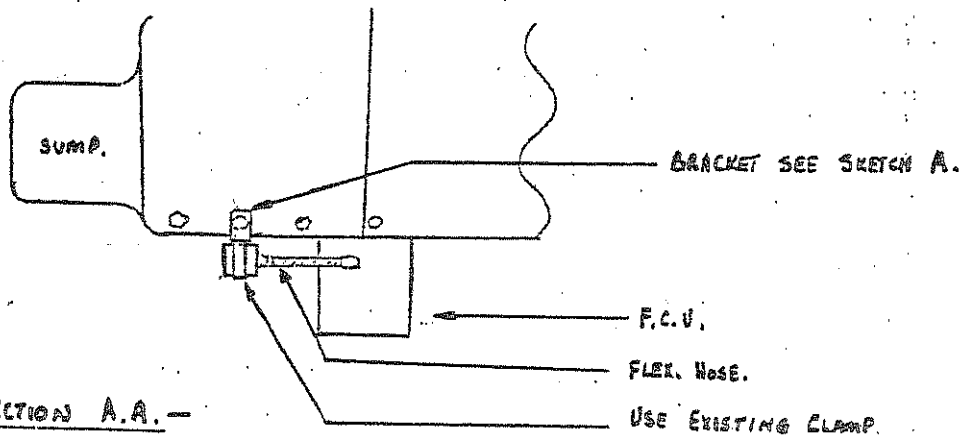
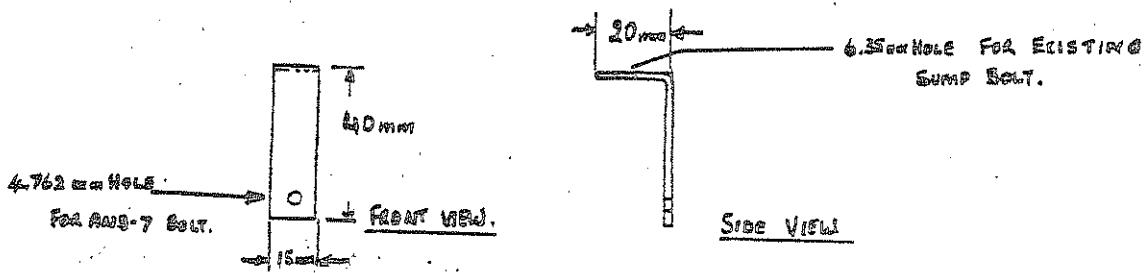
FUEL PRESSURE LINE MODIFICATION — DRAWING N° FM 07 —

The flexible fuel pressure hose between the fuel control unit and fuel pressure transducer can become hard and brittle causing eventual fuel leakage due to its close proximity to the exhaust segments. To prevent this accomplish the following:

- (ii) Remove fuel pressure transducer from existing location (clamped to no. 3 cylinder induction pipe) and retain clamp and attaching hardware.
 - (iii) Manufacture bracket from 4130 steel to dimensions shown on sketch A, minimum thickness of 0, 060 and fit bracket to new position below no 1 cylinder utilizing existing sump attach bolt as indicated in sketch.

- (iv) Attach fuel pressure transducer to steel bracket with existing fuel pressure transducer clamp using AN 3-7A bolt, AN 960-10 washer and AN 363-1032 nut.

- (v) Manufacture new flexible hose, total length 11 cm, measured from outside ends of hose fitting nuts.
 - (vi) Original hose may be utilized and shortened, provided the hose is serviceable, by removing hose end fitting, which attaches to fuel pressure transducer, shortening hose to correct length and re-fitting hose end fitting.

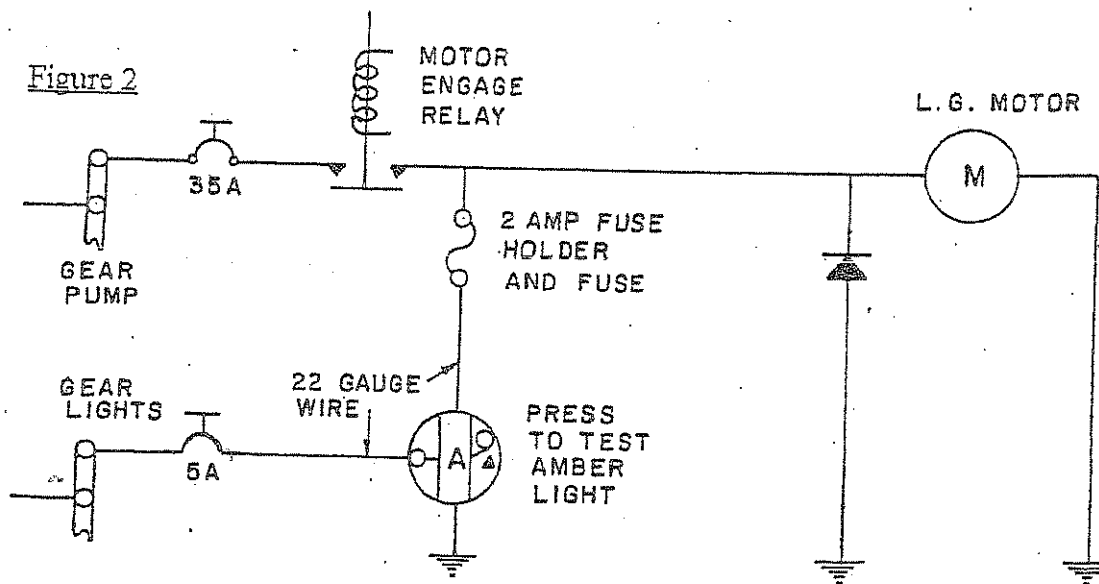
Wiring Diagram Example:

Reason: Field reports have been received of the landing gear hydraulic pump electric motors failing due to excessive operation of the pump.

Description: Insufficient hydraulic fluid in the reservoir to complete the up down cycle causing the pump to run continuously until it either overheats and burns out or trips the circuit breaker. When the voltage from the main supply to the motor is low for whatever reason the motor will not turn fast enough to produce the required pressure to complete the up or down cycle of the landing gear and therefore the shut-off pressure switch will not be activated to turn off the pump as it should.

1. Install an amber warning light on the instrument panel in the cockpit where it is easily visible to the pilot.
2. Wire the warning light mentioned in 1 above into the aircraft wiring between the relay and the landing gear drive motor as indicated in Figure 2 below and install a 2 amp fuse holder and a fuse close to the pick-off point to protect the wiring.
3. Placard the newly fitted amber light with placard wording as indicated by Figure 1.
