# Rolls-Royce

## P U B L I C A T I O N                      T R A N S M I T T A L

SUBJECT:    MAINTENANCE WARNING - EXTERNAL LINES

## MAINTENANCE WARNING - EXTERNAL LINES

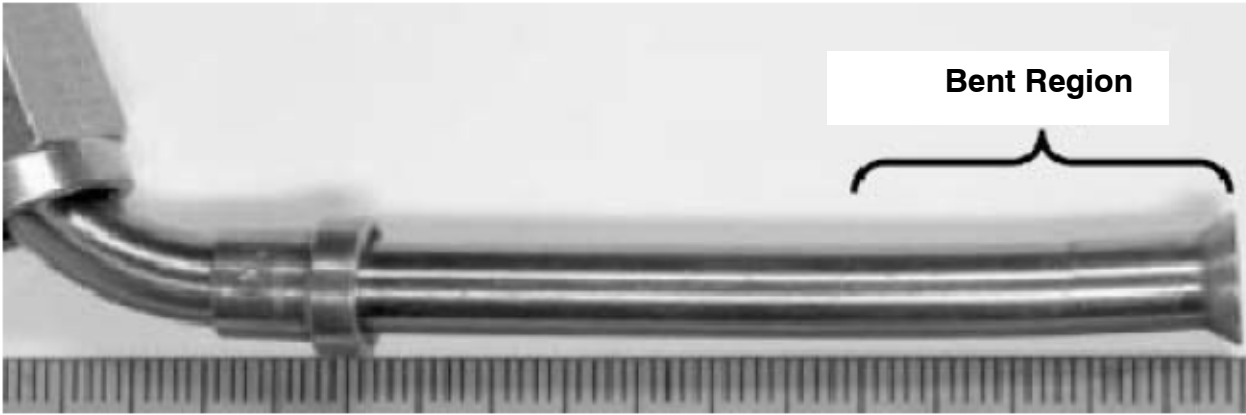
Tube Assembly, P/N 6890581  
 FIG. 1

- A. The tube is bent in an area that is not a principal bend, a region that should be straight. See Figure 1.
- B. Severe fretting was found under the ferrule sleeve caused by misalignment of the tube to fitting joint. See Figure 2.
- C. The flared tube was found cracked 270° circumferentially in the area of ferrule fretting. The crack and fretting were likely caused by misalignment of the tube to fitting joint. See Figure 3.

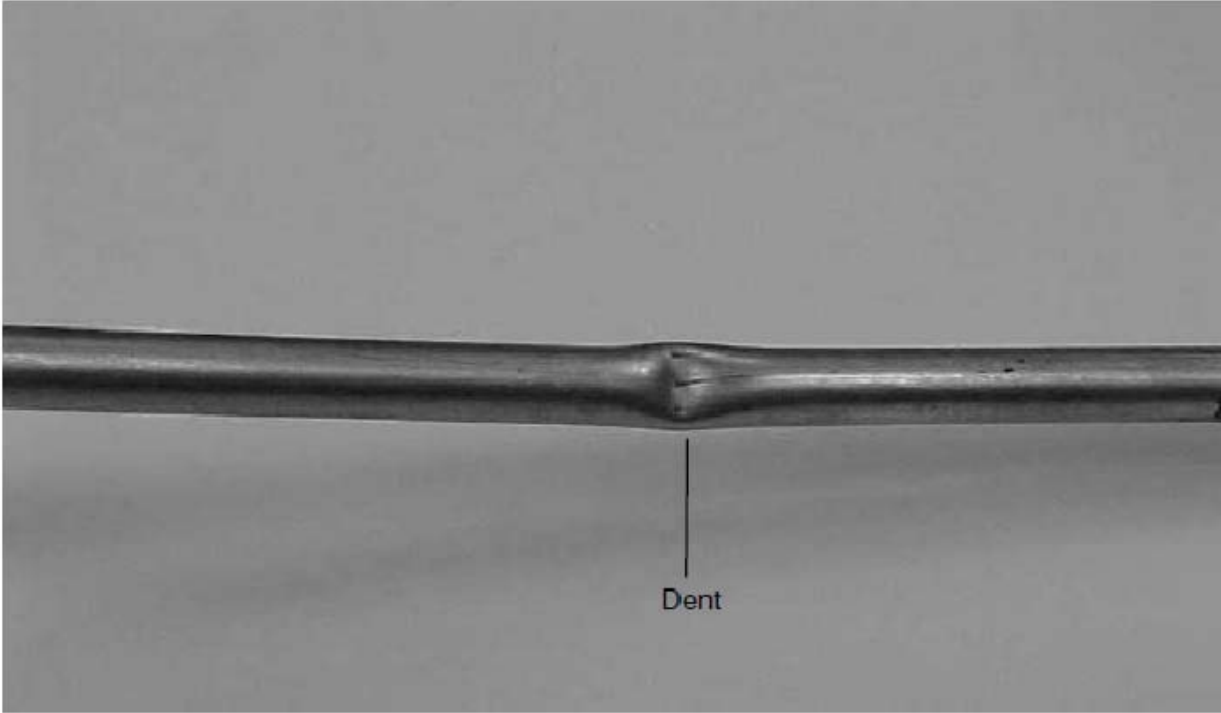
Tube Assembly, P/N 23033896  
 FIG. 4

P/N 23033896 tube assembly was removed from a Model C20R Series engine. Photographs were taken of the deformations in the tube assembly and are indicated in Figure 4. The following discrepancies were noted during the examination of the tube assembly:

- A. The deformations were caused by attempting to use Model C20R Series single engine designated clamping on a multi-engine configuration tube.
- B. The previously mentioned clamp hid the large dent. Only removal of the tube assembly allowed discovery of the extent of damage to the tube.

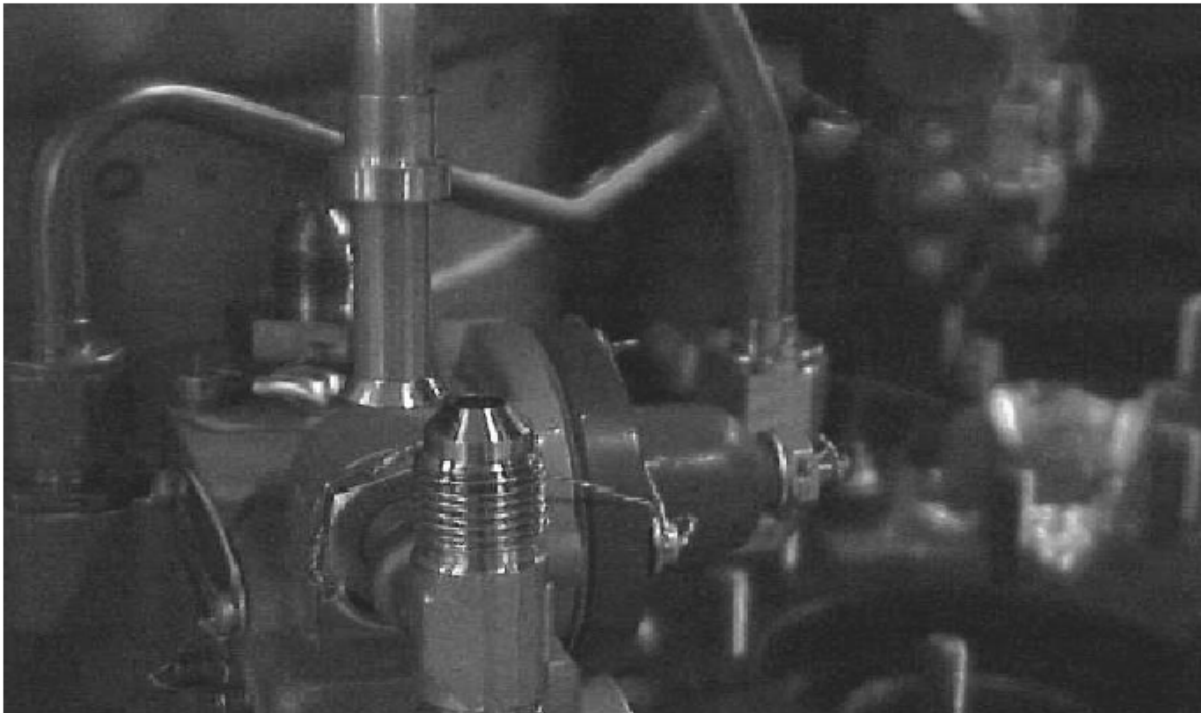
Misaligned Tube  
 FIG. 5

- C. Always use a torque reaction wrench when tightening tube assembly B-nuts.
- D. Tube assemblies must fit and be aligned with the mating flare tube fittings to the degree that at both ends of the assembly, the flares shall be uniformly seated in a free state on the cones of the mating fittings. The fitting shall be without distortions or stretching of the tube assembly, and to the degree that the nuts can be fully engaged up to the final one-half turn with light finger pressure. See Figures 5 and 6.

- E. In the event that a tube does not align with the mating fittings, re-position the mating fittings to the degree that proper alignment may be attained. Final tightening of these fitting lock nuts must be accomplished before the tube assembly is torqued.

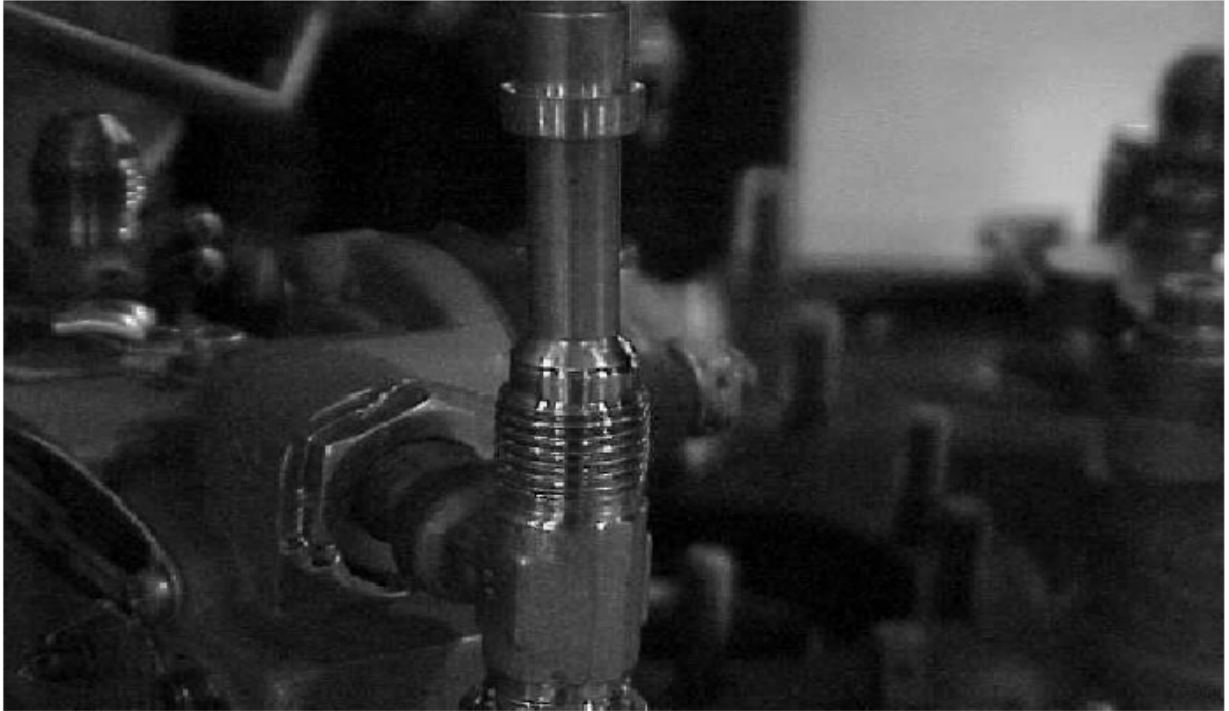
Properly Aligned Tube  
FIG. 6

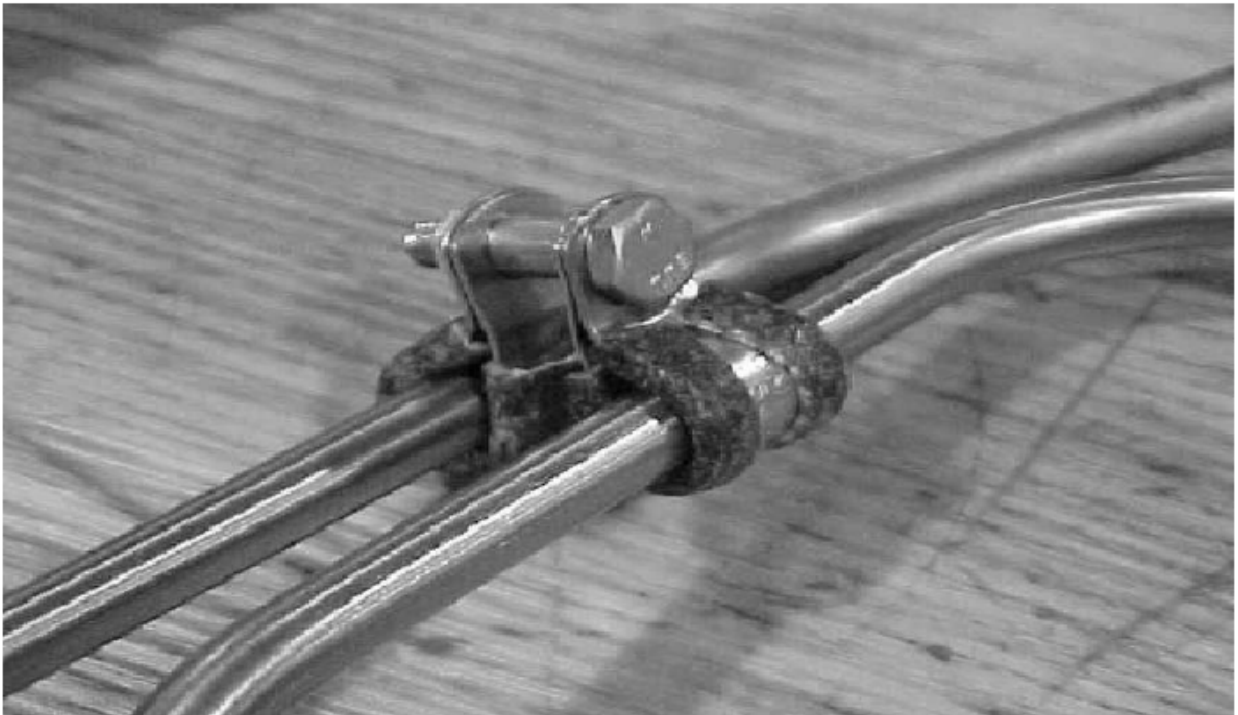
Correct Cushion Material  
FIG. 7

- L. Clamp the tube assemblies as shown in the appropriate Illustrated Parts Catalogs and/or Commercial Engine Bulletins.
- M. Do not install unauthorized clamps, hardware, fittings, chafe material, etc., on the engine tube assemblies. See Figure 7 for a correct cushion material example.
