Airworthiness Directive

AD No.: 2014-0118R1

212, 412 and 412EP helicopters

ATA 63 – Main Rotor Drive – Engine-to-Transmission Drive Shaft Line Nuts – Inspection / Replacement

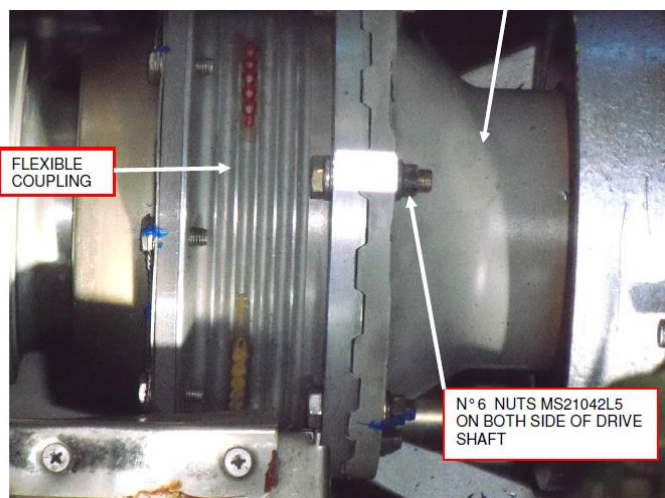
Fig. 1

- 1) Prepare helicopter for safe ground maintenance; disconnect battery and all the electric power source and/or the external power supply.
- 2) In accordance with the applicable Maintenance Manual Chapter 63, gain access to the engine-to- transmission drive shaft.
- 3) Using a source light and a mirror, inspect the nuts P/N MS21042L5 connecting the flexible coupling with the adapter installed on the engine-to-transmission drive shaft (refer to Fig. 1) or inspect the nuts P/N MS21042L4 connecting the flexible coupling with the adapter and nuts P/N MS21042L4 connecting the drive shaft with the flexible coupling (refer to Fig. 2). The configuration depends on the helicopter model and s/n.

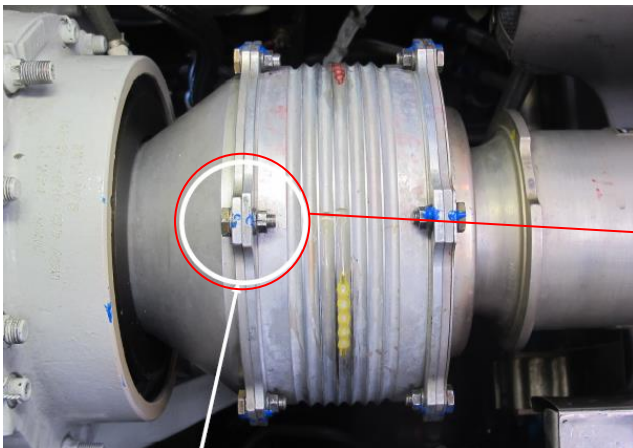
An occurrence was reported on one in-service AgustaWestland AB 412EP helicopter, where during scheduled inspection of the engine-to-transmission drive shaft line, two nuts P/N MS21042L4 that connect a flexible coupling with the coupling adapter were found cracked.

Subsequent technical investigation identified that the reported cracks of the nuts are the result of a production deficiency (causing hydrogen embrittlement) at the nut supplier. Nut P/N MS21042L5 may also be affected.

Note 1: For a typical crack, refer to Appendix 1 of this AD, Fig. 3 and Fig. 4.

- (2) If, during any inspection as required by paragraph (1) of this AD, a nut is found cracked (see Note 1 of this AD), before next flight, replace the nut with a serviceable part having a different P/N in accordance with the instructions of Appendix 2 of this AD.

- 1) In accordance with the applicable Maintenance Manual Chapter 63, replace the nuts P/N MS21042L5 with nuts P/N MS21043-5 or the nuts P/N MS21042L4 with nuts MS21043-4, as applicable depending on helicopter configuration (it is recommended to replace the nuts one at a time). Restore witness mark as required.
- 2) In accordance with the applicable Maintenance Manual Chapter 63, reinstall the access panel and close the access doors previously removed/opened and return the helicopter to a “ready to flight” condition.
