## Airworthiness Directive

**AD No.:** 2018-0081

SZD-55-1 sailplanes

## ATA 27 – Flight Controls – Elevator Control System / Vertical Tail – Inspection

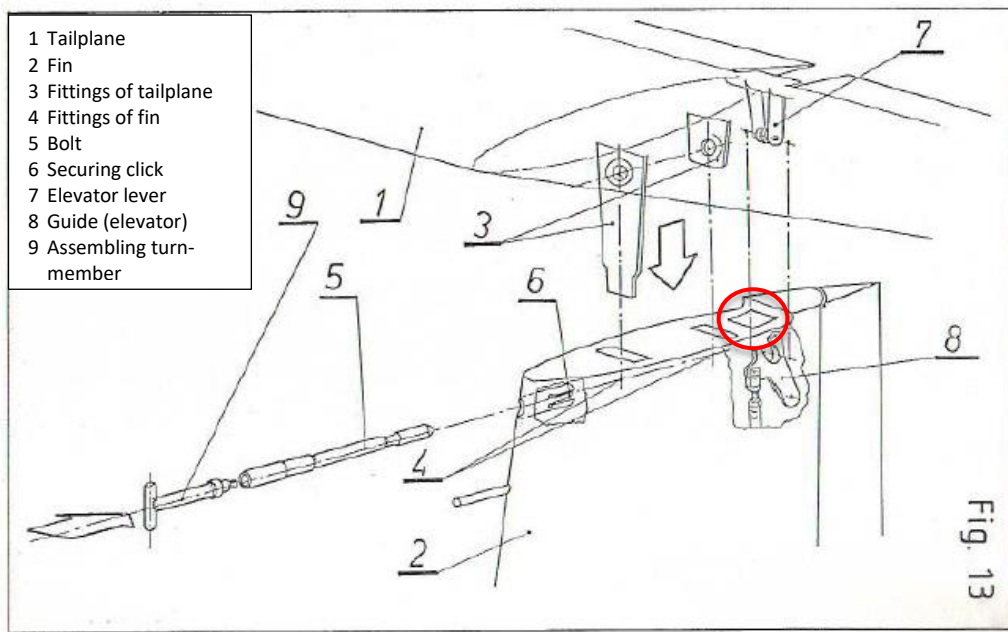
Drawing 1

Following a fatal accident with an SZD-55-1 sailplane, it was found that, during rigging, the elevator lever had not been connected with the guide of the control system. The investigation results also revealed that the opening on top of the vertical tail, through which the elevator control lever is inserted, had been enlarged. The correct dimension of the opening ensures safe rigging and is explicitly defined in the design (see Drawing 1, Appendix 1 of this AD) of the horizontal tail (1), where the connection is such that if the elevator lever (7) is not correctly located inside the guide (8), the tail cannot be secured with bolt (5).

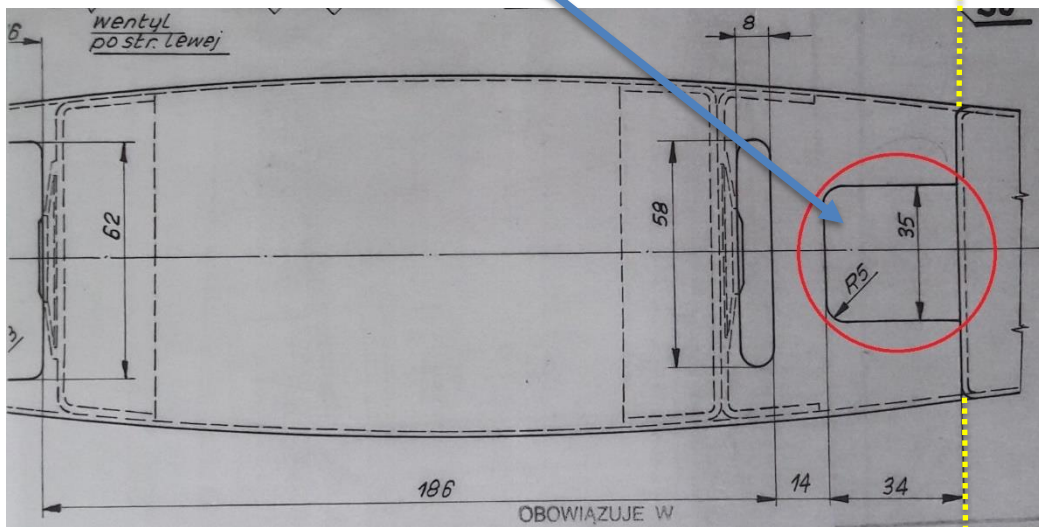
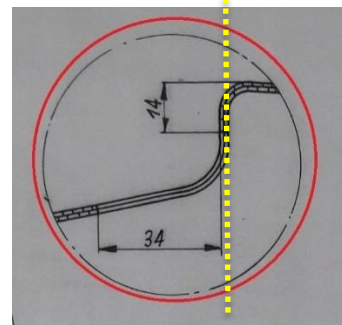
Drawing 2

Slot for the elevator lever

Slot extension not as designed

- (1) Within 60 days, or during the next annual inspection, whichever occurs first after the effective date of this AD, visually inspect the size of the opening on top of the vertical tail (see Drawing 2, Appendix 1 of this AD).

- (2) If, during the inspection as required by paragraph (1) of this AD, discrepancies are detected, before next flight, contact Allstar PZL Glider for approved repair instructions and accomplish those instructions accordingly.

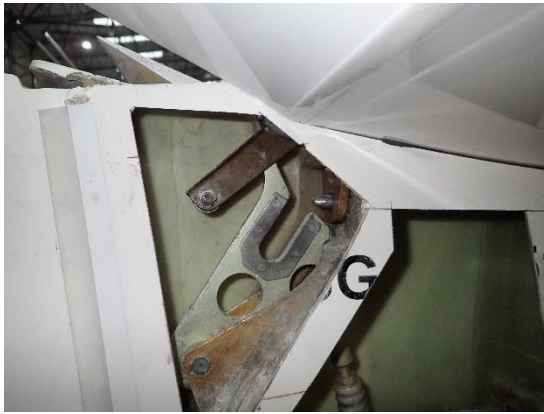
Image 1  
Disconnected elevator control

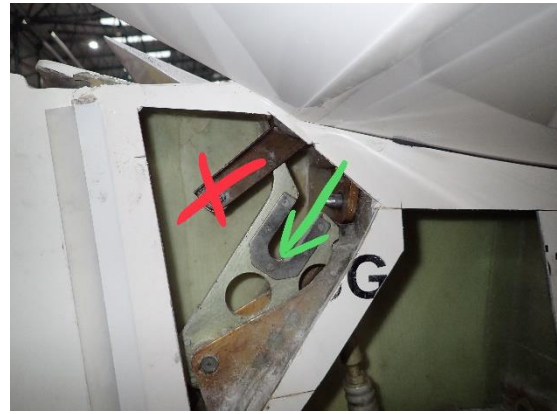
Image 2  
Disconnected elevator control

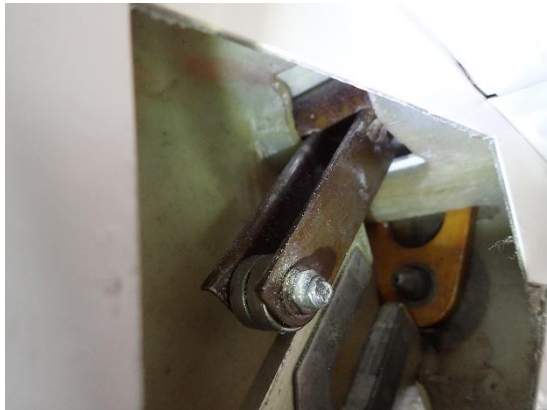
Image 3  
Disconnected elevator control

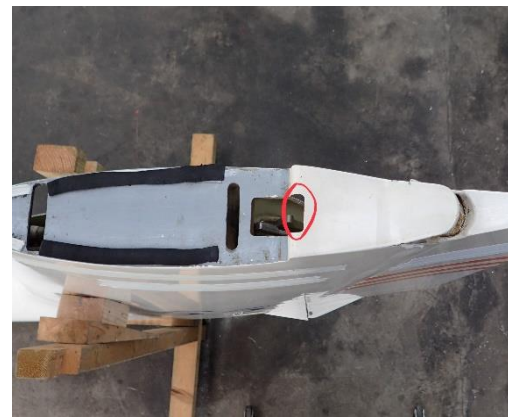
Image 4  
Enlarged opening
