Airworthiness Directive

AD No.: 2018-0226

A330 and A340 aeroplanes

ATA 55 – Stabilizers - Horizontal Stabilizer Centre Box Top Skin – Inspection / Repair

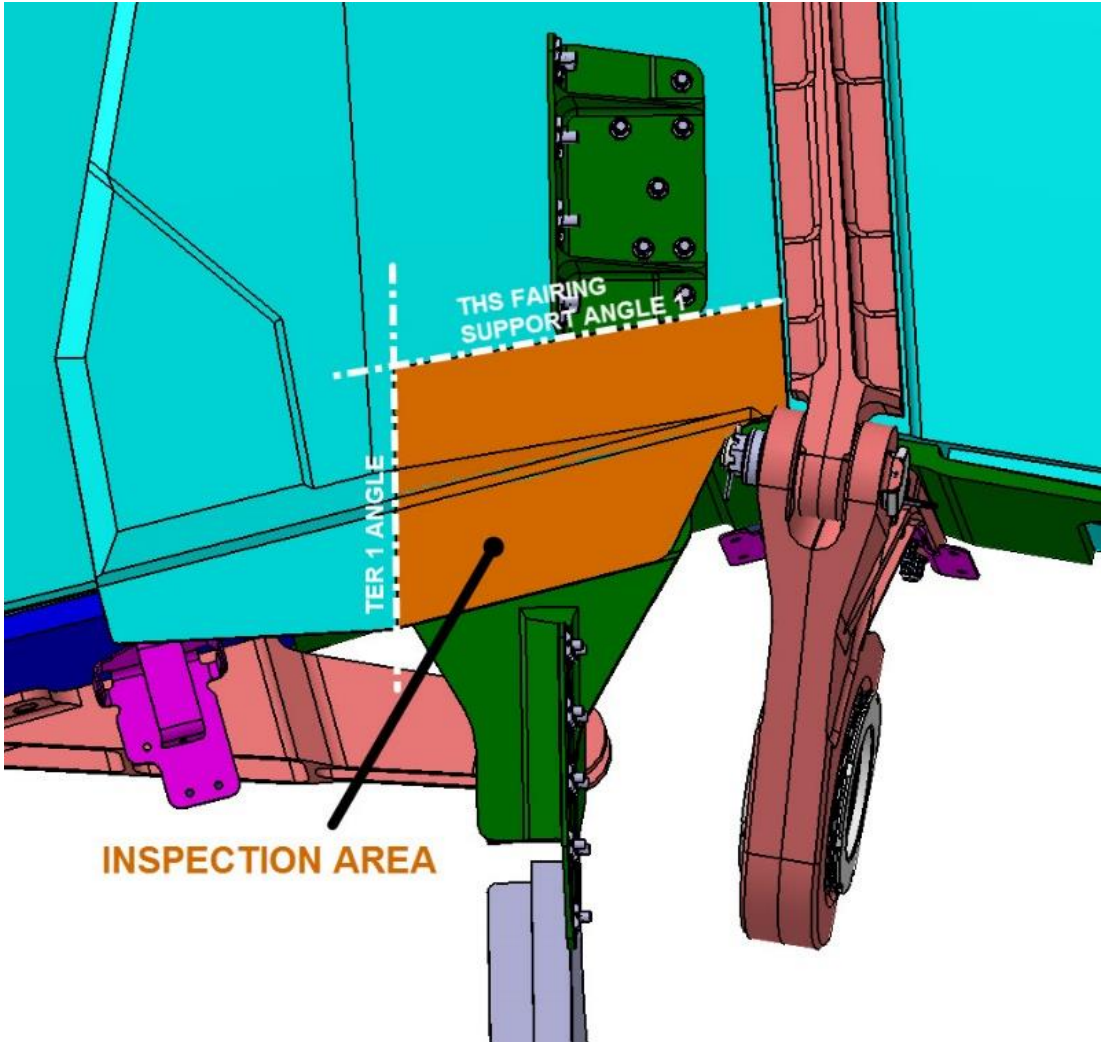
Appendix 1– Affected area to be inspected

Cracks were found in the horizontal stabilizer (HS) centre box (CB) top skin of an A330 aeroplane in pre-mod 41330 configuration. The cracks were initiated at the upper flange corner at Rib 3 rear spar area on left hand side of the CB.

To address this unsafe condition, Airbus published SB A330-55-3046 to provide inspection instructions for the affected area (see Appendix 1 of this AD), only applicable to some pre-mod 41330 A330 MSN. Consequently, EASA issued AD 2017-0078 to require a one-time special detailed inspection (SDI) of the HS CB top skin integral flange area and, depending on findings, accomplishment of applicable corrective action(s).

- (4) If, during any inspection as required by paragraphs (1), (2) or (3) of this AD, as applicable, any crack is found, before next flight, contact Airbus for approved repair instructions and, within the compliance time specified in those instructions, accomplish those instructions accordingly.
