MANDATORY SERVICE

EMAIL pacific@aerospace.co.nz WEB www.aerospace.co.nz PACSB / XL / 101 ISSUE 1

FIREPROOF WIRING PENETRATIONS

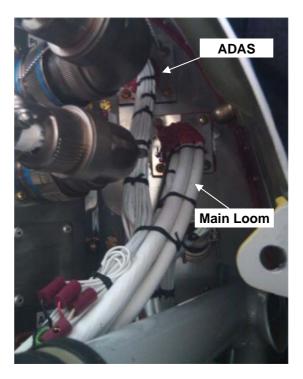
FIGURE 1 FIREWALL (MAIN LOOM AND ADAS)

B. REASON During a review of the Installation Main

A/C Loom (P/N 11-81021) a possibility of

ineffective firewall sealing was identified.

1) Remove the upper engine cowl to get access to the wiring loom feed thru on the LH side of the firewall, (adjacent to the relay box, if fitted) (See Figure 1).

- 2) Remove and retain the Qty 4 screws on the firewall loom feedthrough.
- 3) Remove and discard the two stainless plates and firesleeve material.
- 4) Remove any excess sealant from the loom and inspect the loom for chafing.

- If chafing or any damage are present on Loom, contact PAL for further information:
 - If no chafing / damage are present, continue on Step 5).
- 5) Protect the loom and surrounding equipment and carefully enlarge the firewall loom hole to 1.375" diameter. This may be achieved using a small deburring tool. If this method is not successful it may be necessary to disconnect and pass the loom back through the firewall.

- 6) Cut and split a 3" length of firesleeve and wrap the loom near where it passes through the firewall. The firesleeve should be wide enough to wrap at least 1.5x around the loom.

- 7) Fit two firewall penetration tubes around the firesleeve allowing 0.25" of firesleeve to extend past the end of the tube. Ensure the firewall penetration tubes will securely hold the loom. If the loom is loose in the firewall penetration tubes use a wider length of firesleeve to wrap further around the loom.
