COCKPIT CONTROL HANDLES

- A. EFFECTIVITY PAL 750XL aircraft up to and including S/N 0215.

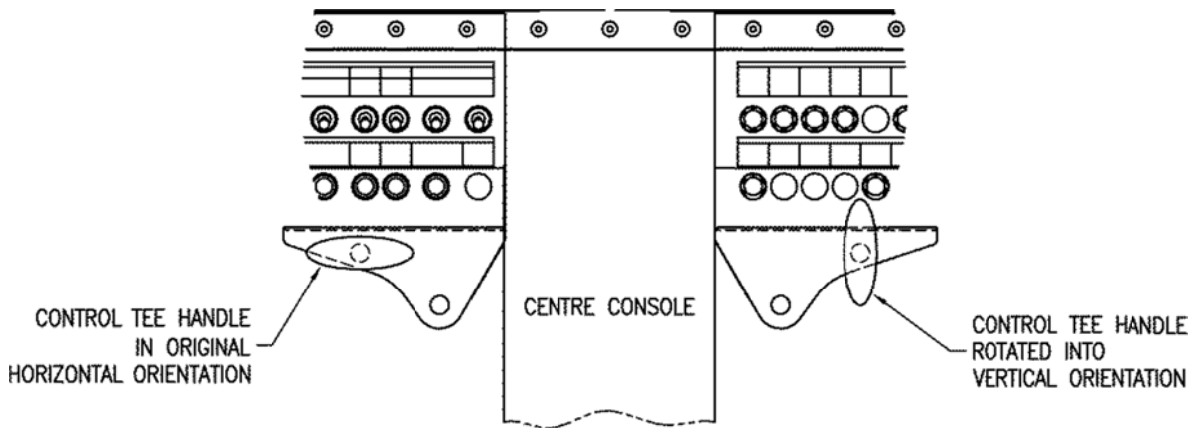
FIGURE 1 CONTROL TEE HANDLE REORIENTATION

- B. REASON During a ground inspection, it has been observed that it was possible for the Control Column to snag on the Cockpit Control Tee handles which are mounted below the Switch Panels adjacent to the Centre Console. Snagging might occur with the Control Column in the full forward and inboard position. Depending on the specific configuration of the aircraft, this could affect the Heater, Ventilation or Engine Air Filter Bypass Tee handles.

- 1) Rotate the Control Handle into a vertical orientation as applicable (Figure 1).
- 2) If there is sufficient thread allowance on the Control Cable Shaft, rotate the Tee Handle 90° clockwise into a vertical orientation by tightening the Handle further onto the shaft.
- 3) If there is not enough thread travel to rotate the Control Handle 90° clockwise, remove the handle by rotating anticlockwise. Depending upon the condition of the thread in the Tee Handle:
 - a) Install a Check Nut P/N AN315-4R onto the Control Cable Shaft or;
 - b) Apply Threadlocker (Loctite 243) to the thread.
- 4) Reinstall the Control Handle so it is oriented vertically (Figure 1). Ensure the handle does not rotate freely on its thread.
- 5) Repeat for the Control Handles on both sides of the Centre Control Console as appropriate.

- 6) Confirm that there is full travel of the Control Columns.

NOTE: If the Control Column still contacts the Tee handle(s), contact Pacific Aerospace Limited for details of an alternative repair scheme.
