Pacific Aerospace Limited
Airport Road, Hamilton
Private Bag 3027, Hamilton 3240, New Zealand
TEL +6478436144 FAX +6478436134

EMAIL pacific@aerospace.co.nz WEB www.aerospace.co.nz PACSB / XL / 091 ISSUE 3

WING L/E TANK ABRASION REPAIR & PATCH

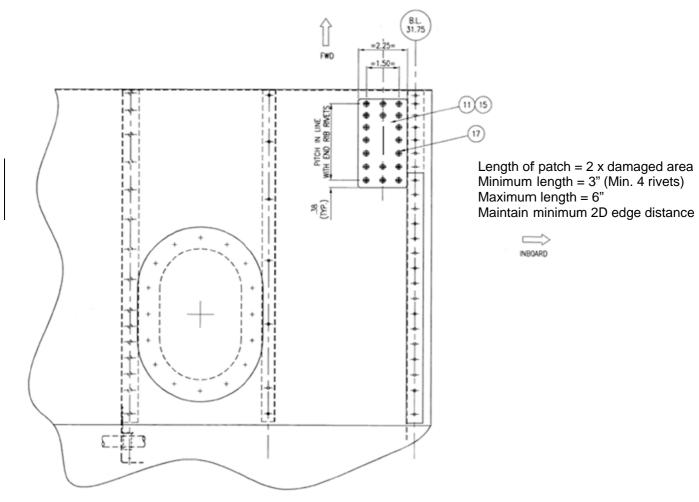
FIGURE 1 REPAIR WING L/E TANK ABRASION

To repair or prevent chafing to wing leading edge due to rubbing by the

ventilation ducting.

<u>VIEW ON UNDERSIDE – R.H. WING</u> L.H. WING REPAIR SIMILAR (AS REQUIRED)

Note 2: Repair this area IAW FAA AC43.13-1B Fig 4-16

- 1) Blend out gouges in skin to remove sharp corners (ratio 20:1).
- 2) Where gouges are located outside the repair patch perimeter as drawn, extend the patch, replicating the indicated fastener pitching as required. Make sure blended area is within rivet attachment area, if the patch exceeds 6" x 6", contact PAL for further information

- 3) If patch rivets are required thru the wing inboard rib, ensure wing tank sealing is maintained/reinstated and replace rivets with the same P/N MS20470 AD4 solid rivets in existing locations (not the AD 42 SB rivet).

- 4) Remove any paint or primer between the mating surfaces and lightly scuff using scotchbrite. Clean with Prepsol/Acetone and allow to dry thoroughly. Apply AMS-S-8802 adhesive sealant liberally to mating surfaces ensuring no air gaps will result. Rivet the doubler patch in place while sealant is still wet.

- 5) Prime and paint in accordance with maintenance manual Chapter 20.
- 6) Install Teflon protection doublers as detailed in Part B of this Service Bulletin.

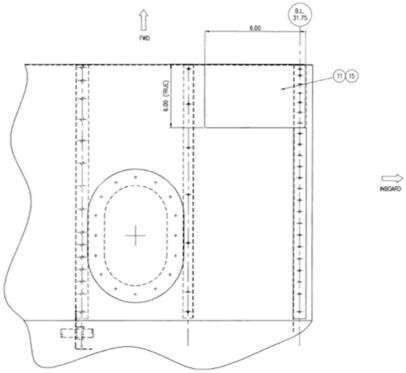
FIGURE 2 WING L/E ANTI-ABRASION PATCH

VIEW ON UNDERSIDE – R.H. WING L.H. WING OPPOSITE HAND

- 1) Ensure mating surfaces of anti-abrasion patch and L/E skin are clean and free from dust or grease before bonding the anti-abrasion patch to the wing L/E skin.
- 2) Apply adhesive sealant on mating surfaces of anti-abrasion patch and wing L/E skin. Install the anti-abrasion patch as shown.
