INSPECTION - ELEVATOR BELLCRANK PIVOT

- A. EFFECTIVITY PAL 750XL aircraft up to and including S/N 215.

- B. REASON It is possible that the Elevator Bellcrank Pivot joint could be assembled with a bolt that is a gauge size too short leaving threads inside the working section of the joint. This can be determined by measuring the length of the bolt. If it is found on inspection that the shorter bolt has been used to assemble this hinge, the bolt will need to be replaced with the next gauge size up.

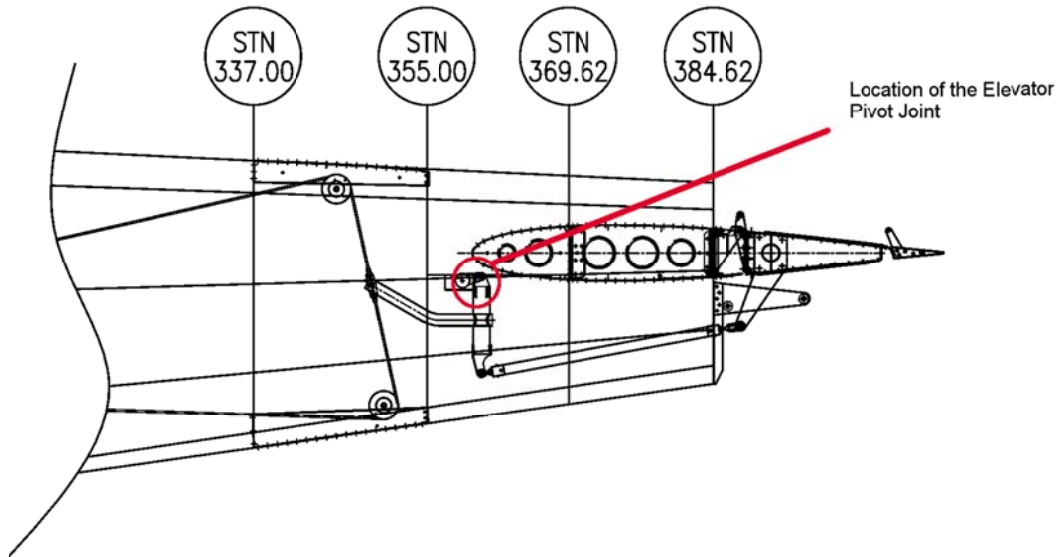
FIGURE 1 LOCATION OF ELEVATOR PIVOT JOINT

- 1) Remove the Control cable cover (Ref. 750XL MM, Chapter 12-00-00, p. 301, Panel F5) to access area of the Elevator Bellcrank Pivot joint (See Figure 1).

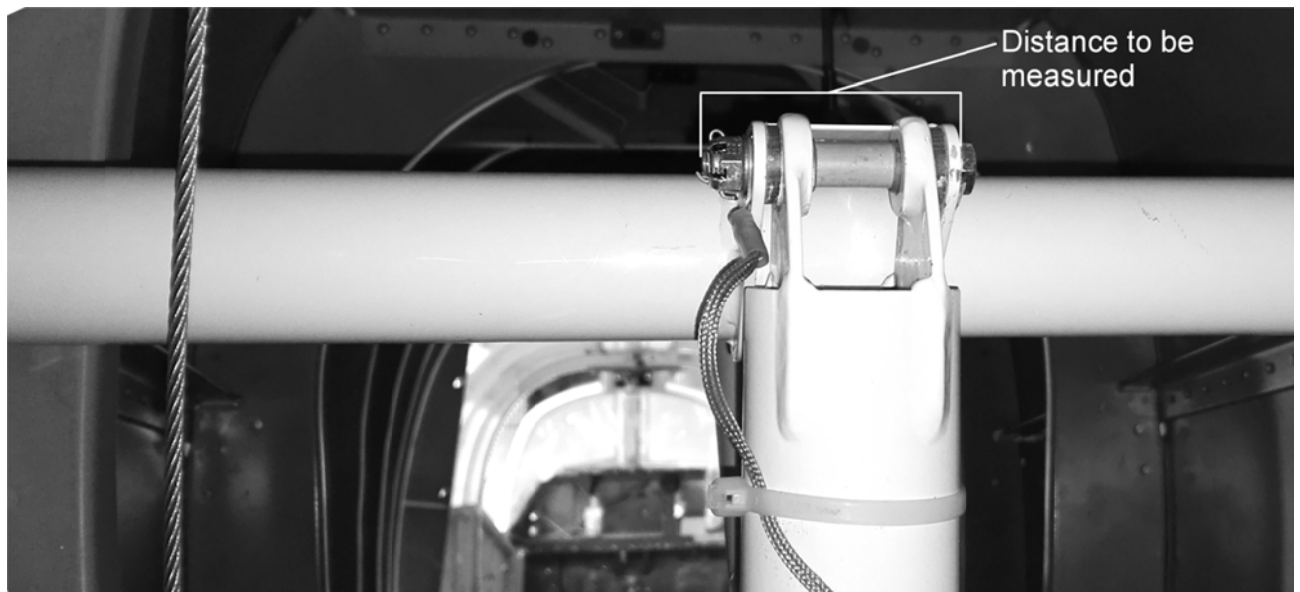
FIGURE 2 ELEVATOR PIVOT JOINT

- 2) Measure the length of the bolt from the underside of the bolt head to the tail (See Figure 2).

- 4) If the bolt fitted in this joint is P/N AN4-20, go to Paragraph 3. (Accomplishment Instructions).
- 5) If the bolt fitted in this joint is P/N AN4-21, no further action is required. Re-install the Control cable cover (Ref. 750XL MM, Chapter 12-00-00, p. 301, Panel F5) and Record Compliance with this Service Bulletin in accordance with Section 4 (Certification).

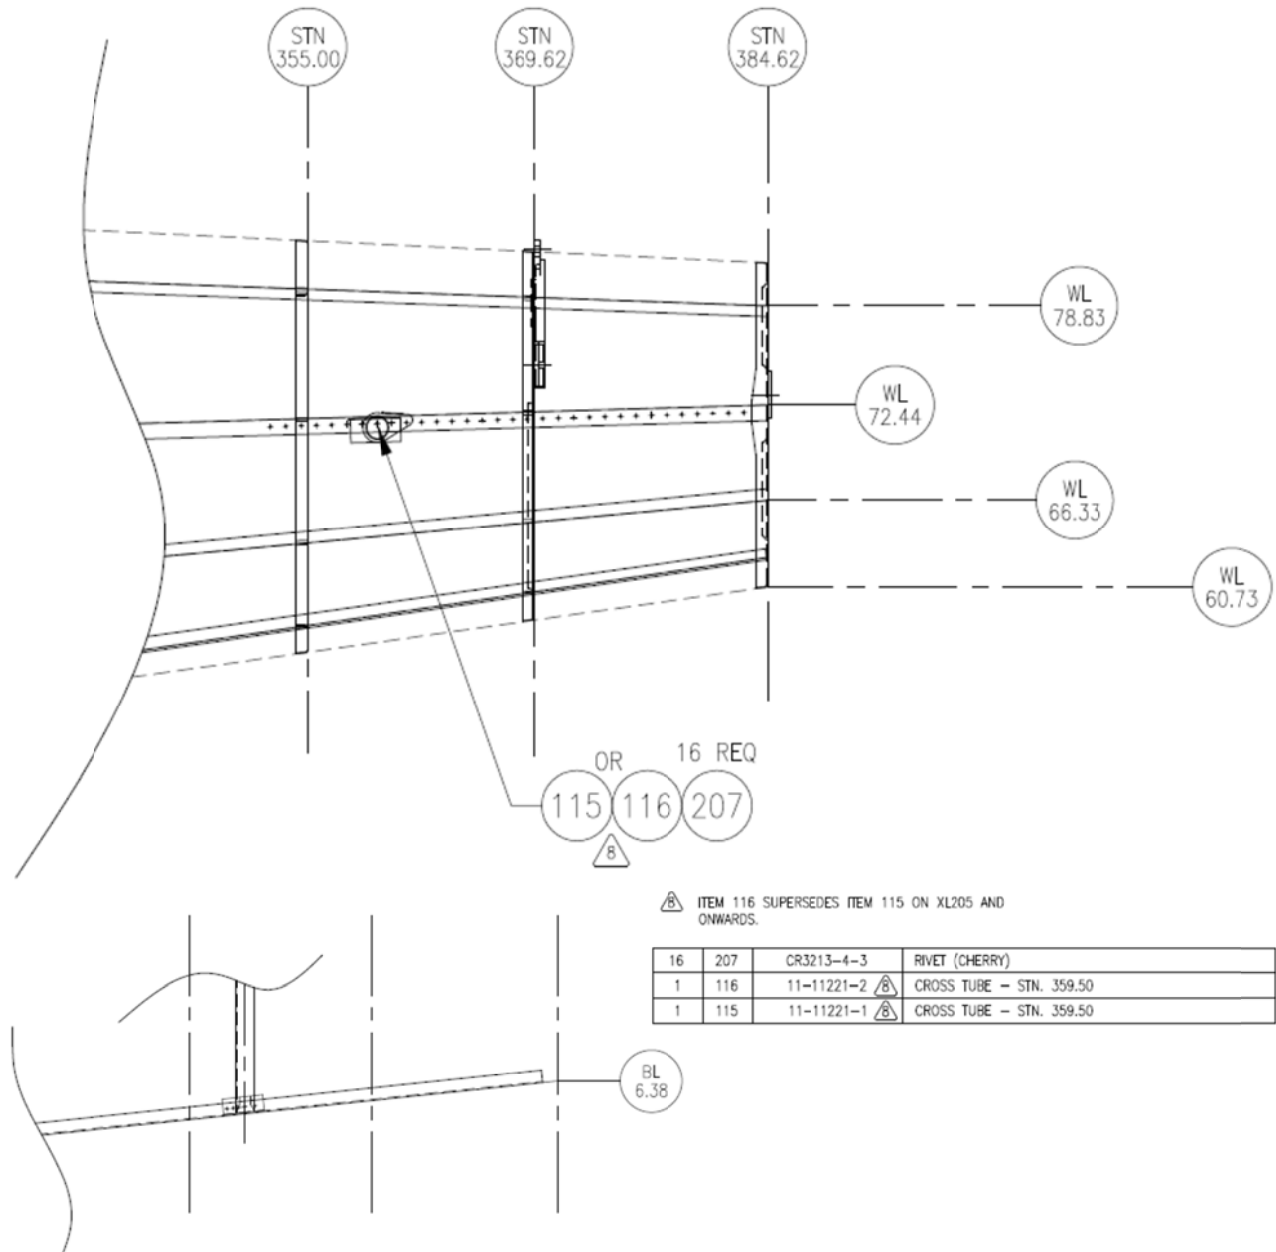
FIGURE 3 RIVET LOCATIONS

- 7) If damage is detected, remove the Cross Tube from the aircraft by drilling out the attachment rivets (See Figure 3) in accordance with the manufacturer’s rivet removal procedures listed in CA-1015 (Cherry Aerospace Process Manual).

- 11) Install the Cross Tube into the aircraft at STN 359.50 using Cherry Rivets P/N CR3213-4-3 (Qty 16, See Figure 3).

NOTE: If the fastener holes were damaged during the removal of the rivets in Step 7) it will be necessary to install oversized rivets, P/N CR3243-4-3.
