Continued Airworthiness Notification to the International Community

Date: October 31, 2019

Subject: This message is to advise you of the FAA's ongoing activities related to cracking and fracturing of the right aileron flight control cable end fittings (terminal attachment fittings) connected to the turnbuckle barrel on various Textron Aviation Inc. (type certificate formerly held by Beechcraft Corporation) (Textron) airplanes.

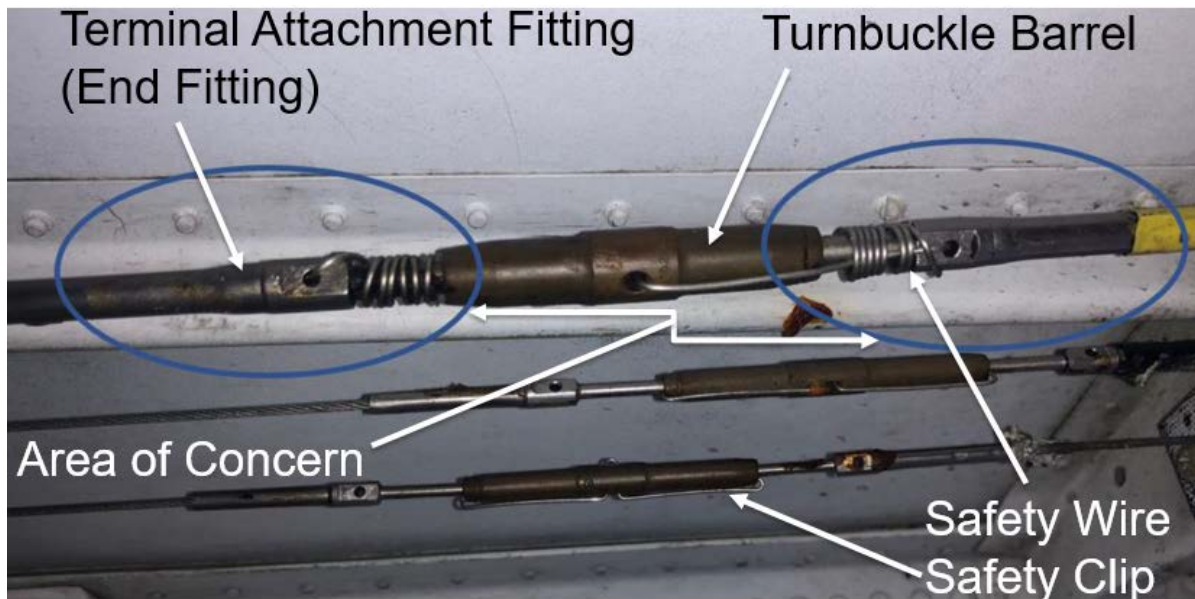
Right Aileron Flight Control Cable
End Fitting location on affected
Bonanza models

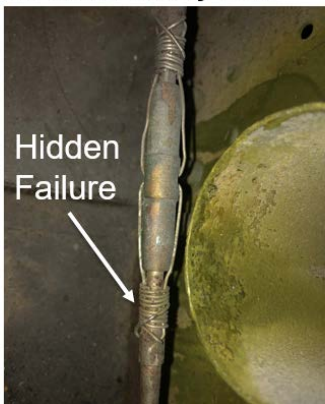
Right aileron control cable with failure under safety wire

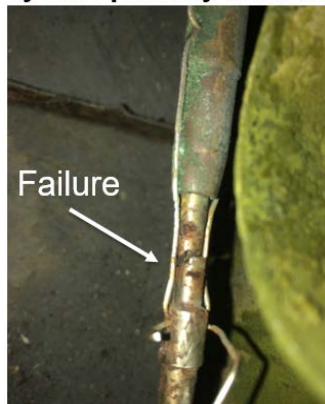
Right aileron control cable with safety wire partially removed

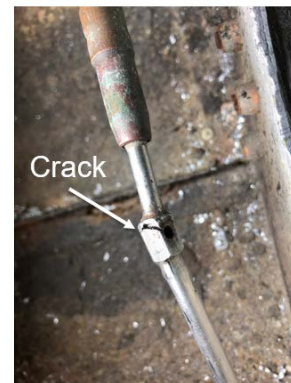
S35 Aileron Cable

Not Severely Corroded
