Feedback

Canadian Aviation Service Difficulty Reports

The following content was published between January 1st, 2019 and August 13th, 2019

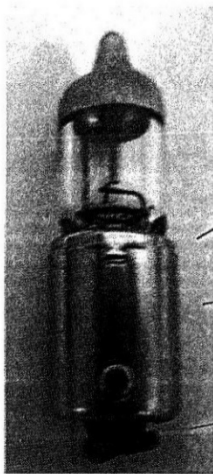
A small amount of smoke was noted in-flight, emitting from the reading light in seats 5A/B. The aircraft returned to base and the bulb was replaced rectifying the defect. The company's safety management system investigation lead to the suspicion that the bulb was an unapproved or counterfeit part. Indications of the part being counterfeit are low quality and overabundance of solder on positive (NON BODY) electrical contact. A complete lack of manufacturing markings or part number (P/N) stamped or etched on the bulb, a lack of solder to secure the bulb housing halves joint, and a smaller than normal insulator separating the bulb housing and center contact.

An inspection of a second company's aircraft found approximately 1/3 of the bulbs installed in the reading lights were of the unmarked, suspected counterfeit variety and several had significantly melted contacts. Upon this discovery, the reading light system on all 5 company aircraft were deferred and disabled until all the bulbs could be inspected and replaced as required.

No solder on joining index

No manufacturers' markings on body

Smaller than normal insulator
Poor quality melted solder

The above picture shows one of the suspect counterfeit / unapproved bulbs.

Within the quality assurance program for your company, the final quality control rests with the installer, and constant vigilance is required at all times. It is a good practice that maintainers installing parts ensure that they are using correct parts by visually comparing the new and the replacement. A correct P/N does not always guarantee that you have the right part.

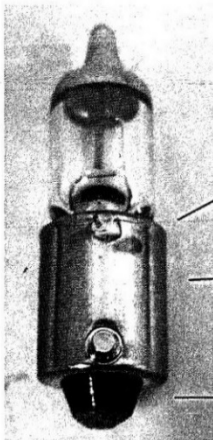
Solder weld present on body housing joint

P/N etched in bulb housing
(Not pictured on underside of bulb)

Larger insulator
Higher quality solder (and less solder)

The above picture illustrates the differences compared to Wamco Parts manufacturer Approval (PMA)
P/N WL8GH003912-06

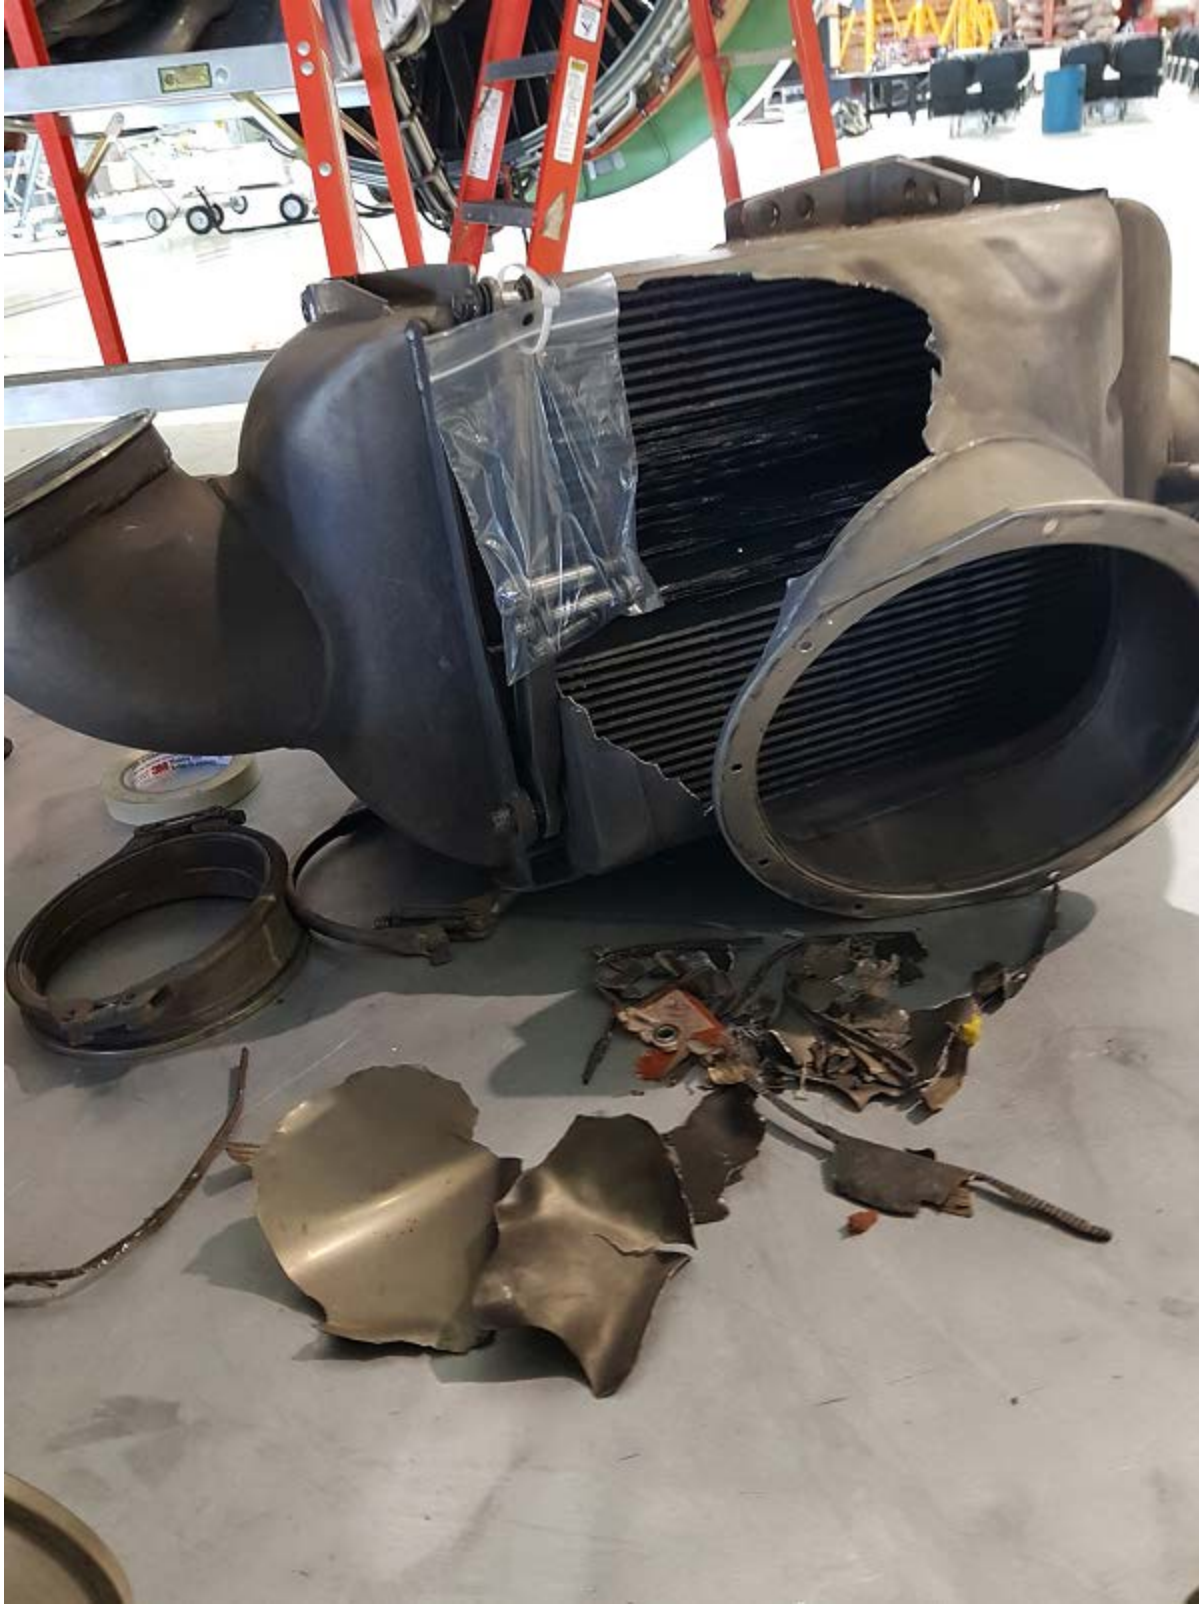
During a regular maintenance visit, metal debris was found protruding from the right hand pre-cooler exhaust outlet of the core cowl. Further inspection revealed separation of the pre-cooler shroud and core cooling fins. Engine bleed inlet and exhaust ducts were inspected for debris, with no debris noted. The engine bleed outlet fins were intact.

Further investigation by this operator revealed the probable cause of the failure to be sulfidation. Sulphur compounds in the air are chemically reacting with the nickel causing the fins to become brittle and flake off. If enough fin material is lost, leading to the pre-cooler not being able to adequately cool the bleed air, eventually the core could collapse.

Pre-Cooler Assembly with pieces from housing

The pre-cooler was replaced, along with the right hand engine strut blanket and outboard core cowl. No further damage was sustained due to the separation. There was no evidence noted as to the cause of this defect. No indications were noted by the flight crew prior to the discovery of this defect.

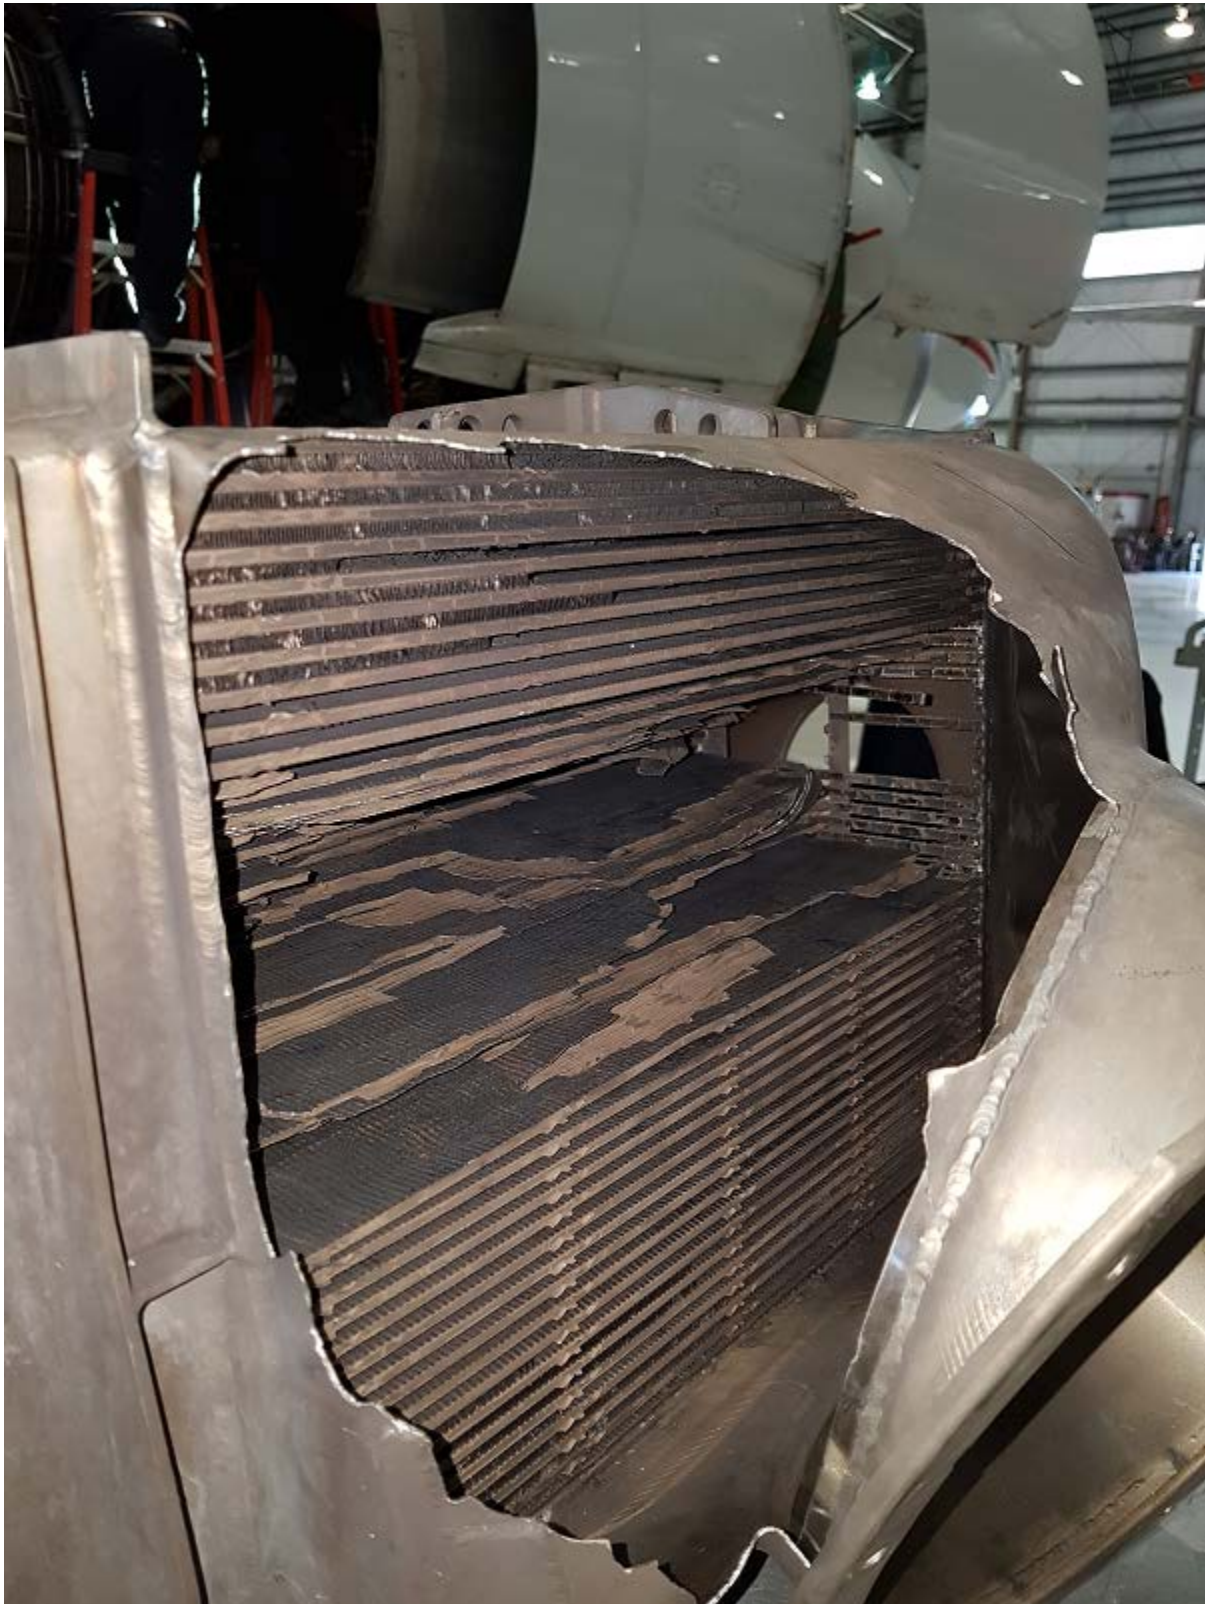
In this case, the piece of the core that let go internally caused the side wall of the cooler to become compromised. The resulting large hole allowed material to escape and cause secondary damage to the engine strut blanket and outboard core cowl.

Close up view of the hole in the housing and missing fins on the internal structure.

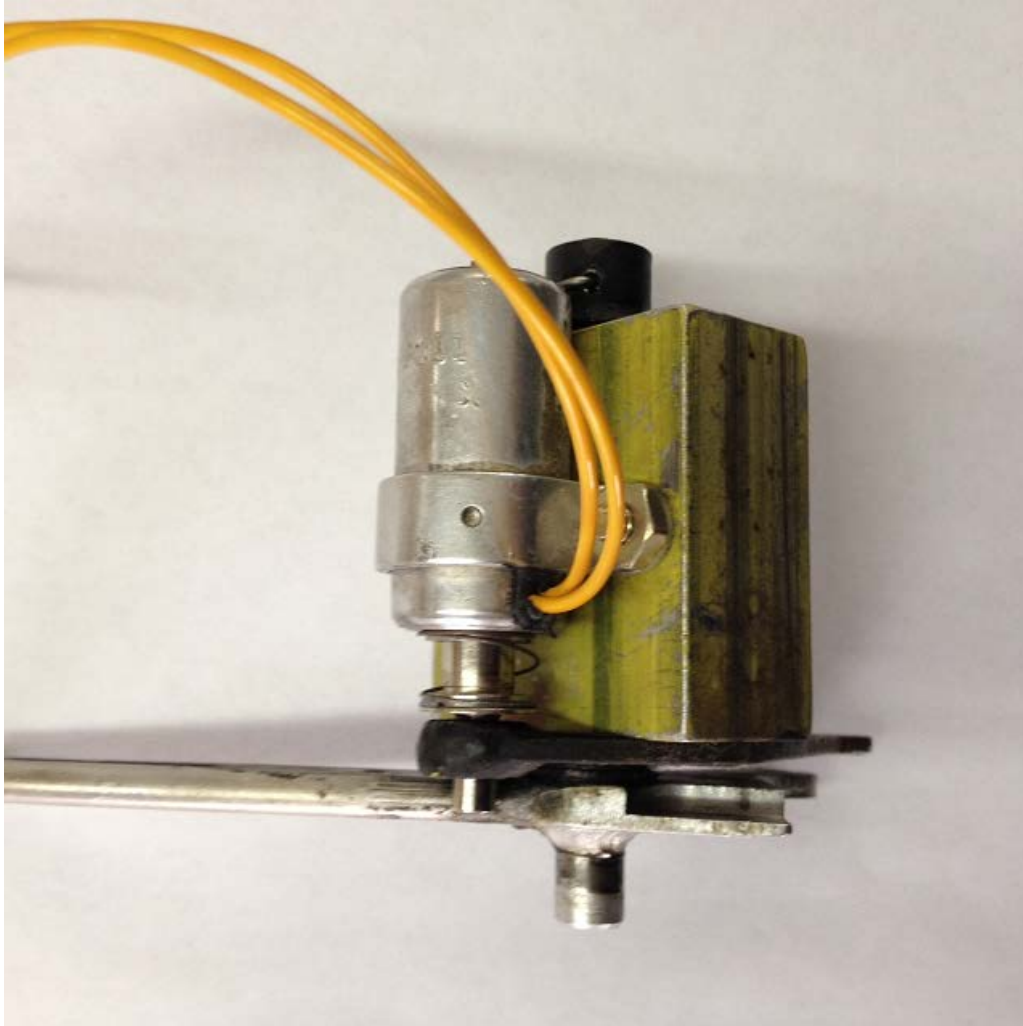
Piper PA31-350 Anti-retraction solenoid

However, during subsequent maintenance to repair defects noted by the pilot, the Aircraft Maintenance Engineer (AME) checked the landing gear selector mechanism without power-on and he could select "gear-up" without the anti-retraction locking pin stopping the handle. The AME investigated further and removed the anti-retraction portion of the landing gear selector mechanism. The AME found that the solenoid assembly shaft was bent and was stuck in the stop lever hole.

When the shaft was rotated 90 degrees, the solenoid could then move freely through the stop lever hole. Inspections conducted since the gear-up incident had found that the solenoid assembly worked properly, preventing the landing gear selector handle from being selected up. At every 100 hours air time, the PA31-350 event # 2 and # 4 inspections call for inspecting the landing gear selector mechanism and the anti-retraction solenoid.

With the solenoid installed, a bent shaft is not obvious and it would be difficult to detect unless the shaft was stuck in the stop lever hole. If the AME were to rotate the shaft during the inspection, a bent shaft would likely be found. This idea was not considered during previous inspections, nor considered necessary as the solenoid operated normally. Piper may want to add to their inspection requirements, to rotate the solenoid shaft in-situ by finger at the spring flange.

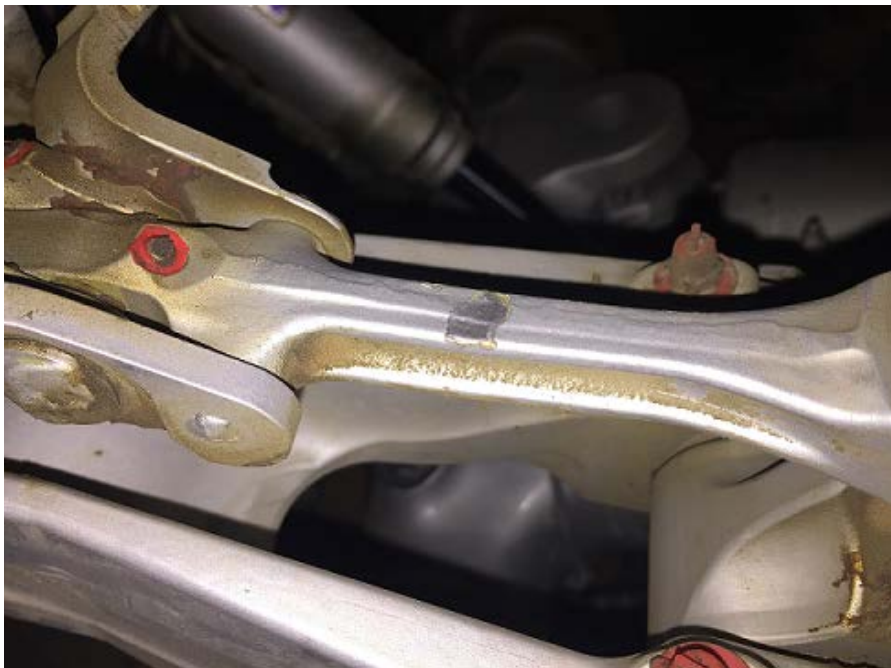
shop visit. The lower arm upper pin Part Number (P/N) D57407 and collar (washer) P/N D57408 at the universal joint, were installed upside down causing the collar to hit the link assembly, P/N GA62048, of the secondary alignment brace. This caused the link to be bent slightly.

Damage to link caused by contact with collar

Maintenance personnel are reminded that when installing components or assemblies onto an aircraft, they are responsible for inspecting that unit and the associated paperwork before installation.

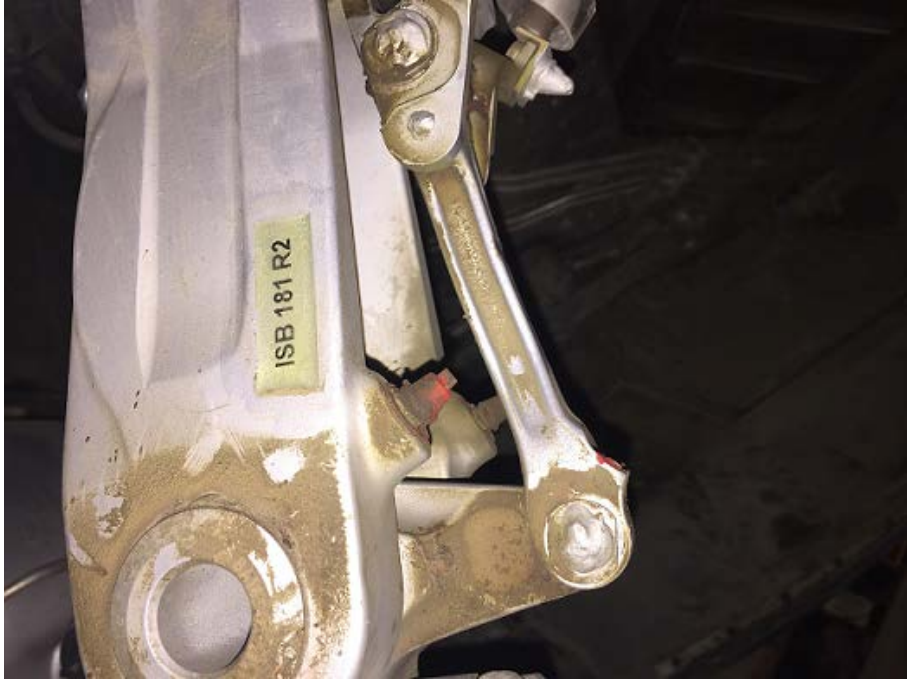
Noticeable bend in link P/N GA62048

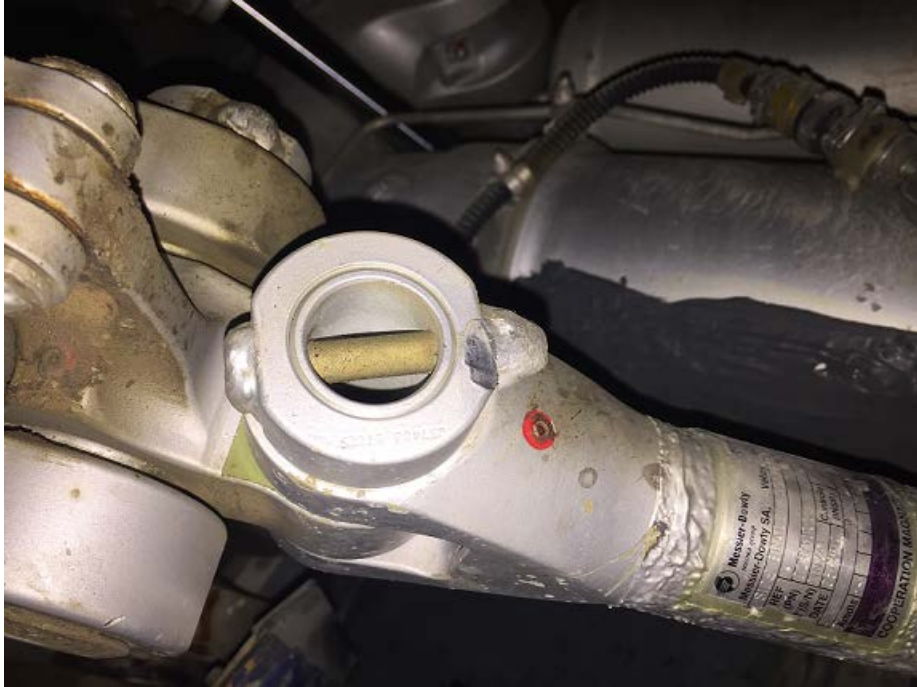
Incorrectly installed collar which shows evidence of contact with link unit

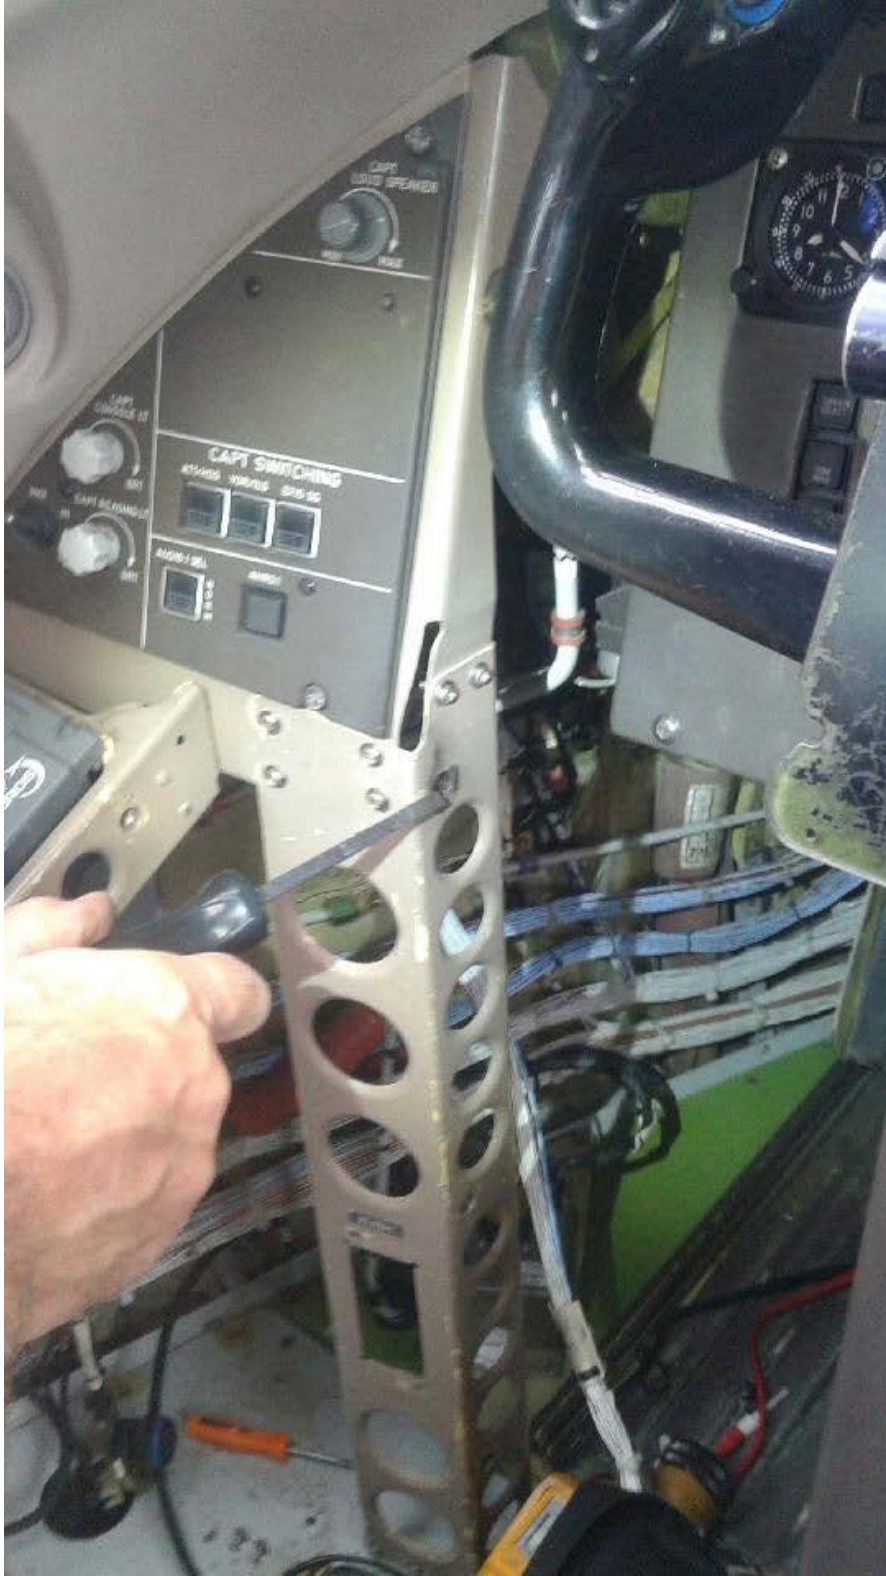
Electrical smoke on take-off by the captain's left knee. Maintenance found 2 chafed Flight Management System (FMS) wires, W09008-815 and W09008-816, both wires were then isolated & secured.

Location of fastener and evidence of arcing

When installing components or performing visual inspections, maintainers are reminded to be diligent for potential chafing between structure and lines, conduits, hoses, electrical harnesses, etc.

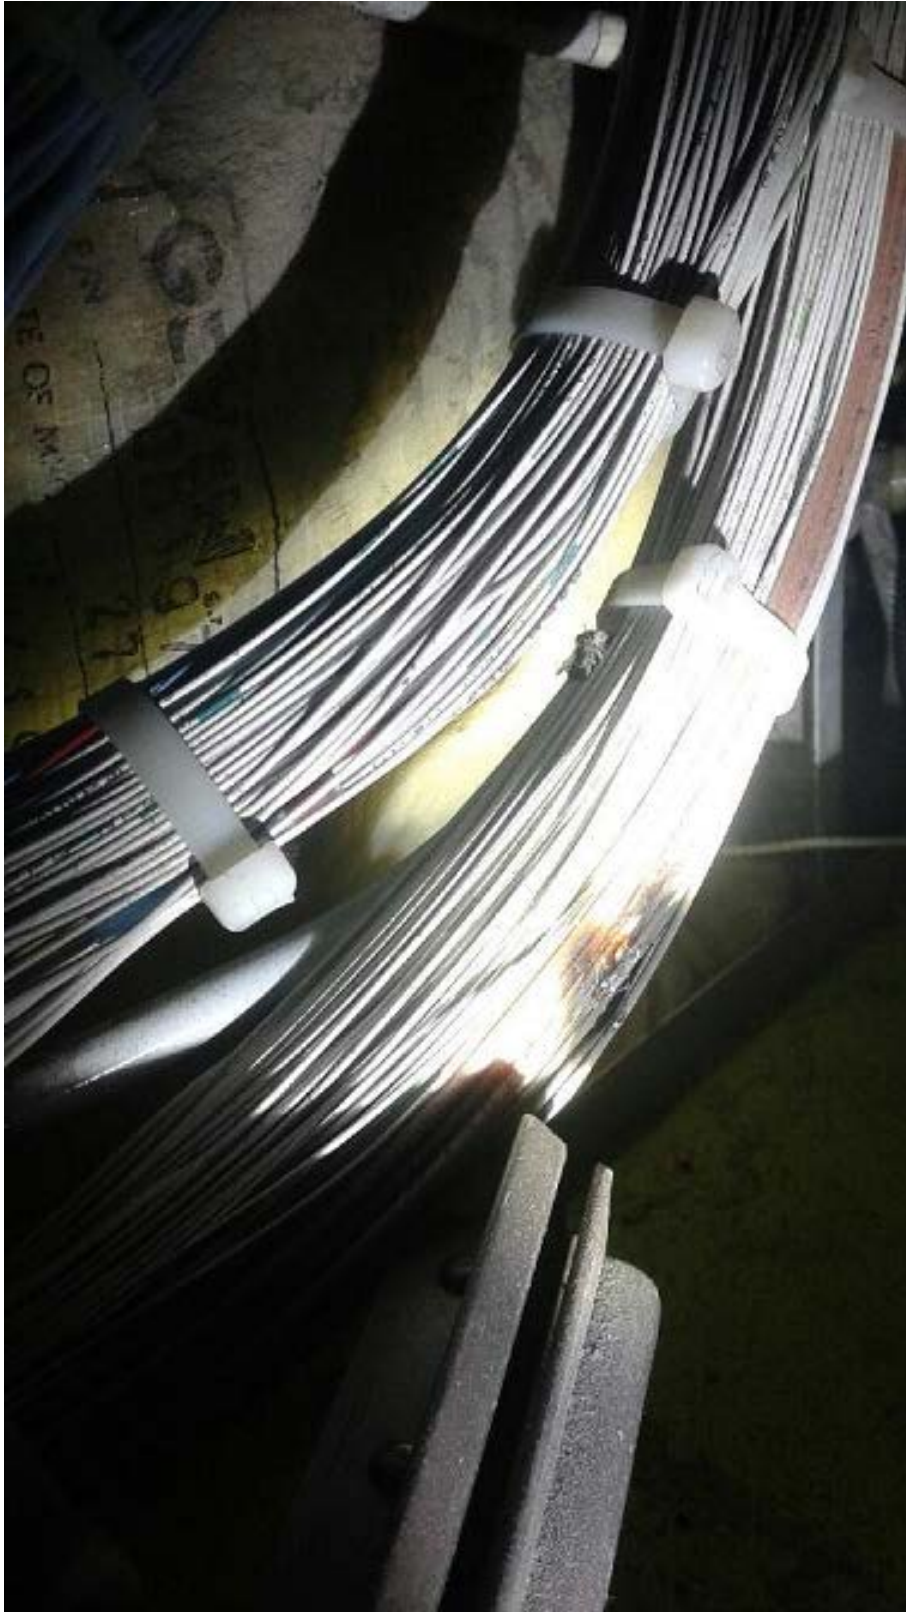
Arcing evidence on wires

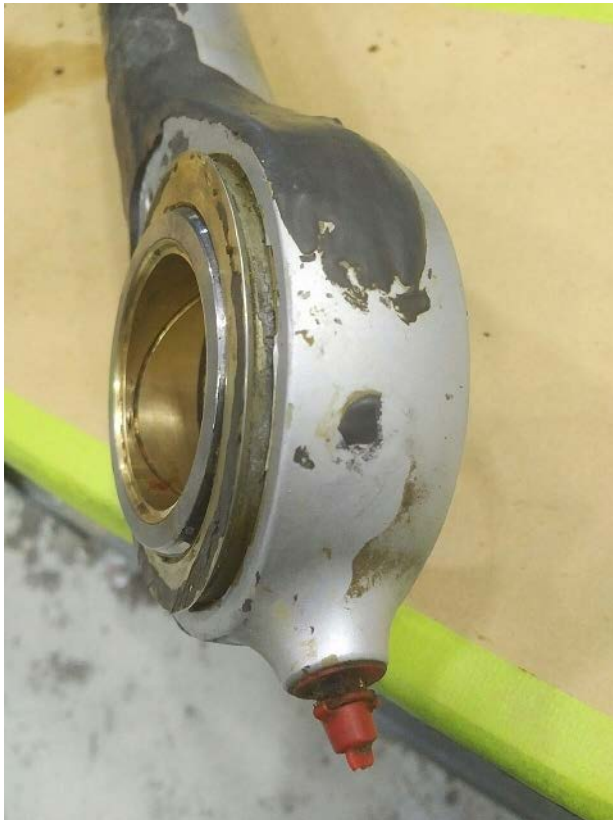
During a walk-around of the aircraft, the right-hand main landing gear (R/H MLG) side brace lower attach bearing brace was found to be migrating from the assembly bore. The R/H MLG side brace assembly was replaced and gear swings carried out in accordance with ATR42 AMM JIC 32-11-53 RAI 10000. No further faults.

Bearing seen migrating from housing

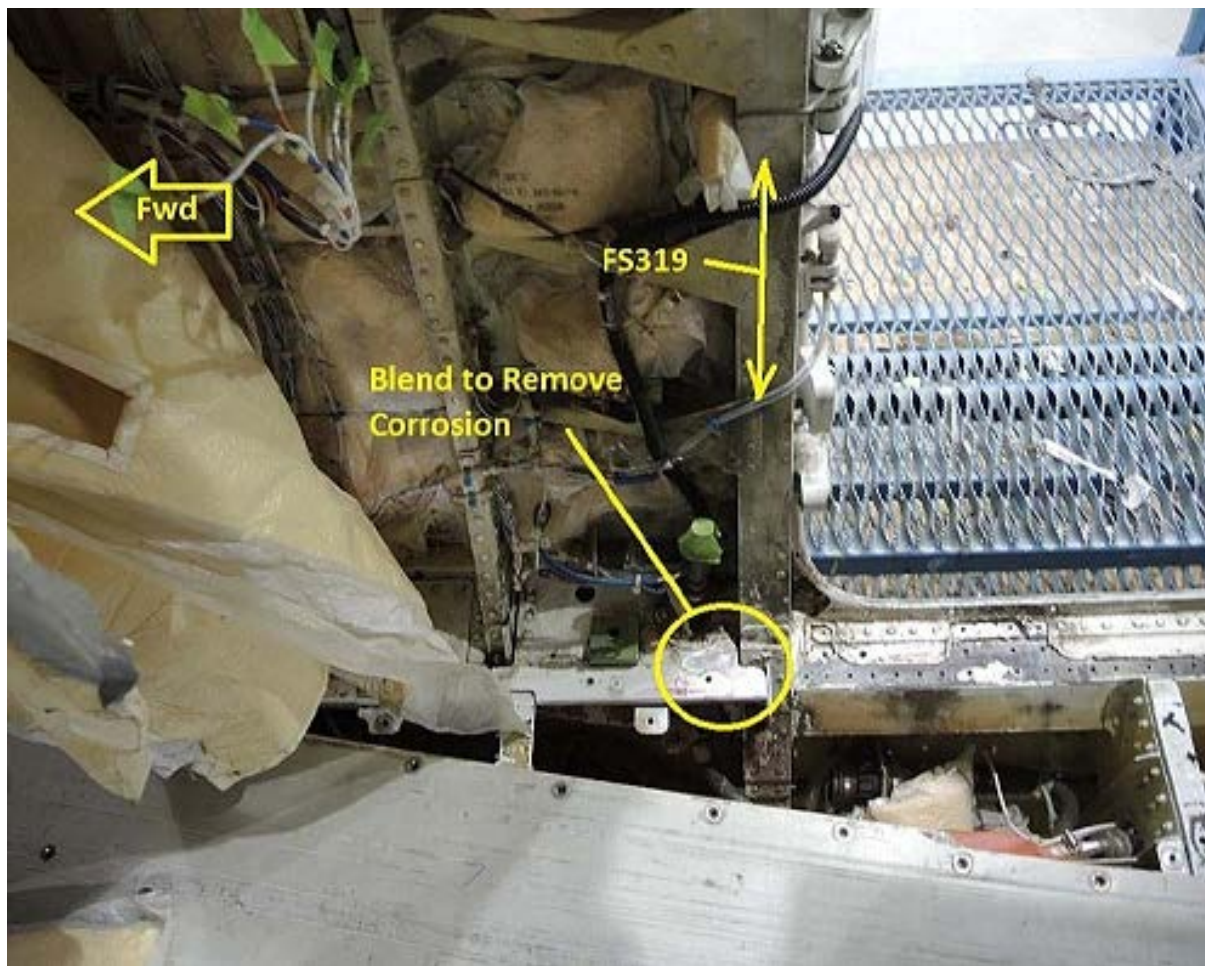
During a routine inspection, corrosion was found on the floor support sill between fuselage stations FS.317 and FS.319.7 at stringer 18R. The corrosion was deep enough to require blending.

There are currently 40 similar reported events of floor support structure corrosion dating back to 2005. The corrosion in many cases was so severe that it required replacement of the floor sill, stringers and other structures. Transport Canada recommends a more frequent inspection interval of this area to maintain the protective finish to prevent corrosion. The application of corrosion inhibiting compound may also provide added protection to prevent the corrosion damage from occurring.

Area of corrosion shown

Blend to remove Corrosion

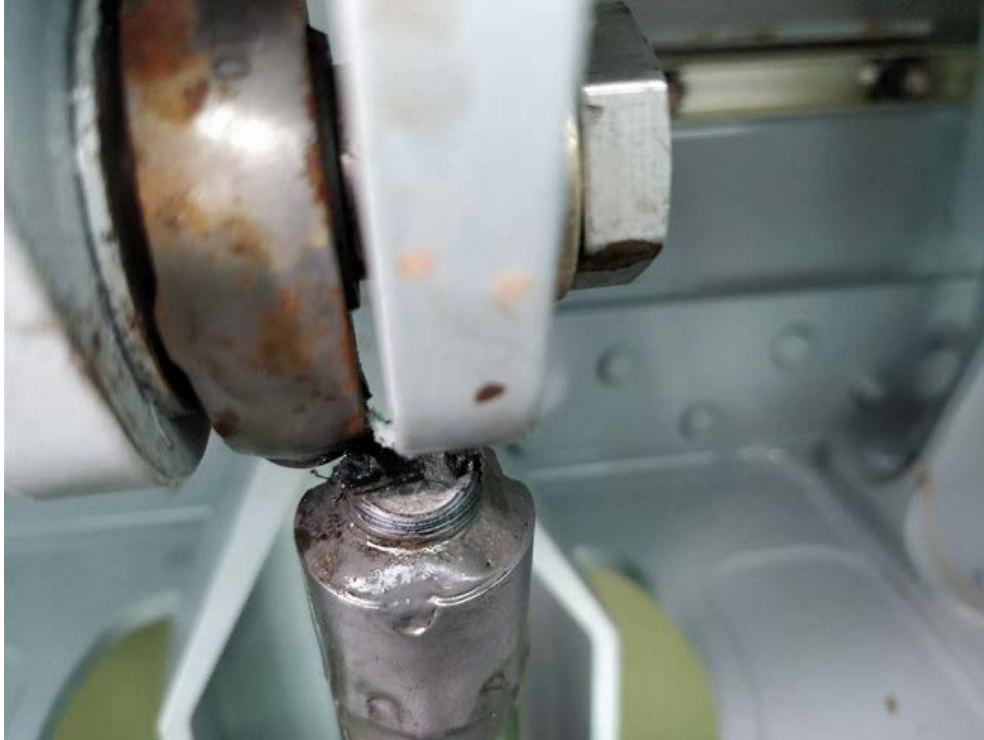
While performing the maintenance task for the operational test of the elevator power control units, the technicians found that the left elevator movement was abnormal when the test was performed with elevator PCU #1. When access was gained to inspect the elevator PCU, it was discovered that the PCU #1 rod end was sheared and the bearing was jammed. Evidence of light corrosion was also found on the rod end and this type of defect was not expected on such a low time aircraft. The aircraft had been operating briefly in a maritime environment with flights to the islands.

Sheared rod end with visible corrosion

To remove the PCU, both the rod end and attachment bolt had to be cut and additional damage was found on the elevator PCU fitting. Bombardier was contacted and the fitting damage was repaired following their repair instructions. The other (5) PCUs from the left and right elevators were inspected as per Service Bulletin 670BA-27-074 with no additional findings. The left elevator PCU#1 and all the associated hardware was replaced with new parts.

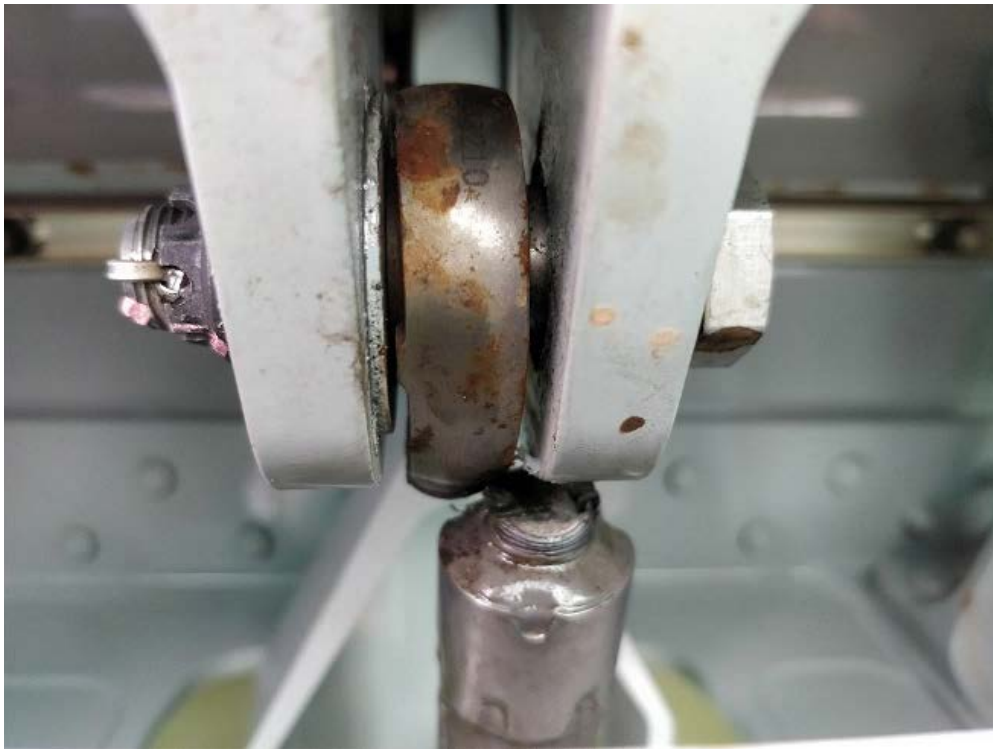
Sheared rod end with visible corrosion (2)

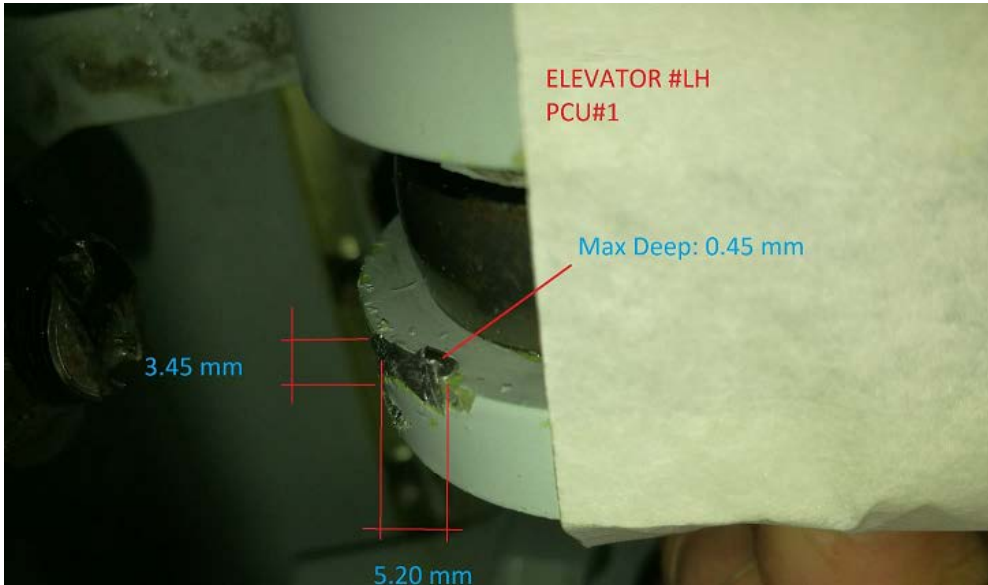
Damage to PCU fitting

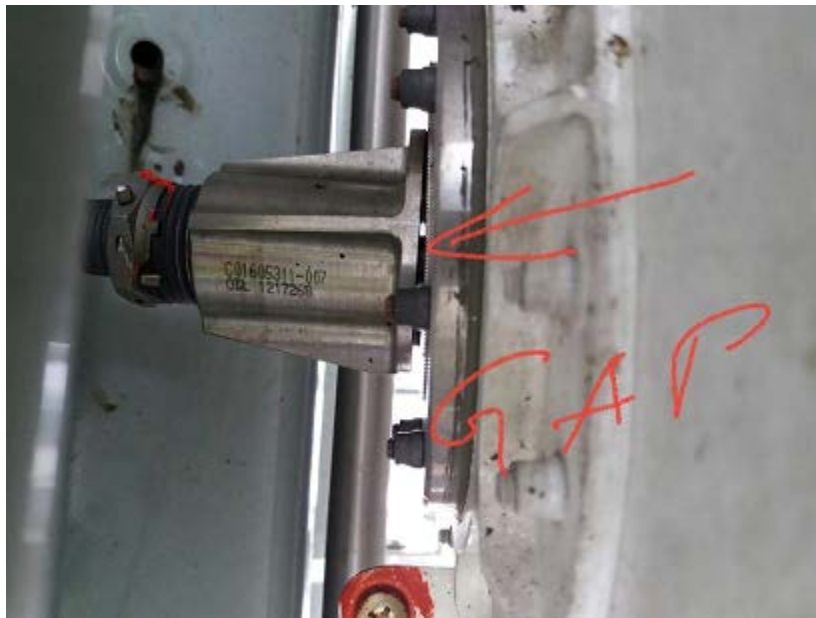
The right-hand (R/H) Main landing gear (MLG) door external fitting assembly part number (P/N): C01605015-N0007, was found loose, allowing the MLG middle door to migrate out of rig and contact the surrounding structure.

Loose main landing gear door fitting – notice gap

Some wear and delamination was found on the MLG door where it had contacted the other structure. The manufacturer was contacted and the damaged area was repaired.

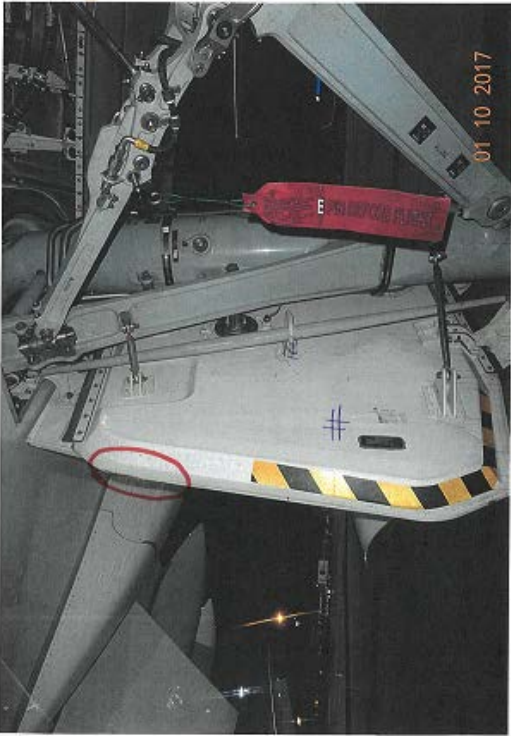
R/H main gear door wear area - Gear door wear – front view

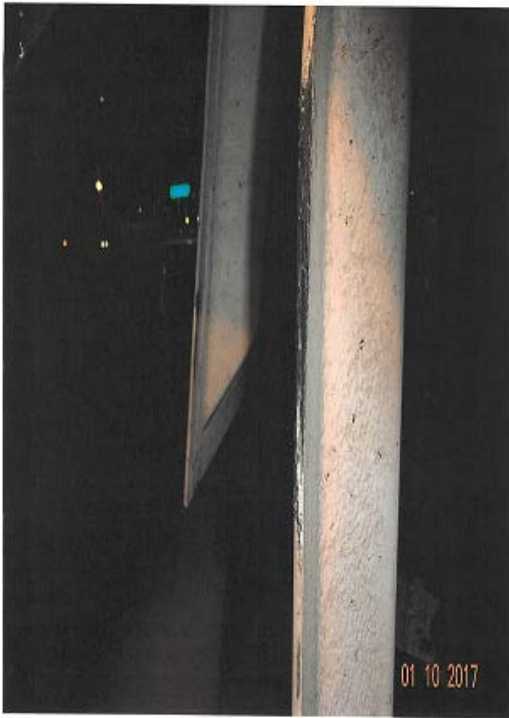
R/H main gear door wear area - Gear door wear – side view

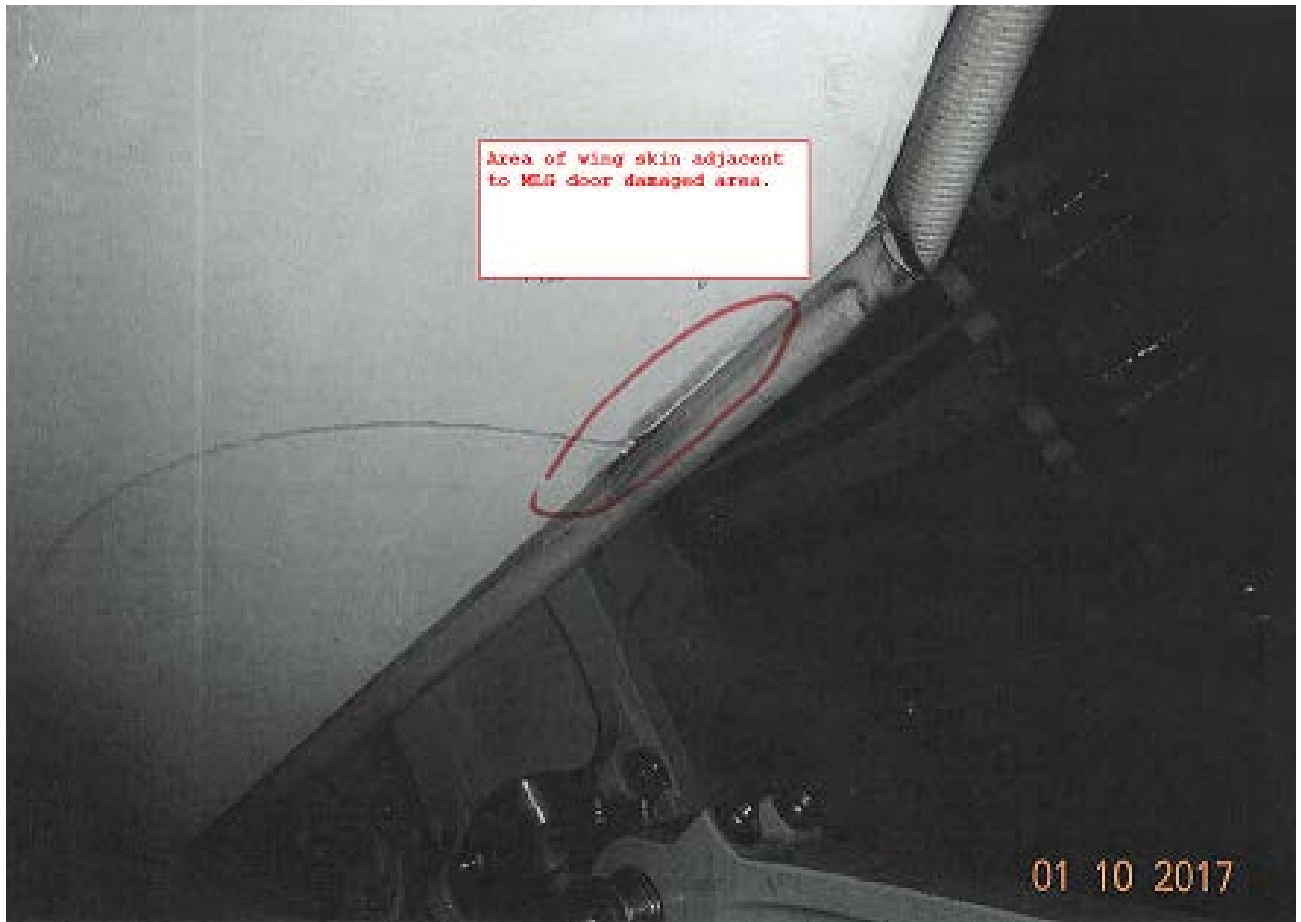
Area of wing skin adjacent to MLG door damaged area

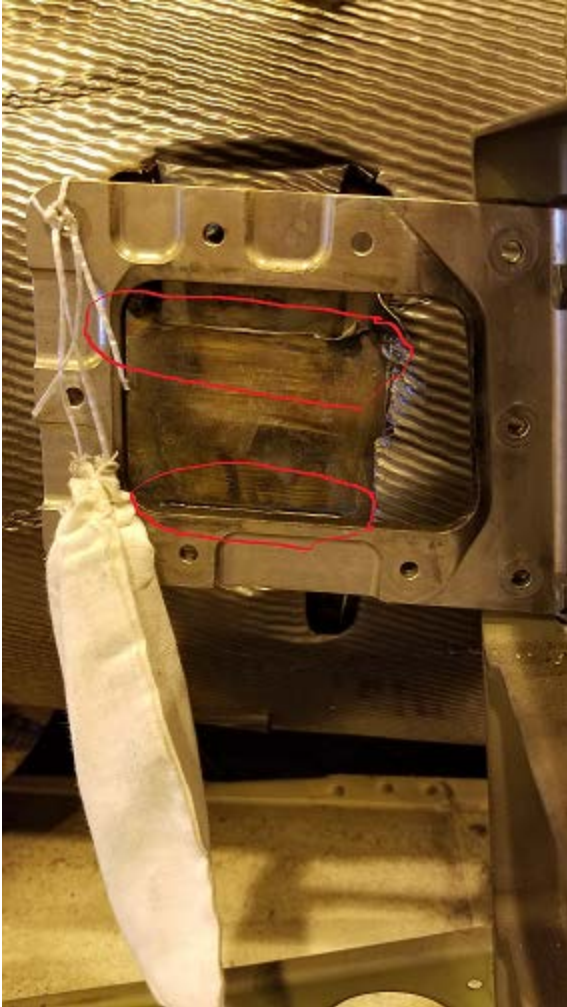
During general visual inspection task DH4-000-05-410-302 of the left-hand nacelle, maintenance discovered that both trunnion mounts of the aft jet pipe assembly had broken off. Upon further investigation, both of the right-hand aft jet pipe assemblies trunnion mounts were also found broken.

Once one of the mounts breaks off, the tailpipe is allowed to vibrate and can cause the other mounts to break off. Timely discovery of the damage is essential to limit the amount of damage.

Mount broken off the tailpipe

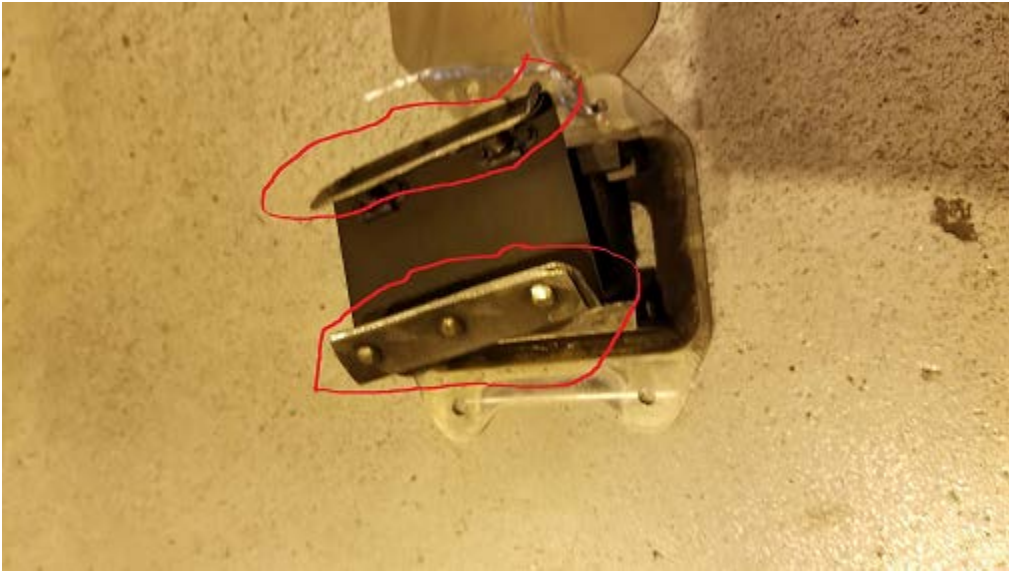
Broken mount

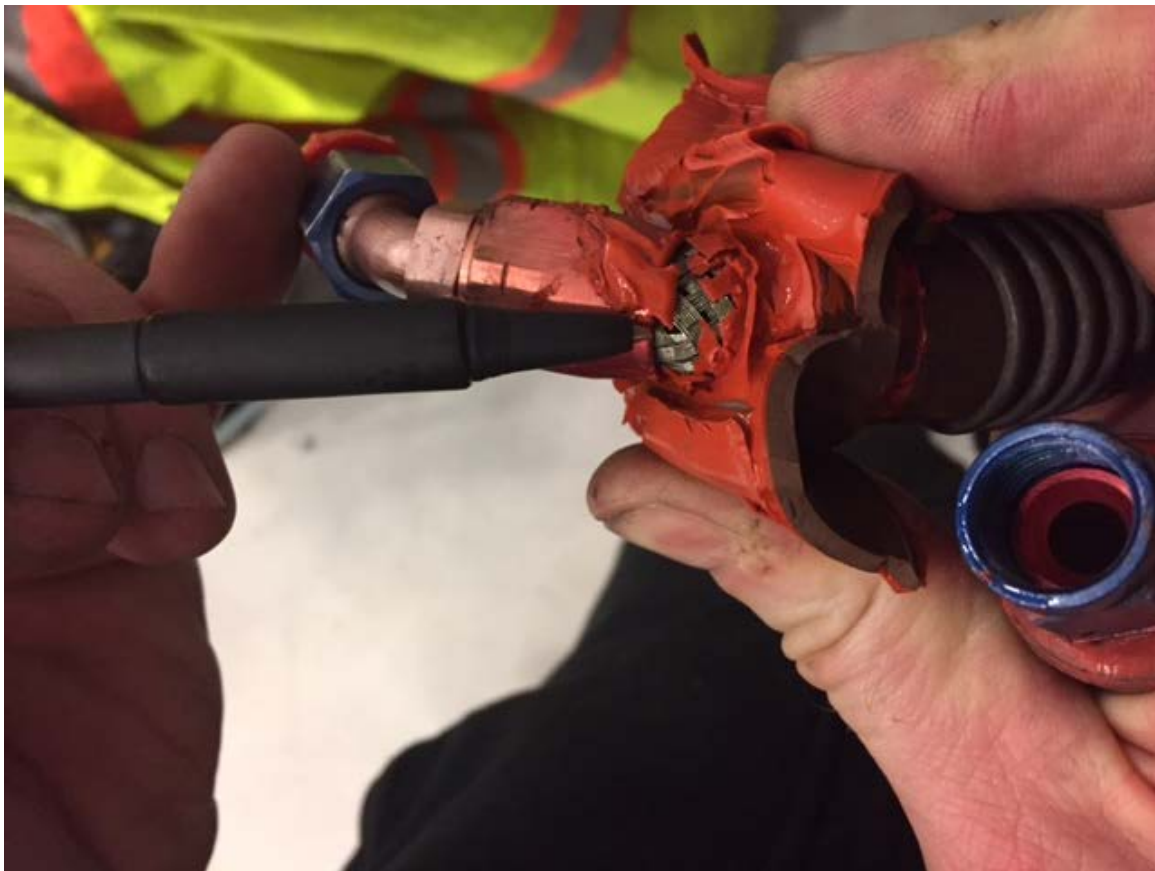
The L/H engine fuel motive flow line from the firewall to the Fuel Control Unit was found to be leaking

Leak in a braided fuel line

Most of the time, it's impossible to detect if fluid lines are deteriorating. These fuel lines are on-condition, however, they should still be carefully inspected during inspections.
