**INSPECTION – ENGINE MOUNT CHAFING**

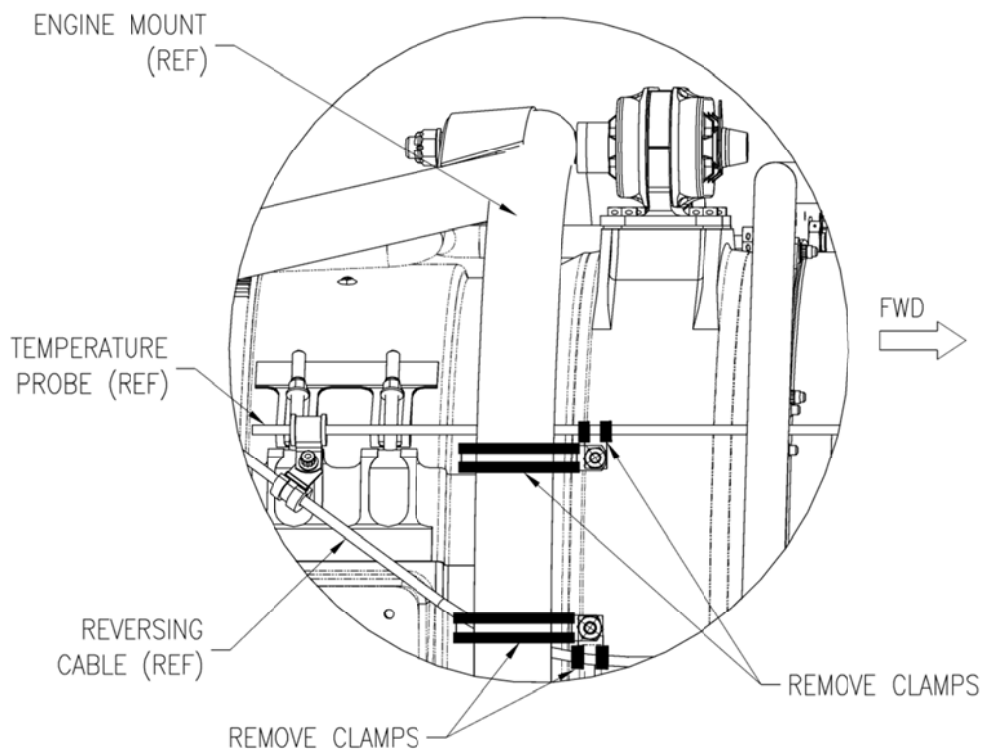
**FIGURE 1 VIEW ON R.H.S OF ENGINE SHOWING REMOVAL OF CLAMPS (IF APPLICABLE)**

- 3) If Issue 1 of this Service Bulletin has not been carried out, inspect the Engine Mount on R.H.S. (See Figure 1).
  - a) If chafing or any damage is present on Engine Mount, Temperature Probe or Reversing Cable, contact PAL for further information.
  - b) If no chafing / damage is present, continue on Step 4).
- 4) Remove the P clip attaching the Temperature Probe to the Reversing cable (See Figure 2).
- 5) Route the Temperature Probe and Reversing Cable to achieve a nominal clearance of at least 1/8" with the Engine Mount Tube with no load applied to the Temperature Probe.
- 6) Reinstall the P clip ensuring that there is no bending pressure applied to the Temperature Probe. The spacer may be relocated or the P clip reversed to suit the no-load Temperature Probe location.

- 1) Remove the Upper Engine Cowl to get access to the Engine Mount inspection area (refer to 750XL Maintenance Manual, Chapter 71).
- 2) If Issue 1 of this Service Bulletin has already been carried out, or if Support Clamps have been fitted at the time of manufacture, proceed as follows:
  - a) **REMOVE** the Support Clamps attaching the Temperature Probe and Reversing Cable to the Engine Mount Tube (refer to Figure 1 below).
  - b) Inspect the Temperature Probe and Reversing Cable for cracking, with particular attention to the attachment of the Temperature Probe to the Fireseal Flange.
  - c) If the Temperature Probe or Reversing Cable Tube is cracked or broken, contact PAL for further information.
  - d) Install anti-chaffing Blade Tape on the Engine Mount Frame (go to Step 4).

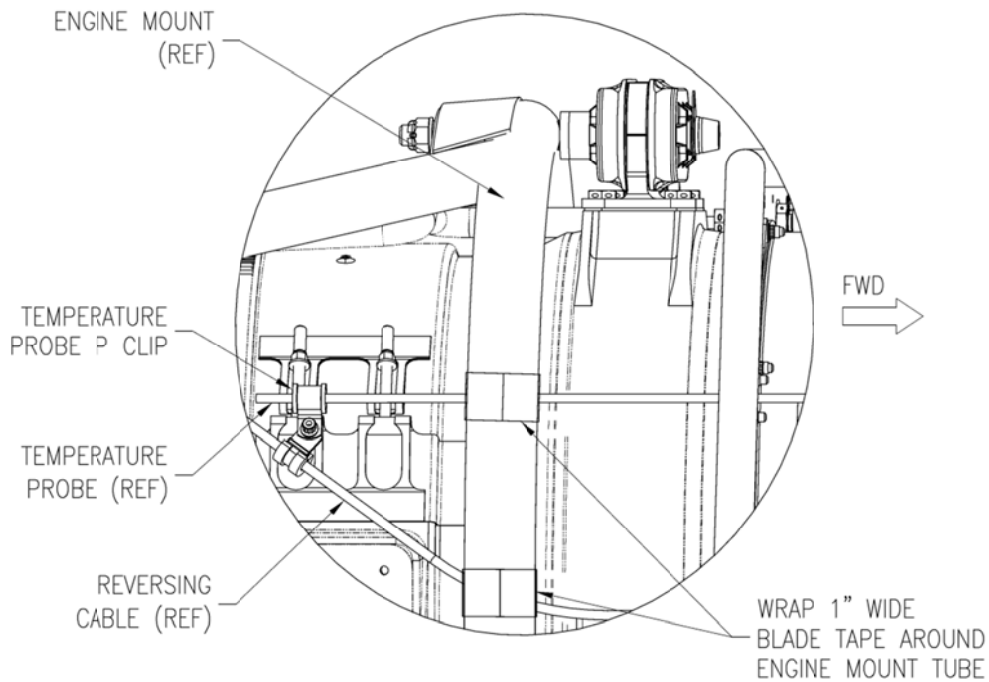
**FIGURE 2 VIEW ON R.H.S OF ENGINE SHOWING INSTALLATION OF BLADE TAPE**

- 7) Ensuring the surface is clean, install 1" wide (min) Blade Tape around the Engine Mount Tube adjacent to the Temperature Probe and Reversing Cable (See Figure 2).
- 8) Reinstall the Upper Engine Cowl (Refer to 750XL Maintenance Manual, Chapter 71).
