FUEL PICKUP ASSEMBLY – LEADING EDGE TANKS

| | | 750XL | 8001 and 8002 |
-
| B. | <u>REASON</u> | During a review of the installation of the wing leading edge tank fuel pickup assembly, it was found that this part may have been installed pre-stressing the Wing Spar Web and/or the Pickup Assembly Pipe. | |

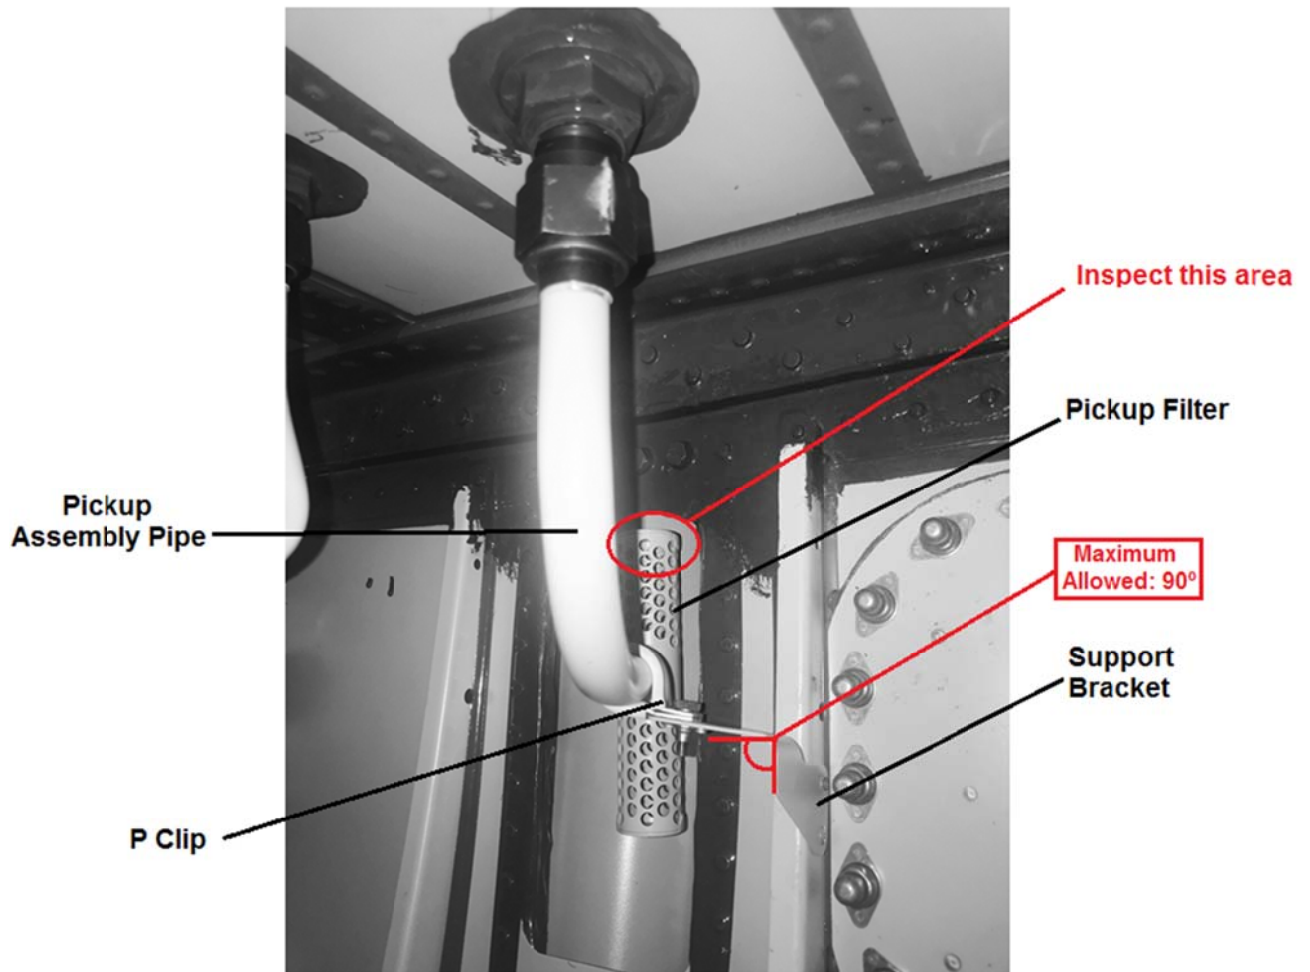
FIGURE 1 INSPECTION AREA – LH WING VIEW (RH WING VIEW IS OPPOSITE SIDE)

- If the angle of the Support Bracket is greater than 90°, this indicates that the flange of the bracket supporting the P Clip has been pulled aft and the Fuel Pickup assembly **is** likely under stress. Continue on Step 4).

- If the angle of the Support Bracket is 90°, this indicates that the Fuel Pickup assembly **is not** under stress, and then no further rectification action is required. Go to Step 10).

- 6) Loosen the screw attaching the P Clip to the Support Bracket and check (See Figure 1):
 - If the Pickup Assembly Pipe springs aft towards the wing spar (i.e. if the gap between the Pickup Filter and the edge of the Cutout is seen to decrease and there is a gap between the P Clip and the Support Bracket), then a corrective action will be required. Go to the Part B of this Service Bulletin.

- If no spring-back is observed and the P Clip can be reattached without stressing either the Pickup Assembly tube or the Attachment Bracket, then no further corrective action is required. Continue on Step 7).

- 1) Inspect the Wing Spar Web for cracking adjacent to the attachment of the Fuel Pickup Assembly.
 - If cracking is found, contact Pacific Aerospace Fleet Support to enquire about details for a repair scheme. No further flight is permitted until such cracking is repaired.

- 2) Inspect the clearance between the Pickup Filter and the Fuel Sump Cutout.
 - If the aft end of the Pickup Filter **is** touching the edge of the Fuel Sump Cutout, the Fuel Pickup Assembly installed must be replaced by the Fuel Pickup Assembly P/N 11-57031-1.
