# MANDATORY SERVICE

PACSB / XL / 117 ISSUE 2

## FLAP ASSEMBLY SCREW JACK P/N 11-45621-1 & 11-45622-1

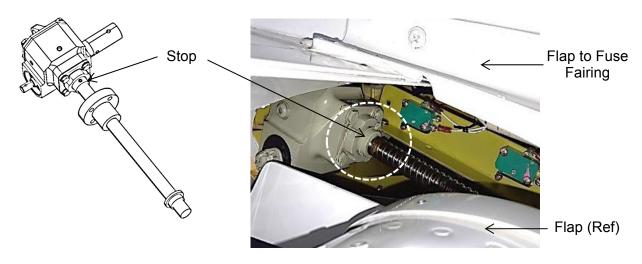
Figure 1 Correct Configuration

- <u>NOTE</u>: Visual inspection may be performed by suitably qualified AME/pilot with current licence and rated on type.
- A.1) Switch the battery power 'ON' and lower the flap to 40<sup>o</sup>.
- A.2) Carry out visual inspection of the Screw Jack Assembly on both sides to check the configuration (Ref Figure 1).
- A.3) If the Screw Jack Assembly is fitted with correct 'Stop' orientation as shown in Figure 1, no further actions are required.

- B.1) Remove the Screw Jack Assembly.
- B.2) Disassemble the Screw Jack. Refit the 'Stop' as shown in Figure 1.
- B.3) Reassemble the Screw Jack.
- B.4) Reinstall the Screw Jack Assembly.

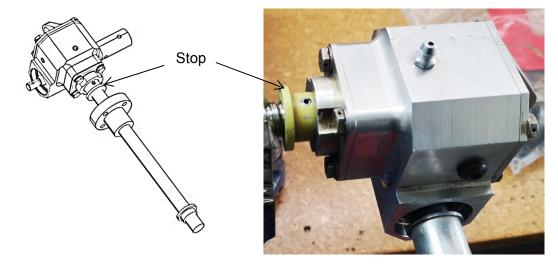
#### Figure 2 Incorrect Configuration

- A.4) Operator to record compliance in aircraft logbook.
- A.5) If the Screw Jack Assembly is fitted with incorrect configuration of the 'Stop' as shown in Figure 2, go to Part-B.
