**[Docket No. FAA-2020-0098; Product Identifier 2020-NM-011-AD; Amendment 39-19844; AD 2020-03-20]**

#### **Airworthiness Directives; The Boeing Company Airplanes**

**ACTION:** Final rule; request for comments.

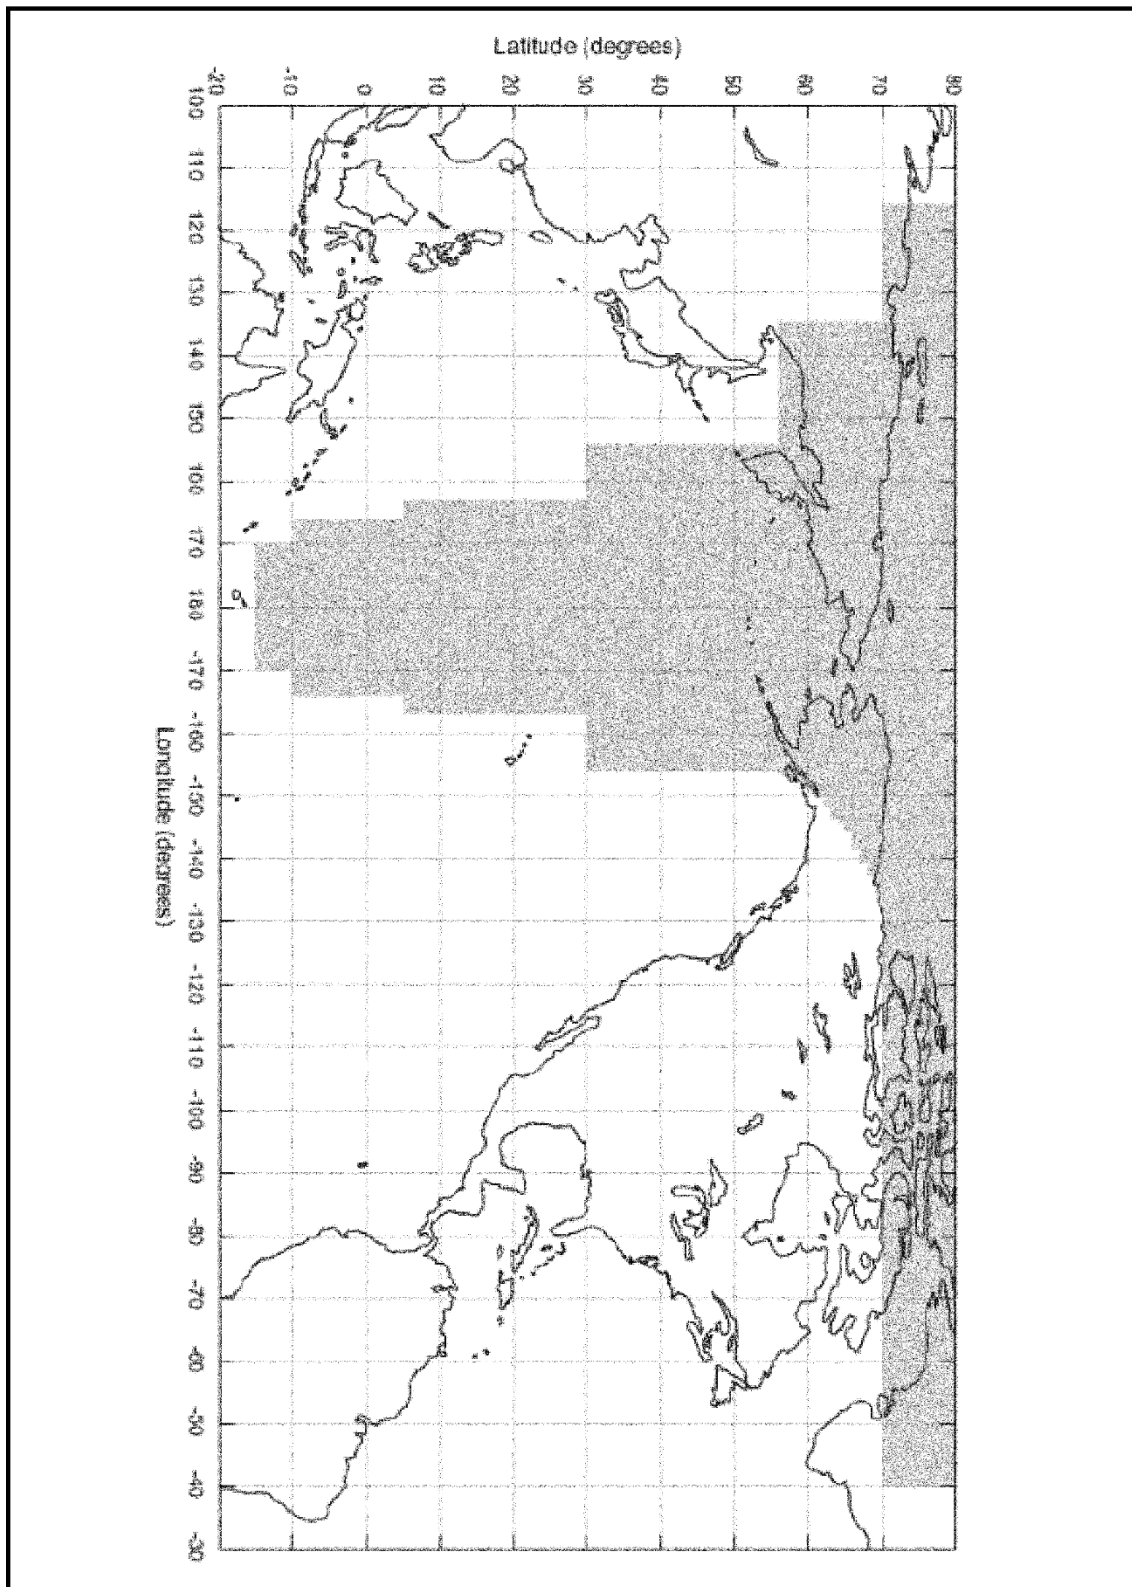
Figure 2 to paragraph (g) – AFM – Limitations or Certificate Limitations continued

Operations that require less than 0.3 RNP (For example, 0.1, 0.11, 0.15, etc.) in the region identified below are prohibited with GLU-2100 OPS software number COL4D-0087-0002, COL4E-0087-0001, COL48-0087-0700, or COL49-0087-0701 installed.

Region bounded by the following coordinates:
