Feedback

Canadian Aviation Service Difficulty Reports

The following content was published between April 2, 2020 and July 7, 2020. The full accessible version of each article is available on the Feedback [website](#).

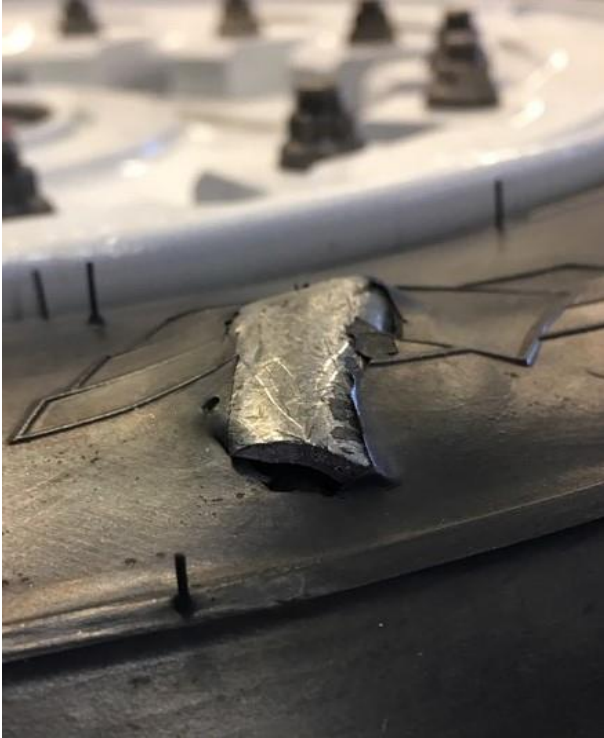
Following the installation of a new tire on the aircraft main wheel during the tire inflation and pressure test, the maintenance personnel noticed a piece of metal protruding from the tire sidewall. When the tire was installed and prior to inflation, the piece of metal was not visible. The tire was a new part received from a supplier who had received it from the original equipment manufacturer (OEM).

It appears that during manufacture of the tire, a piece of metal fell into the mold and was molded into the tire sidewall. The tire manufacturer's post-inspection requirements (Quality Control) did not detect the foreign object inside the tire sidewall. The defect was not discovered until the tire was inflated by maintenance personnel after installing the tire. The supplier and tire OEM were advised of this event by the operator and Transport Canada Continuing Airworthiness.

Fig 1: Metal showing after inflation close-up

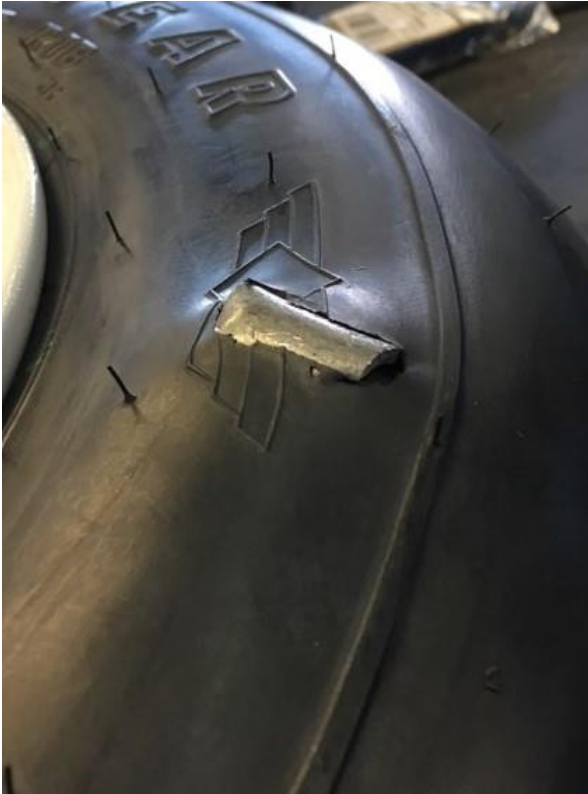
Fig 2: Metal Protruding

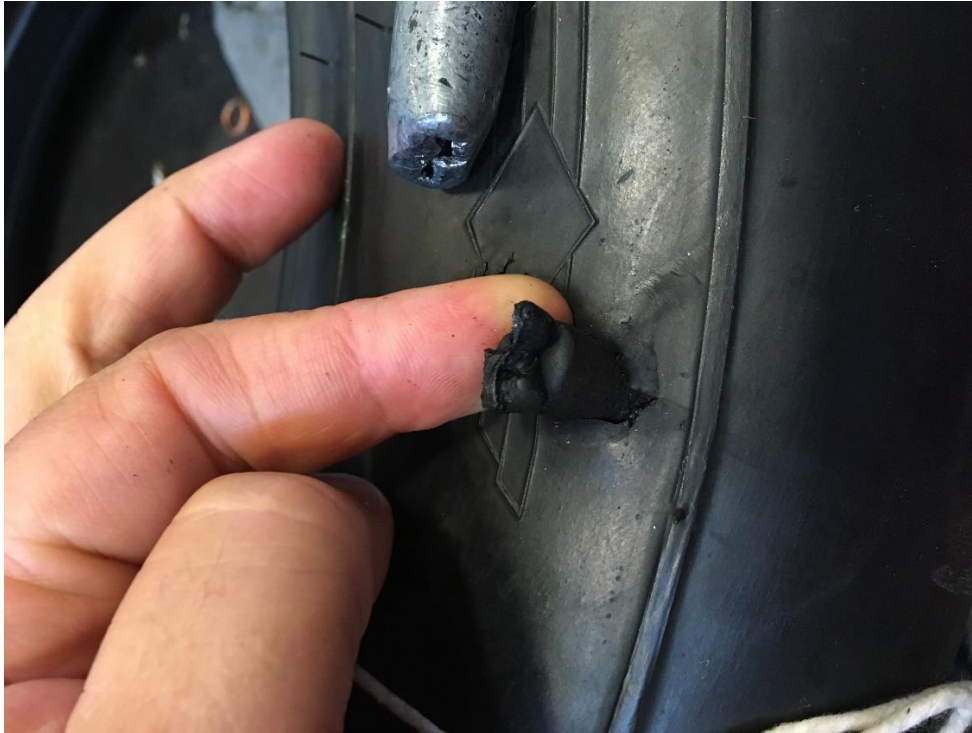
Fig 3: Indications metal was molded into tire

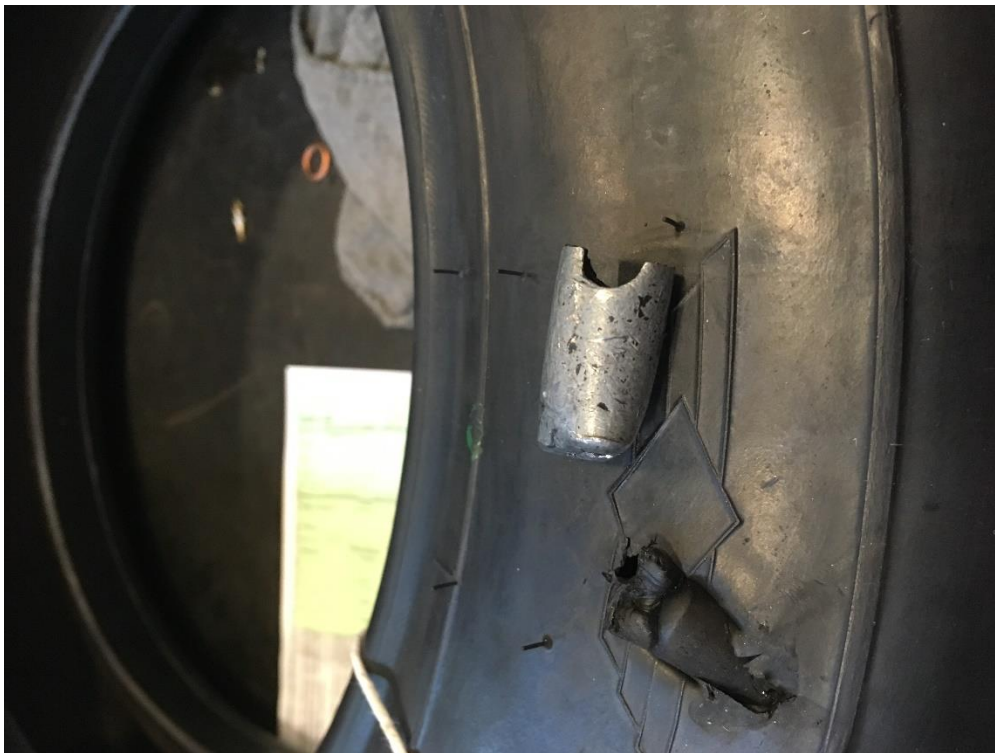
Fig 4: Metal removed

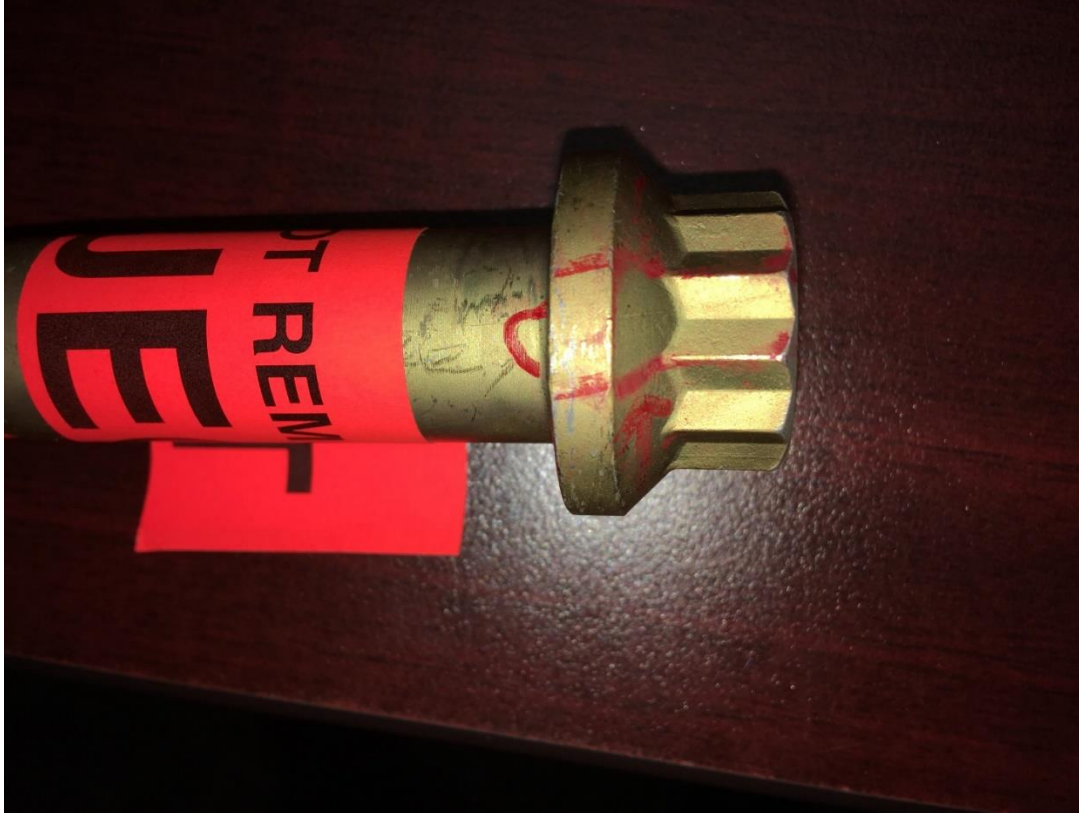
A batch of bolts (part number (P/N) MS21250-12032) was procured in a lot of 50 for use as wing attachment bolts on a Canadian military CC130H Hercules aircraft. Prior to installation, the Royal Canadian Air Force (RCAF) technical order requires that the bolts undergo magnetic particle testing. During the magnetic particle testing, one bolt was found to be cracked longitudinally in the bolt head.

A batch of bolts (P/N MS21250-14038) was procured in a lot of 26 for use as wing attachment bolts on Canadian military CC130H Hercules aircraft. Prior to installation, the RCAF technical order requires that the bolts undergo magnetic particle testing. During the magnetic particle testing, four bolts were found to be cracked longitudinally in the bolt head.

Figure 1. MS21250-12032 bolt showing area where crack was found

Due to the pre-installation testing requirements for these wing attachment bolts, the defective bolts were discovered and not installed on the aircraft. As these bolts were installed in a critical component, the operator/military had additional inspection requirements before installation. This occurrence shows the importance of good quality control practices when using standard aviation hardware which can be procured from many suppliers.

This was a military aircraft and a military required inspection process that could be easily adapted for use on civilian registered Hercules aircraft and provide additional safety. Additional inspection requirements like this are a good safety practice when standard hardware is used in critical areas.

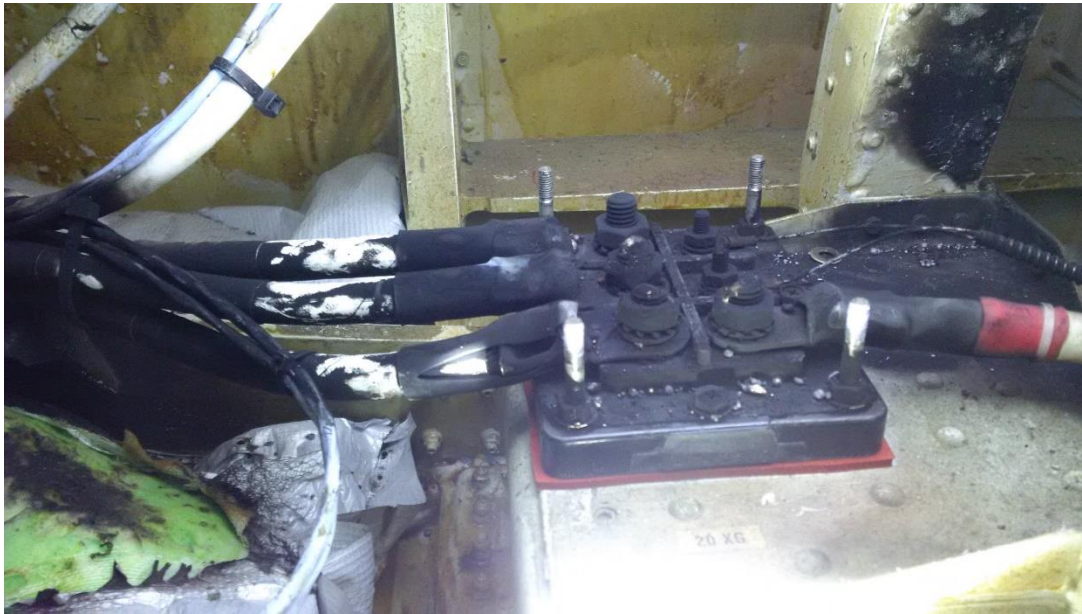
Evidence of fire was discovered in the forward avionics bay caused by the ground power unit receptacle. Sparks from loose feeder 20xg terminal B were arrested by the blanket insulation between frames 7 and 8, and self-extinguished. The remaining soot was cleaned and the area was inspected. The external power receptacle was replaced.

Pic 1: Evidence of fire. Soot present on wiring and structure.

The operator of this aircraft was fortunate that the fire had extinguished itself and had not caused more extensive damage to other components. The crew was also fortunate that an emergency landing was not conducted. To confirm wear and tear of the external power receptacle, Airbus recommends performing the GO-NOGO test, Aircraft Maintenance Manual (AMM) Task 24-41-00-220-801-A on an interval of 36 months/8000 Flight Cycles.

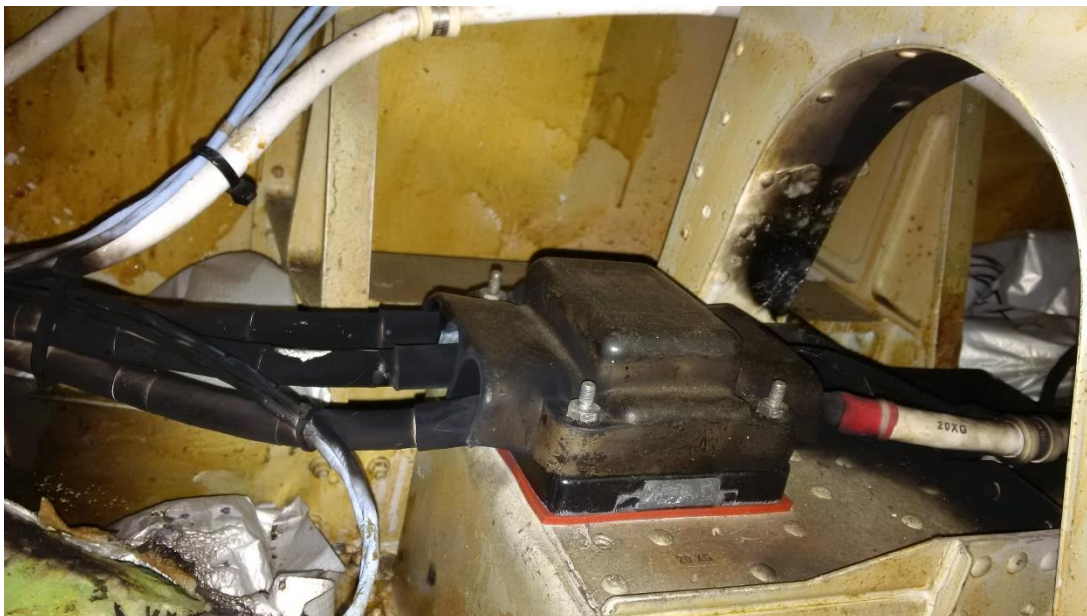
Pic 2: Shared receptacle cover.

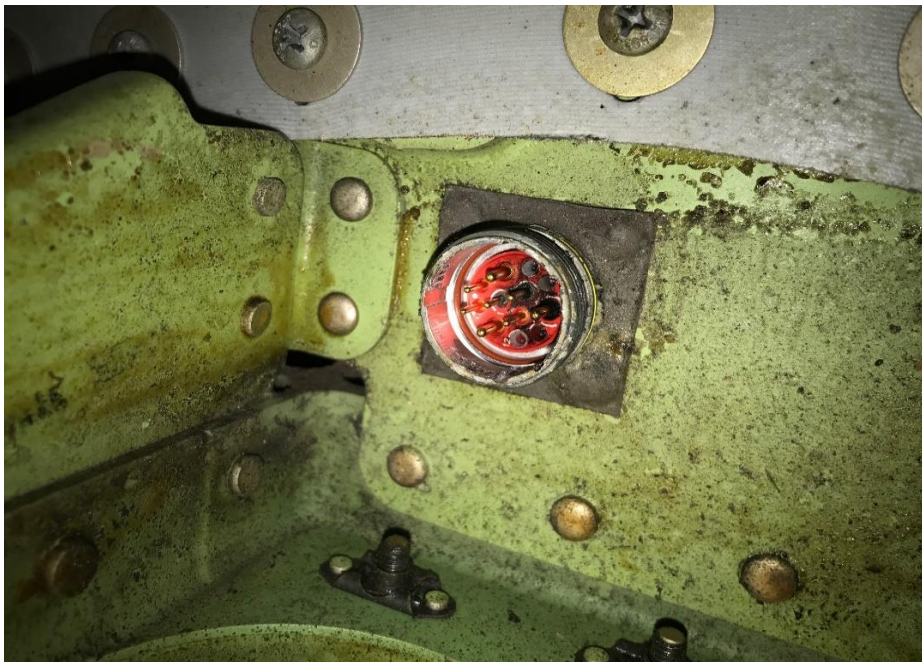
Intermittent Flight Data Recorder (FDR) light caused by burnt Logo Light connector and receptacle. Extensive troubleshooting found that the FDR fault only happens when the Logo Light is turned to on position. Horizontal stab connector D40190 was checked and found that the receptacle and the connector were toast.

Pic 1: Evidence of arcing and soot on the connector pins

The following parts were replaced and no further occurrences were reported:
Connector Part Number (P/N): BACC63BP14C12SN, receptacle P/N:
BACC63BV14F12PN.

As maintenance personnel, additional consideration must also be given to the operating environments that may cause early buildup of corrosion. Electrical connectors and receptacles often hide the defect until the unit arcs and creates a fault. Please follow your aircraft's corrosion prevention and control program for appropriate methods to avoid such a snag.

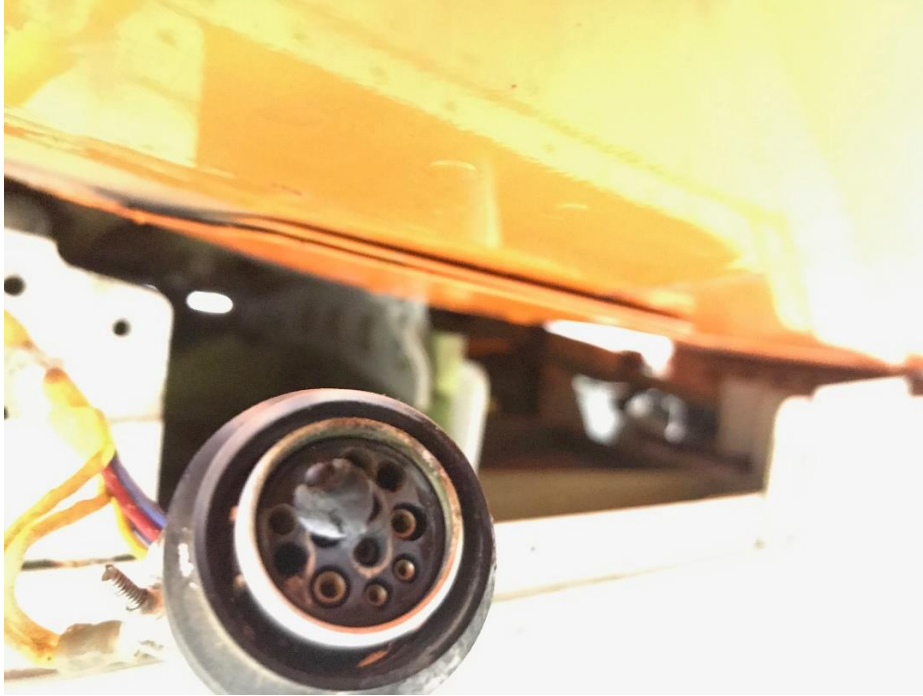
Pic 2: Melted receptacle

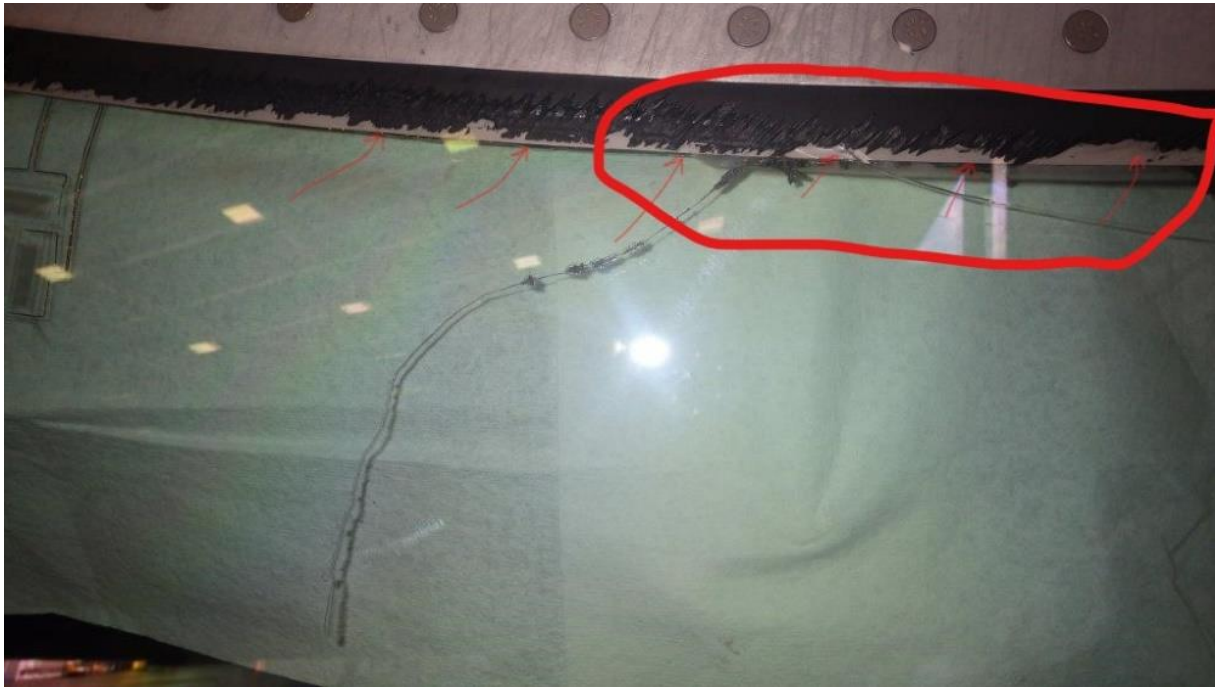
In many cases, cracking windshield events are caused by arcing of the heater elements or arcing at the terminal blocks. It has been found that water ingress has been the root

cause of many of these occurrences. As noted in the attached pictures, the foggy area near the terminal block denotes water ingress. The window sealant erosion is also evident and is likely that it did not keep the water out.

Figure 1. Window crack and red circle showing the foggy area of water ingress. Arrows show the worn away sealant that allowed the water to get in.

Maintaining the integrity of the window sealing should prolong the life of these cockpit windows by preventing ingress of moisture.

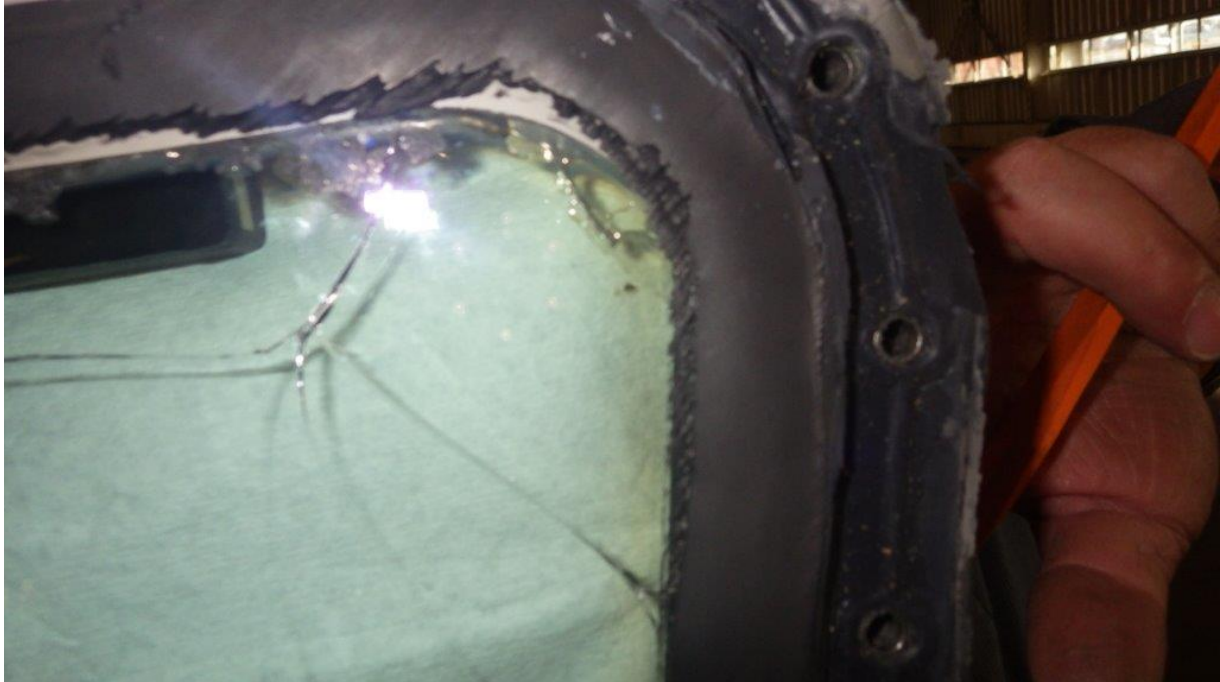
Figure 2. Cracking near terminal block and sealant eroded.

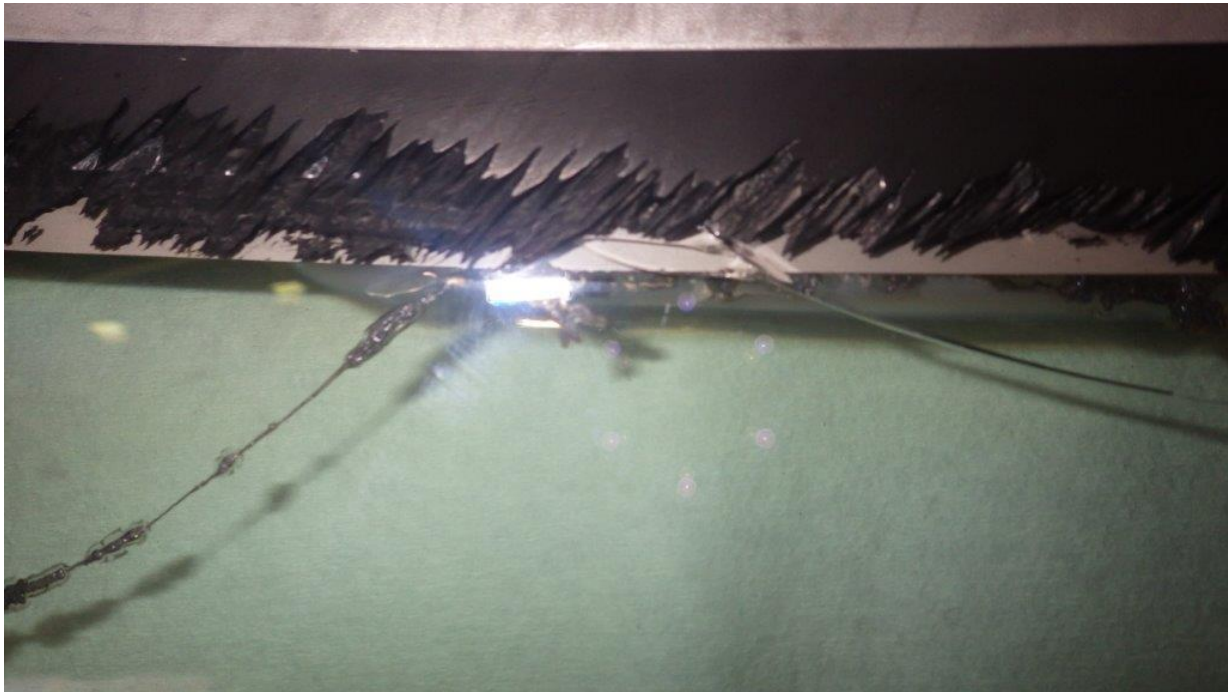
Figure 3. Close-up of foggy area and eroded sealant.

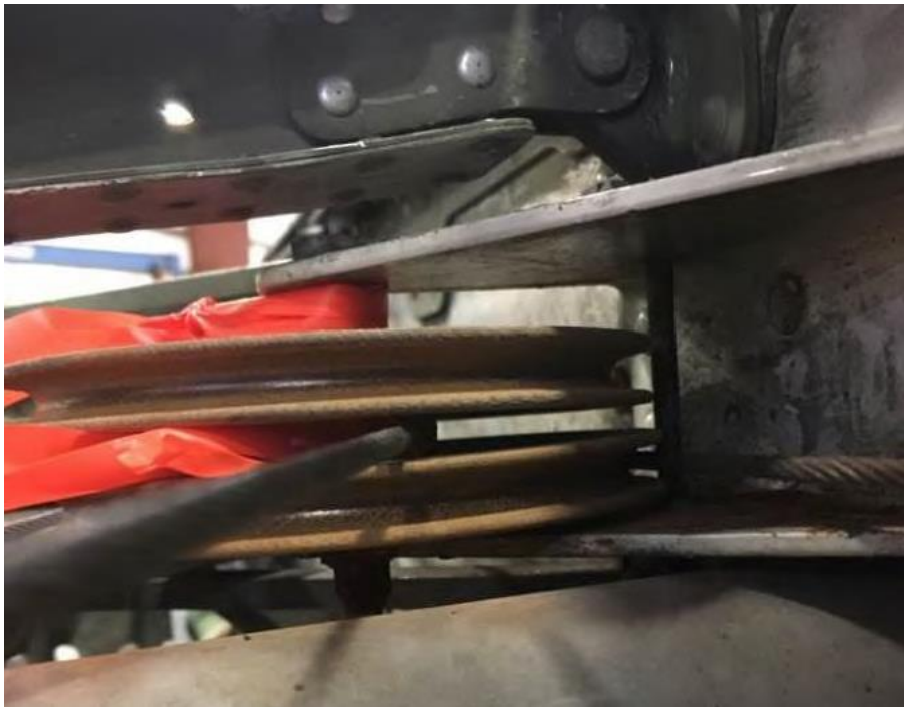
During heavy maintenance check, maintenance observed that the left-hand aileron cable circuit was off a pulley in the upper fuselage centre wing area and riding on the pulley retainer bolt. Further inspection showed that the bearing and centre body of the pulley had failed, allowing the pulley to tilt on the bolt, thus creating a loosening effect and allowing enough space for the cable to come off the pulley with the cable safety keeper still in place.

Aileron cable riding between two pulleys

A cable that has jumped of the pulley could cause the flight control to deflect from the neutral position and give the first indication that something is wrong. If the cable tension is low, inspect the whole control circuit and determine what is causing the cable tension to drop. It is very easy to miss that the cable has jumped off the pulley and it could cause a flight control jam in the most severe case.

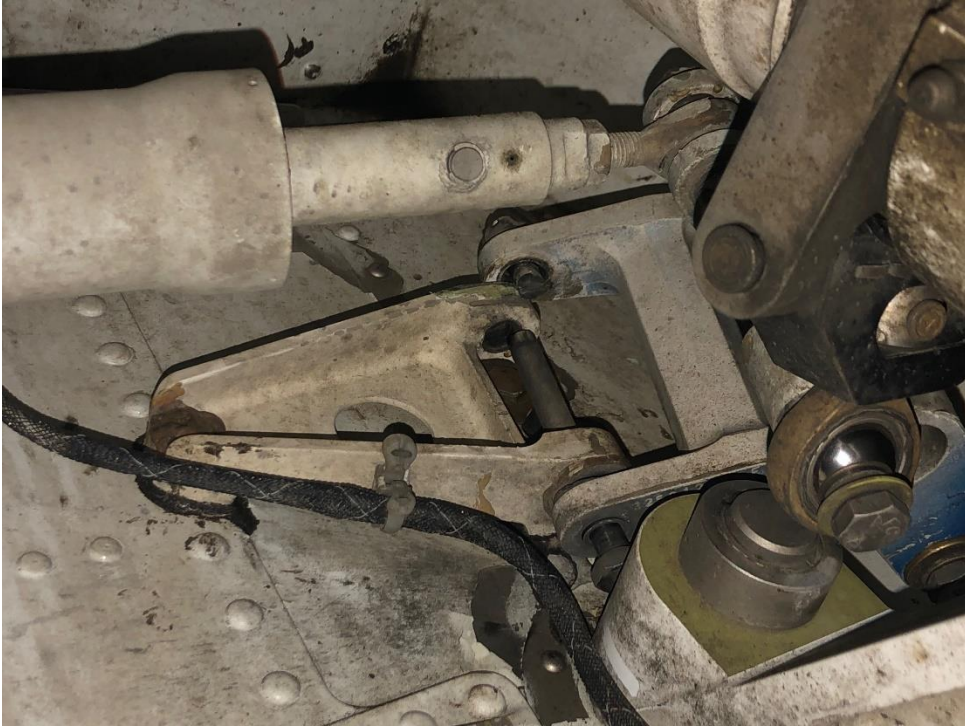
The crew shutdown and the aircraft was towed back to the hangar. Upon inspection, it was discovered that the steering bolt that attached the fork bearing to the fuselage mounting bracket had sheared off.

Pic 1: Sheared bolt in assembly

The steering bolt, fork bearing, bracket and attachment bracket were replaced and new hardware installed. Aircraft returned to service with no further faults found.

The crew of this aircraft was fortunate that the component bolt failed on the ground and not while in-flight. Pilatus has no lubrication schedule set for this bolt but has set a 600hr inspection interval for the steering components.

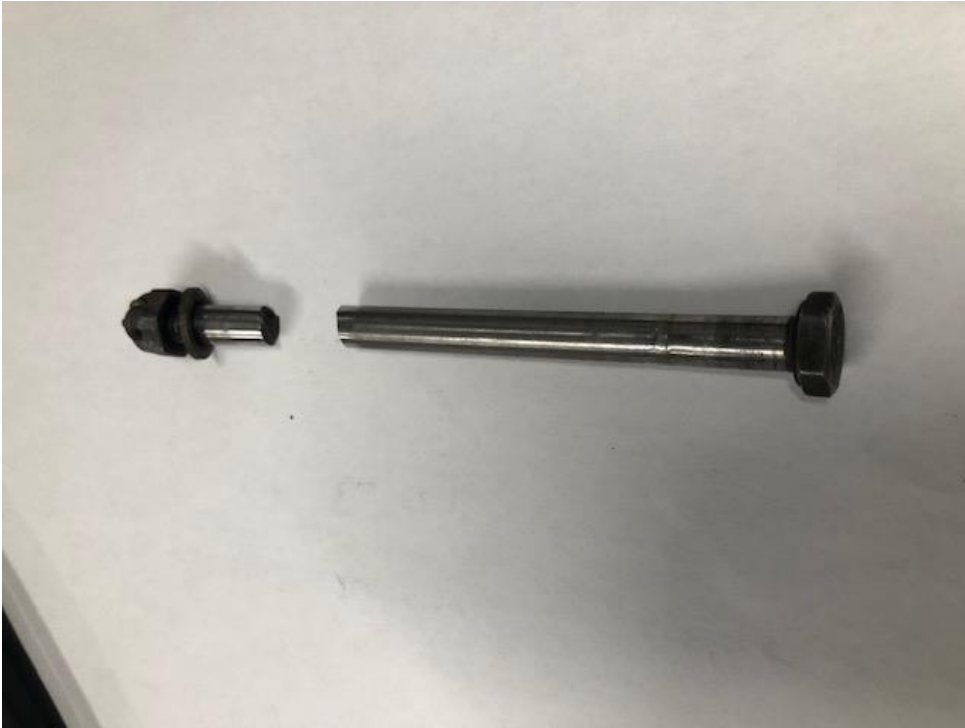
Pic 2: Sheared bolt

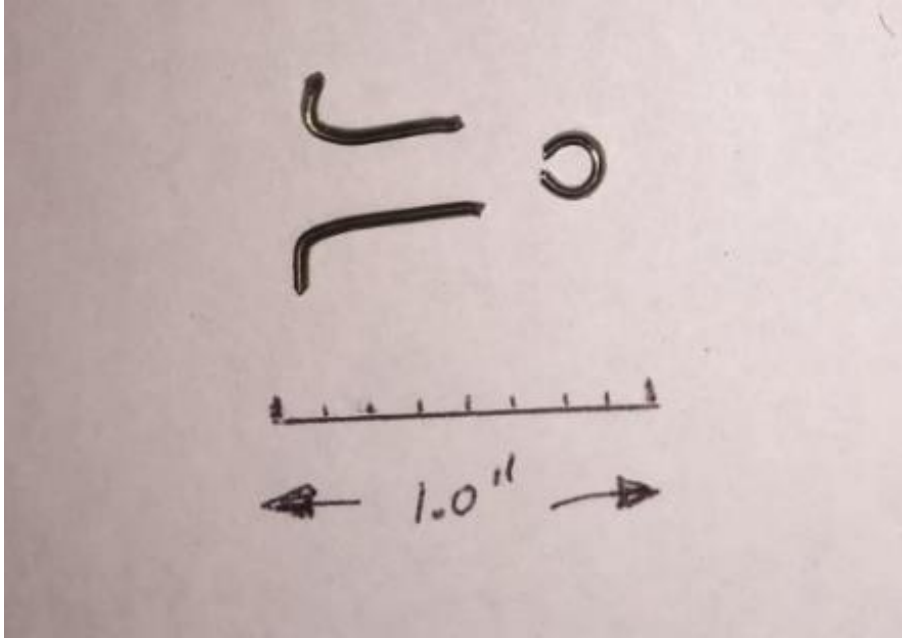
During routine maintenance, a piece of metal was found in the left-hand (L/H) engine oil sump screen. Further investigation found that the cotter pin installed into the #4 cylinder connecting rod bolt had broken. The head of the cotter pin was the piece of metal found in the oil sump screen and the remainder of the cotter pin was found still installed in the bolt/nut. The cotter pin's remnants were removed, and the torque of the nut was checked and found to be within the specified range. Had the connecting rod bolt/nut loosened, the results could have led to failure of the engine.

Cotter pin remnants

Although the sump screen performed as intended and prevented metal from entering the oil system, it may have been much worse had the nut backed off the connecting rod. Maintainers must be thorough when performing maintenance and adhere to Canadian Aviation Regulations (CARs), Instructions for Continued Airworthiness (ICAs) or standard industry practices (AC43-13-1B) as applicable. The cause of this cotter pin's failure was not identified, however repetitive use, improper size or incorrect installation procedures are known contributing factors to broken cotter pins. Never reuse cotter pins and ensure you have the proper size for the application by verifying the correct part number from the Illustrated Parts Catalog (IPC).

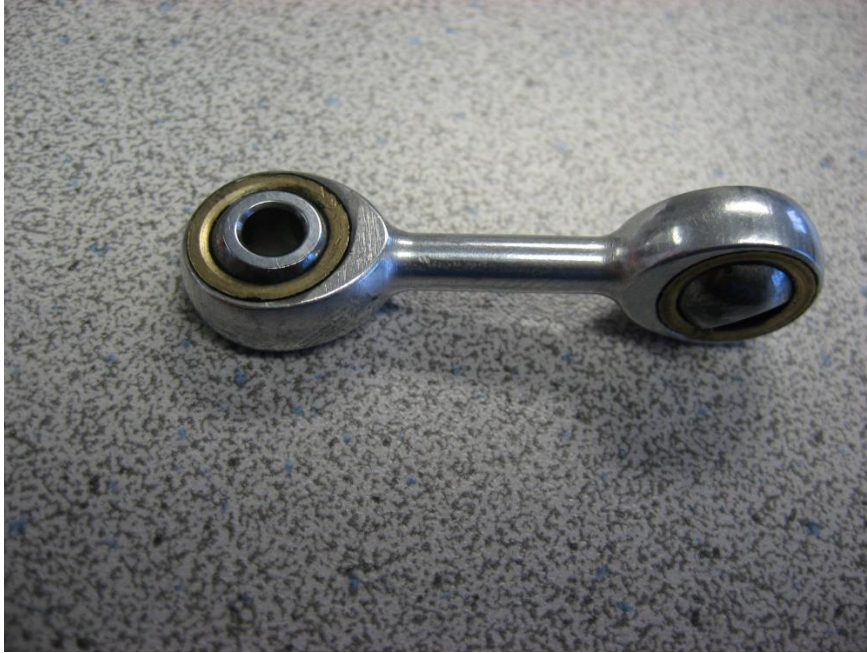
During run up, it was noted that the idle was high (around 70% belts engaged). Upon inspection, it was found that the bearing had come out of the part number (P/N) B564-2 link at the servo end.

Figure 1: Pre R44 SB-71 throttle link P/N B564-2 having aluminum-bronze bearing races.

R44 Service Bulletin (SB)-62 identifies a failed throttle link where the bearing separated from the housing. Compliance with this SB involves the installation of a large-diameter washer to prevent loss of control if a bearing fails. The incorporation of the large-diameter washer is also published in the Robinson Illustrated Parts Catalog throttle control installation.

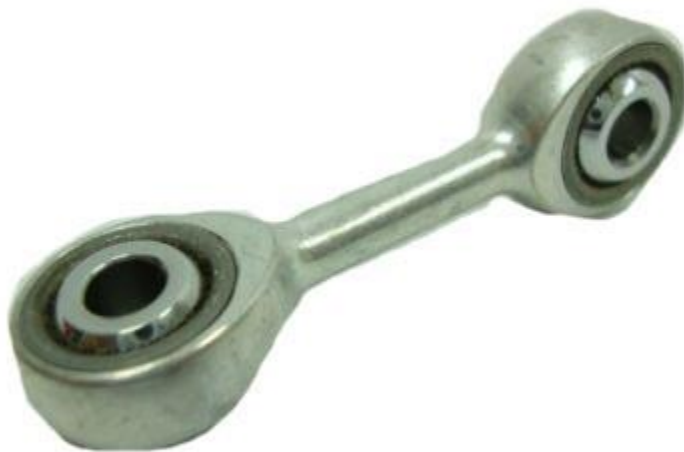
Figure 2: Post R44 SB-71 throttle link P/N B564-2 having Teflon™-lined steel bearing races.

R44 SB-71 introduces a throttle link with a Teflon™-lined steel bearing race designed to prevent race separation from the link body. This SB requires replacing the earlier links having aluminum-bronze races while retaining the large-diameter safety washer requirement.
