Canadian Aviation Service Difficulty Reports

The following content was published between August 14, 2019 and December 31, 2019

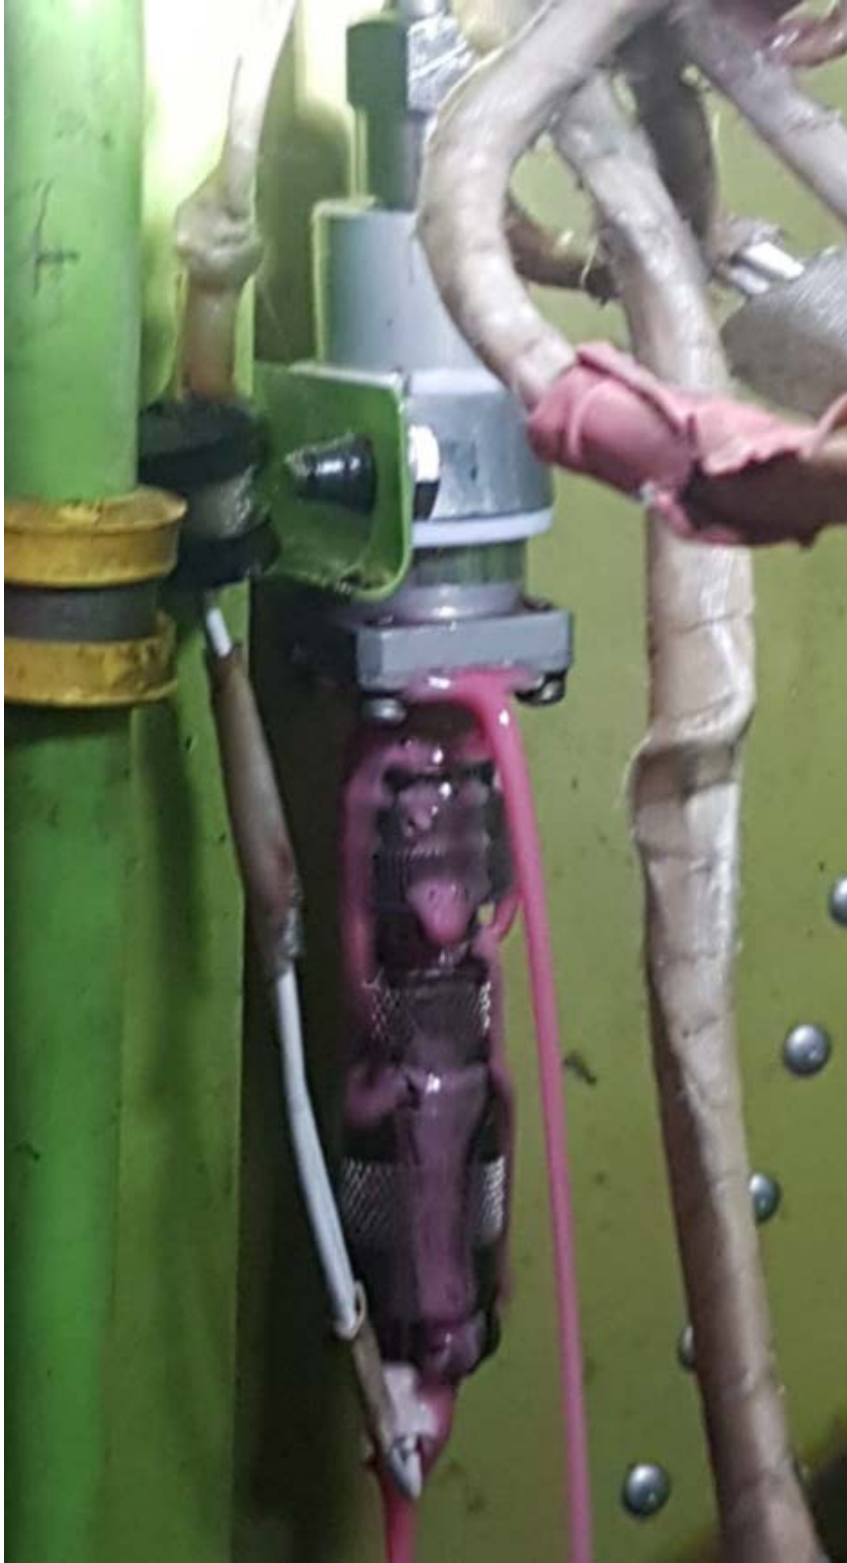
Hydraulic pressure had dropped to 100-150 Pounds per Square Inch (PSI) with the Left-Hand (LH) pump flashing amber on the hydraulic synoptic page. The crew declared an Emergency and returned to the airport for an uneventful landing. Maintenance found the LH main low pressure switch S9 connector body to have bulged and failed, causing a large leak and subsequent loss of fluid.

Pic#1 – Low pressure switch S9 leak

(SB) 45-29-17 was issued in 2010 and is currently at revision 2. The SB subject matter recommends replacing low pressure switches in the main, auxiliary and spoiler systems. Transport Canada Civil Aviation (TCCA) recommends that operators follow the manufacturer's recommended Service Bulletins.

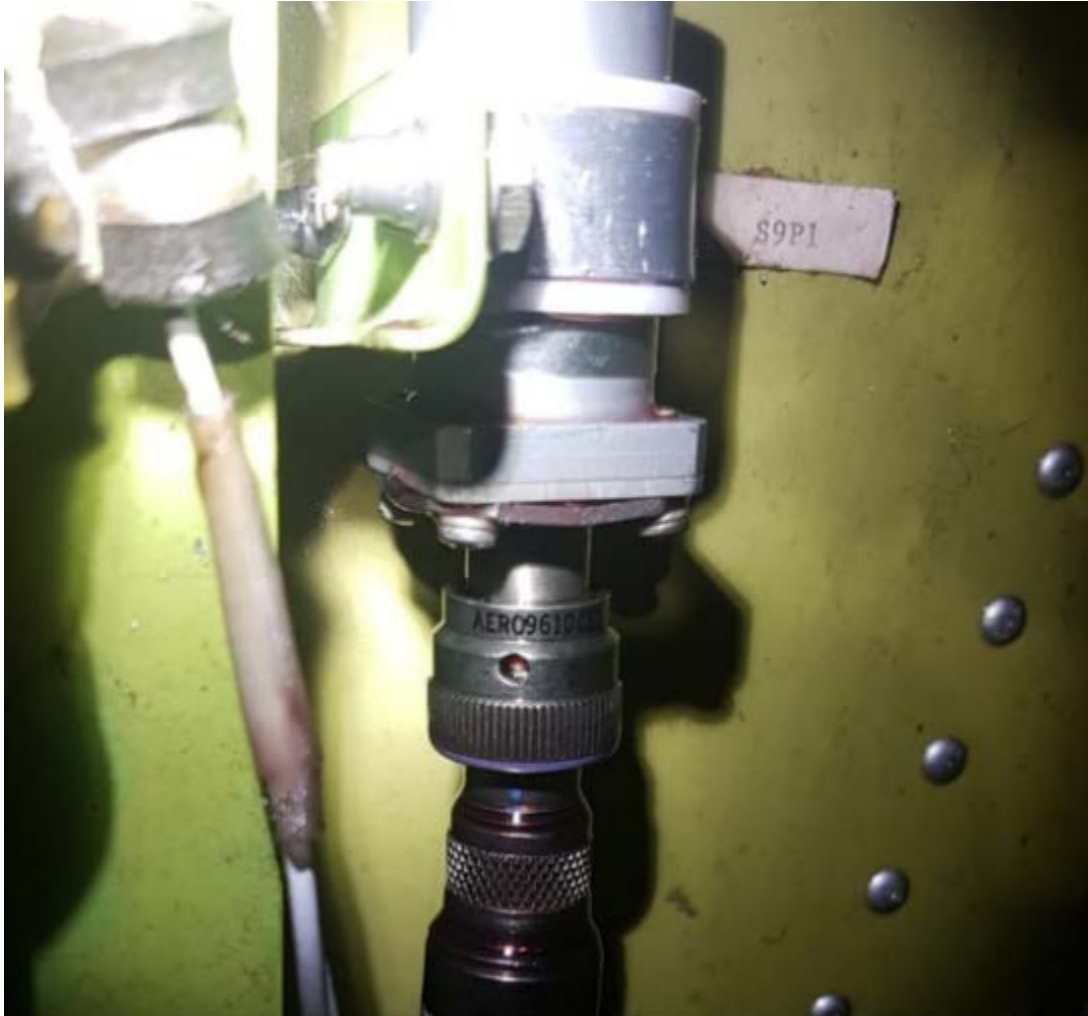
Pic# 2 - Bulge in connector body and subsequent protruding O-ring

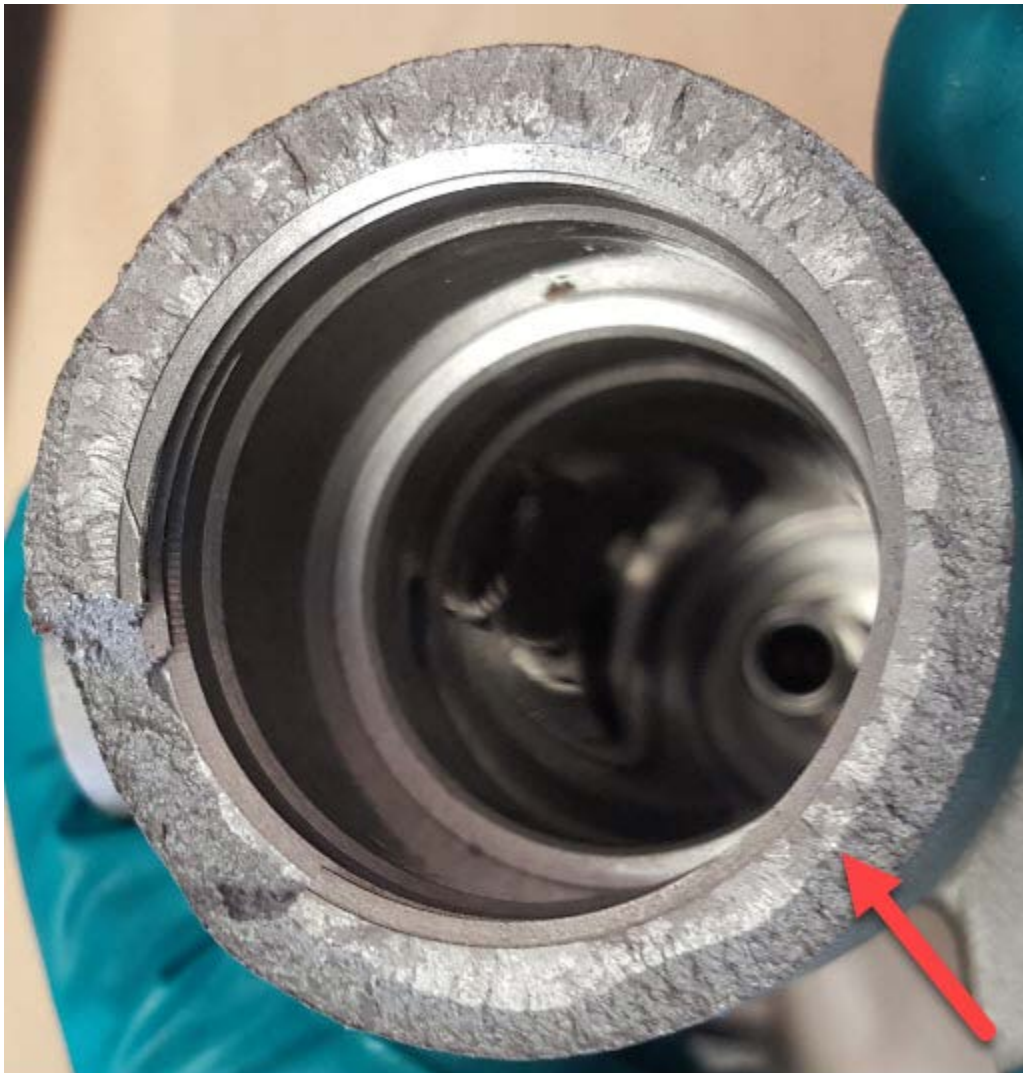
failed in 2 stages, an initial crack extending around the cylinder, followed by subsequent catastrophic failure of the cylinder. The stamp on the outer cylinder of the brake valve indicates that it was originally assembled in 1Q89 (assumed to be 1st quarter 1989) and cure date of 3Q87 (assumed to be 3rd quarter 1987).

This is a typical fatigue failure that started progressing slowly and then finally failed. These types of failures are hard to detect even if the part is sent for overhaul, unless nondestructive testing is used to detect the cracks before failure. If the same part keeps failing after a certain number of cycles, a recurring defect report can be used to determine the life limit of the part and remove it from service before failure.

1. End view of the valve where you can see how the crack progressed.

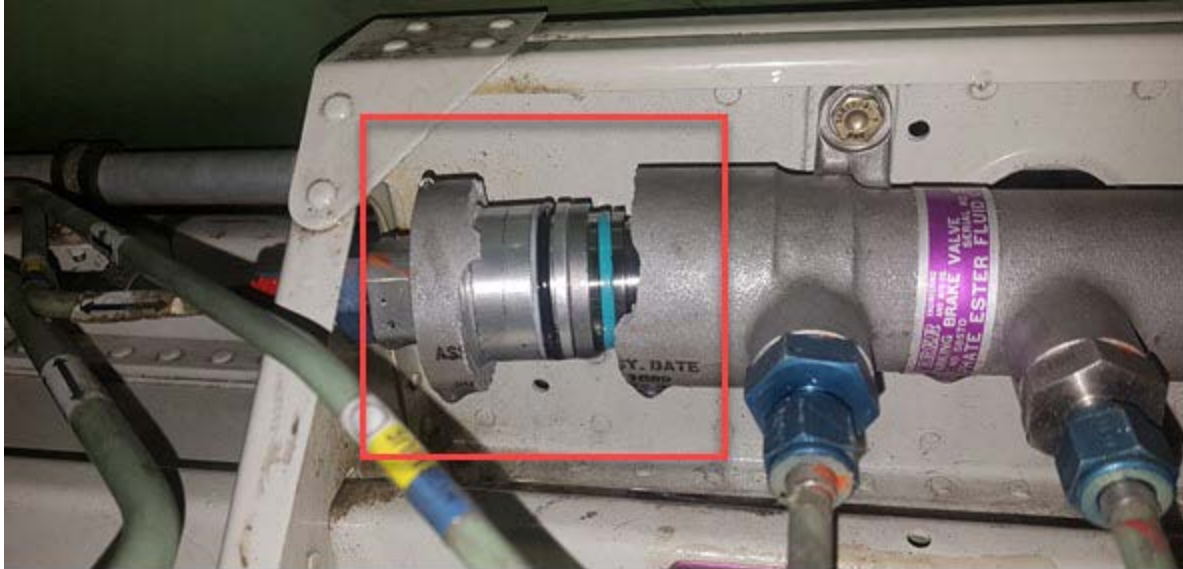
During parking, when applying park brake #2, the hydraulic gauge went to zero and a large amount of hydraulic fluid was running down the right side of the aircraft. Inspection of fuselage panel 264BR revealed the brake control valve was severed. Park brake control valve was replaced with a serviceable unit, in accordance with aircraft maintenance manual chapter 32-44-16. Inspection of the failed part revealed the part

2. Failed valve body as found in the aircraft.

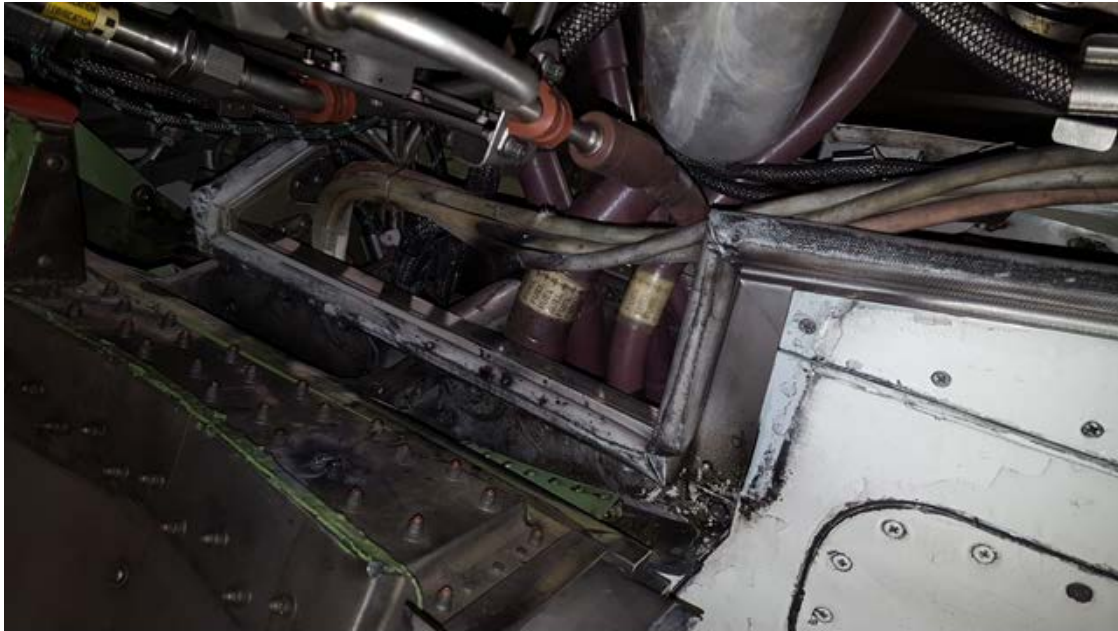
After opening the cowlings for troubleshooting a generator snag, burn damage was discovered on the left hand (LH) lower thrust reverser fireshield. Further inspection revealed that the damage was actually caused by arcing of the internal drive generator (IDG) #1 power feeder cables. The power cables were chafing on the fasteners when the panel was closed and had worn through the insulation causing the arcing to occur.

The fasteners on the LH lower fireshield panel were found contacting the generator power feed wire bundle and had worn through insulation causing arcing and burn damage to the wiring. The arcing occurred adjacent to the engine main fuel line causing at least one of the fasteners in the fireshield panel to almost melt away. Bombardier was advised and the investigation found that the wiring had not been installed correctly per the aircraft technical publications documents.

Fig 1: RJ900 - Nacelle location of wire chafing on panel fasteners

Transport Canada is publishing this article as an awareness to operators to use care when installing wiring to prevent instances where chafing can occur.

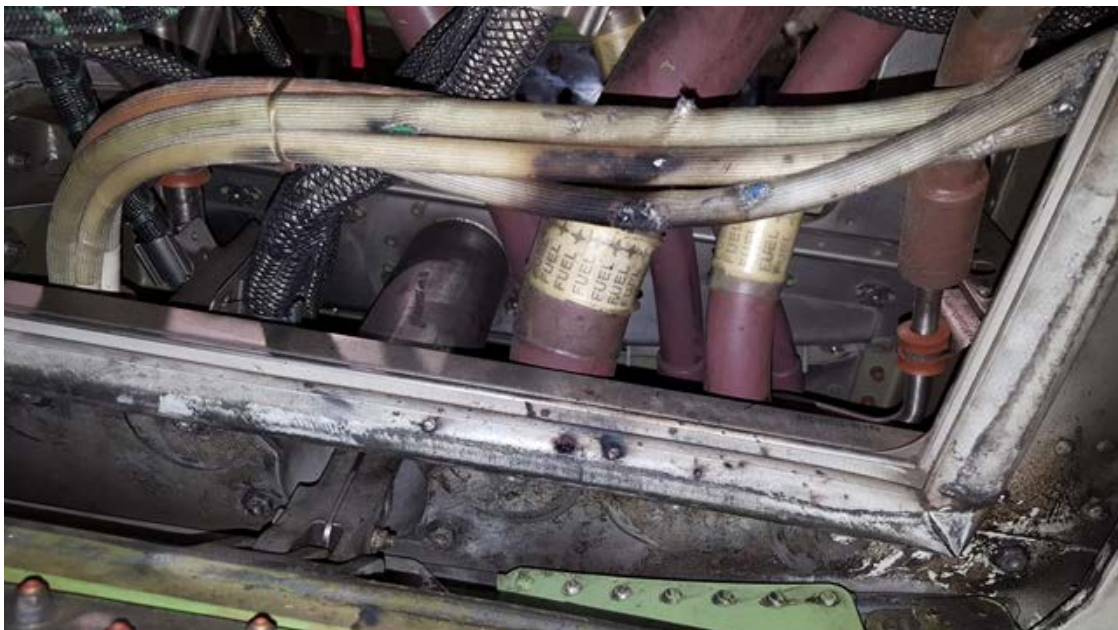
Fig 2: RJ900 - Burnt wires next to fuel line

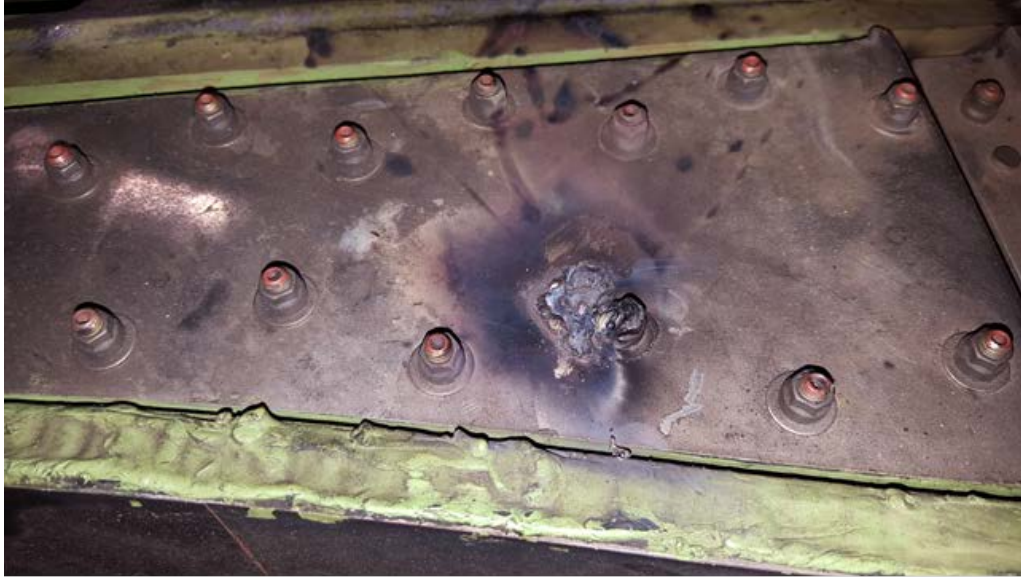
Fig 3: RJ900 - Fastener damaged by arcing

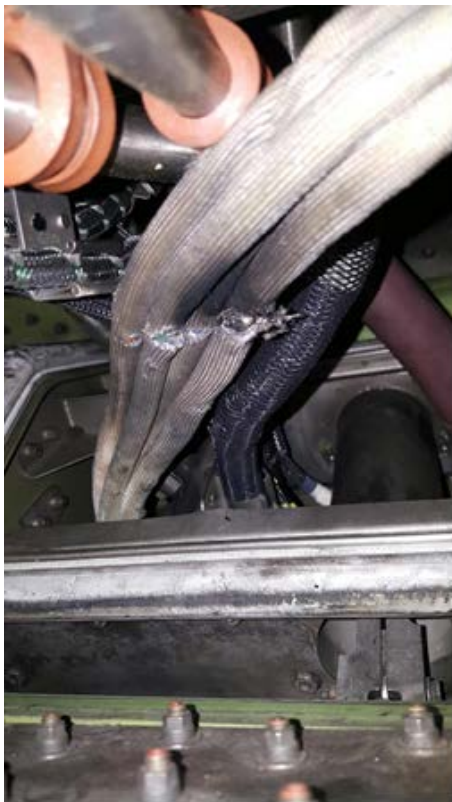
A similar occurrence was also reported on the RJ700 model aircraft series. The submitter advised that IDG cables were not routed correctly and that the oil raft bracket assembly part number CN628-0126-003 was missing. This event was also the result of an installation error.

Fig 4: RJ700 – Damage to wires

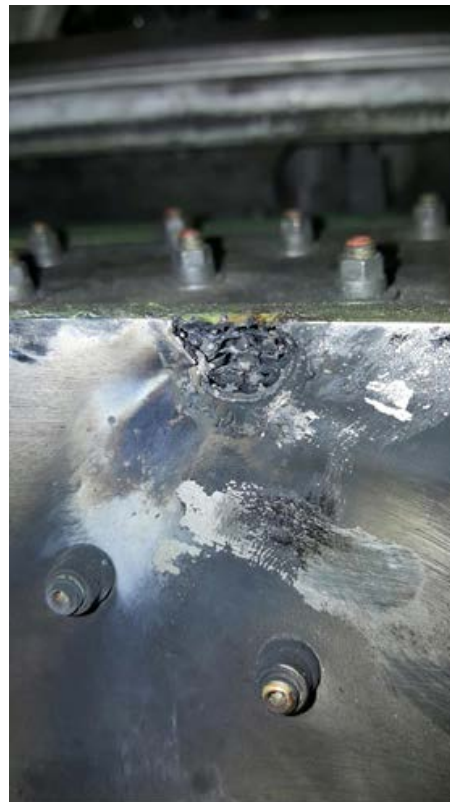
Fig 5: RJ700 – Damage to fastener and panel

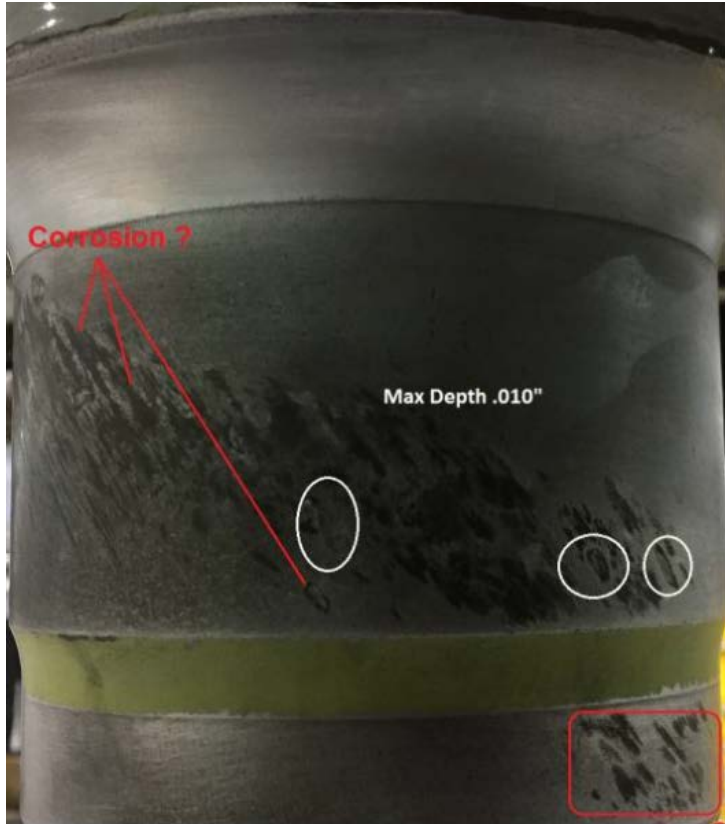
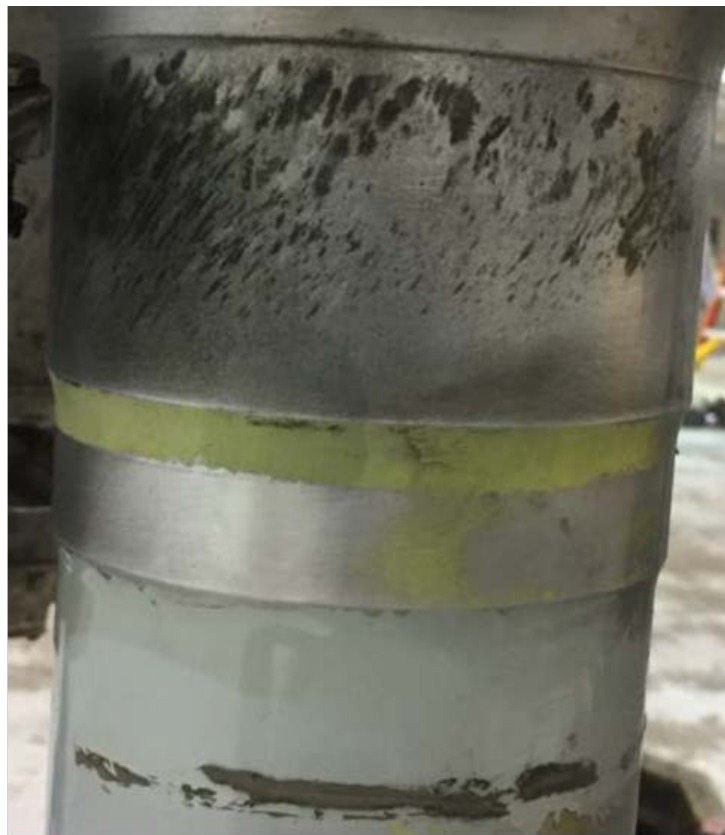
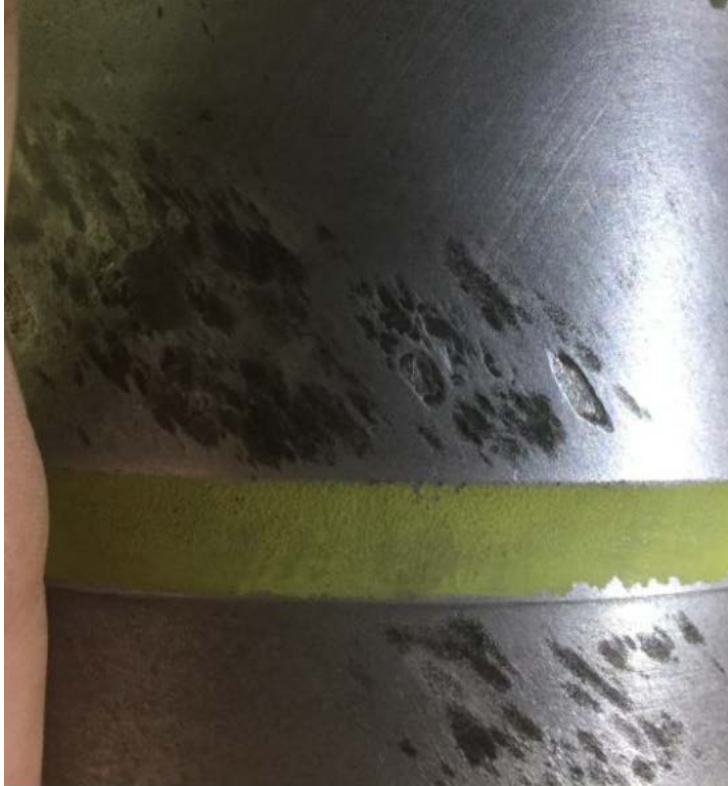
A popping sound was heard from the nose wheel steering when the nose wheel was turned. The sound was coming from the steering collar on the nose gear. While replacing the steering collar and sleeve on the nose landing gear, pitting and gouges were found on the shock strut tube. The damage was assessed and was bad enough that the shock strut was replaced.

The nose landing gear strut time since last overhaul (TSO) was just 13 980 hours when this damage was discovered. This is approximately 3 ½ to 5 ½ years in service for this model of aircraft depending on operator utilization. The gouging and pitting damage was caused by fretting between the steering collar and the strut, and may have occurred due to lack of grease. The damage was so severe that the shock strut tube required replacement before the 20 000 cycle overhaul limits were reached.

All 3 photos: Pitted collar area which is now showing corrosion

The steering collar lubrication task interval, as per the Maintenance Review Board Report (MRBR), is due every 500 hours air time. Proper application of the specified lubricants at the prescribed intervals are designed to prevent this type of damage from occurring. In severe service environments more frequent lubrication is required.

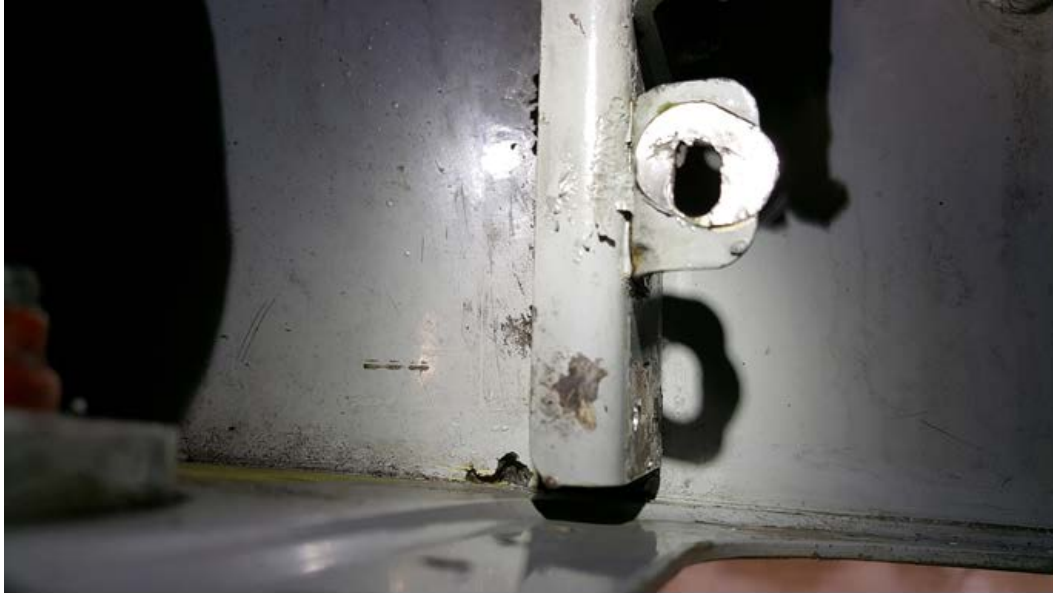
While cleaning and prepping for painting and sealing after completing the Repair Engineering Order REO 601R-57-21-2562, this corrosion area was noticed, forward of the left main landing gear trunnion on the rear wing spar. It is at the base of the spar where it meets the left-hand lower wing plank in the lower web area at wing station 52. The operator contacted Bombardier for repair instructions and was advised to blend out the corrosion. They found the corrosion very deep and after all the corrosion was removed, the blend was approximately 0.430 inches deep and the remaining spar material thickness was 0.079 inches. Bombardier issued a temporary repair to add a repair angle inside the tank to repair the spar until the next C check, when the final repair will be accomplished, to either splice or replace the damaged wing spar.

The corrosion found was very deep and the location is often very dirty and not easily inspected. Currently no other Service Difficulty Reports have been submitted for similar defects. Transport Canada would like to raise awareness of this issue and remind operators and maintainers to report any similar findings via the Web Service Difficulty Reporting System.

Figure 1 – Corrosion as seen before repair.

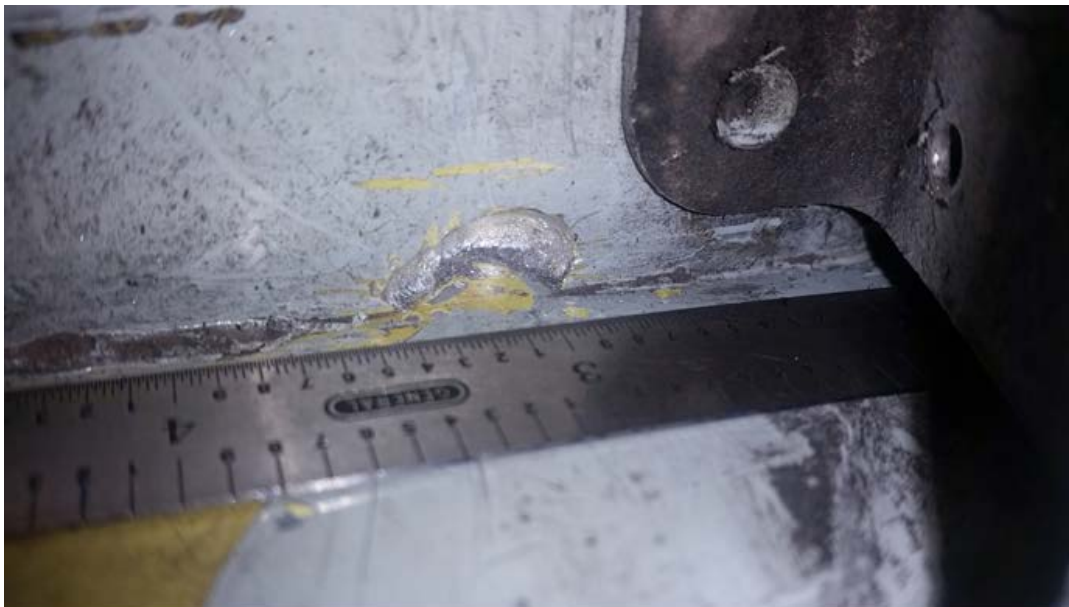
Figure 2 – Damaged area during blend-out

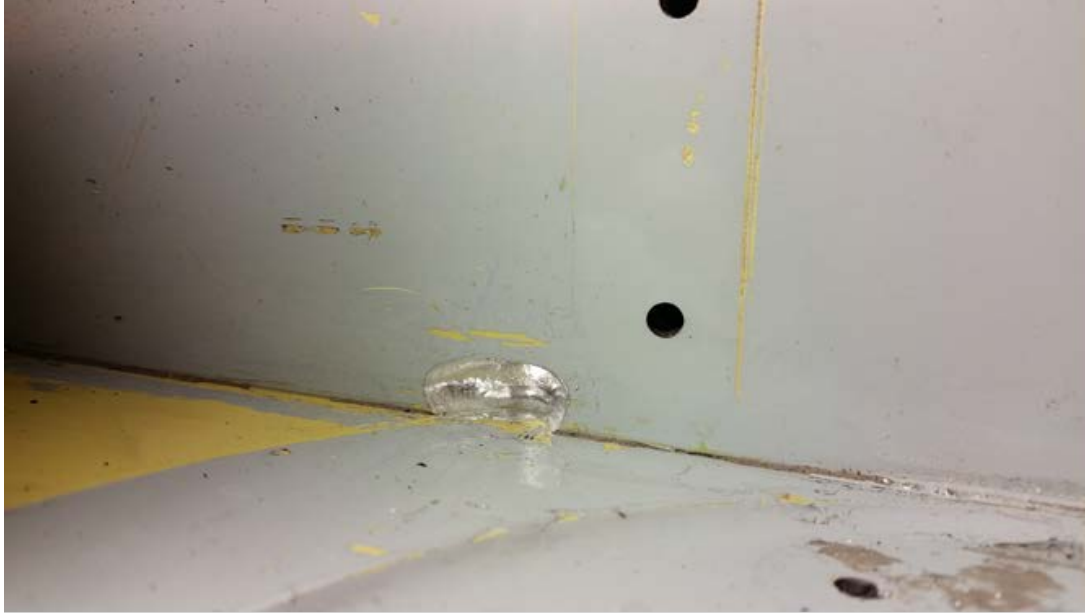
Figure 3 – Final blend-out of corrosion damage

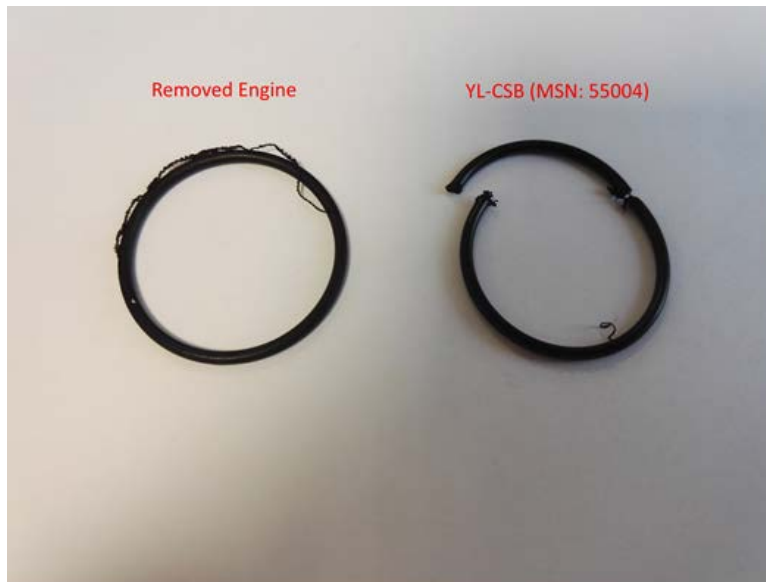
In the attached figures, the O-rings are shown from (2) engine driven hydraulic pump suction lines showing shearing/shaving type of damage. The O-ring that is broken in 2 places was removed from subject aircraft. The other O-ring was from another engine that was removed from service by the same operator. The suction line from the removed engine was found to have O-ring damage when it was removed as a means to repair the in-service engine. In both cases shaving damage is evident on both O-rings.

In summary both O-rings suffered some type of installation damage and our concern is that there may be other cases of O-rings on engines still in-service with similar damage.

Fig 1: O-ring from subject aircraft and o-ring from another engine previously removed

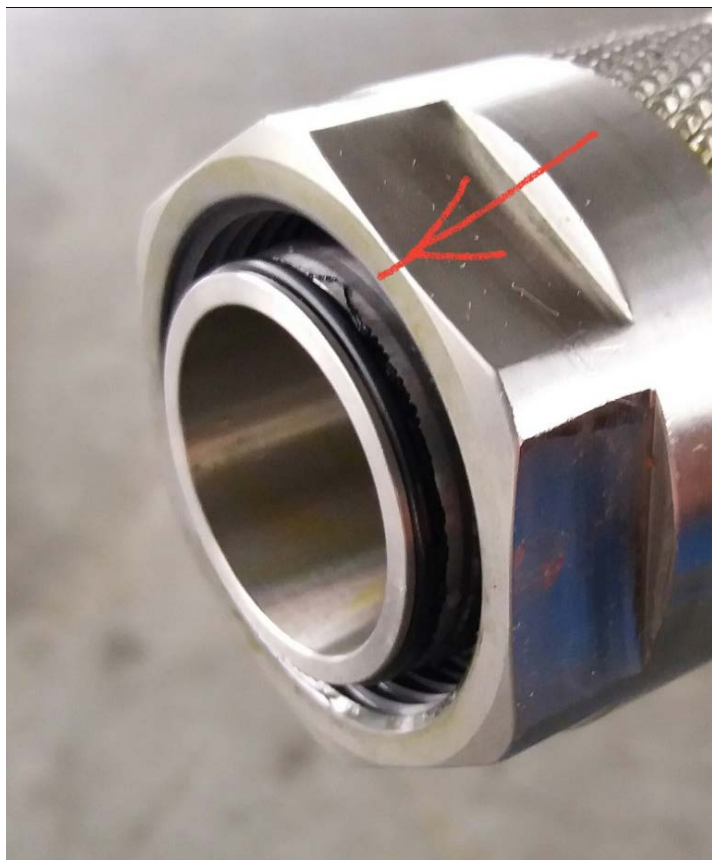
Fig 2: O-ring shown installed in suction line from previously removed engine

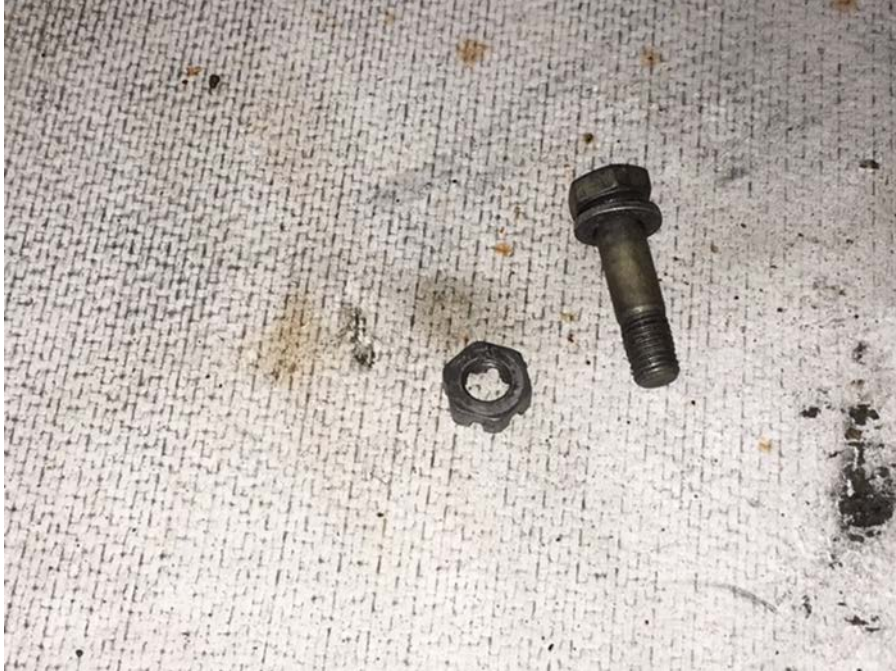
The bolts (BACB30LJ5D12 or BACB30NR5DK12), washers (AN960PD516) and nuts (BACN10JD105) were found in the respective canoe fairings at Wing But Line 254 and 355. The cotter pins (MS24665-304) were not found.

Pic 1: Bolt and nut found in flap canoe

One of the signatures required by this section may be that of the person who has signed the maintenance release. Although the omission of the cotter pins did not end up causing an incident, the bushing could have migrated out of the fittings causing the loss of the flap assembly. Maintainers can institute a dual inspection system for all work performed. It never hurts to get a second look.

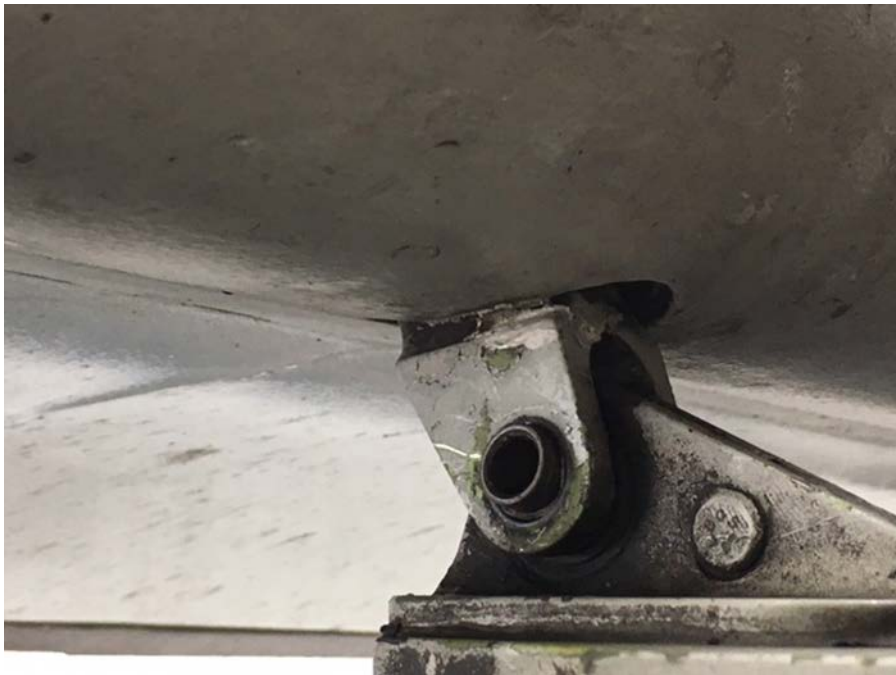
During routine maintenance of the flap system, it was discovered that the two bolts that attach the right hand fore flap to the fore flap sequencing carriage assembly were missing. The flap was being retained by the two attachment bushings (69-43503-1 and 69-43503-2) that remained connected to the brackets on the fore flap and the carriage fittings and the links to the mid flap.

Pic 2: Bushing remains in fitting holding flap in place

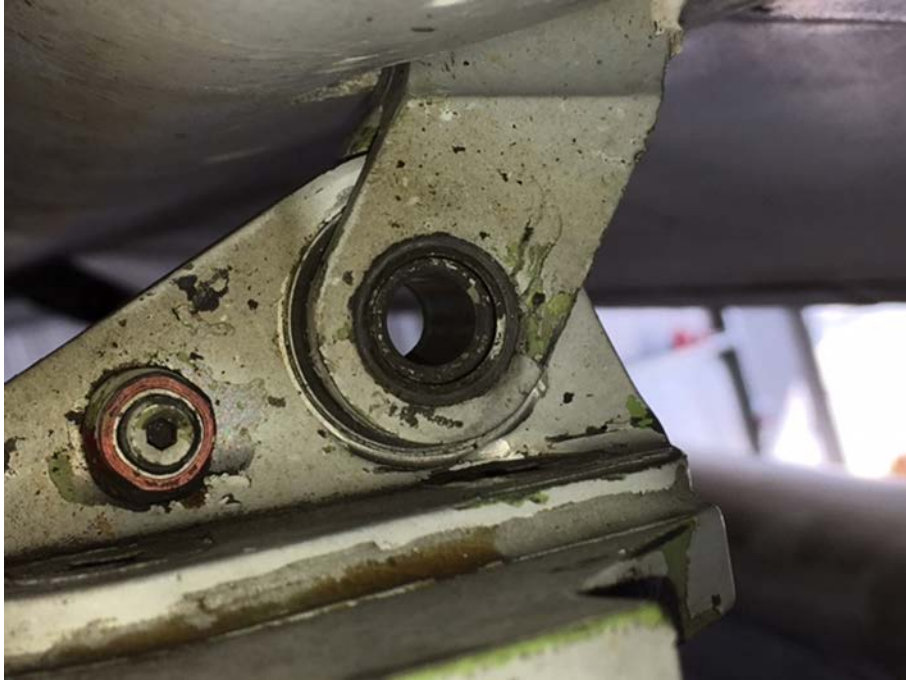
Pic 3: Bushing in fitting

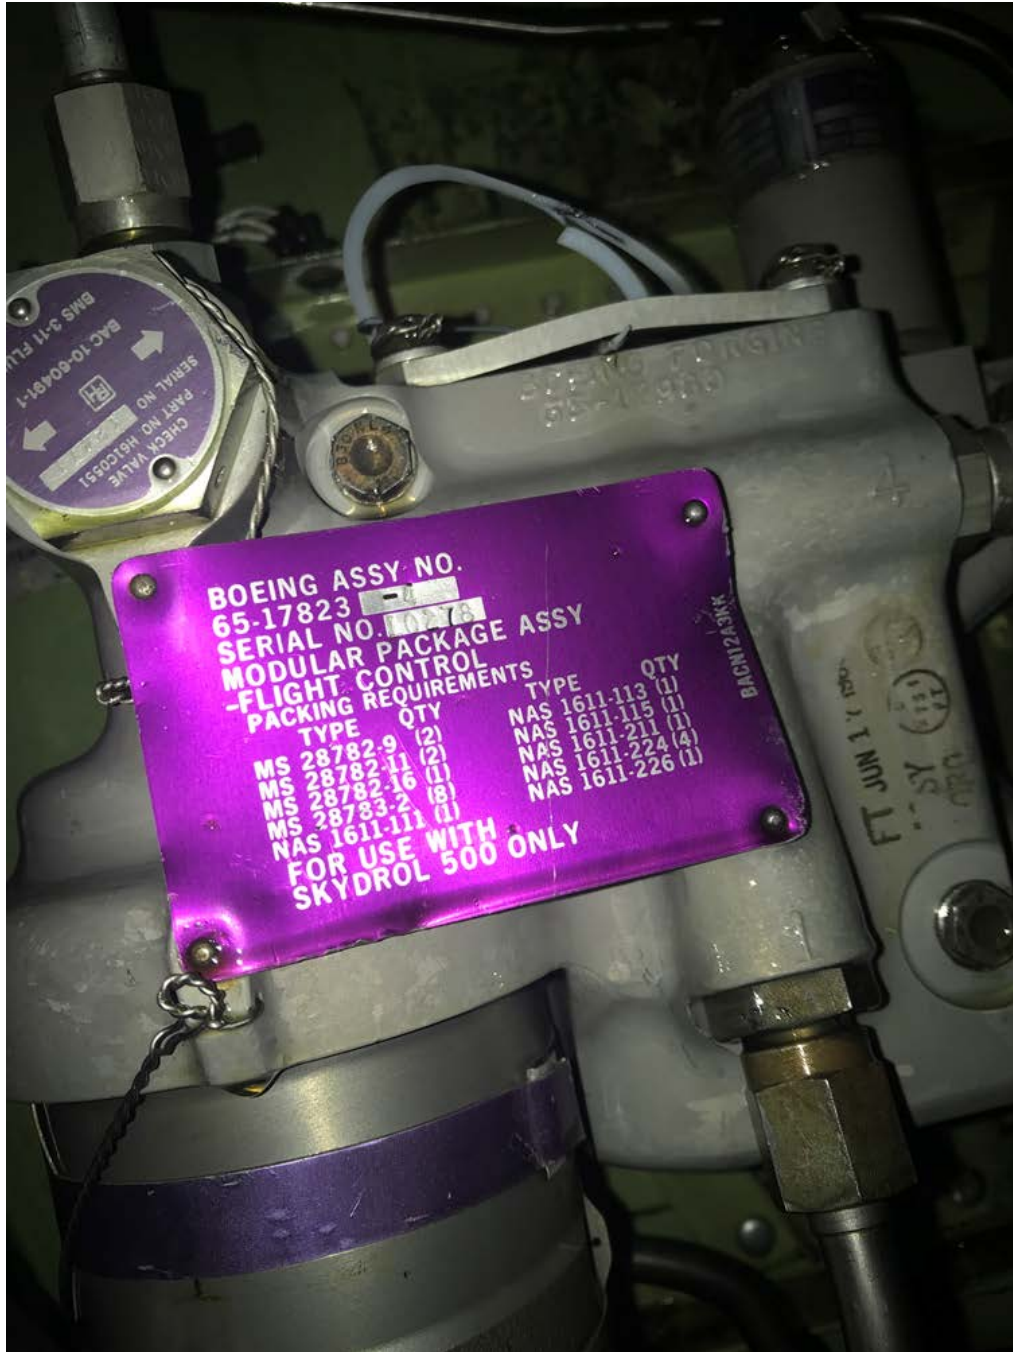
During a daily inspection of the aircraft, a hydraulic leak was found in the aft airstair area. Closer investigation found the hydraulic "a" system elevator module had split. The failure occurred at the attach point of the valve assembly motor to the body of the modular package. The modular package assembly was replaced and the aircraft returned to service.

Picture 1: Module assembly showing missing valve

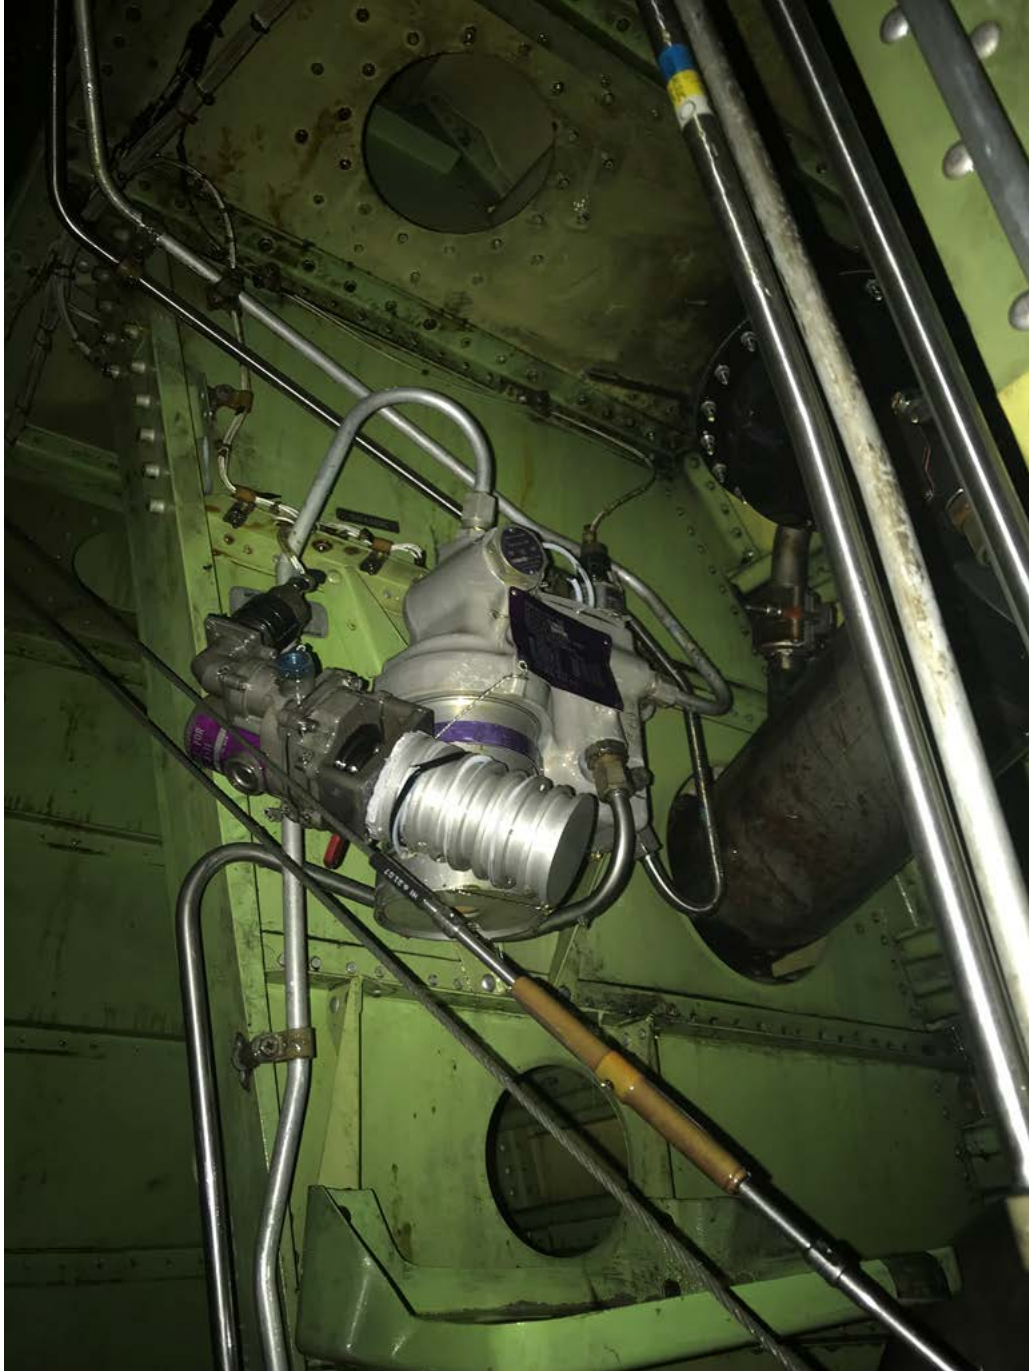
Picture 2: Valve found hanging beside module assembly

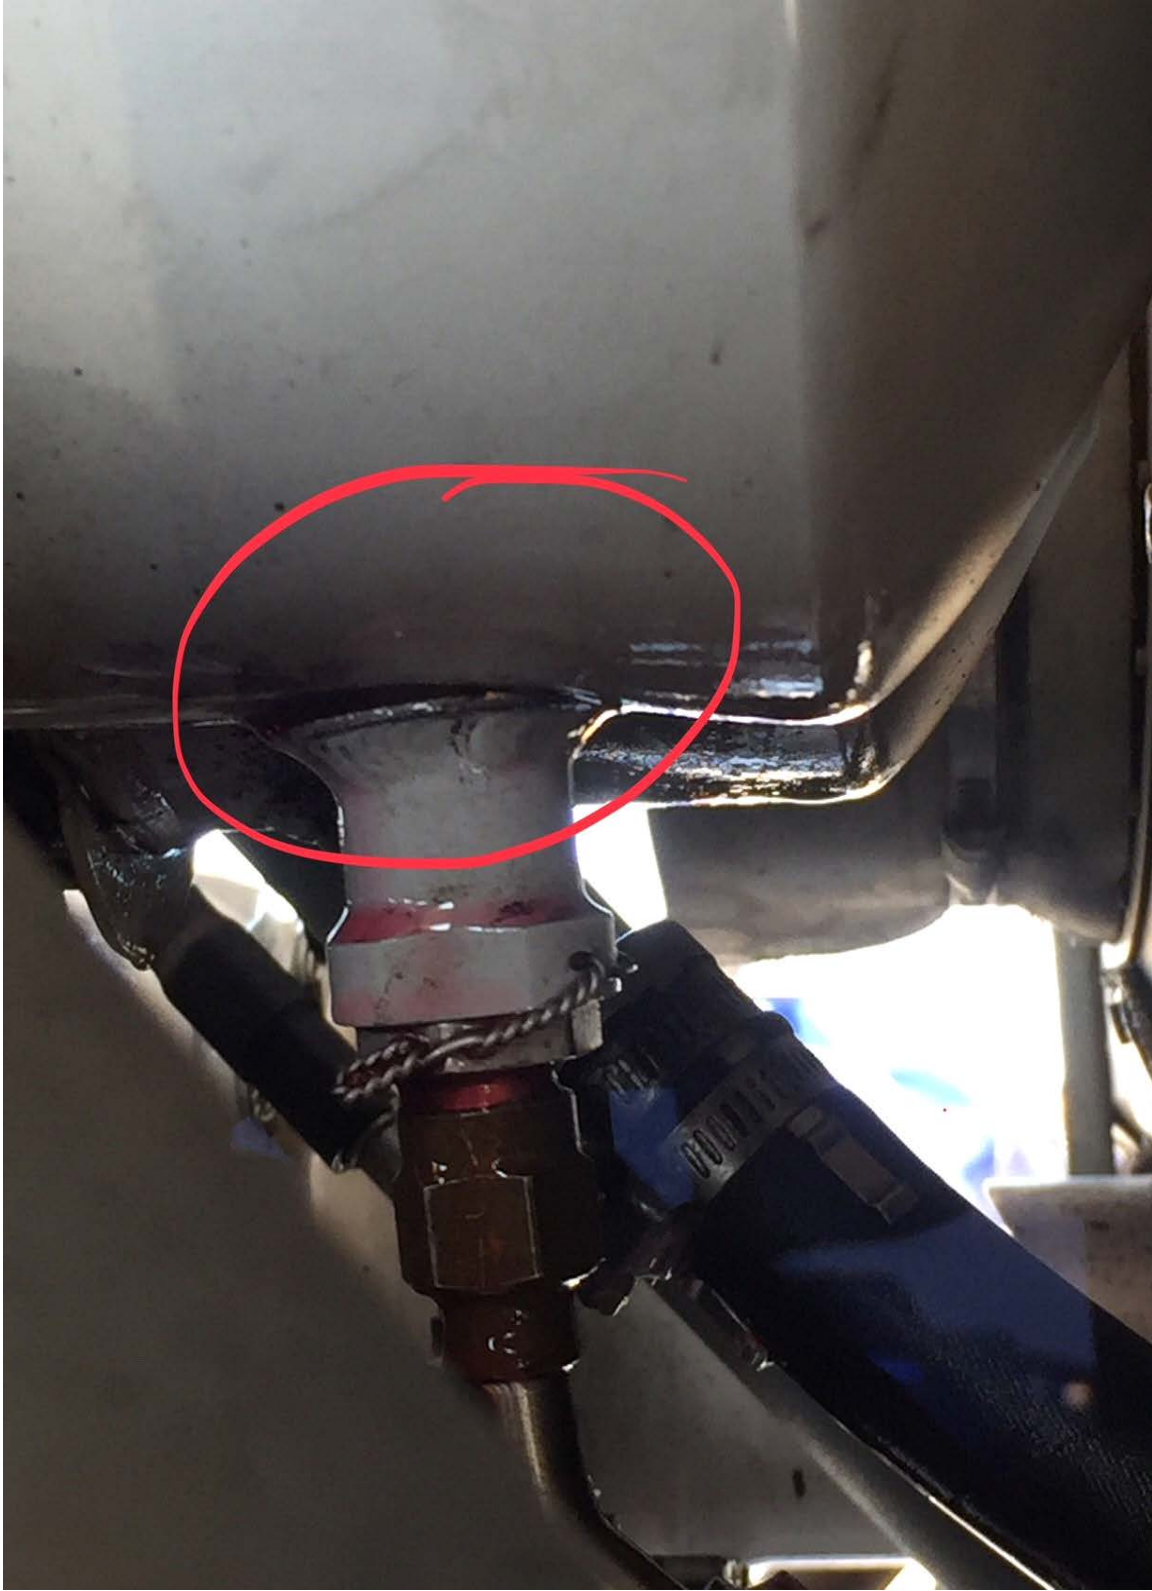
The pilot was in cruise flight inbound to the airport approximately 8 miles back when the hydraulic pressure light illuminated first. Shortly after, a servo light illuminated and it was followed by a limit light. After landing, a large amount of hydraulic fluid was noted on the left hand side of the aircraft. It was also noted that the fluid had come from the left hand hydraulic tank and the tank was now empty. The maintenance department dispatched an Aircraft Maintenance Engineer to inspect the aircraft. A broken weld was found on the bottom of the left hand reservoir tank. The cracked left hand hydraulic tank part number (P/N) 355A75-1330-03 was removed and replaced with a new tank. As a precautionary measure the right hand hydraulic tank P/N 355A75-1330-04 was also replaced with a new tank. Inspection of the right hand hydraulic tank welds showed some similar early signs of wear.

Airbus Helicopters previously acknowledged that some cases of cracks were found on the left hand hydraulic reservoir suction line in Service Letter No. 952-29-89. The letter was published to identify the root cause of the cracking as a stressed installation of the hose. To limit this type of Service Difficulty, Airbus Helicopters advised a check of the hose installation in accordance with the Standard Practices Manual and visual checks during routine inspection intervals. Cracks found at any time on the left hand or right hand hydraulic system reservoir are considered as a reportable Service Difficulty.

Cracked Hydraulic reservoir suction line base

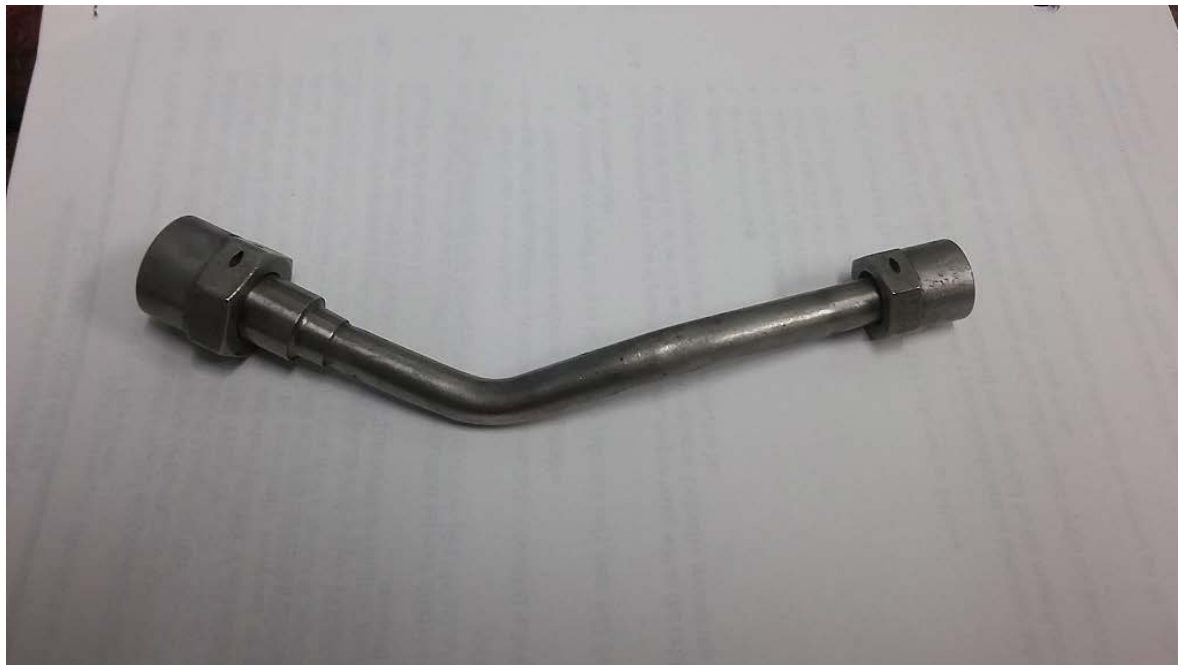
During a scheduled inspection, maintenance found fuel leaking from the left hand engine. Further investigation revealed that the primary fuel pressure tube assembly (part number 3035618) was cracked at the flange area. The tube assembly was replaced, successful ground runs and leak checks performed. Aircraft was returned to service.

This type of failure can be caused by many factors such as mishandling of the line, improper alignment prior to final torqueing or excessive vibration. Maintainers must be careful when working with fluid lines to avoid dangerous situations.

Cracked Fuel line
