**SUBJ: ATA 53 Fuselage – Pilatus Flugzeugwerke AG P3 models -Fuselage to Horizontal Tail Fittings – Identification, Repetitive Inspections** SAIB: CE-20-08 R1  
Date: August 10, 2020

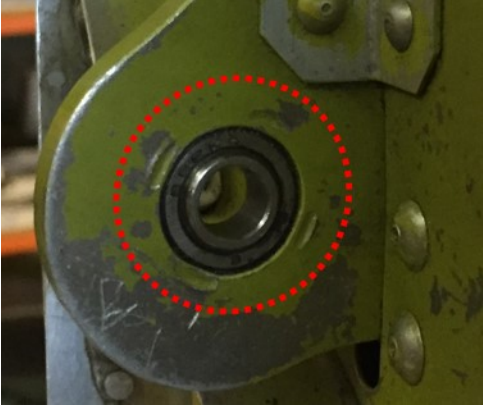
Fuselage to horizontal tail fitting: original manufactured by Pilatus Flugzeugwerke AG

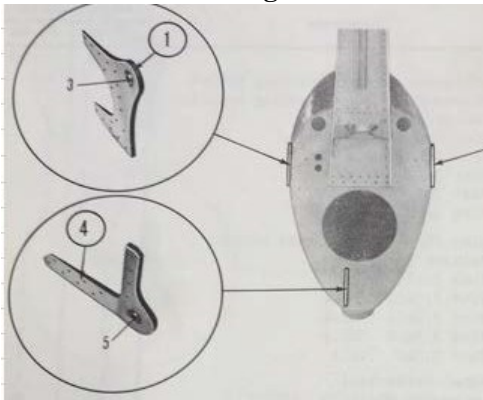
Fuselage to horizontal tail fitting: damage caused by using a centre punch tool during

maintenance Fuselage to horizontal tail fitting

- (3) If during the inspection required by paragraph (1) of this AD any fuselage to horizontal tail fittings with signs of damage caused by using a center punch tool are found, before next flight, replace the fitting with a serviceable part or repair the fitting in accordance with an approved repair solution.
