Feedback

Canadian Aviation Service Difficulty Reports

The following content was published between July 8, 2020 and December 29, 2020. The full accessible version of each article is available on the Feedback [website](#).

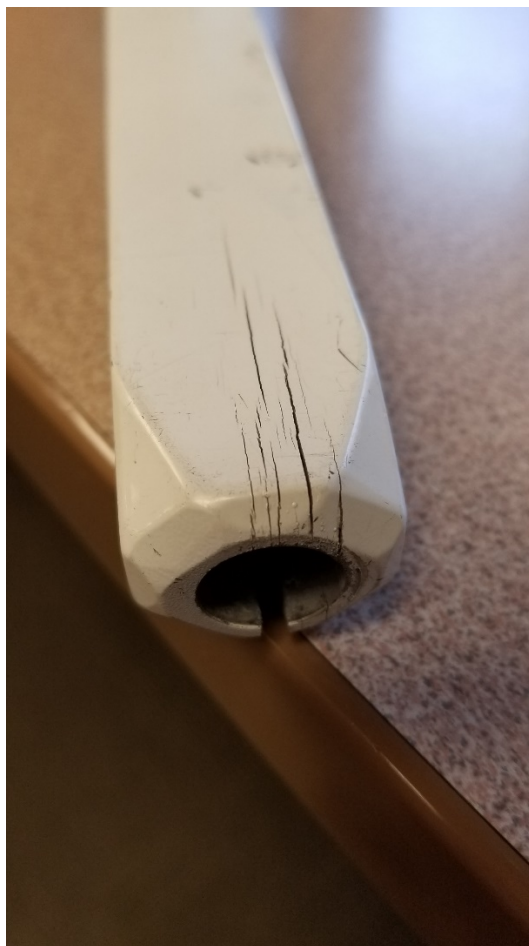
While conducting a routine check, the passenger door inner handle lever was discovered with multiple cracks at the knob location and also at the inner handle shaft pivot point taper pin hole. Maintenance personnel replaced the door inner handle lever and the function check was carried out with no further fault noted.

Fig 1: Lever cracking on both sides

The passenger door mechanism and lever is a high use item on the aircraft and the areas where the cracks were found are reasonably accessible and visible. Regular and routine inspections are a good method to ensure the integrity of the mechanism.

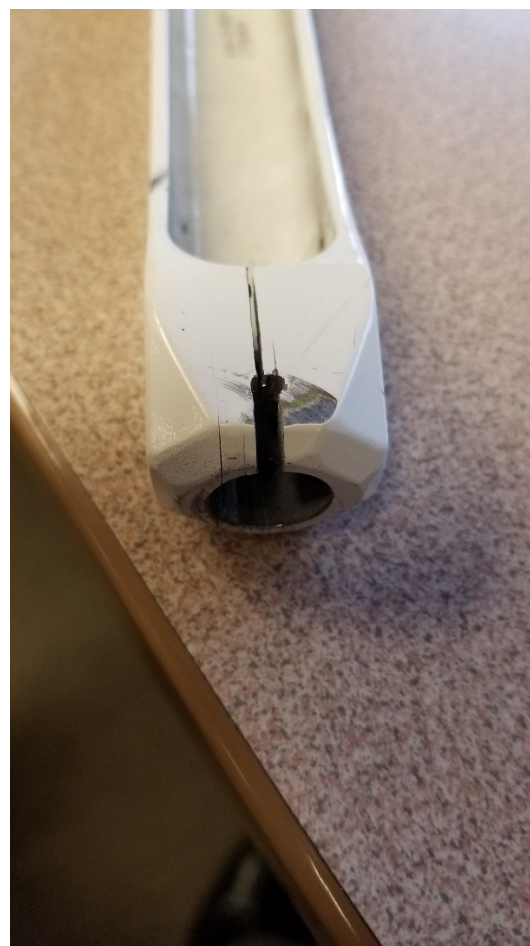
Fig. 2: Lever crack through taper pin hole

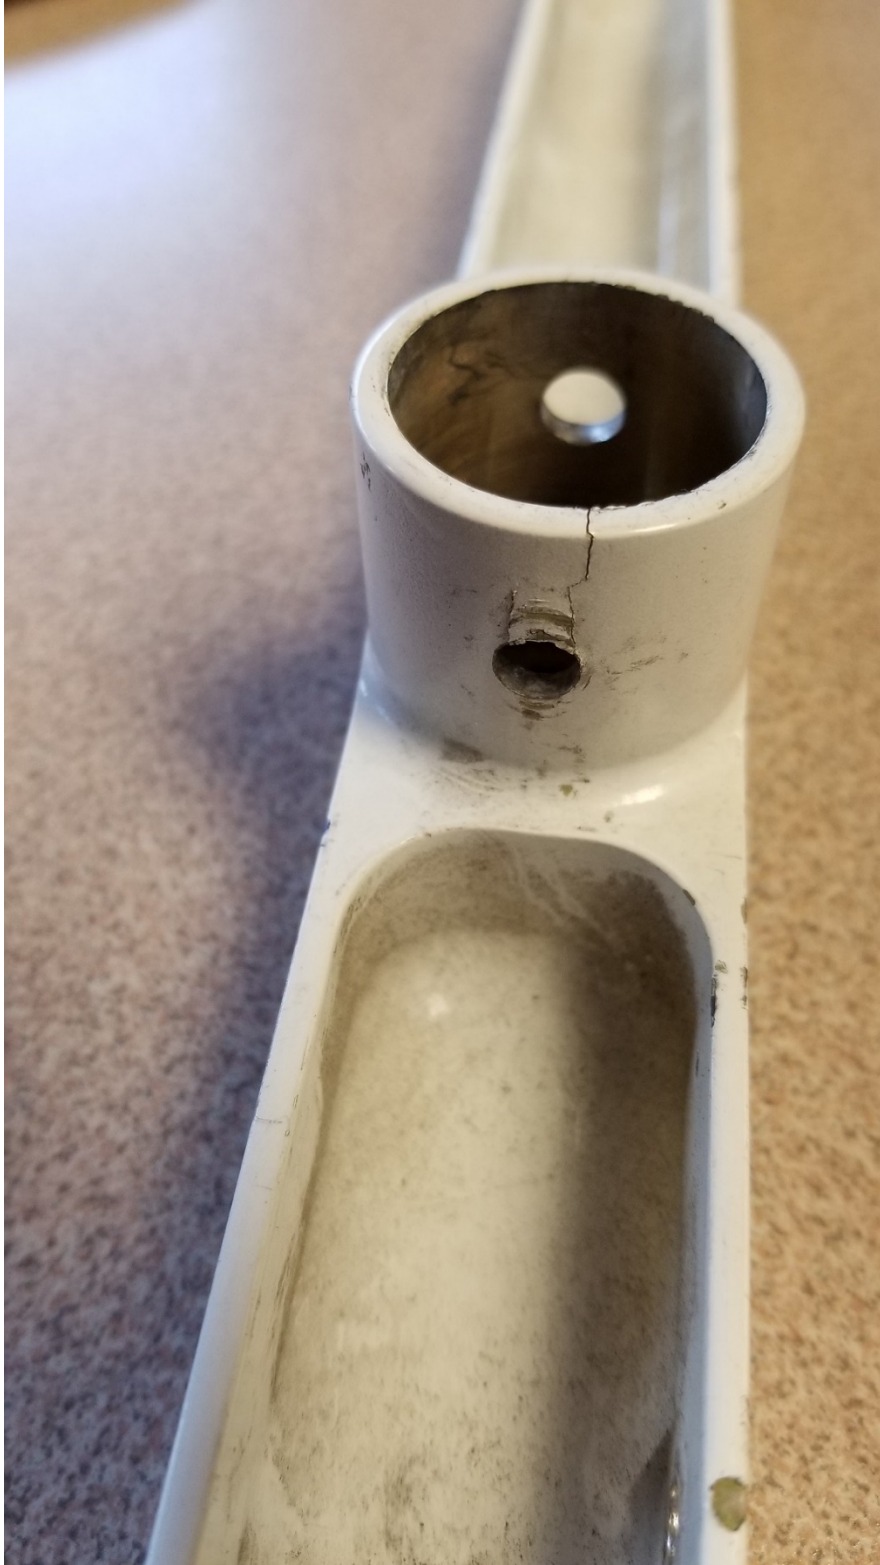
Fig. 3: Cracking and stress at pivot point

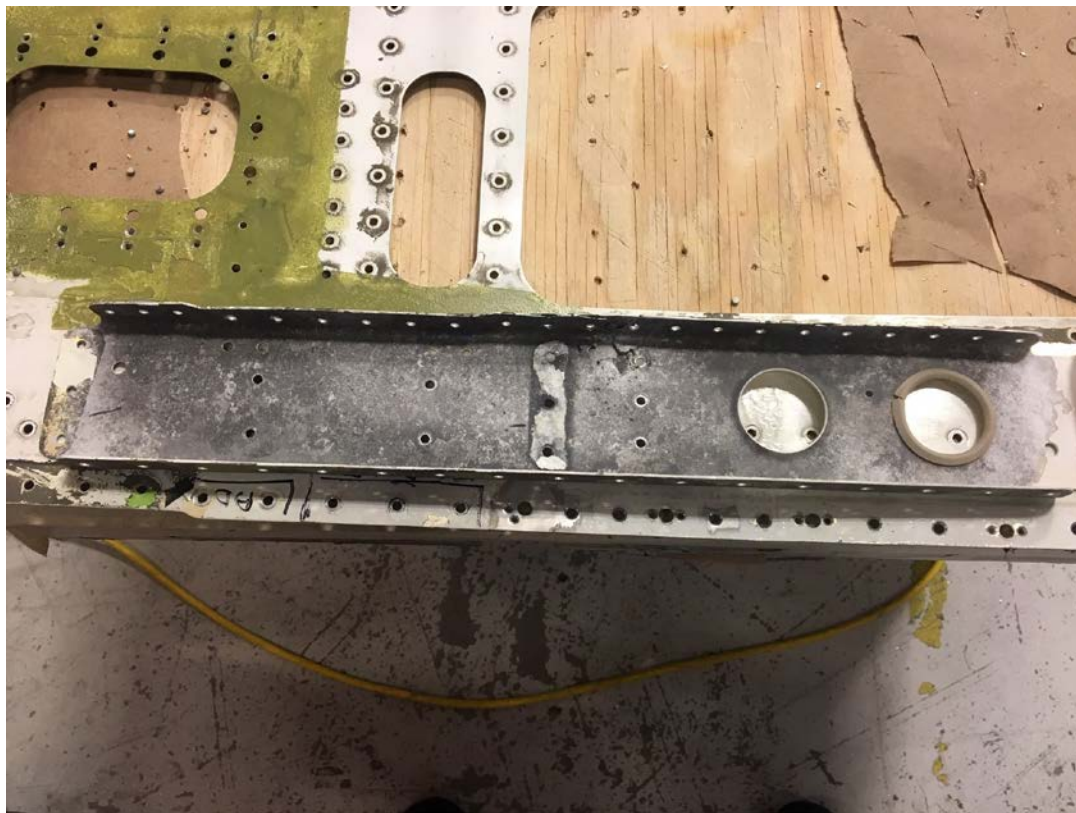
During scheduled maintenance, level two corrosion was observed within the passenger door structure below the door handle cut-out. Repairs were carried out in accordance with the structural repair manual and required the replacement of channel part number 601R318057-1 due to the extent of the corrosion damage. The aircraft had accumulated 42 008 hours air time and 21 756 flight cycles at the time the corrosion was found.

The corroded area exhibited extensive deterioration, including pitting and flaking of metal. Aircraft maintenance program inspection intervals should be sufficient to ensure that corrosion is found at level 1 or below before progressing to level 2 and beyond, as was found in this case.

Fig 1: Corrosion damage

Issues with excessive corrosion at the passenger door area are being reported more frequently, and the number of Service Difficulty Reports (SDRs) indicates an increasing trend. The passenger door is a high traffic area and can accumulate contaminants and moisture on a daily basis and at all times of the year. This area requires frequent and regular detailed inspections including cleaning of the drain holes. Following each inspection, preventive measures such as the application of corrosion inhibiting

compounds (CIC) is a recommended industry practice. By following these criteria, an operator's maintenance program can prevent damage like was found here.

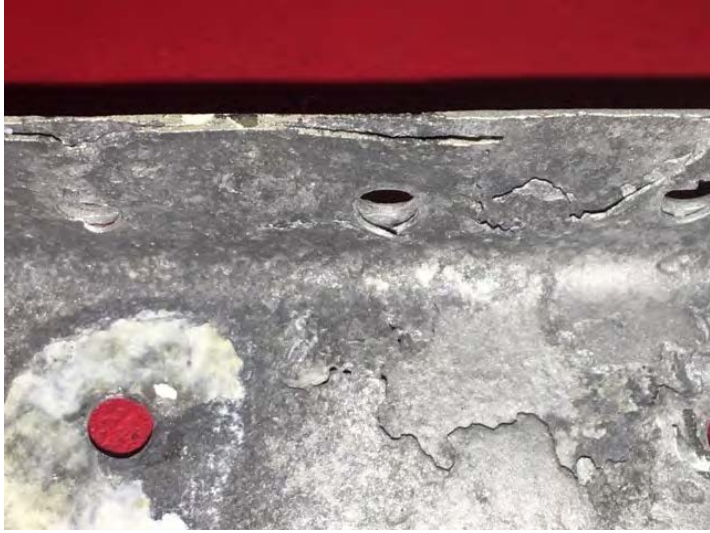
Fig 2: Close-up of corrosion showing depth and flaking

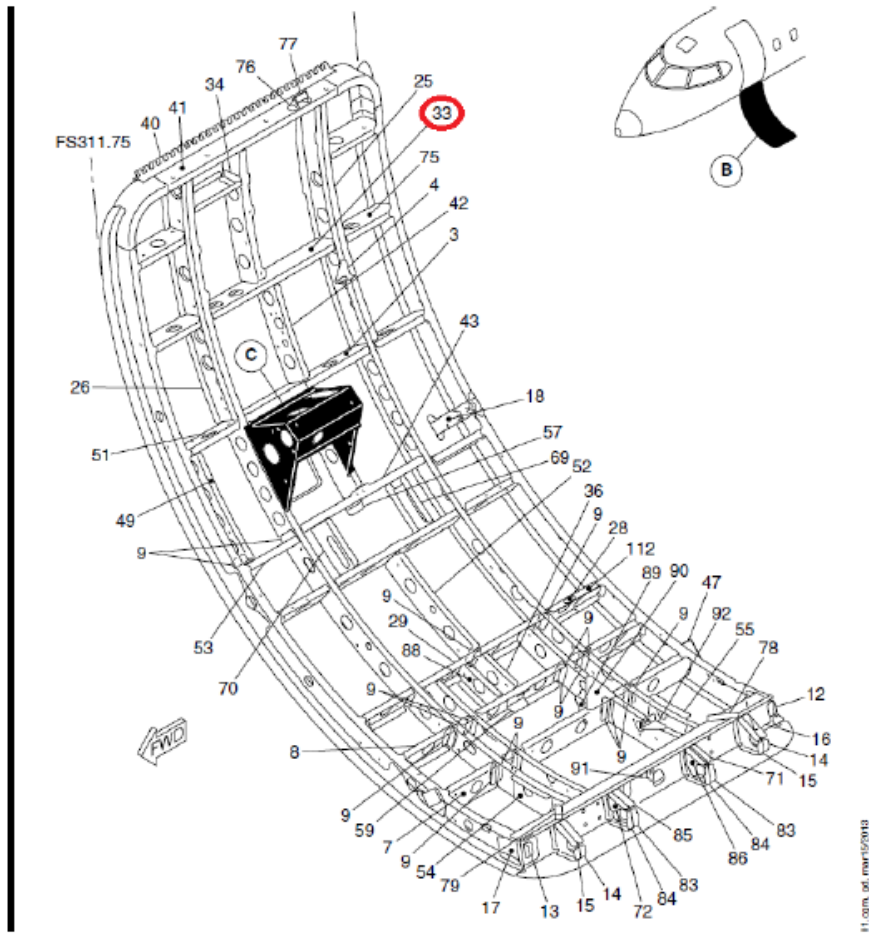
Fig 3: Location of corroded area

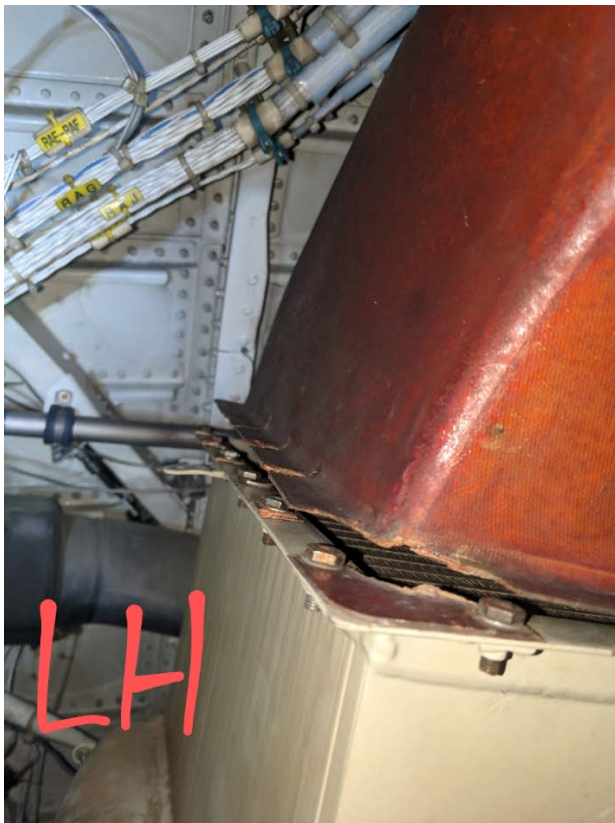
During unscheduled maintenance actions in the aft equipment compartment, the aircraft maintenance engineer (AME) observed that the left and right ram air heat exchanger diffuser ducts were cracked and separated from their respective heat exchangers. The diffuser mating surfaces had pulled through the attaching hardware, the duct flanges were broken and the ducts were cracked.

The damaged ducts were found on a RJ900 that had been in service for 14 years. The cracking was so severe that at least half of each duct attachment was completely detached from the heat exchangers. The cracked ducts were found by alert maintenance personnel during the performance of an unrelated maintenance event. This finding illustrates the value in carrying out a general visual inspection (GVI) of the area when performing maintenance because something else needing attention may be discovered.

Fig 1: Left-hand (LH) duct aft and outboard showing separation from heat exchanger

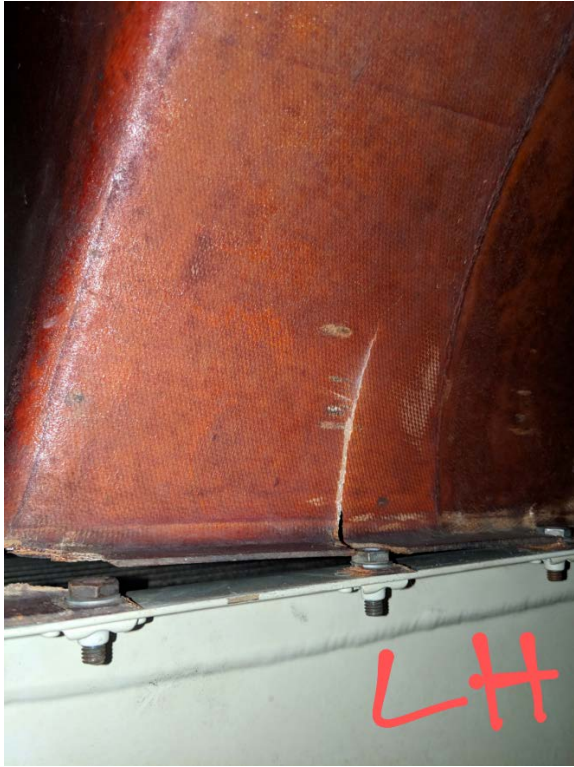
Fig 2: LH duct aft edge separated

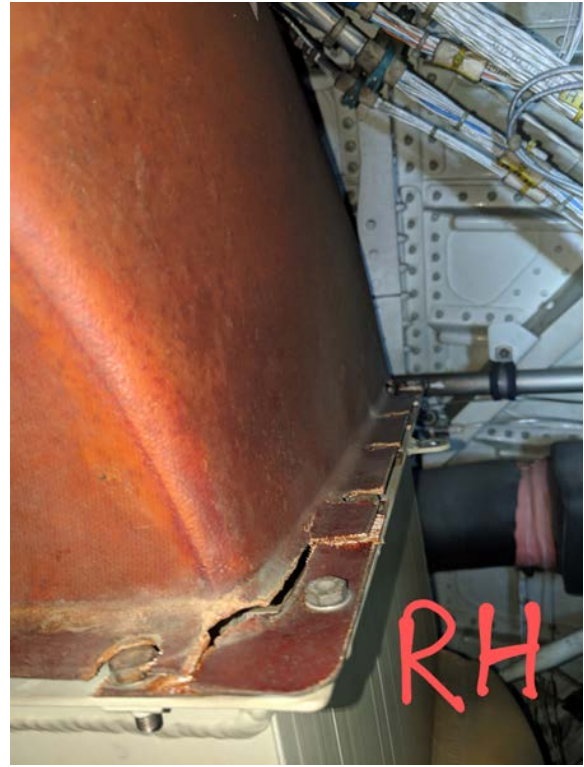
Fig 3: Right-hand (RH) duct outboard

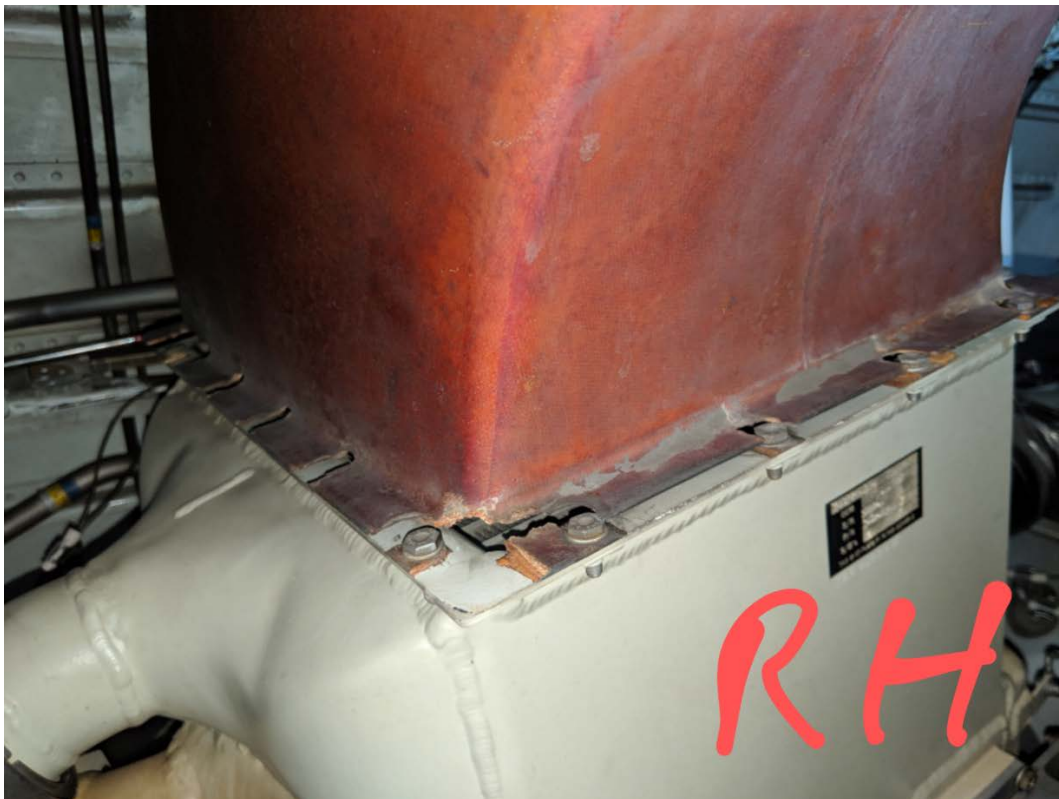
Fig 4: RH duct inboard and front showing separation from heat exchanger

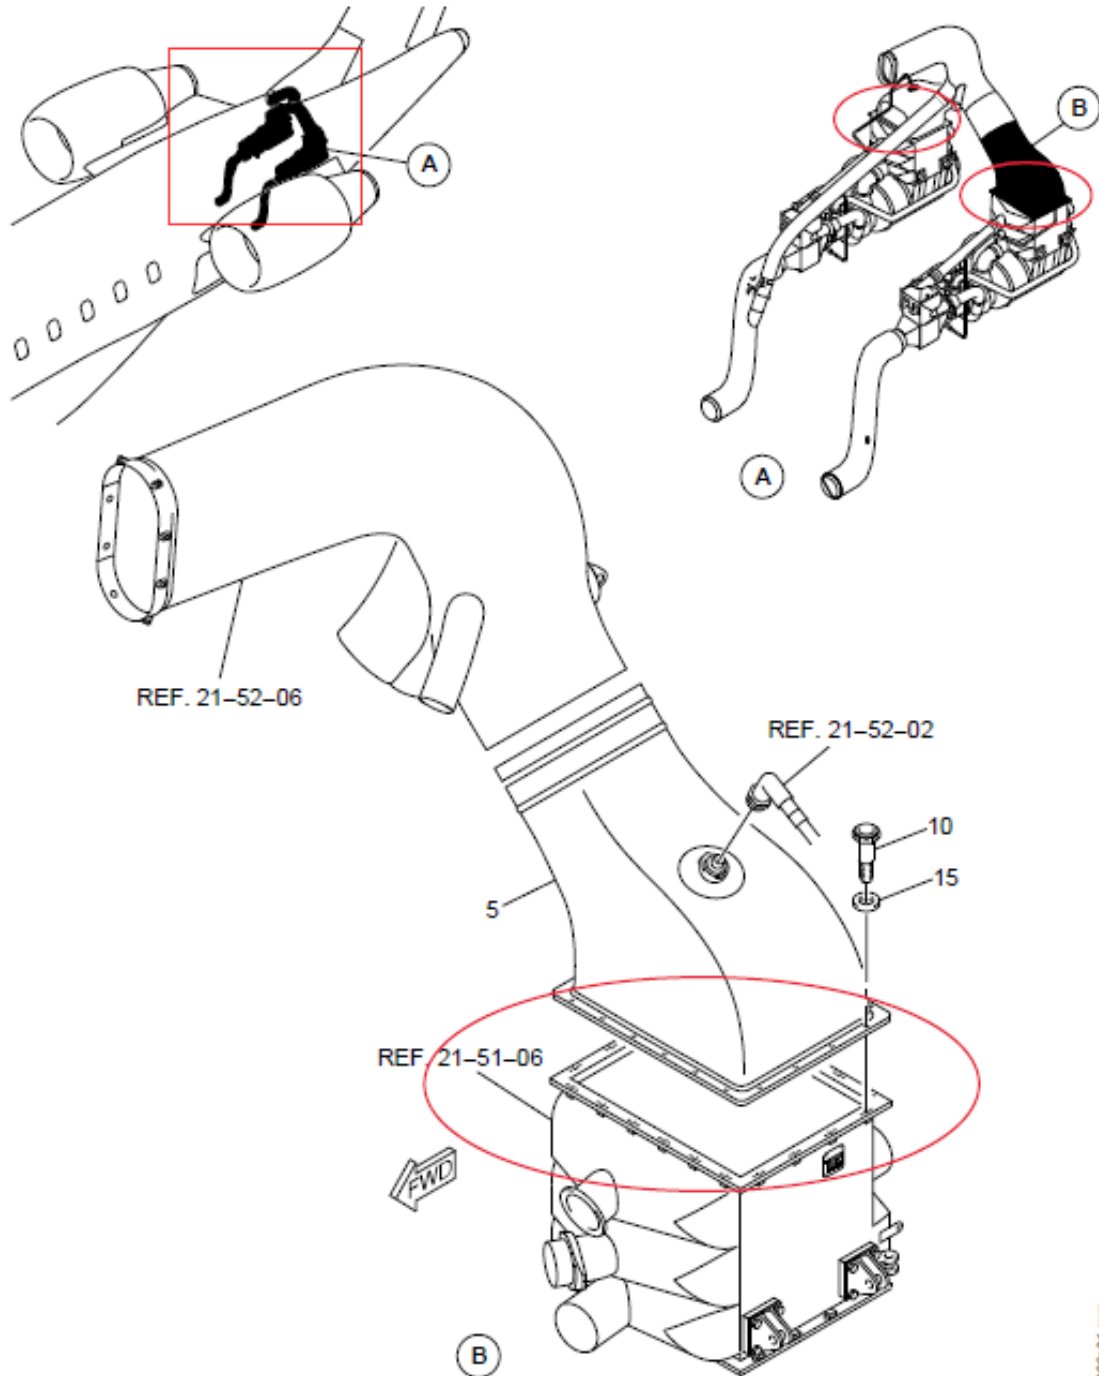
Fig 5: Parts manual showing the cracked ducts

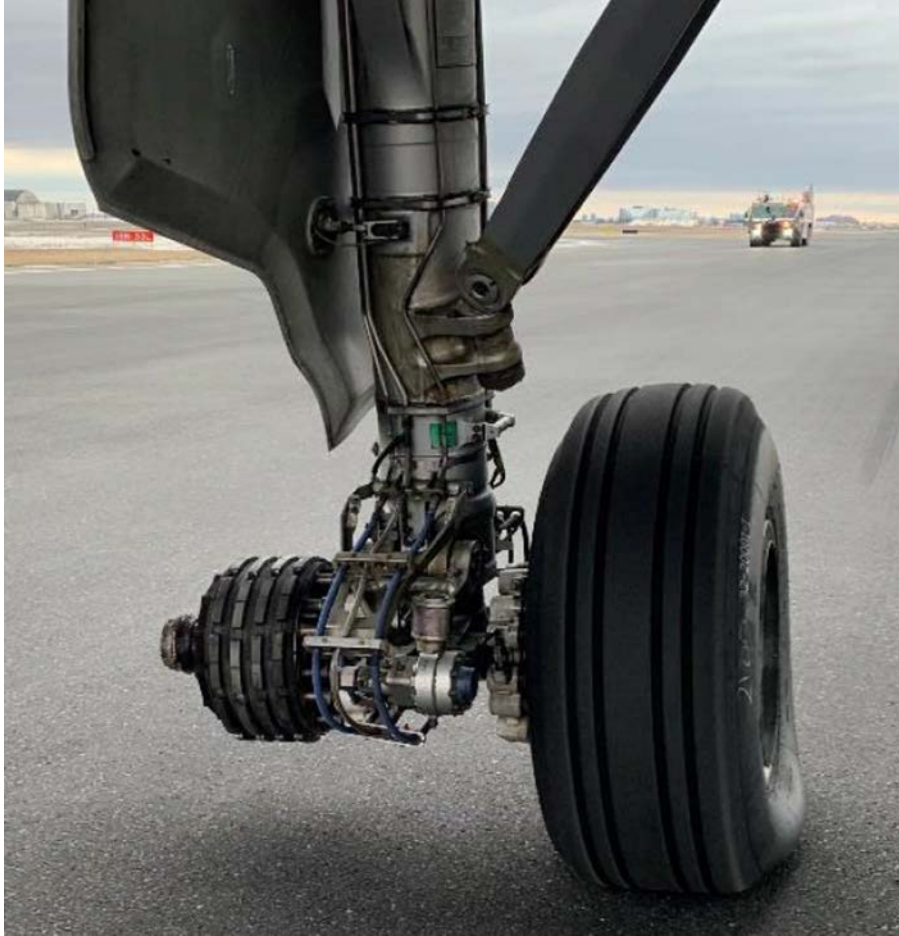
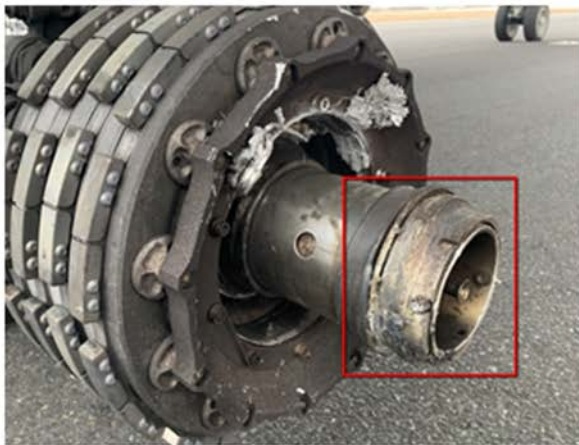
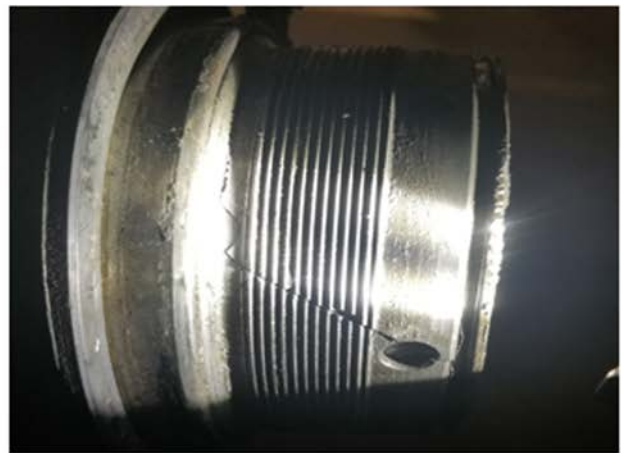
After departure, it was observed that one of the wheel assemblies had potentially departed the left main landing gear (MLG). The aircraft did a fly-by of the tower and the tower confirmed that the number four (#4) wheel assembly was indeed missing. The flight continued to its destination airport. The crew declared an Emergency and the aircraft landed uneventfully with Airport Fire Rescue standing by. The aircraft stopped on the runway and the damage was assessed before the aircraft moved to the operator's maintenance facility. All passengers were deplaned on the runway and transported by bus to the terminal. Maintenance was on site after landing to inspect the landing gear. Upon visual inspection, wheel #4 was missing and the inner hub was found fractured in two (2) locations. The right-hand MLG assembly was replaced along with a new wheel assembly. The state authority reported that the wheel assembly had been found and retrieved fully inflated.

The event detailed above is quite interesting. The investigation to determine the cause of the wheel assembly departure is ongoing. Preliminary inspection, performed by the wheel assembly manufacturer, points to a sudden lock-up of the wheel's outboard bearing. The pictures below show a crack radiating through one of the axle nut retention bolt holes. This crack could have been caused by the lock-up torque radiating from the bearing or the cause of the bearing being loose and failing.

- A flight crew alert message advising crew to be mindful of HOT BRAKES Electronic Centralized Aircraft Monitor (ECAM) message triggered during taxi-out; and
- A fleet campaign to inspect and replace all MLG wheel bearings

As stated above, the investigation to determine the cause of this failure is ongoing. Transport Canada recommends that operators of all types of aircraft be mindful of wheel bearing conditions upon wheel assembly installation. Always follow the manufacturer's recommendations when greasing bearings and installing wheel assemblies.

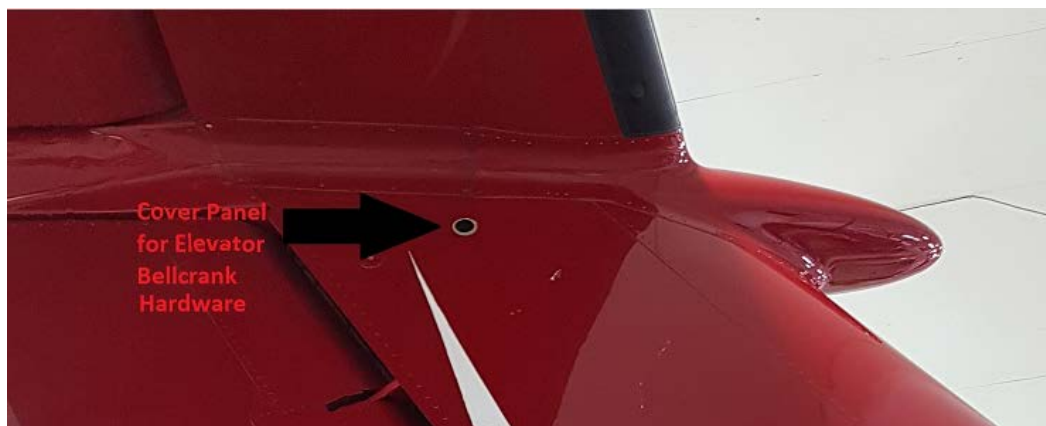
Pic #1 Elevator bellcrank hardware location

While conducting a Phase 4 Inspection on the empennage section of a B200 aircraft, one of the engineers opened a button size cover (approximately 1 and a half inch diameter) to have a look at the elevator bellcrank. After removing the cover, he found that there was no nut or washer on the end of the bolt that attaches the elevator bellcrank to the vertical stabilizer. Upon review of the Phase 4 Inspection and vertical stabilizer inspection for B200 aircraft, we realized that the cover to gain access to the bolt and nut for the elevator bellcrank system is never required to be opened during an inspection. The engineer doing the inspection took it upon himself to open up the cover to see what was inside and that is how he made the discovery of the missing nut and washer. Due to the fact that this is a new aircraft and the cover had not been removed since it was delivered to us, it would seem that the aircraft had this defect since it was manufactured. We have contacted Textron Aviation and informed them of our findings, a new washer and nut were installed on the bolt and the aircraft was returned to service.

Transport Canada reminds maintainers and operators that this incident exemplifies the need to remain vigilant, human factor errors do not discriminate between new or old aircraft.

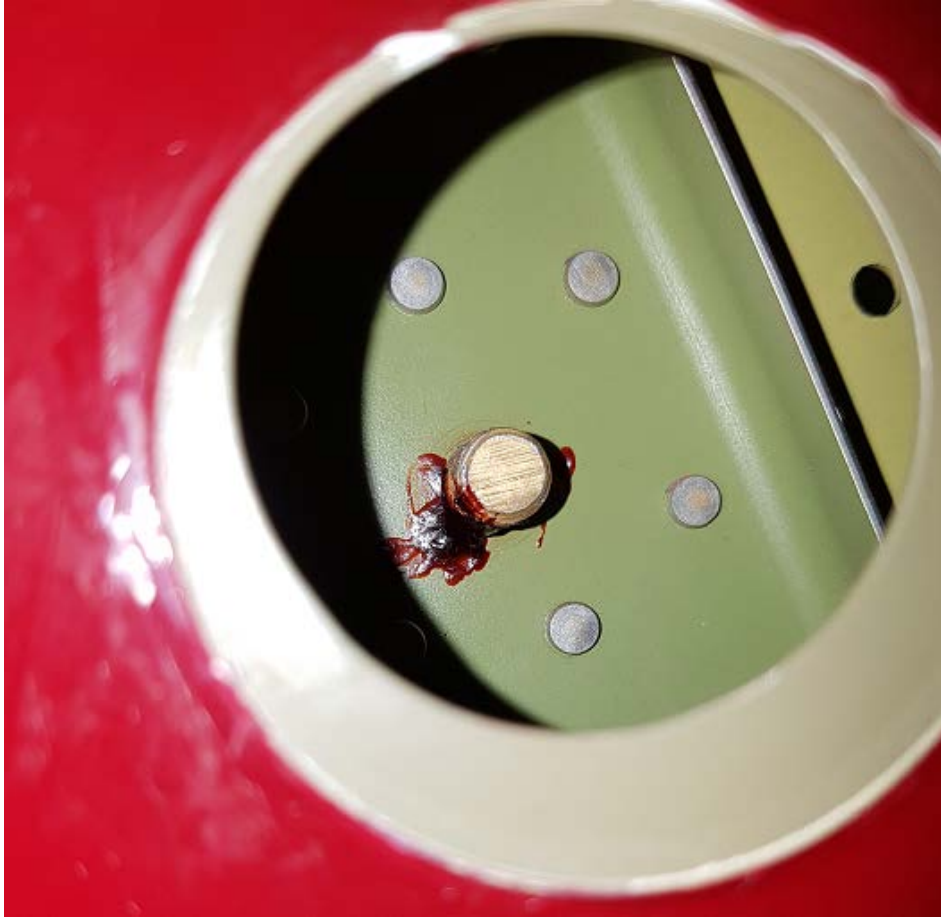
Pic #2 Missing nut and washer

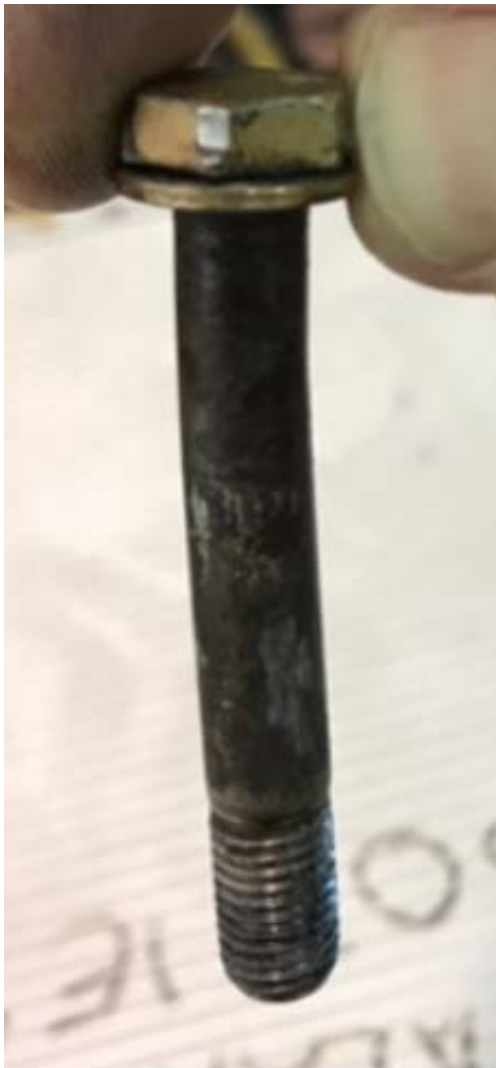
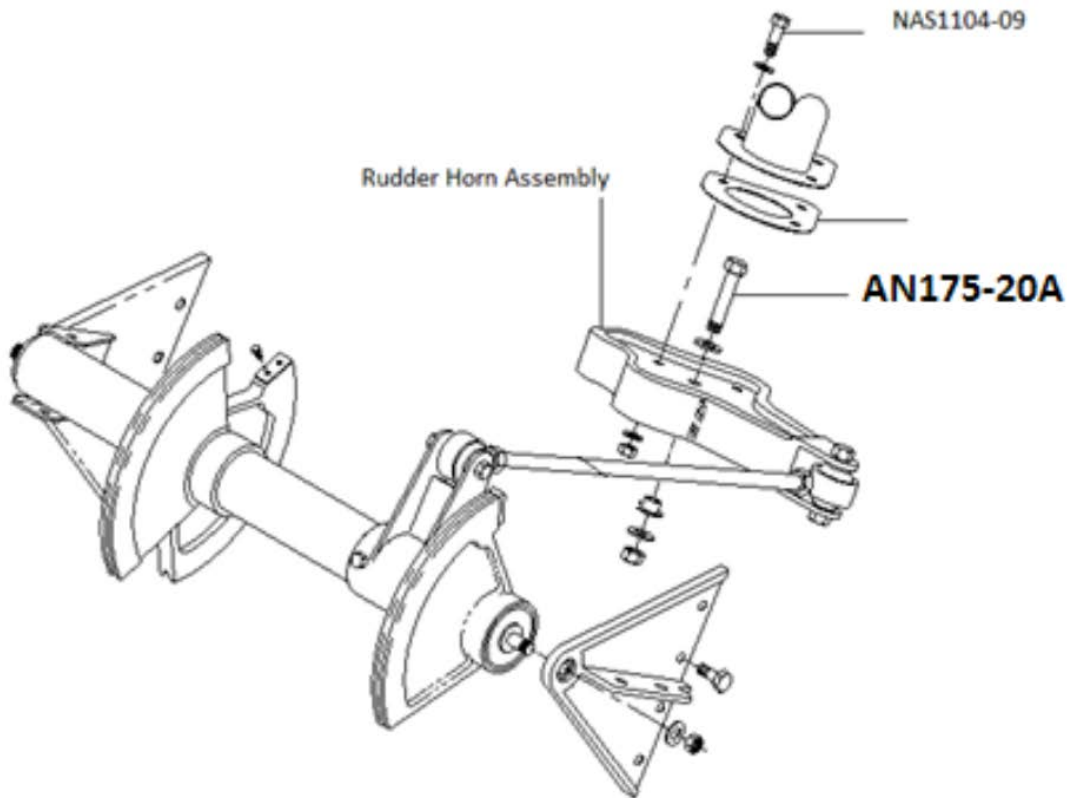
The B300C aircraft was undergoing a scheduled Phase 4 Inspection. During this inspection, maintenance discovered that the rudder horn assembly part number (P/N) 101-524059-1 rudder bearing bolt P/N AN175-20A was bent and the pivot bearing P/N MS28913-5C was seized and corroded. Given the fact that several examples of this type of damage was discovered in the past on the King Air fleet, the operator decided to create an in-house inspection of the rudder horn assembly that would be carried out in conjunction with the Phase 4 Inspection. No inspection of this nature could be found in the Beech program. As well, this bolt and bearing does not have a scheduled lubrication interval. The bearing is a sealed unit. An inspection of the surrounding area was carried

out and the bolt and bearing will be replaced with a serviceable unit. The operator believes that the bent bolt is a result of the rudder lock not being applied on the ground during high winds.

Pic#1 – Lower rudder attach bolt P/N AN175-20A

Beechcraft King Air F90, 200, 300 and B300 series aircraft share this design and Textron Aviation published Model Communique KA-2015-01 in March 2015 describing this scenario. KA-2015-01 recommends the inspection of bolt P/N AN175-20A any time the rudder is removed. Transport Canada Civil Aviation (TCCA) recommends the use of a rudder lock as noted by the submitter of the Service Difficulty Report (SDR), and that particular attention be given to this area whenever possible.

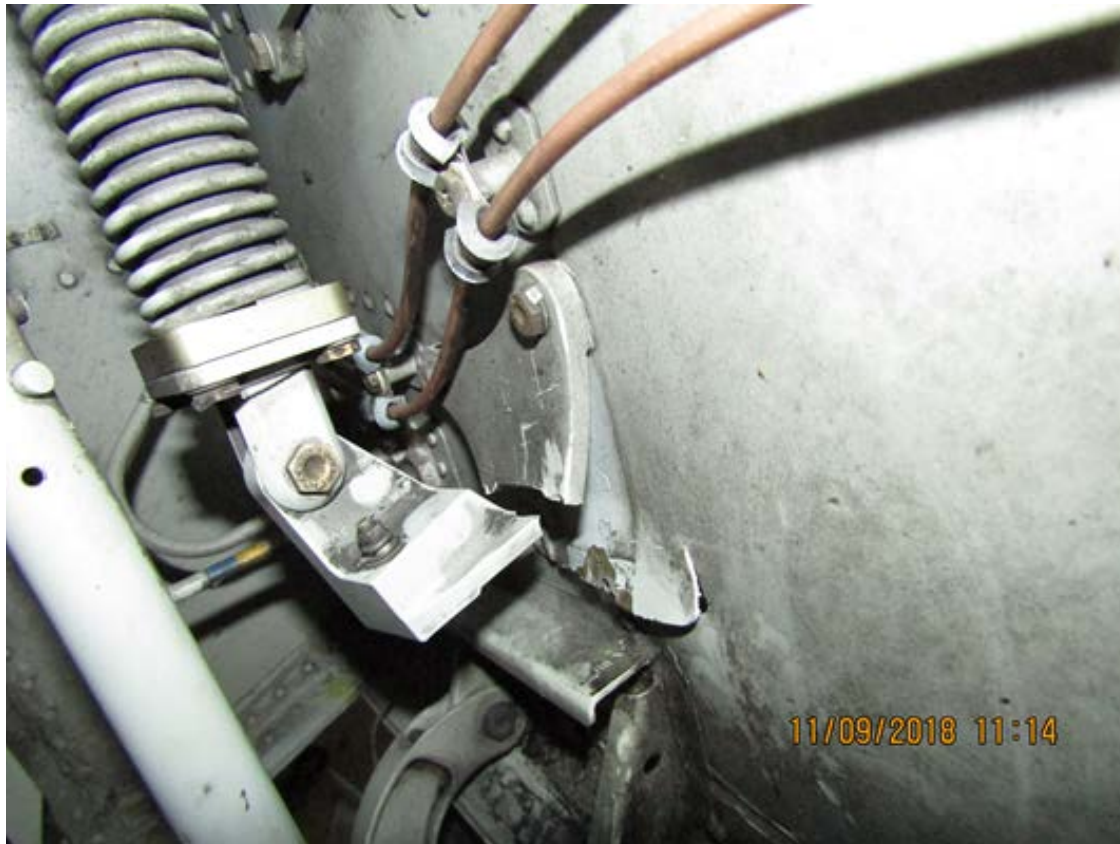
During the approach, the gear disagree message appeared on the engine-indicating and crew-alerting system (EICAS) accompanied by the EICAS Display 1, an indication that the nose landing gear (NLG) was not in the down and locked position. The Quick Reference Handbook (QRH) was applied and a manual landing gear extension was accomplished. Upon inspection, the NLG door spring bracket was found broken and the associated web was found to be damaged.

Figure 1: Broken bracket viewed from front

cracking was present and detectable prior to the bracket failure. The area is readily accessible and can be easily inspected visually for damage.

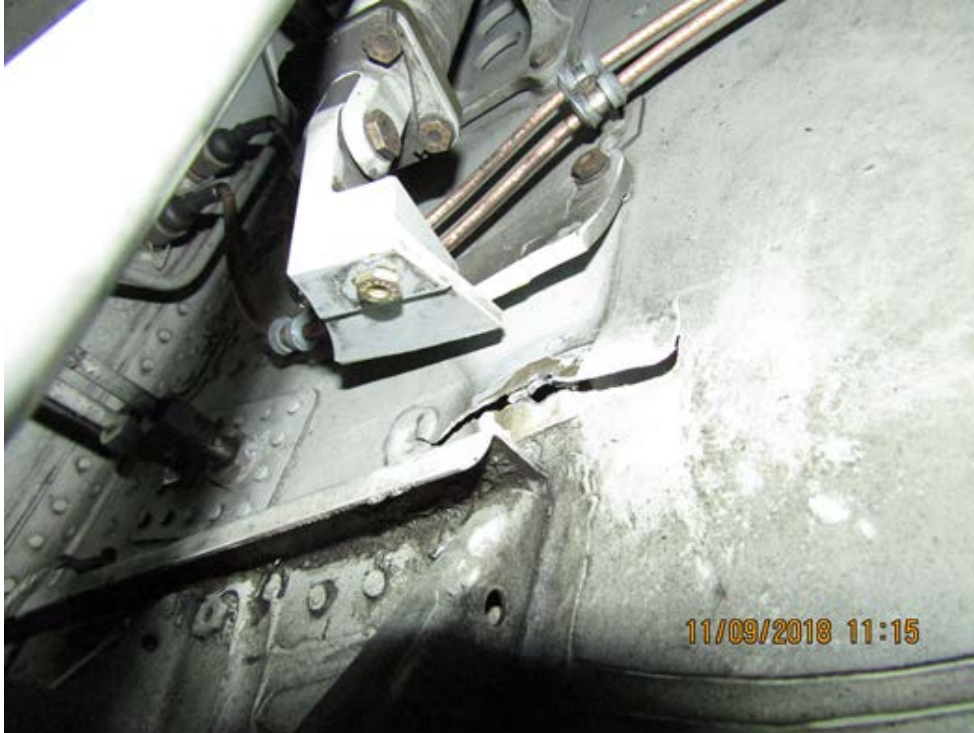
Figure 2: Broken bracket viewed from below shows damage to fitting attachment

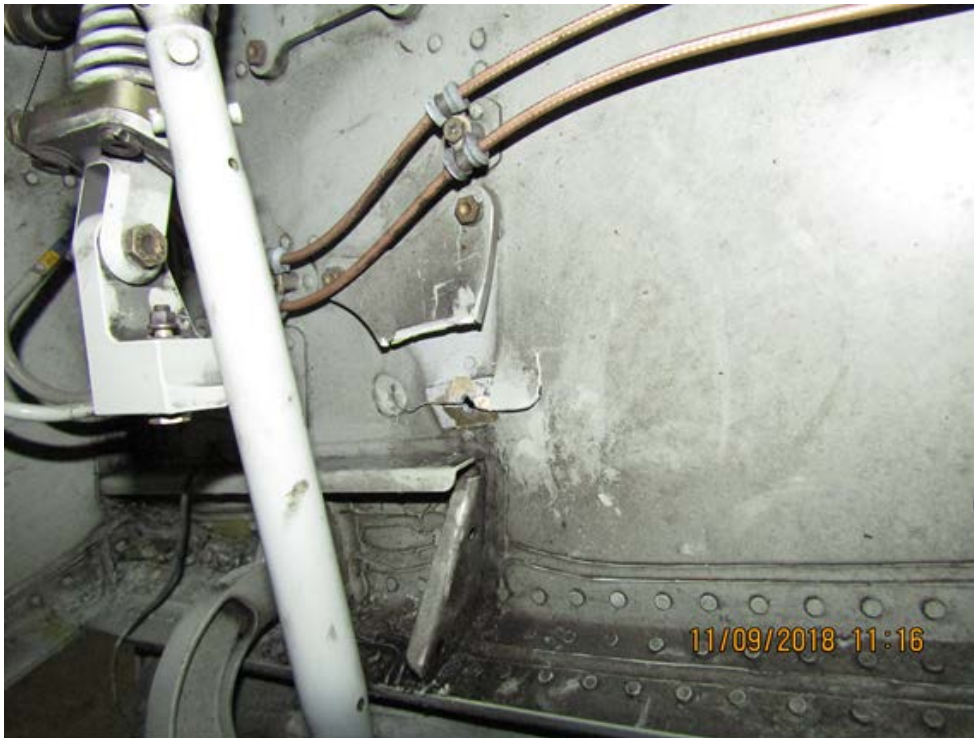
Figure 3: Broken bracket viewed from front showing bulkhead damage

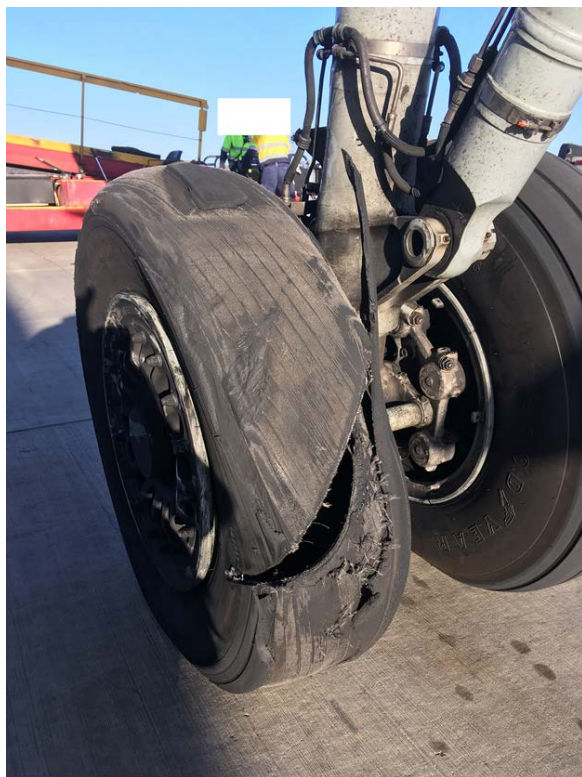
The pilot reported that during takeoff the left-hand inboard main wheel tire ruptured. The aircraft landed back at the departure airport without additional failures and taxied to the bay. During the preliminary inspection by maintenance staff, it was observed that the rupturing tire had caused damage to the gear door composite, main leg fairings and nearby hydraulic lines and harness brackets. The tire that failed was a retread. Both main wheels were replaced prior to towing the aircraft to the hanger for further investigation and defect rectification. The main landing gear door is beyond repair and an order has been placed for a replacement door.

Image of the damaged tire

There is a higher risk of tread separation with recap tires than brand new tires. Tire tread that separates from the recap tire can cause substantial damage to aircraft. Operators operating on gravel runways should consider using only new tires to reduce the risk of tire failure. Recapped tires can fail on any runway but are more likely to do so in rough conditions.

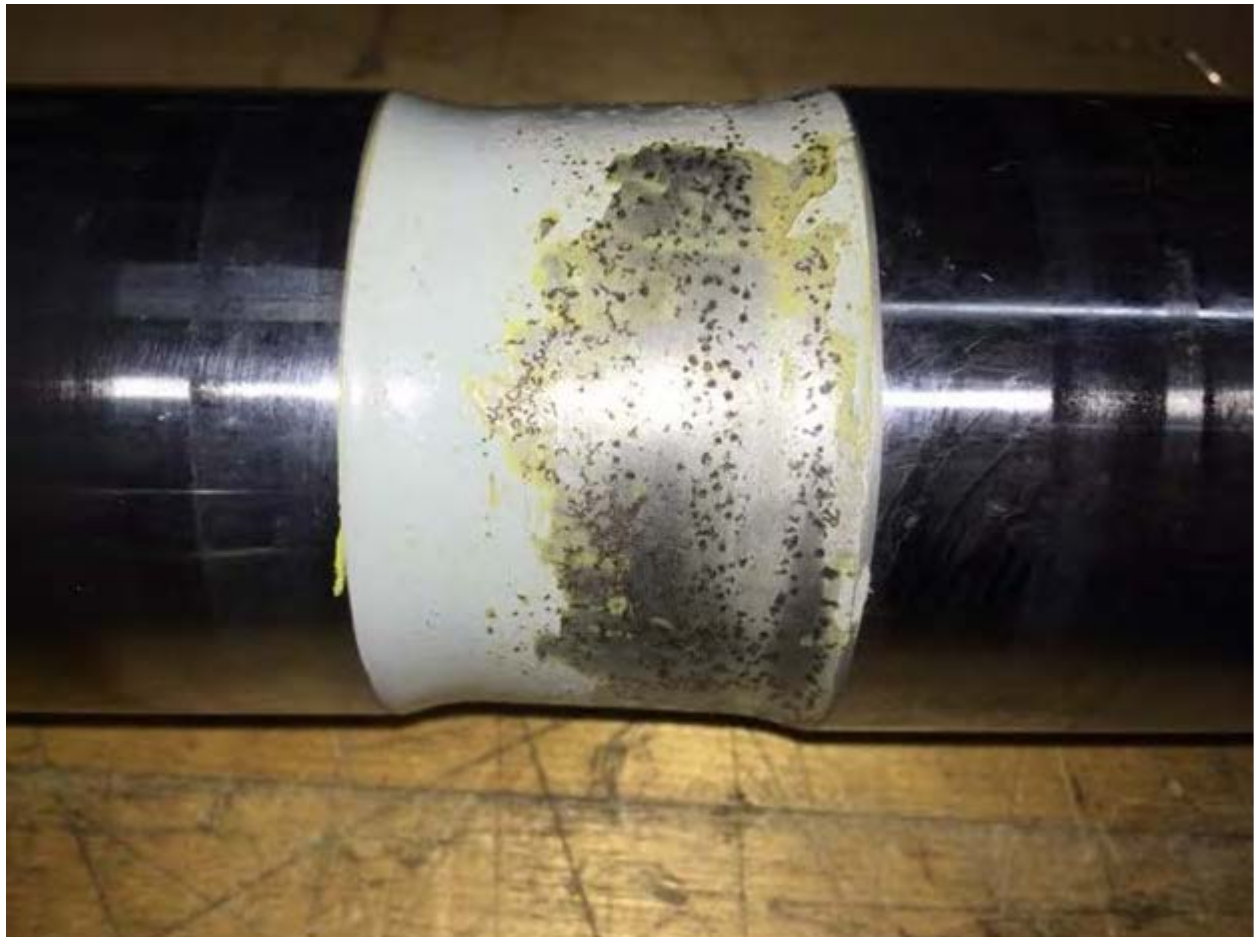
During scheduled maintenance, corrosion (pitting) in excess of allowable limits was observed on the left main landing gear axle, part number 46108-3. Similar findings were also observed on the right main landing gear axle. Both affected axles were replaced.

Pitting on the painted part of the axle

Anytime the wheel is removed, the axle should be inspected for damage such as scratches, corrosion, damaged chrome or damaged threads. The axle nut should also be inspected for damage. Some aircraft have very high torque on the axle nut and this can damage the threads on the nut or the axle. In this case, the corrosion was under the paint and could only be seen clearly once the paint was removed.

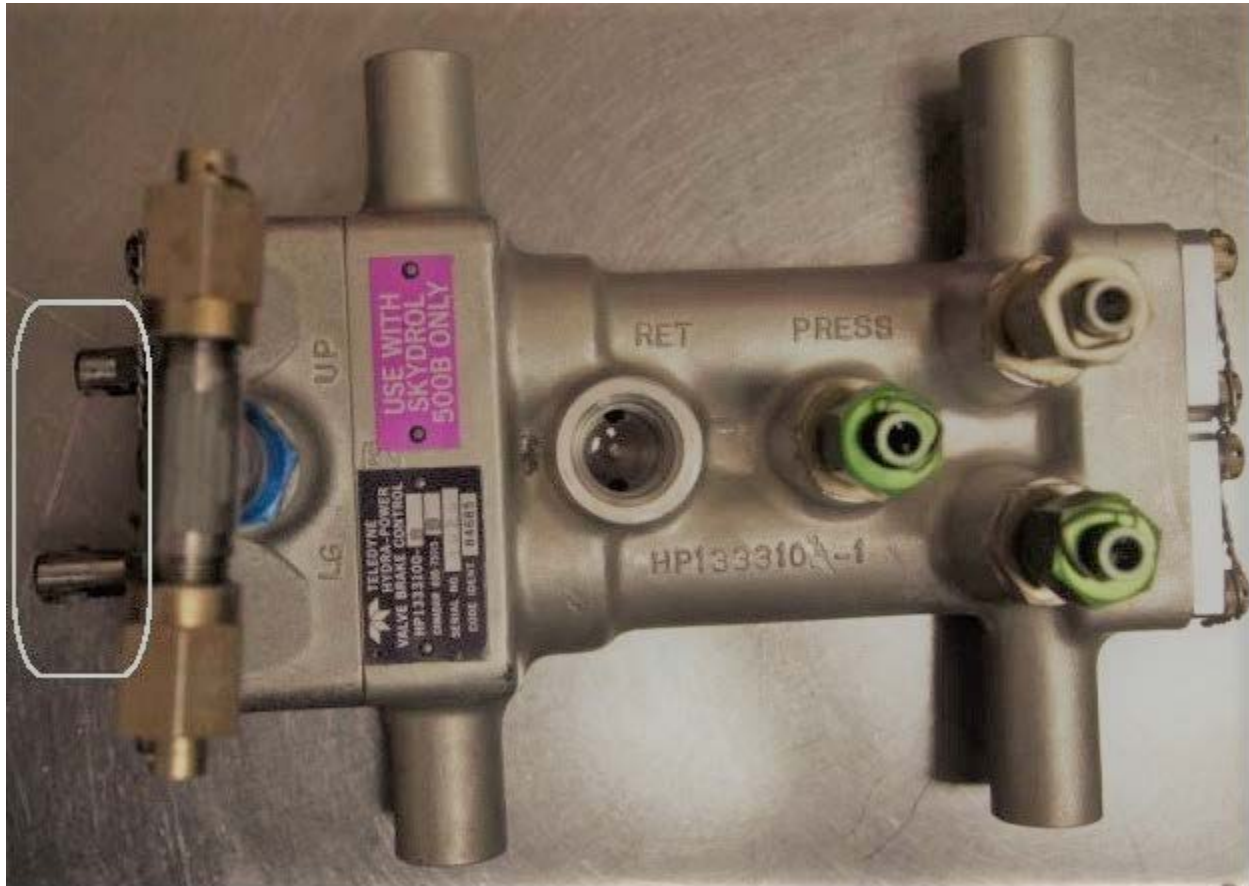
During an investigation of an aircraft landing overrun, the dual BCV, Tactair part number (P/N) HP1333100-9 (Bombardier P/N 600-75115-9), was found with a broken spring that reduced the brake pressure to the #2 brake. The #2 BCV (position left inboard) was shop tested and found that the brake performance was degraded as the output pressure was 150 psi instead of the normal pressure of 2850 to 3000 psi. During the pre-disassembly visual inspection, the input plunger (rod) on the BVC was found to be recessed and was asymmetrical when compared with the adjacent input plunger (rod). The vendor found that the root cause of this condition was determined to be a broken power brake spring inside the valve assembly.

Fig 1: BCV showing misalignment of valve plunger positions.

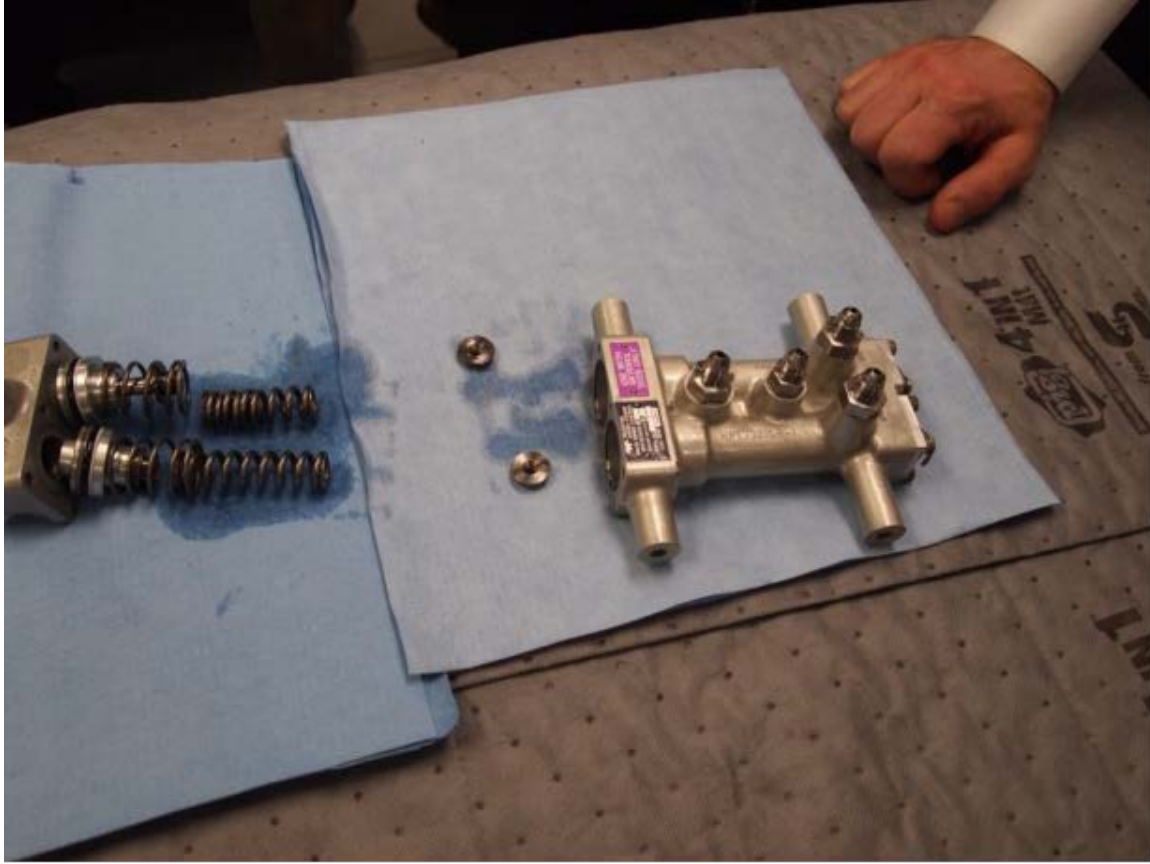
The final accident report for this incident found that the failed BCV (broken spring) was one of a number of contributing factors to the runway excursion. The report also concluded that the BCV spring failed (due to fatigue) during the incident as braking operation had been normal on the previous landing.

Fig 2: Disassembled BCV showing broken spring that caused the misalignment of the plungers.

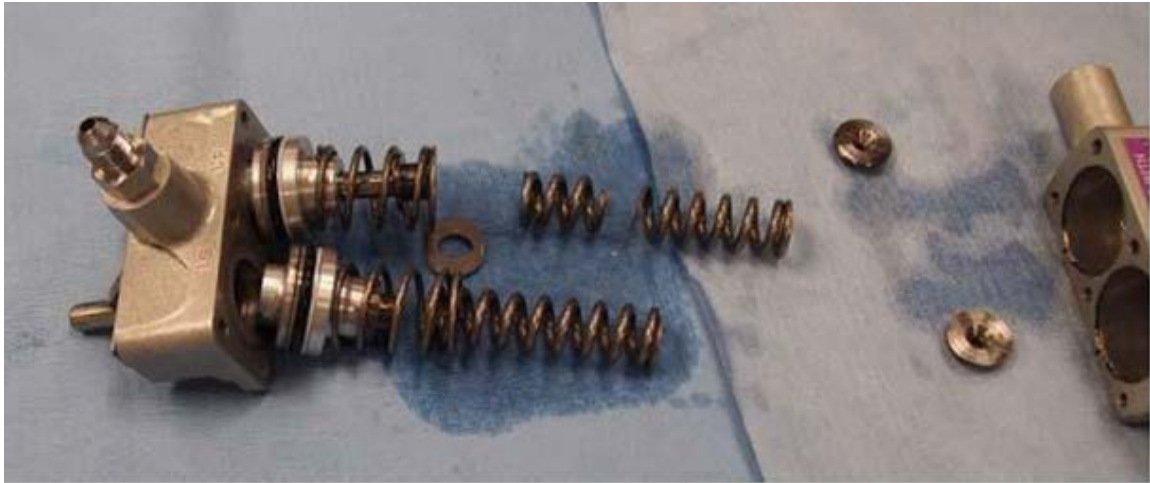
Fig 3: Close up of broken spring of the BCV.
