Feedback

Canadian Aviation Service Difficulty Reports

The following content was published between July 8, 2020 and December 29, 2020. The full accessible version of each article is available on the Feedback [website](#).

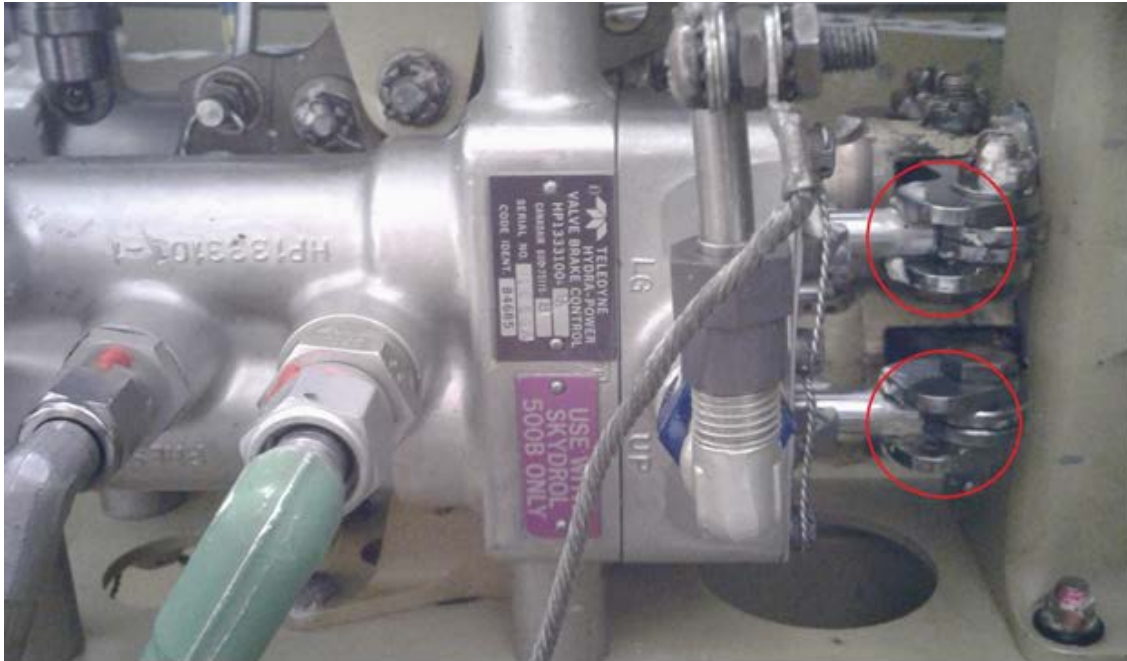
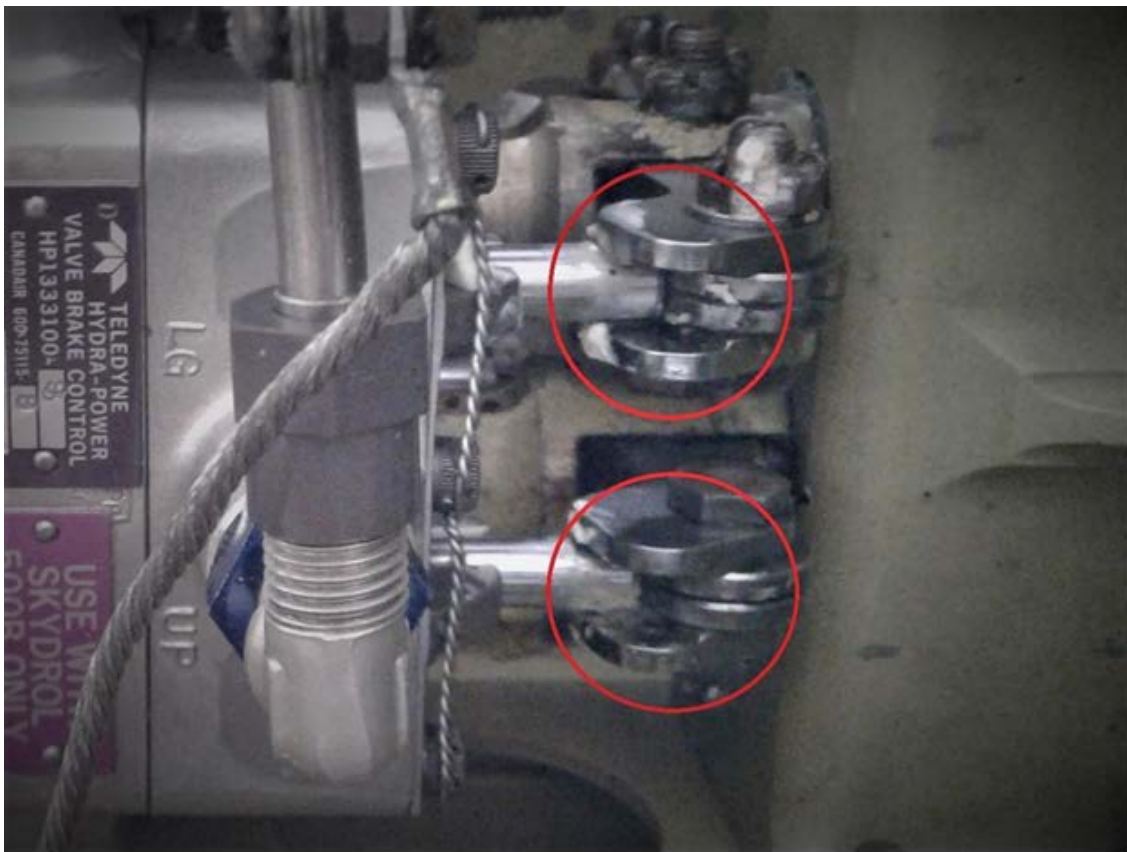
Fig 4: Challenger 601 brake valve installation showing plungers contacting brake levers.

Fig 5: Close up of brake valve plungers in normal condition in contact with brake levers.

Maintainers and operators should investigate any brake pedal issues reported by the crew as BCVs with high time in service may be prone to spring breakage. To check the integrity of the internal brake valve spring, depress both brake pedals and release. Then perform a visual inspection of the BCV with a light and mirror to confirm the brake valve plungers contact the brake levers. If both valve plungers are contacting the levers, the brake springs are not broken. (Refer to Figures 4 and 5 for a visual view of this condition.)

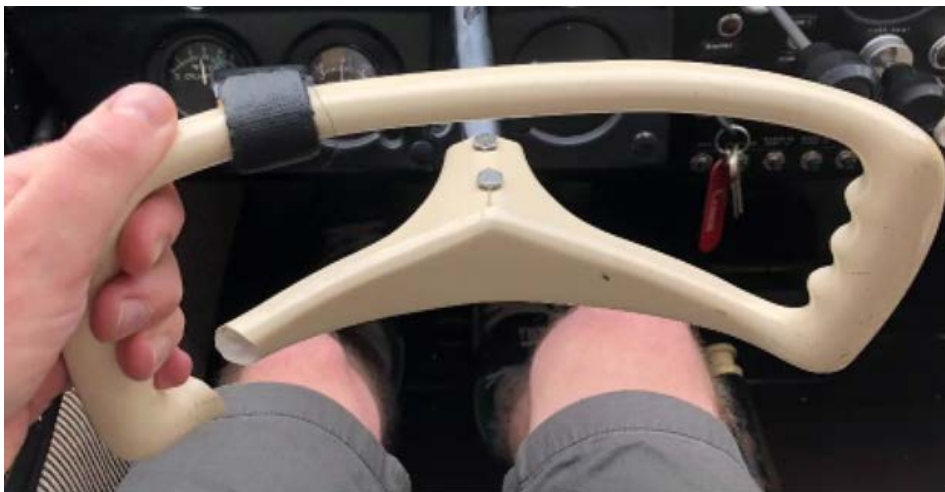
The control wheel (part number 0513168-2) cracked / broke in the lower left-hand (LH) area when the pilot was on final approach. The pilot grabbed the unbroken side of the wheel and landed without incident. The control wheel is the original plastic style and had not been replaced with the newer magnesium style in accordance with Cessna Service Letter SL64-8.

NOTE: The co-pilot's control wheel was inspected and found to be cracked and "glued" back together in the same spot.

Cracked Plastic Control Wheel

A cracked control wheel during a critical phase of flight such as landing, where control inputs are at their greatest, could result in sudden loss of control of the aeroplane. Transport Canada Civil Aviation (TCCA) would like to reiterate the gravity of the Federal Aviation Administration (FAA) Special Airworthiness Information Bulletin (SAIB) CE-01-41R2 published in October 2007, which focuses on fatigue cracking of plastic (acrylic) control wheels. As noted in the SAIB, owners, operators and maintenance personnel should place special emphasis on periodic 100-hour and annual inspections of plastic control wheels until they are replaced with metallic control wheels.

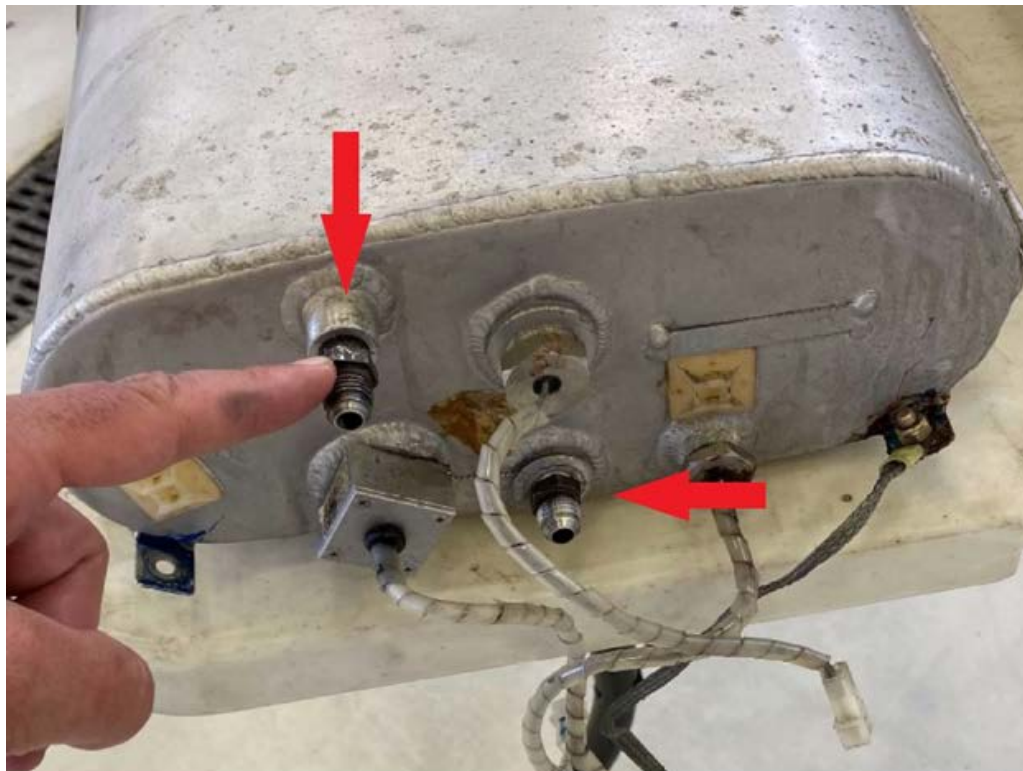
ECU (Engine Control Unit) A FAIL and ECU B FAIL indications displayed during flight. Maintenance personnel discovered that the fuel supply line and the return fuel lines were found crossed (engine drawing fuel from return fitting) at the right wing root attach point connections. The lines are the same size and can be easily mixed up when being reattached following wing removal.

Fuel supply and return line fittings

It is possible to mix up the fuel supply line and return fuel line connections on both left-hand and right-hand wing root connection points, although the part numbers are unique. This is also possible on DA 40 D and DA 40 NG model aeroplanes. Transport Canada Civil Aviation reminds maintenance personnel of the importance of labeling hoses / fittings during disassembly.

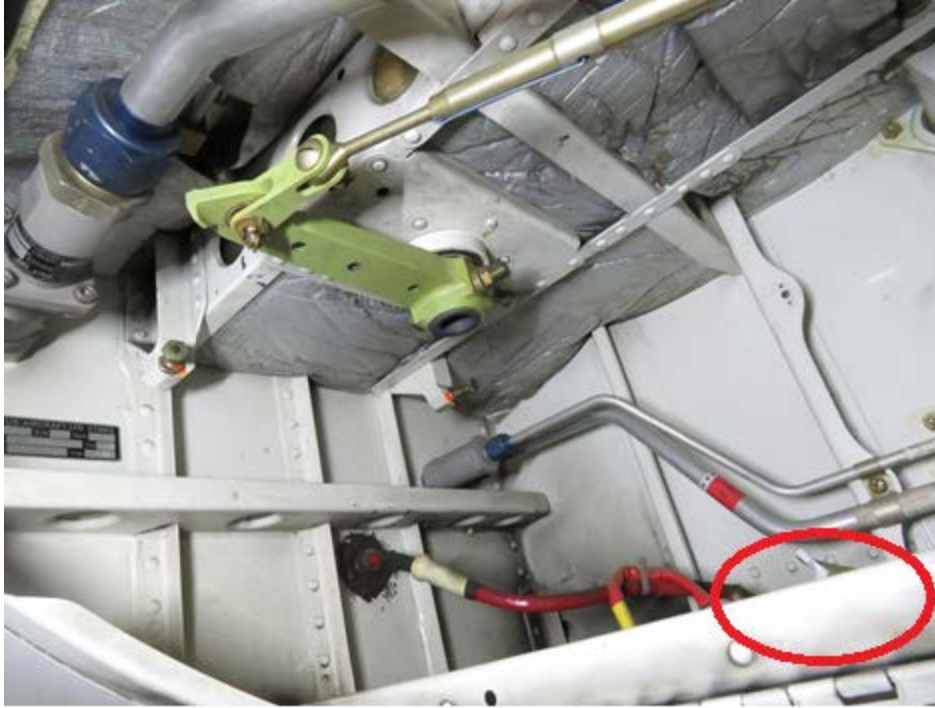
The flight crew of the subject aircraft reported that they lost all rudder steering control during ground taxi maneuvers. An investigation was performed and found that the forward rudder bellcrank part number 527.20.12.116 was cracked in half. The cracked bellcrank resulted in loss of steering and rudder control. The cracked bellcrank as well as a damaged rod end was replaced. A full rigging and control check was completed to return the aircraft to service.

The flight crew of this aircraft was fortunate that the bellcrank failed during taxi and not in the air. Inspection by maintenance found that the bellcrank did not appear overstressed or bent. The aft flange of the cracked portion seemed to have distorted as the bellcrank was in the final stage of failing. Black residue in the area of the forward cracked pieces was also noted.

After removal, the failed bellcrank was sent to Pilatus headquarters in Stans Switzerland for failure analysis. Preliminary findings point to a very small corrosion spot as the starting point of the crack/fracture.

Pic. 1 Bellcrank assembly as found by maintenance prior to removal. Broken piece of bellcrank (circled) found on floor of cavity.

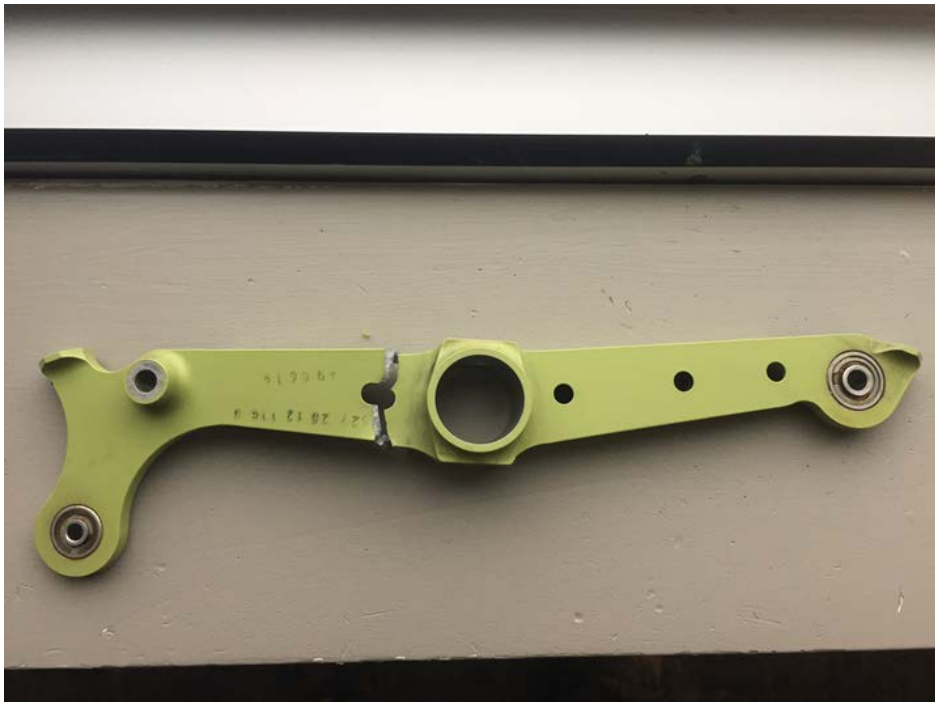
Pic. 2 Bellcrank removed on bench. Crack evident.

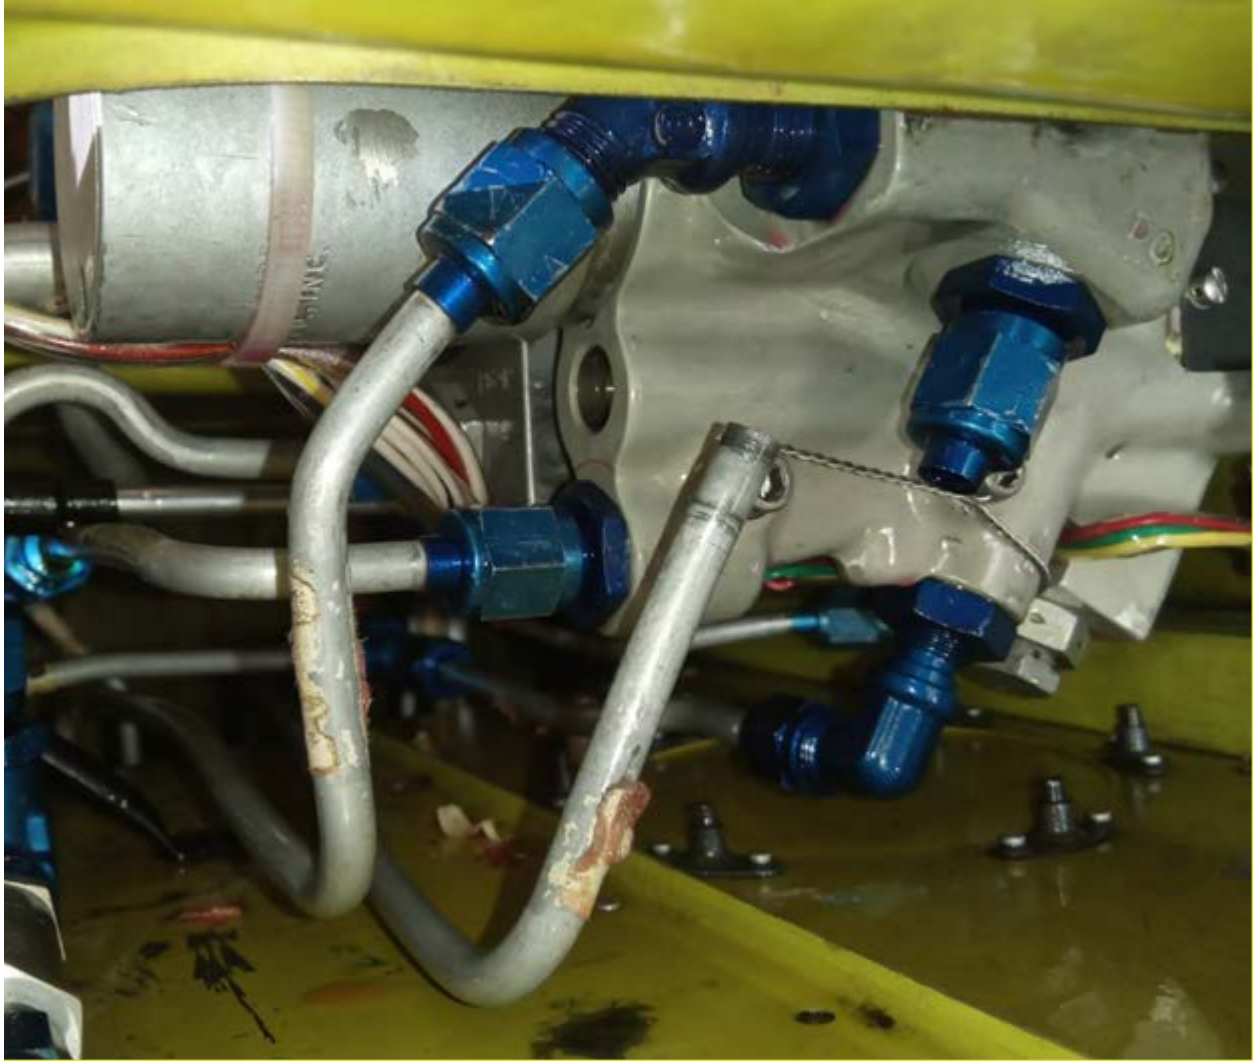
Upon inspecting the aircraft during the recovery from the runway, there was hydraulic fluid leaking from the aircraft. An aluminum hydraulic line was found broken at the flare. Once the line broke, the hydraulic pumps expelled the fluid from the reservoir down to the top of the normal system standpipe. The rest of the fluid was expelled by the pilot while operating the emergency system.

Piper PA31 gear up landing events have occurred on at least 3 occasions due to a cracked hydraulic line flare at the powerpack. A failed line in the hydraulic system can allow all the fluid from the hydraulic reservoir, including that portion contained in the power pack emergency sump, to drain out.

Hydraulic door open tube assembly failure at flare

Operators and maintenance personnel are reminded that improper alignment, clamping and torqueing of hydraulic lines and fittings can lead to torsional or bending pre-loads, and introduce fatigue cracking.

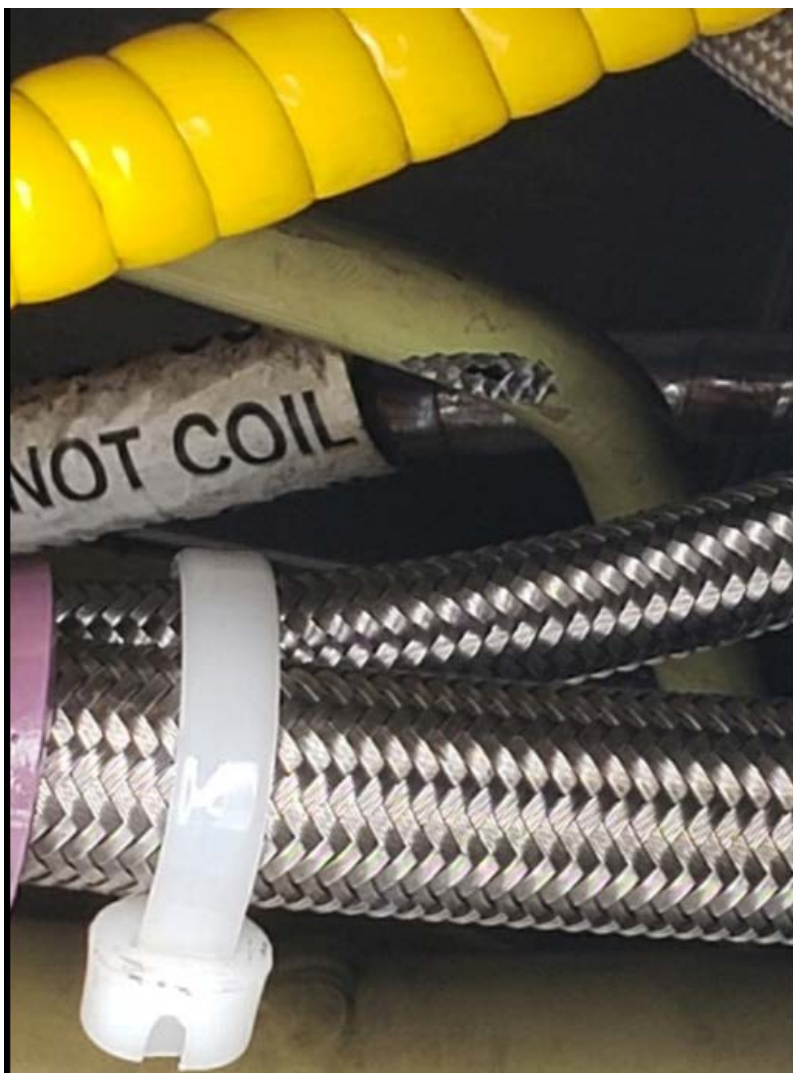
A RH OIL PRESSURE warning message appeared while cruising at 33 000 feet. The message was intermittent. Once the message reappeared, we reduced the right-hand engine thrust to idle, performed immediate action and shut the engine down. Maintenance personnel found the oil fill line chafed and a defective check valve at the

Although not the only contributor to this event, had the oil fill line not been chafed it may have been able to contain the engine oil.

Chafed oil fill line

Congested areas are prone to such events and maintainers must pay particular attention to the routing of lines and bundles when working in such areas.

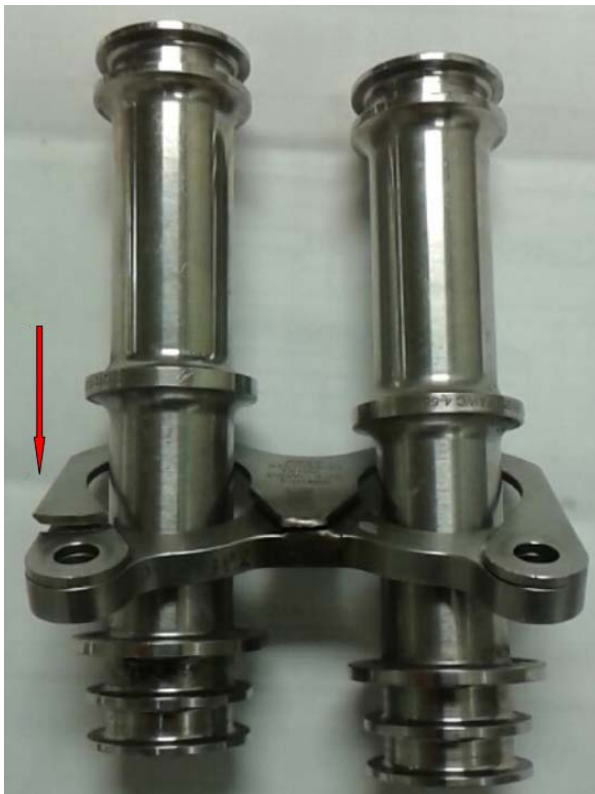
Photo 1 Transfer tube assembly

During the accomplishment of a scheduled maintenance task (replacement of the Fuel Metering Unit (FMU) to the Fuel/Oil Heat Exchanger (FOHE) transfer tubes), an Aircraft Maintenance Engineer (AME) noted that the fuel transfer tube bracket on the left engine was cracked. The assembly was replaced with a serviceable component and the aircraft was returned to service.

Pratt & Whitney Canada (P&WC) is aware that cracks develop occasionally on the weld, equally in the pre- and post-mod configurations (see P&WC Service Bulletin No.3533R1). These cracks typically do not affect the functionality of the bracket and are usually discovered during opportunistic inspections when the tubes/bracket assemblies are replaced.

Transport Canada would like to make maintainers aware of the possibility of these cracks and to pay particular attention to these transfer tubes when circumstances provide access to the FMU as well as during scheduled maintenance.

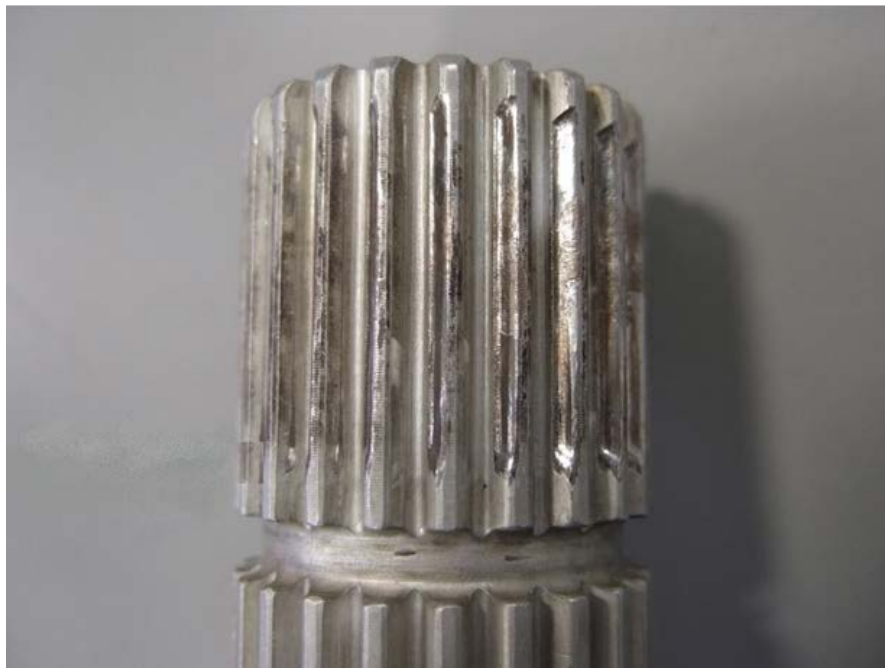
Example of the wear found on the tail rotor output wheel spline

STC SR00491DE is for installation of an Air Comm air conditioning kit on an Airbus Helicopters model EC120B helicopter. Similar to this Service Difficulty Report (SDR), Air Comm received reports of wear at the spline joint that consists of the air conditioner drive pulley and the tail rotor output wheel. This spline joint is an integral piece of the power transmission components responsible for the tail rotor drive. Air Comm published Service Bulletin (SB) EC120-111815 to specify an inspection of the pulley-output wheel interface for wear. The Federal Aviation Administration (FAA) has mandated inspection of affected aircraft with Airworthiness Directive (AD) 2017-06-11. Owners, operators and maintainers should be aware that the corrective action and compliance time specified in the SB and AD are different. In addition, the FAA AD requires the inspection results to be reported to the FAA.
