AIRCRAFT ACCIDENT REPORT AND EXECUTIVE SUMMARY

Reference:		CA18/2/3/10273	
Aircraft Registration	ZS-OKS	Date of Accident	22 February 2023		Time of Accident	0951Z	
Type of Aircraft	Beechcraft Baron BE55		Type of Operation		Private (Part 91)		
Pilot-in-command Licence Type	Airline Transport Pilot Licence (ATPL) Aeroplane		Age	54	Licence Valid	Yes	
Pilot-in-command Flying Experience	Total Flying Hours		4900.0		Hours on Type	53.3	
Last Point of Departure	Pearly Beach Private Airstrip, Western Cape Province						
Next Point of Intended Landing	Oudtshoorn Aerodrome (FAOH), Western Cape Province						
Damage to Aircraft	Substantial						
Location of the accident site with reference to easily defined geographical points (GPS readings if possible)							
R43 road, 3.7km from Runway 15 threshold at Global Positioning System (GPS) determined to be 34°39'01"S 019°30'48"E at an elevation of 65.6 ft							
Meteorological Information	Wind velocity: 230° at 6KT; Temperature: 23°C; Dew Point: 11°C; Visibility: ≥10000m; Cloud: CAVOK; QNH: 1019 hPa

Probable Cause							
Loss of engine power due to incorrect setting of the fuel condition levers which led to fuel starvation and the subsequent unsucce

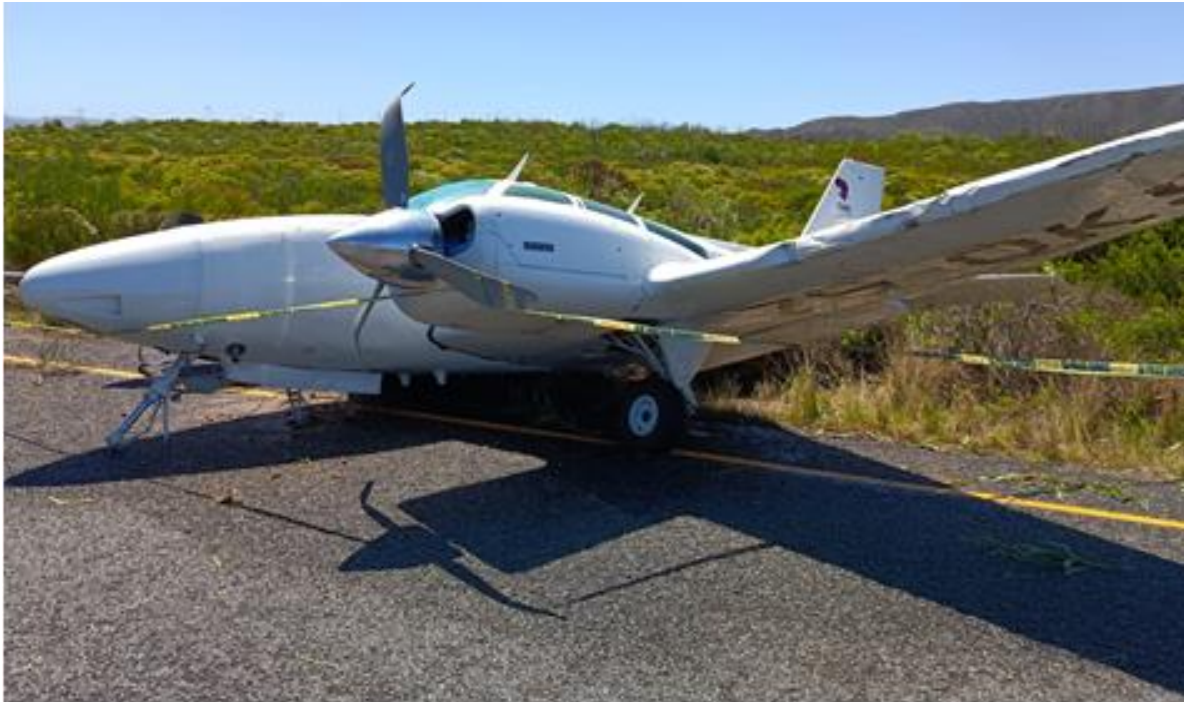
1.3.1. The aircraft sustained substantial damage to the right main landing gear, propellers and wings during the accident sequence.

Figure 2: The aircraft as it came to rest. (Source: Operator)

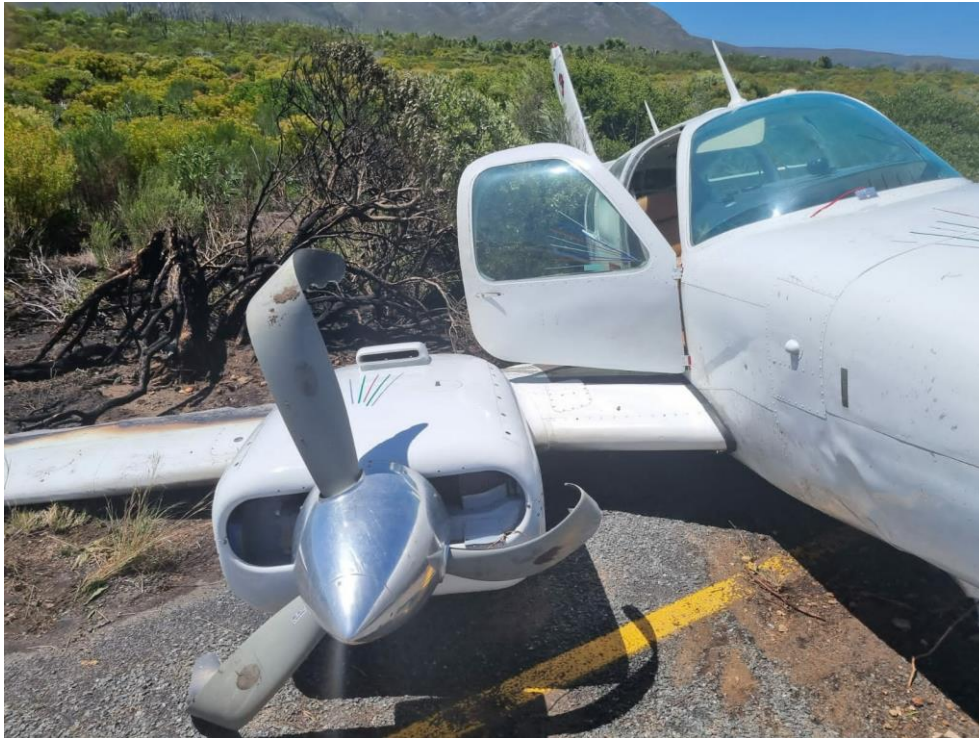
1.12.3. The inspection of the airframe, engine and propeller indicated that there was no pre-impact failures, and all damage was attributed to the impact forces during the forced landing sequence. The left-side propeller damage had minimal rotation force during impact, an

indication of no significant engine power. Pronounced damage was to the right propeller blades than the left propeller blades due to the collapse of the right gear assembly which resulted in the propeller strikes on the ground whilst rotating. Both engines were subjected to a teardown inspection by the AMO; no anomalies were noted.

Figure 3: Damage to the right wing and propeller blades. (Source: Operator)

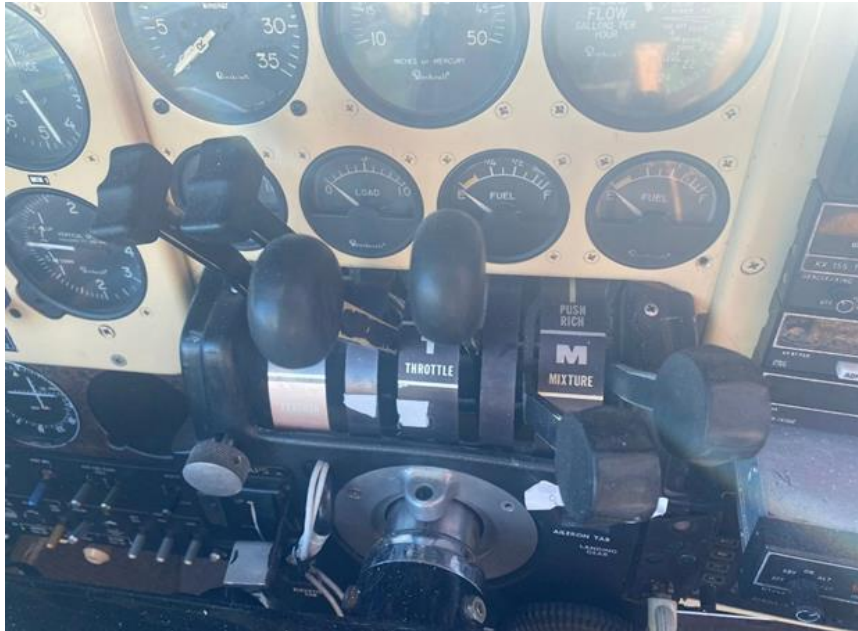
- Right and left engine power levers were towards the 'open' position.
- Propeller levers were towards the 'unfeathered' position.
- Right and left engine mixture levers were in 'lean' position. (Figure 4)
- The magneto switches were found in the 'on' position.
- Fuel selectors were found in auxiliary position.
- Landing and strobe lights were found in the 'on' position.
- Flaps selector was found in the first notch (take-off) position.

Figure 4: The throttle lever power quadrant after the accident. (Source: Operator)

- 2.2.5. Based on the position of the aircraft's power controls as they were found at the accident scene (Figure 4), it is probable that the pilot may have inadvertently over leaned the engine mixtures which led to loss of both engines power due to non-standard positioning of the levers. The position of the fuel mixture lever during recovery rendered the optimal fuel flow of 13 gallons per hour (Gal/hr) to maintain normal flight, which was impossible as both fuel condition levers were set at a position which supplied 7 to 8 Gal/hour. Therefore, the engines power loss was probably due to fuel starvation.

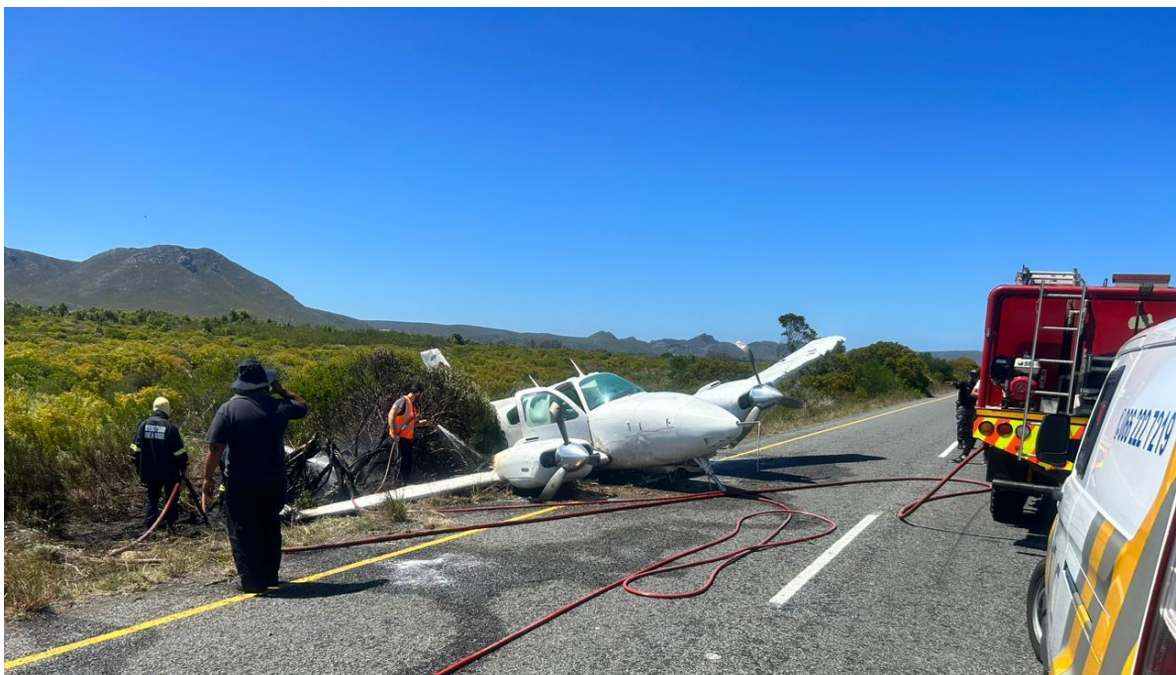
1.14.1. A post-impact fire initiated from the right-wing trailing edge after the landing sequence. A truck driver who was driving by helped the pilot contain the fire using a portable fire extinguisher to contain the fire before the arrival of EMS. The fire was extinguished by the EMS personnel.

Figure 5: The EMS at the accident site. (Source: EMS)

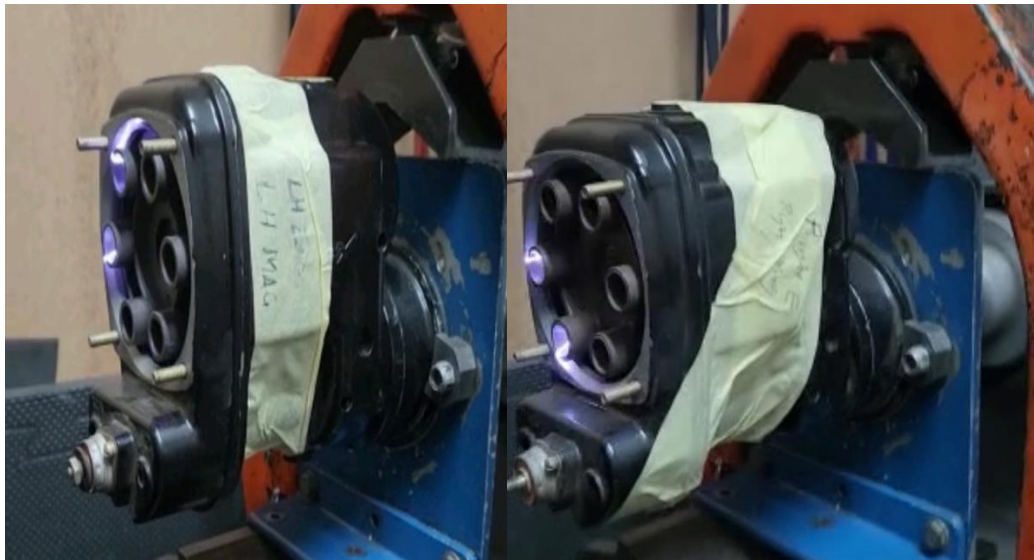
1.16.2. On 24 February 2023, the electric components – four magnetos and two alternator generators – were taken to an approved AMO at George Airport (FAGG) for testing. The components were tested by qualified aircraft maintenance engineers (AME) in the presence of the investigators using calibrated equipment. No anomalies were detected on the components. The AMO had an AMO certificate that was issued by the Regulator on 2 November 2022 with an expiry date of 30 November 2023.

Figures 6 and 7: The left and right magnetos during testing.

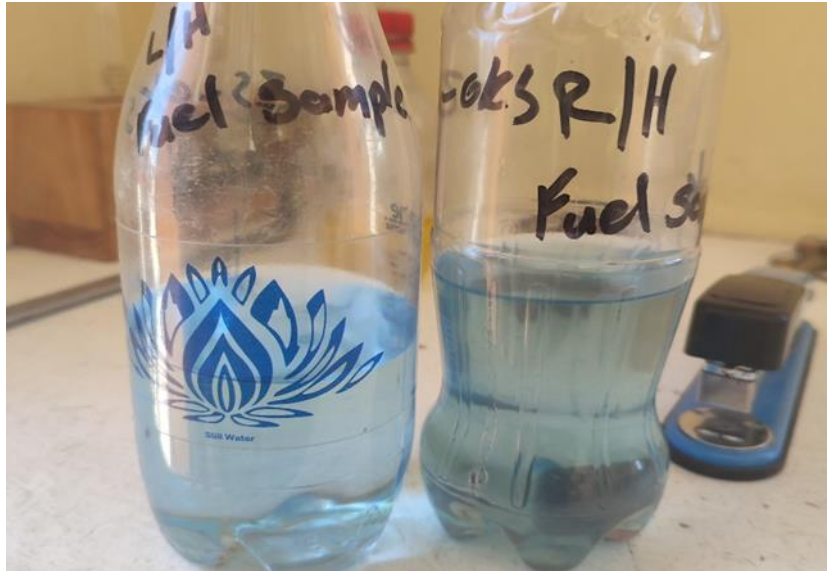
1.16.3. Fuel samples from the fuel tanks were tested for water and contaminants, and none was detected. The aircraft fuel system, including fuel pumps, were bench tested on 16 March 2023 and they met all the parameters set out by the manufacturer.

Figure 8: The fuel samples from the left and right tanks.

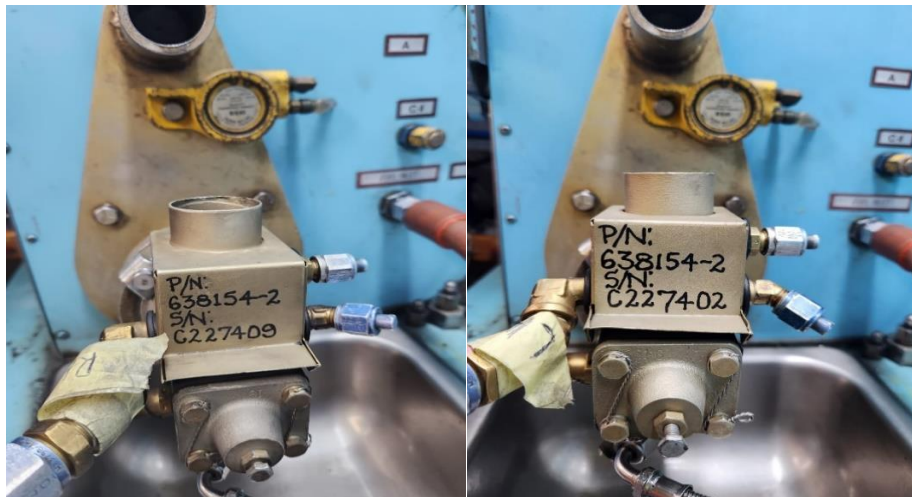
Figures 9 and 10: The left and right fuel pumps on a test bench.
