LIMITED OCCURRENCE INVESTIGATION REPORT – FINAL

Reference Number	CA18/2/3/10473							
Classification	Accident			Date	28 July 2024		Time	0820Z
Type of Operation	Private (Part 91)							
Location								
Place of Departure	Grand Central Airport (FAGC), Gauteng Province			Place of Intended Landing	Lebenya Farm, Swartruggens, North West Province			
Place of Occurrence	On Runway 15 at Lebenya Farm, North West Province							
GPS Co-ordinates	Latitude	26° 37' 39" S	Longitude	26° 37' 05" E	Elevation	4 386ft		
Aircraft Information								
Registration	ZS-IIL							
Make; Model; S/N	Cessna; C182N (Serial Number: 182-60499)							
Damage to Aircraft	Substantial			Total Aircraft Hours	2 550.7			
Pilot-in-command								
Licence Type	Private Pilot Licence (PPL)			Gender	Male		Age	61
Licence Valid	Yes	Total Hours	199.4		Total Hours on Type	90.1		
Total Hours 30 Days	10.6			Total Flying on Type Past 90 Days	33.8			
People On-board	1+1	Injuries	0	Fatalities	0	Other (on ground)	0

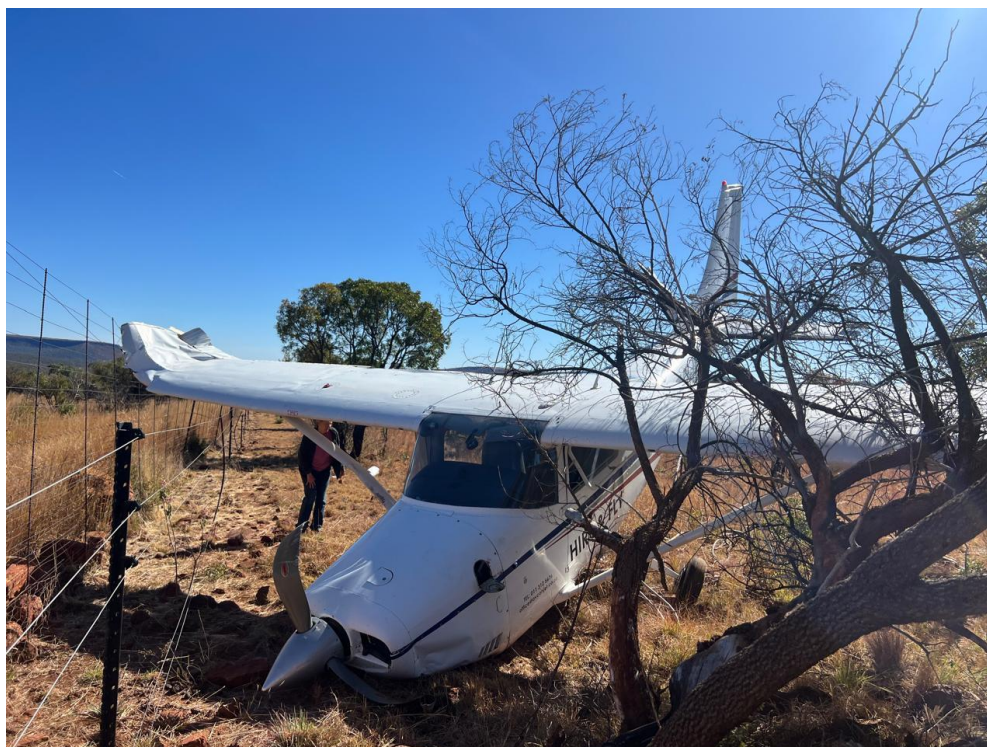
Figure 2: The aircraft on the right side of the runway. (Source: Operator)

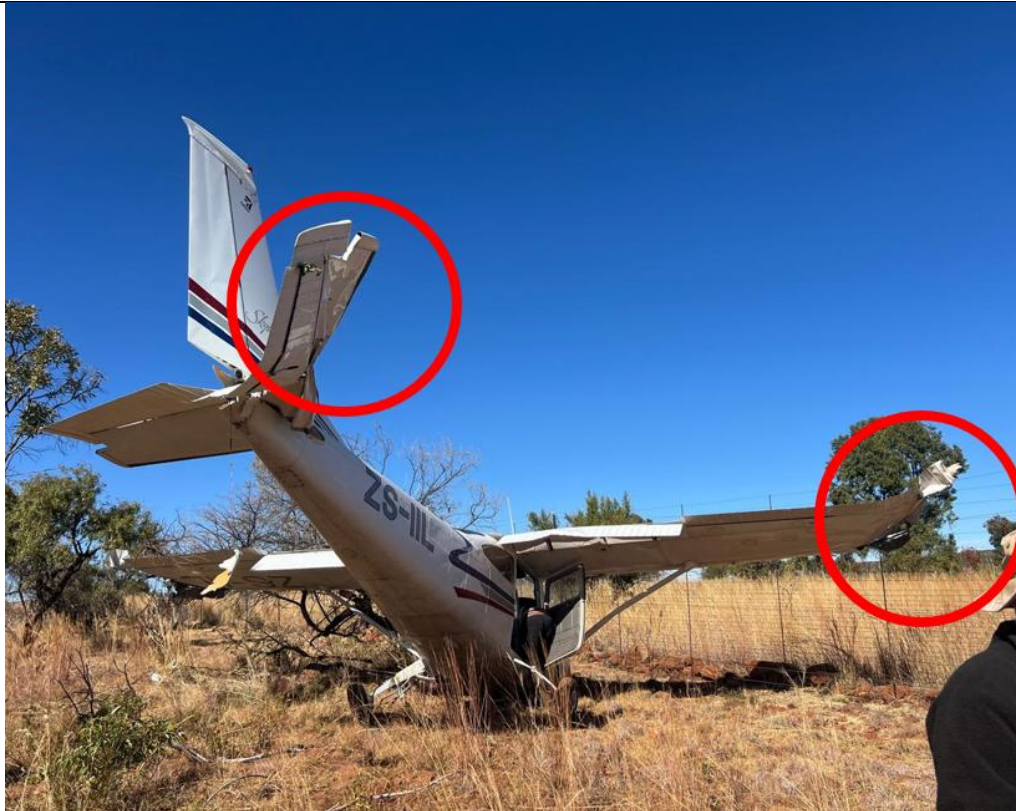
Figure 3: The rear view of the aircraft. (Source: Pilot)

The aircraft sustained damage to both the right-side wing tip and the elevator (circled in red); it likely impacted the ground with the right-wing tip and elevator. The pilot stated that he turned the control column to the right during the landing approach to compensate for the crosswind from the right.

The damage to the right-wing tip and elevator indicated that the pilot used the wing-low (sideslip) method.

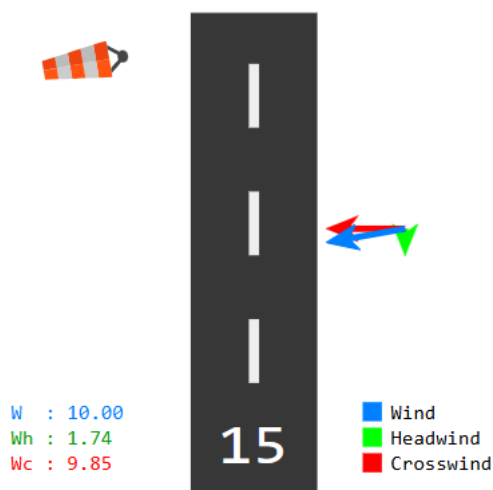
Figure 4: The calculated crosswind component at the time of the accident.

The maximum demonstrated crosswind component of the aircraft is 15 knots. The pilot encountered a crosswind of 9.85 knots from the right during landing on RWY 15. The crosswind component was within the maximum demonstrated crosswind component of the aircraft.
