**LIMITED OCCURRENCE INVESTIGATION REPORT – FINAL**

<b>Reference Number</b>	CA18/2/3/10476					
<b>Classification</b>	Accident	<b>Date</b>	7 August 2024	<b>Time</b>	1045Z	
<b>Type of Operation</b>	Training (Part 141)					
<b>Location</b>						
<b>Place of Departure</b>	Rhino Park Aerodrome, Gauteng Province		<b>Place of Intended Landing</b>	Rhino Park Aerodrome, Gauteng Province		
<b>Place of Occurrence</b>	During the landing roll on Runway 27 at Rhino Park Airfield, Gauteng Province					
<b>GPS Co-ordinates</b>	<b>Latitude</b>	25° 49' 59.54" S	<b>Longitude</b>	028° 32' 32.75" E	<b>Elevation</b>	4775 ft
<b>Aircraft Information</b>						
<b>Registration</b>	ZU-NEE					
<b>Make; Model; S/N</b>	Shadow Lite CC; Jabiru J430 (Serial Number: 570)					
<b>Damage to Aircraft</b>	Substantial			<b>Total Aircraft Hours</b>	2237.7	
<b>Pilot-in-command</b>						
<b>Licence Type</b>	Commercial Pilot Licence (CPL)		<b>Gender</b>	Male	<b>Age</b>	24
<b>Licence Valid</b>	Yes	<b>Total Hours</b>	363.7		<b>Total Hours on Type</b>	87.1

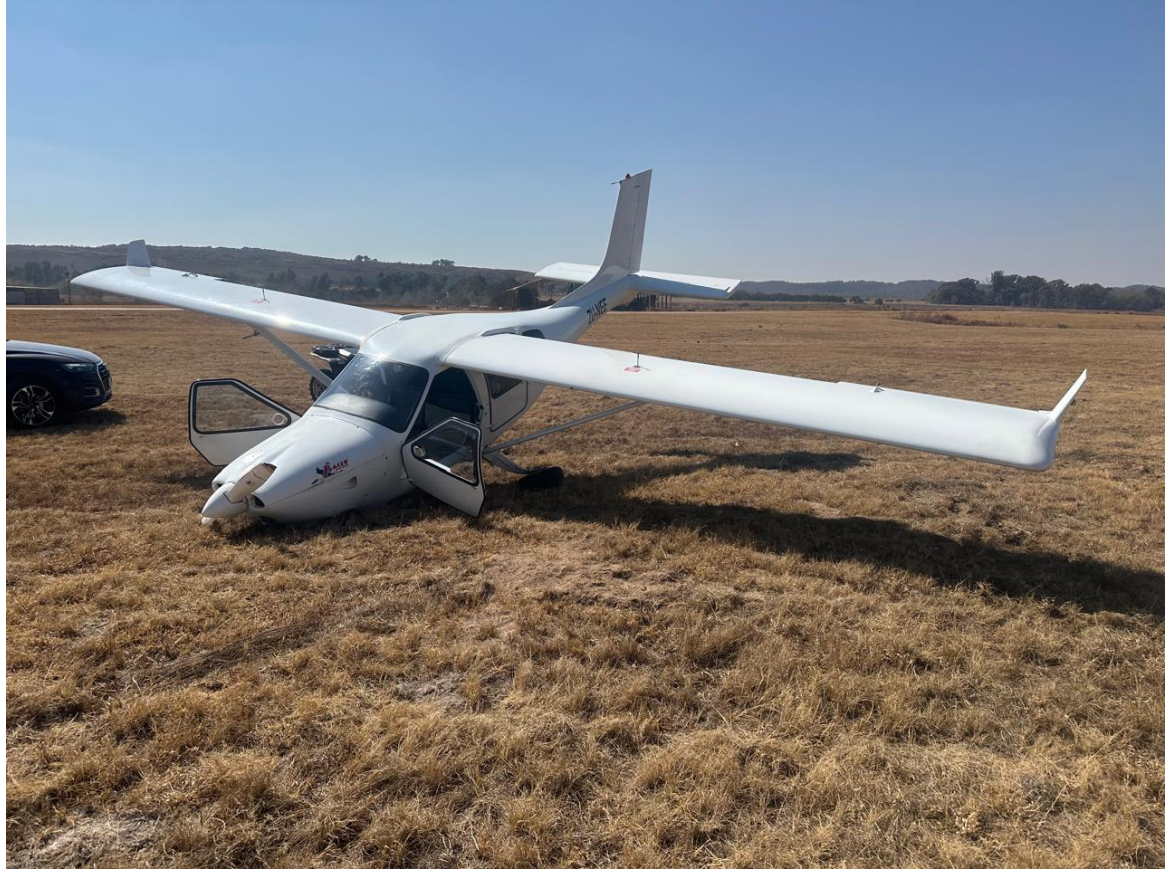
**Figure 2:** The aircraft as it came to rest. (Source: Operator)

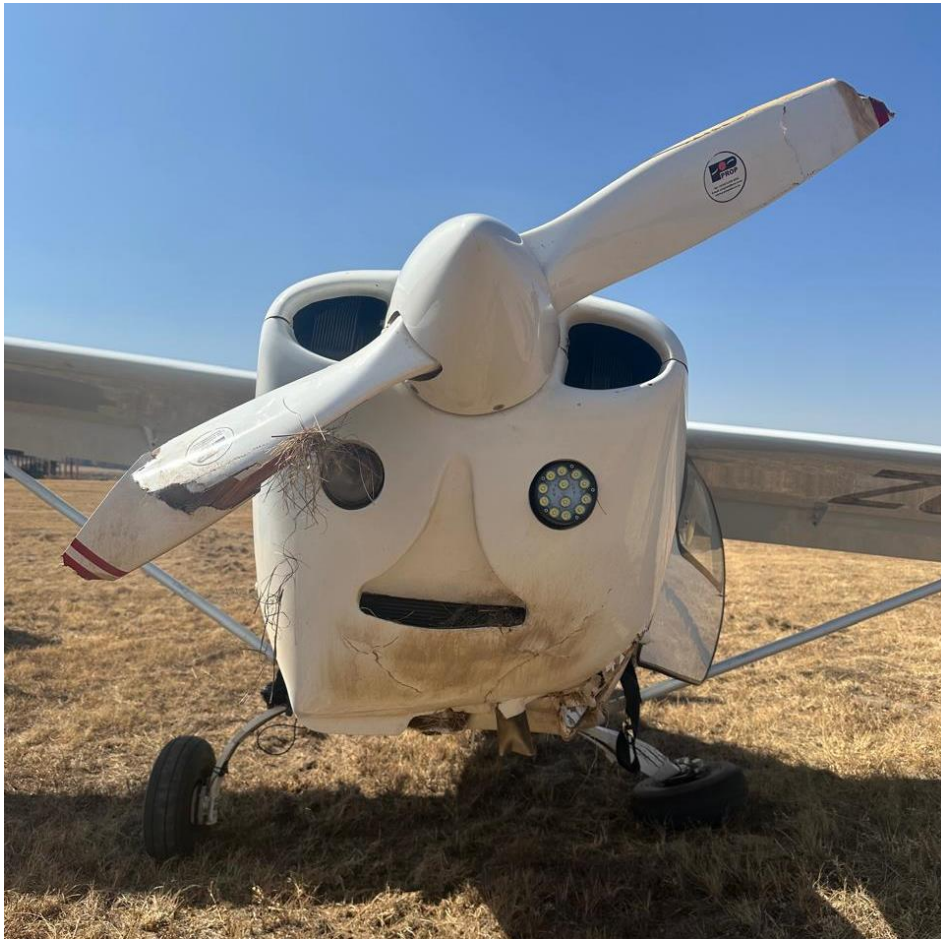
**Figure 3:** Damage to the propeller and the broken main left landing gear strut. (Source: Operator)

2.6 The aircraft landed hard due to the incorrect air speed and power mismanagement by the student pilot (flaring too early) which resulted in the aircraft impacting the runway hard with the left main landing gear; the landing gear failed during the landing roll.

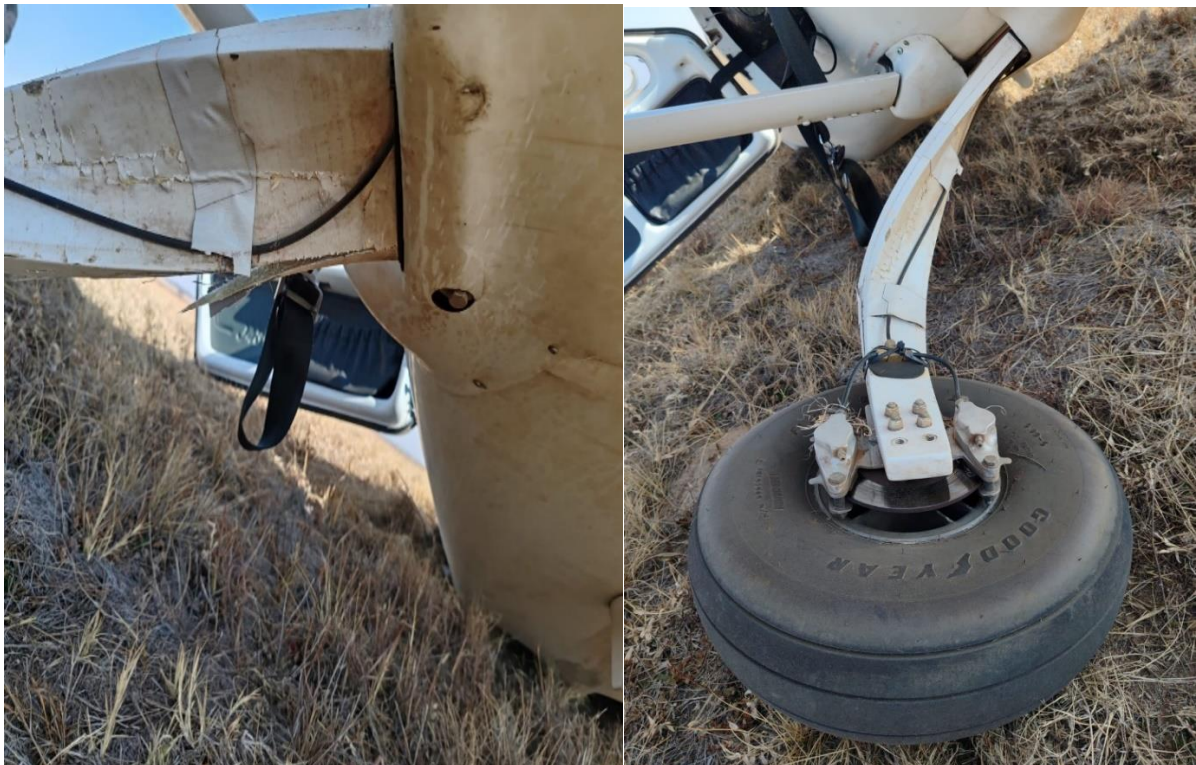
**Figures 4 and 5:** Delamination and damage to the left main gear. (Source: Operator)

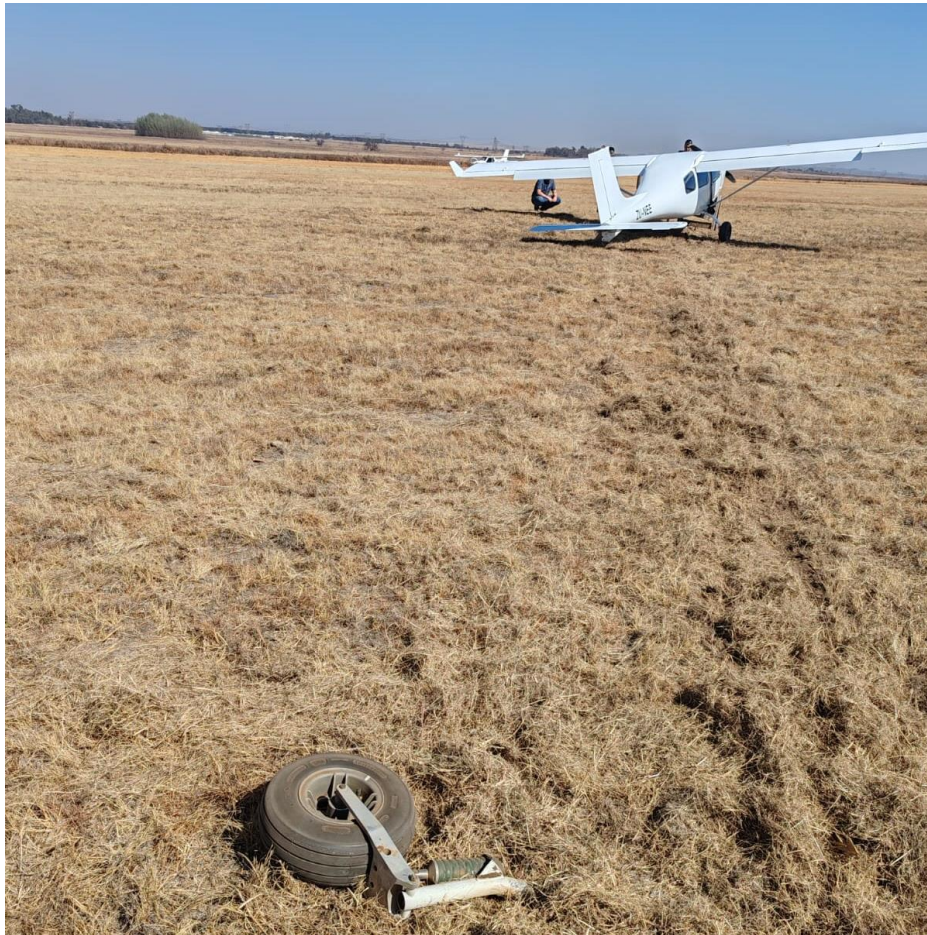
**Figure 6:** Damage to the landing gear. (Source: Operator)

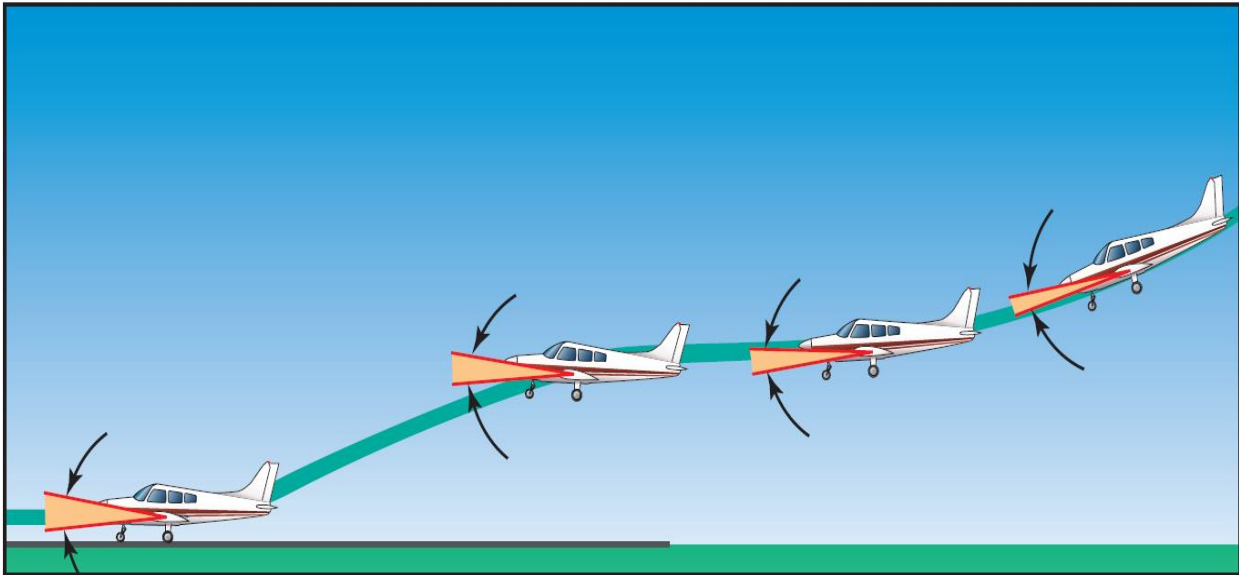
*Sometimes when the airplane appears to temporarily stop moving downward, the round out has been made too rapidly and the airplane is flying level, too high above the runway. Continuing the round out would further reduce the airspeed, resulting in an increase in angle-of-attack to the critical angle. This would result in the airplane stalling and dropping hard onto the runway. To prevent this, the pitch attitude should be held constant until the airplane decelerates enough to again start descending. Then the round-out can be continued to establish the proper landing attitude. This procedure should only be used when there is adequate airspeed. It may be necessary to add a slight amount of power to keep the airspeed from decreasing excessively and to avoid losing lift too rapidly. Although back-elevator pressure may be relaxed slightly, the nose should not be lowered any perceptible amount to make the airplane descend when fairly close to the runway unless some power is added momentarily. The momentary decrease in lift that would result from lowering the nose and decreasing the angle-of-attack may be so great that the airplane might contact the ground with the nosewheel first, which could collapse. When the proper landing attitude is attained, the airplane is approaching a stall because the airspeed is decreasing and the critical angle of attack is being approached, even though the pitch attitude is no longer being increased.*

**Figure 8:** Rounding out too high. (Source: FAA-8083-3A)

The aircraft landed hard after the student pilot flared too high, followed by the main landing gear failure and runway excursion to the left.
