**LIMITED OCCURRENCE INVESTIGATION REPORT – DRAFT**

| <b>Reference Number</b> | CA18/2/3/10546 | | | | | |
| <b>Registration</b> | ZS-RJC | | | | | |
| <b>Make; Model; S/N</b> | Robinson; R44 Raven II (Serial Number: 10347) | | | | | |

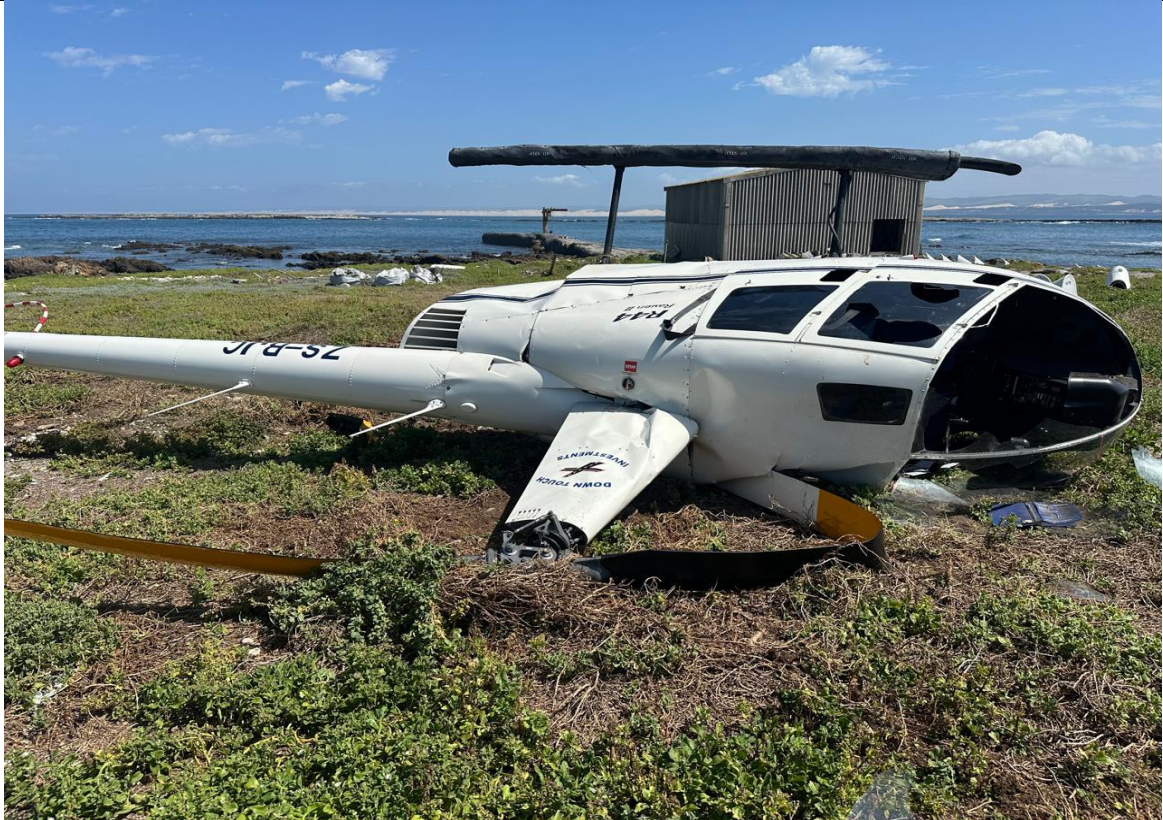
Whilst transitioning and about 15 metres (m) above ground level (AGL), the cardboard box slid off to the right and on to the pilot's cyclic pitch control lever. As a result, the cyclic pitch control lever advanced to the far-right position. The helicopter rolled to the right and the pilot could not recover timeously. Subsequently, the main rotor blades struck the ground. The helicopter impacted the ground on its starboard side approximately 20m from the point of lift-off. The helicopter sustained substantial damage. None of the occupants was injured; the penguin was also unharmed.

**Figure 2:** The helicopter as it came to rest. (Source: Pilot)

The cardboard box that contained the penguin slid off from the passenger's grip to the right and on to the pilot's cyclic pitch control lever. Consequently, the pilot lost control of the helicopter.

1. Strict adherence to Standard Operating Procedures (SOPs): Operators should reinforce adherence to SOPs and the Air Operator Certificate (AOC) to ensure that no animals are transported on-board aircraft unless permitted by the AOC and SOP. This would prevent illegal or unsafe practices.

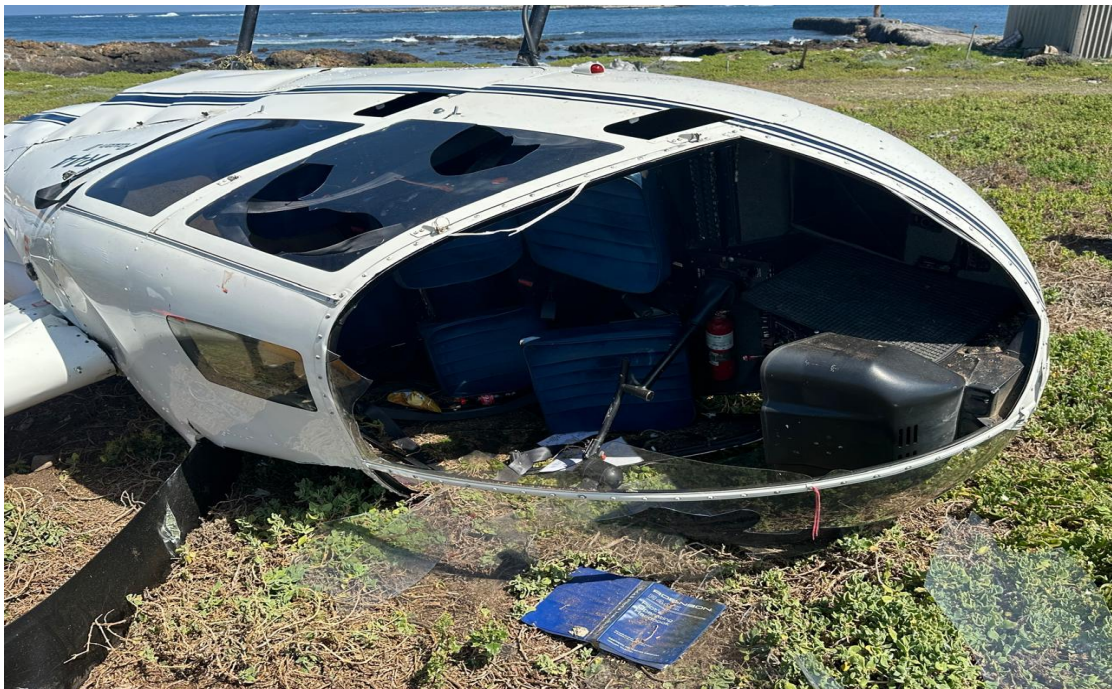
**Figure 3:** Closer view of the helicopter cabin. (Source: Pilot)

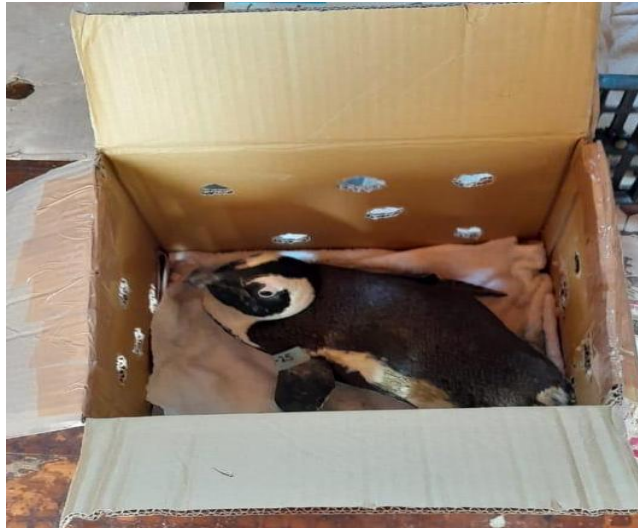
**Figure 4:** The penguin in a cardboard box. (Source: Operator's Safety Manager)

The transportation of the penguin in a cardboard box was not conducted in accordance with Part 127, Subpart 7 of the CAR 2011 as amended.

Whilst the pilot conducted inspection of the helicopter at Bird Island with no abnormalities found, the pilot omitted to state in the risk assessment form the intention to transport the penguin in a cardboard box on-board. The pilot made the decision despite that the procedure in which the penguin was transported was not in line with Part 127.07.34 of the CAR. An evaluation of the situation and potential hazards (such as cargo shifting) should have been conducted. The lack of secure containment for the penguin created a dangerous situation. The absence of a proper, secured crate meant that the penguin's containment was not suitable for the flight conditions. Proper cargo handling is crucial to ensure that items on-board do not interfere with flight controls or the safety of the passengers.

| <p>2. Training on load security: All personnel should receive training on the importance of securing loads, including non-standard items such as animals. This could include clear guidelines on the proper securing of cargo to prevent movement during flight.</p> <p>3. Pre-flight safety briefings: Safety briefings regarding carrying of passengers and the risks associated should be adhered to prior to flights. This will ensure that passengers are informed of the risks involved whilst also emphasising the responsibility of both pilots and passengers to manage those risks, thereby ensuring a safe operation.</p> <p>4. Risk assessment: It is recommended that when a deviation from a process is anticipated by the crew, the operator is notified to ensure that a risk assessment in line with their approved Safety Management System is completed and adhered to.</p> |
