**AIRCRAFT ACCIDENT REPORT AND EXECUTIVE SUMMARY**

<b>Reference:</b>		<b>CA18/2/3/10568</b>	
<b>Aircraft Registration</b>	<b>ZU-IMP</b>	<b>Date of Accident</b>	22 March 2025		<b>Time of Accident</b>	1300Z	
<b>Type of Aircraft</b>	Impala Mk I		<b>Type of Operation</b>		Private (Part 94)		
<b>Pilot-in-command Licence Type</b>		Commercial Pilot Licence (CPL) Aeroplane	<b>Age</b>	59	Licence Valid	Yes	
<b>Pilot-in-command Flying Experience</b>		<b>Total Flying Hours</b>		1 896.2 (Fixed Wing)	<b>Hours on Type</b>	26	
<b>Last Point of Departure</b>		Saldanha/Vredenburg Airport (FASD), Western Cape Province					
<b>Next Point of Intended Landing</b>		Saldanha/Vredenburg Airport (FASD), Western Cape Province					
Damage to Aircraft		Destroyed					
<b>Location of the accident site with reference to easily defined geographical points (GPS readings if possible)</b>							
Approximately 400m from Runway 20/02 at Saldanha/Vredenburg Airport (FASD), Western Cape Province

**Synopsis**

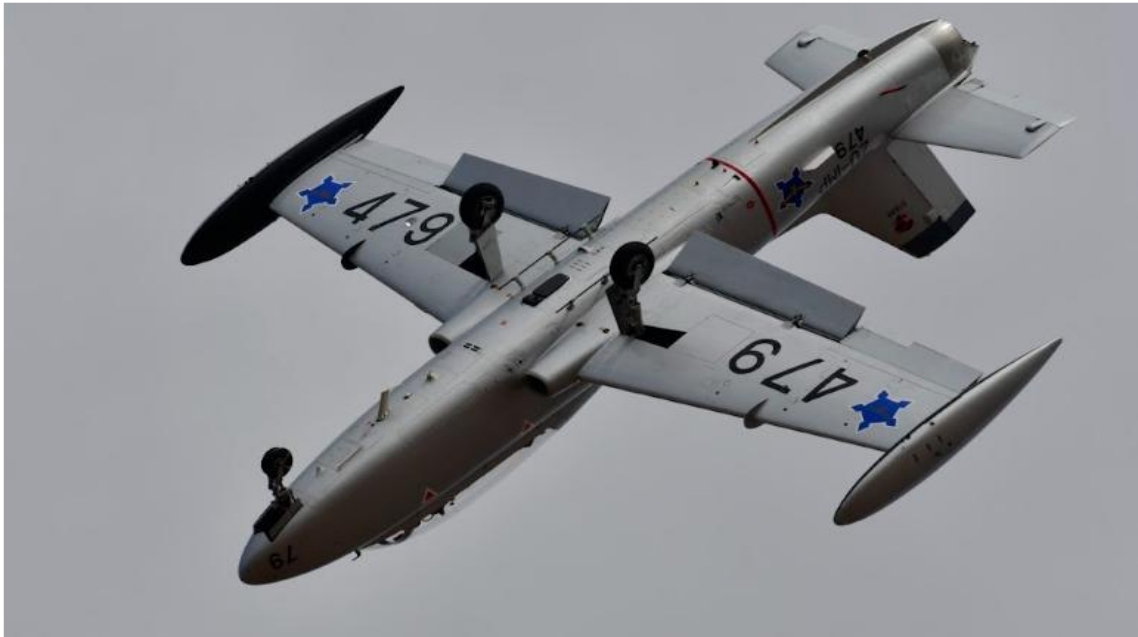
- 1.1.8. The first eyewitness who was attending the airshow stated that the ZU-IMP pilot performed a “dirty roll” (with the landing gear and flaps extended) manoeuvre to demonstrate the aircraft’s capabilities. At the top of the roll, the aircraft’s nose pitched down. As the aircraft continued to roll to level-wings position, it lost significant altitude. The aircraft appeared to stall, the nose pitched down and the aircraft disappeared behind the hangars. Moments later, white smoke followed by thick black smoke emanated from behind the hangars.

**Figure 1:** The aircraft in a nose-down attitude with the undercarriage and flaps extended (dirty roll manoeuvre). (Source: Airshow video footage)

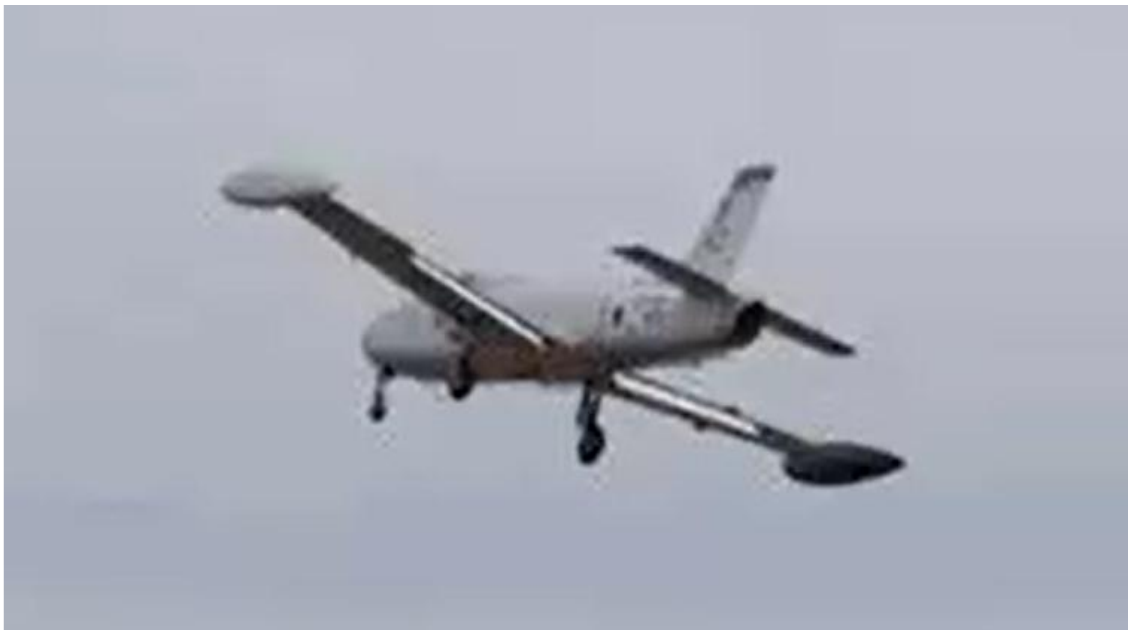
**Figure 2:** The right wing begins dipping to the right. (Source: Airshow video footage)

2.2.10. The progressive drop of the right wing was indicative of a possible aerodynamic stall of the right wing, reduced roll control effectiveness, or an asymmetric aerodynamic condition. The altitude at which the manoeuvre was executed provided limited height above ground level, thereby, significantly reducing the available margin for recovery once control was compromised.

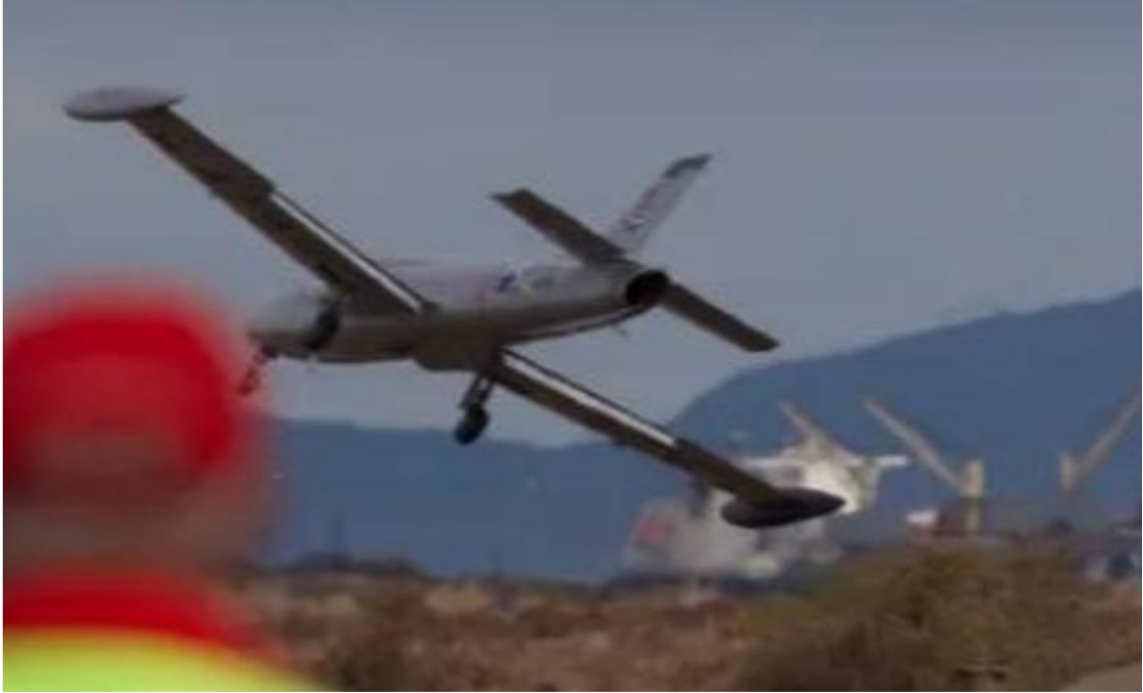
**Figure 3:** The right wing dipping right. (Source: Airshow video footage)

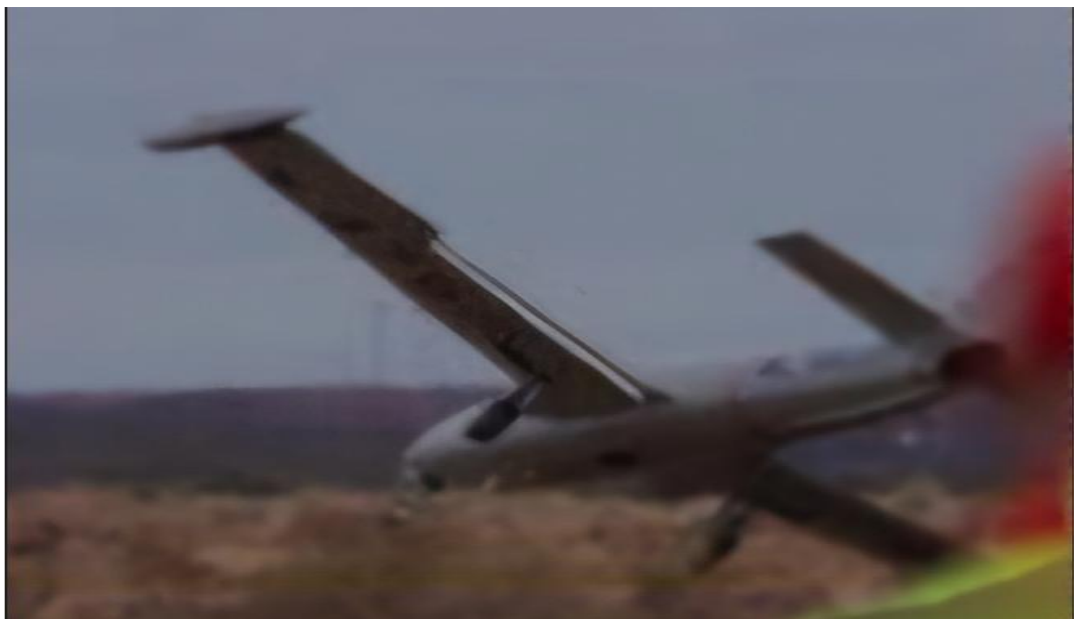
**Figure 4:** The right wing impacts the ground. (Source: Airshow video footage)

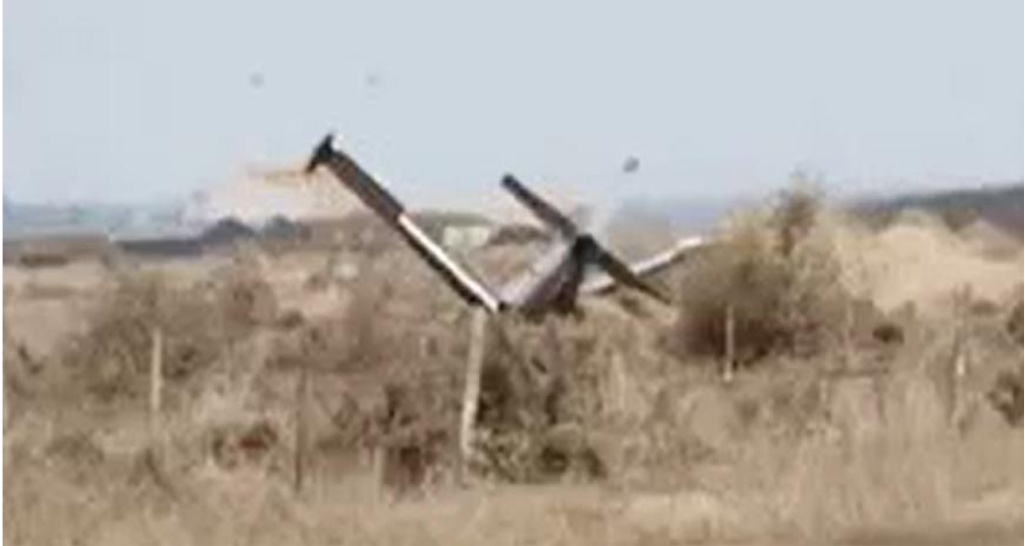
**Figure 5:** The aircraft impacts the ground. (Source: Airshow video footage)

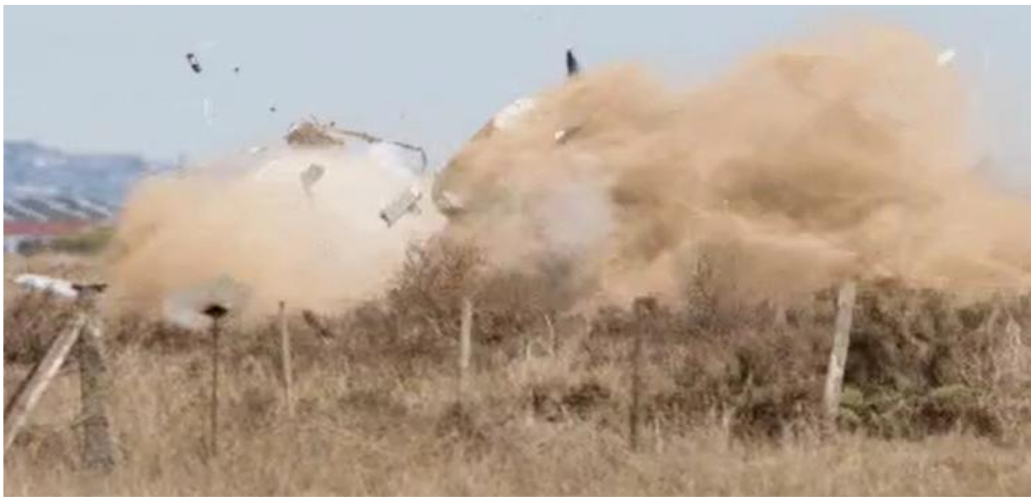
**Figure 6:** The aircraft disintegrates. (Source: Airshow video footage)

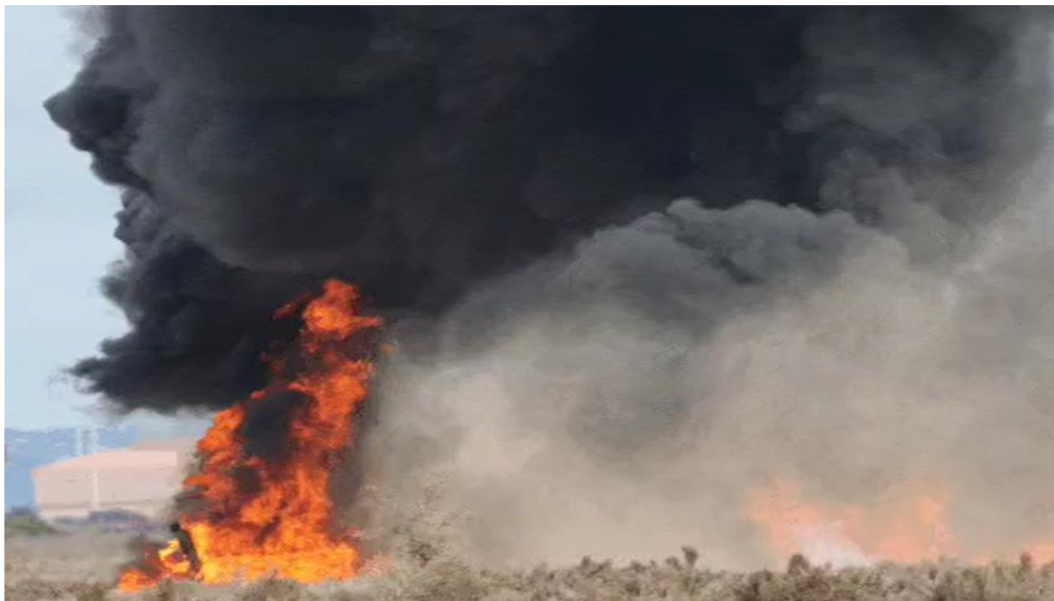
**Figure 7:** Post-impact fire eruption. (Source: Airshow video footage)

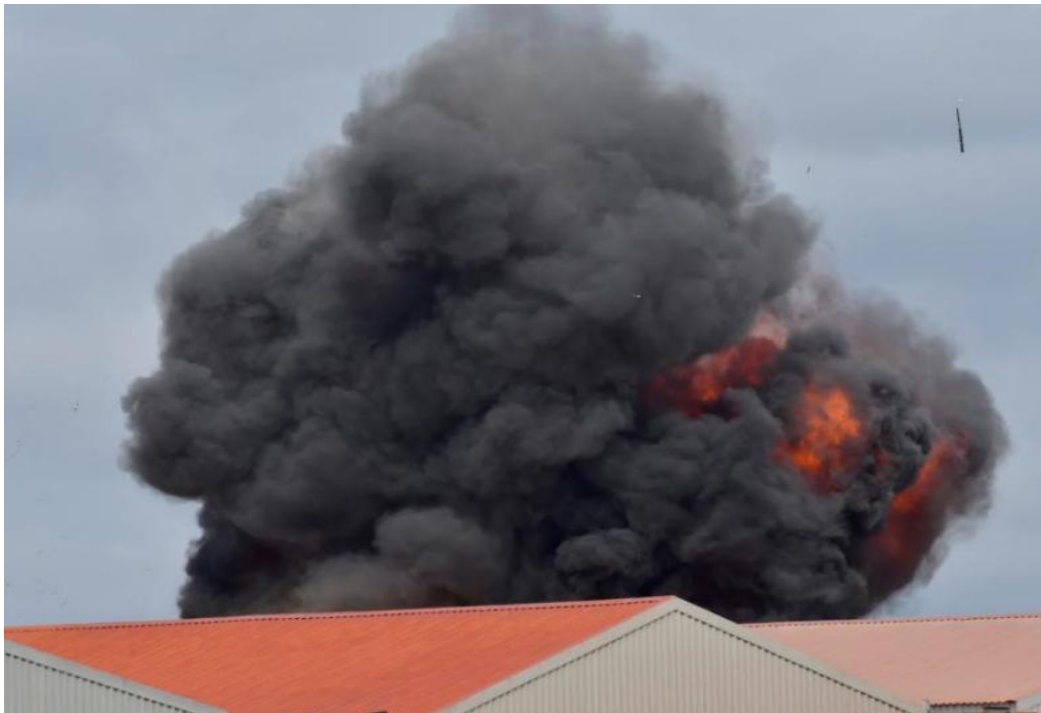
**Figure 8:** Thick smoke billowing from behind the hangars. (Source: Eyewitness)

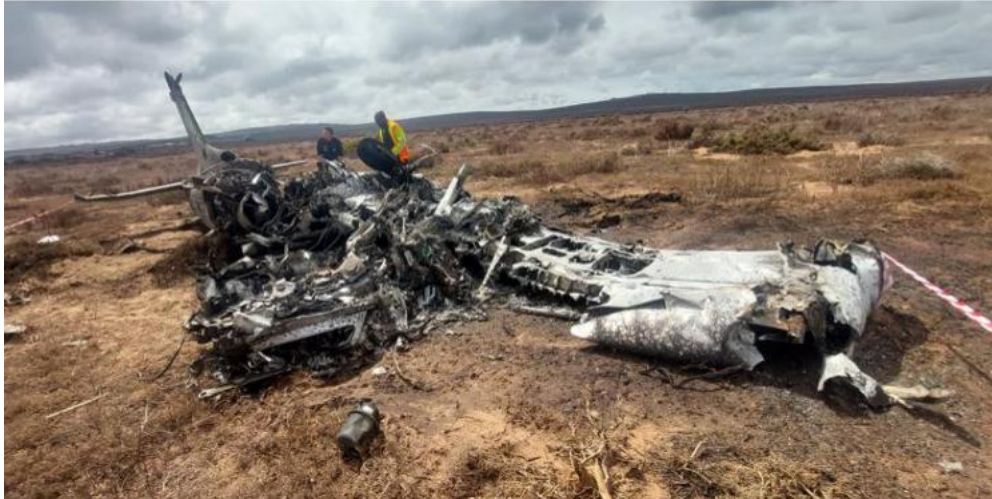
1.3.1. The aircraft was destroyed by impact forces and post-impact fire.

**Figure 10:** The wreckage after the fire was extinguished.

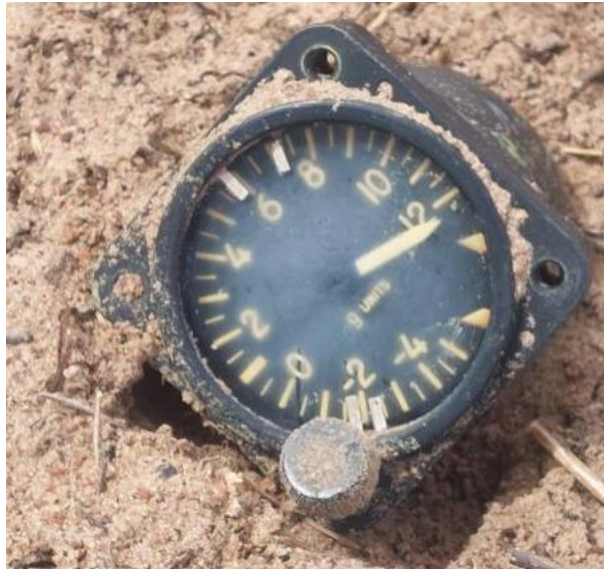
1.12.1. The accident occurred at FASD, approximately 400m to the left of Runway 02. After ground impact, a force exceeding 12g was recorded on the detached G-meter instrument, consistent with a high-energy crash. *An aircraft G-meter (or accelerometer) is a flight instrument that measures the acceleration forces acting on an aircraft along its vertical axis, it helps pilots monitor structural load limits and maintain safety, particularly during aerobatics, turbulence, or unusual attitude recovery. In simple terms, a G meter measures how many times the force of gravity the airplane is subjected to, where 1 G is straight and level, unaccelerated flight.* (Source: <https://www.aopa.org>).

1.12.2. The accelerometer, which records changes in the acceleration force was located approximately 5m to the right of the main wreckage. Its displacement from the wreckage suggested that it was either forcibly ejected due to the impact forces or it detached as the structure around it was destroyed.

**Figure 12:** The detached accelerometer (G-meter) found near the wreckage.

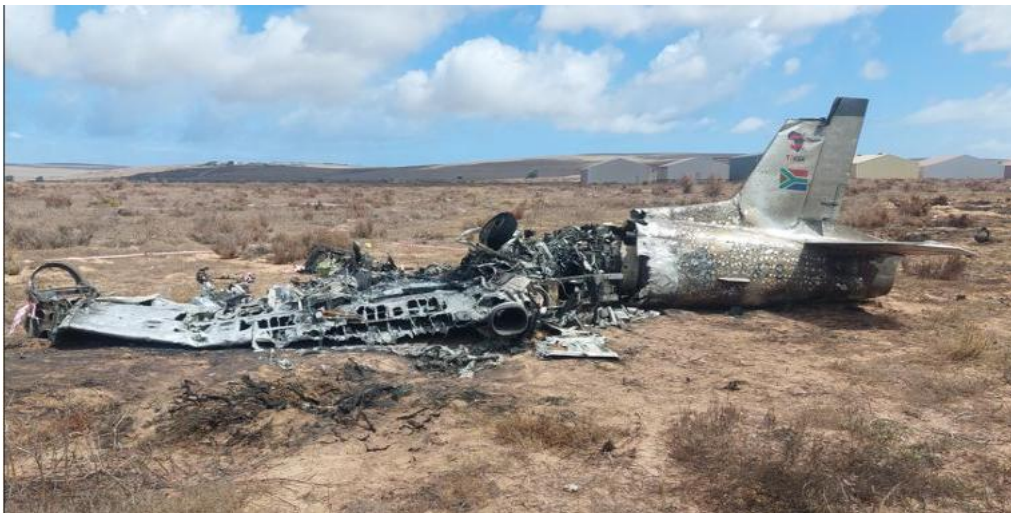
1.12.3. The aircraft impacted the ground with the right wing first. It skidded approximately 130m from the first point of impact to its resting position, where it rested on its belly. The resting position was oriented 175 degrees magnetic heading. Approximately two-thirds of the airframe was destroyed because of the impact. The post-impact fire consumed the fuselage from the nose to the mid-section. The detached components were found scattered along the impact trajectory which suggested that they had separated from the aircraft either during the initial impact or as the wreckage travelled (tumble) forward.

**Figure 13:** The wreckage post-accident with hangars in the background.

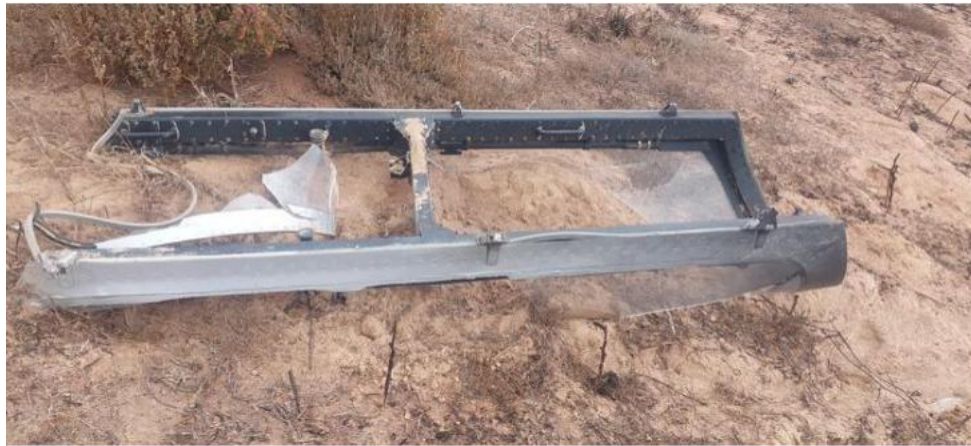
1.12.4. The canopy was found approximately 50m behind the main wreckage which suggested that it separated either in-flight or during the impact sequence. Its position, relative to the rest of the debris, suggested that it may have been dislodged due to aerodynamic forces, structural failure or during ground contact.

**Figure 14:** The recovered jettisoned canopy.

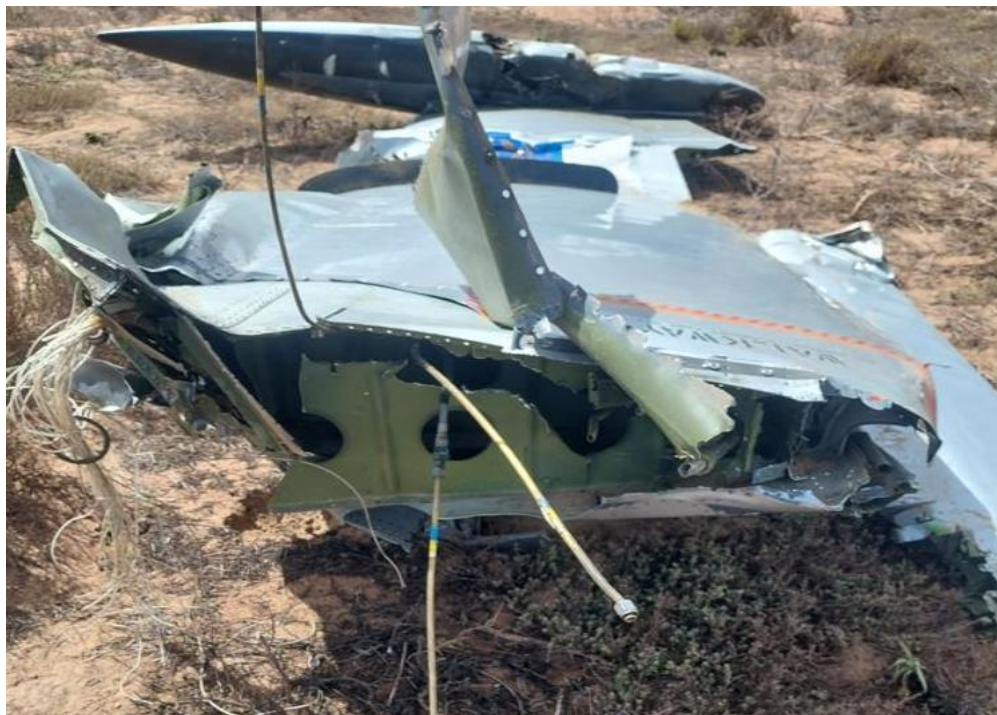
1.12.5. The right wing separated from the main fuselage when the aircraft skidded after the crash. The wing skin was severely torn, exposing internal components including ribs and spars. Jagged and bent metal edges suggested a high-stress separation after high impact with the ground; it was located approximately 60m behind the main wreckage which suggested that it detached due to impact forces or structural failure as the aircraft was still in motion on the ground. The position of the wing, in relation to the rest of the wreckage, indicated that it might have broken off whilst the aircraft was tumbling forward.

**Figure 15:** The right wing showing structural failure and the damaged hydraulic line.

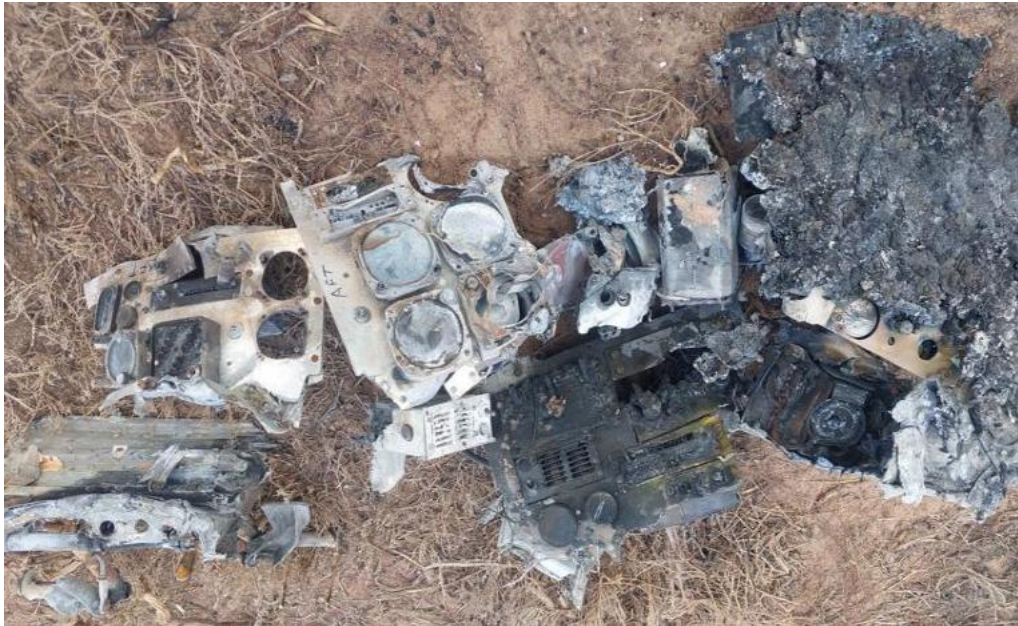
1.12.6. Large sections of the panels were charred and melted, which indicated exposure to intense heat. Some areas were completely blackened and fused together because of the

fire. The burn patterns on the aircraft were uneven due to heat exposure, with some instruments retaining partial structure whilst others were destroyed. Most dials, screens and switches were either missing, warped or burnt beyond recognition. Some circular instrument housings remained intact, but their glass and internal mechanisms were either shattered or melted. The right-most section was almost entirely reduced to ashes, which suggested higher heat concentration. The instrument panel was fragmented, which meant that it broke upon impact. The level of fire damage suggested that the cockpit was engulfed in flames post-impact, likely caused by residual fuel or electrical system ignition.

**Figure 16:** The damaged instrument panels.

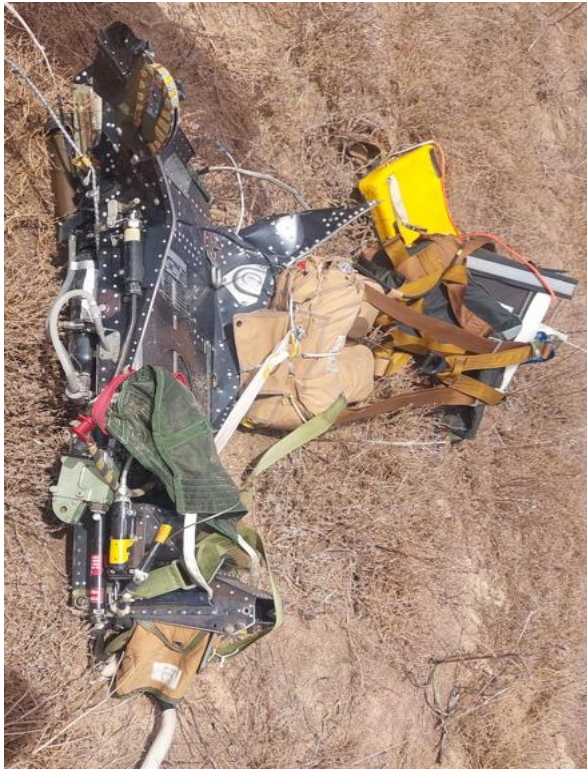
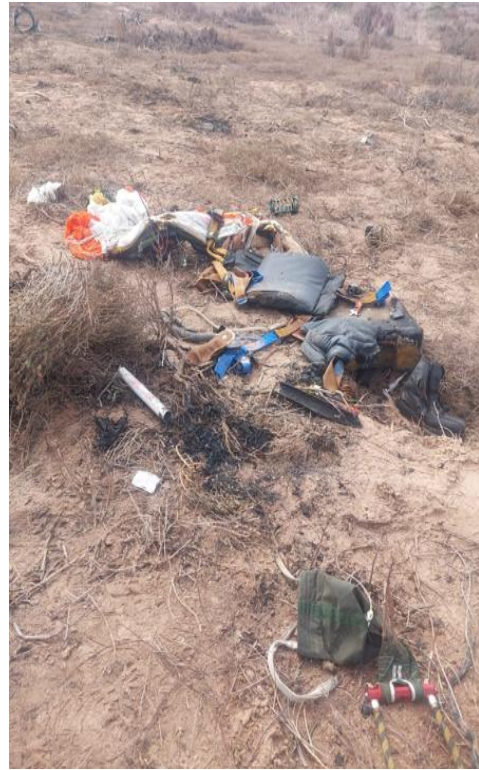
**Figures 17 and 18:** The front and the rear seat.

1.12.7. The aircraft was equipped with a ballistic recovery system (BRS). The main rear parachute and rocket motor assembly were recovered at the accident site. The rear parachute was found intact and still packed (see Figures 17 and 18), and the rocket motor had not fired (see Figure 19). Figure 20 shows a fired rocket motor.

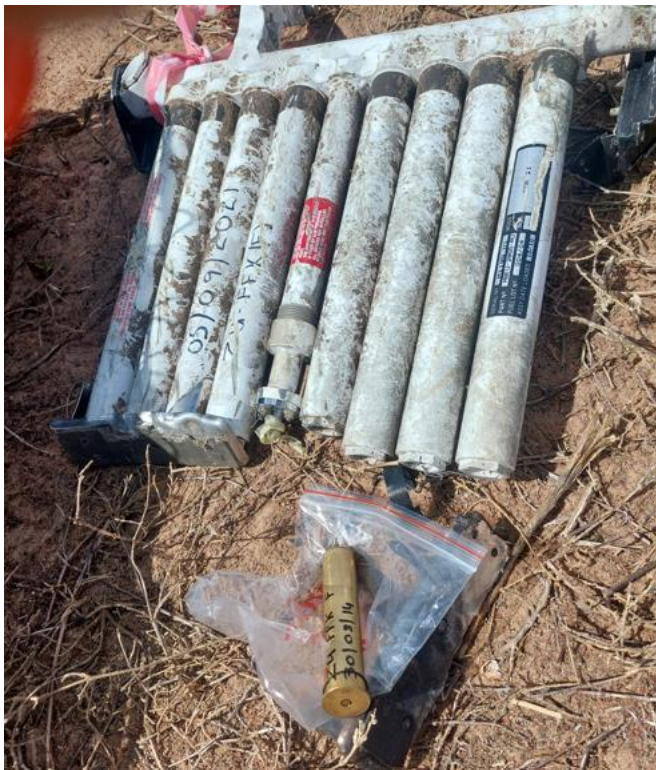
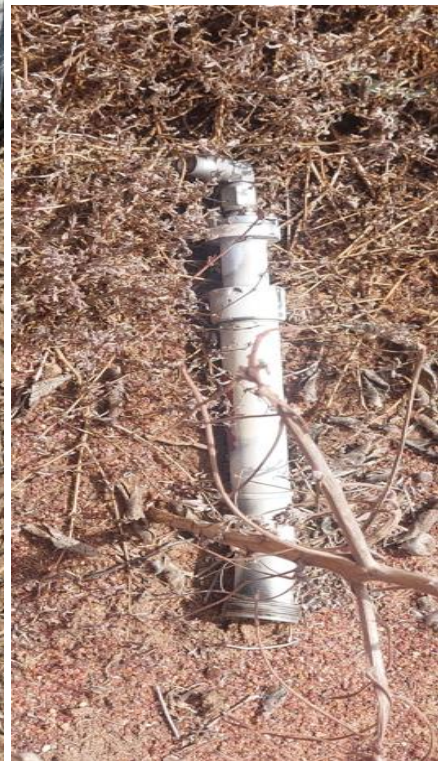
1.12.8. Examination of the wreckage and available evidence did not reveal an attempt made to activate the ballistic recovery system.

**Figures 19 and 20:** The rocket motor assembly which was not fired (left), and one that was fired (right).

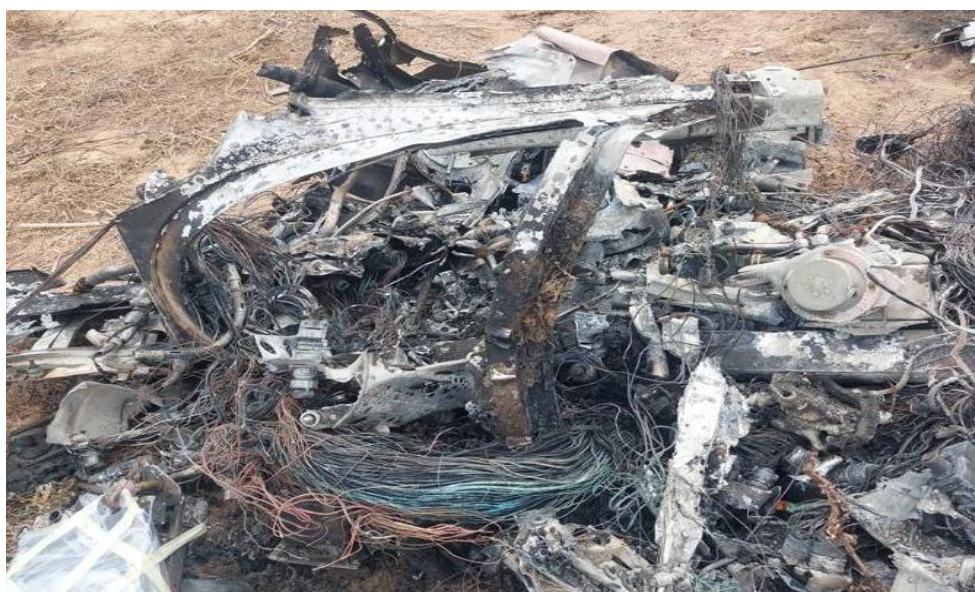
1.15.1. The accident was not survivable due to the severity of the impact and the subsequent fire. The cockpit structure sustained catastrophic damage upon impact with the ground and compromised its integrity.

**Figure 21:** The cockpit structure.
