**AIRCRAFT ACCIDENT REPORT AND EXECUTIVE SUMMARY**

| | | | | <b>Reference:</b> | | CA18/2/3/10609 | |
| <b>Aircraft Registration</b> | TL-ADE | <b>Date of Accident</b> | 16 October 2025 | | <b>Time of Accident</b> | 0953Z | |
| <b>Type of Aircraft</b> | Cessna 206H Stationair | | | <b>Type of Operation</b> | Private (Part 91) | | |

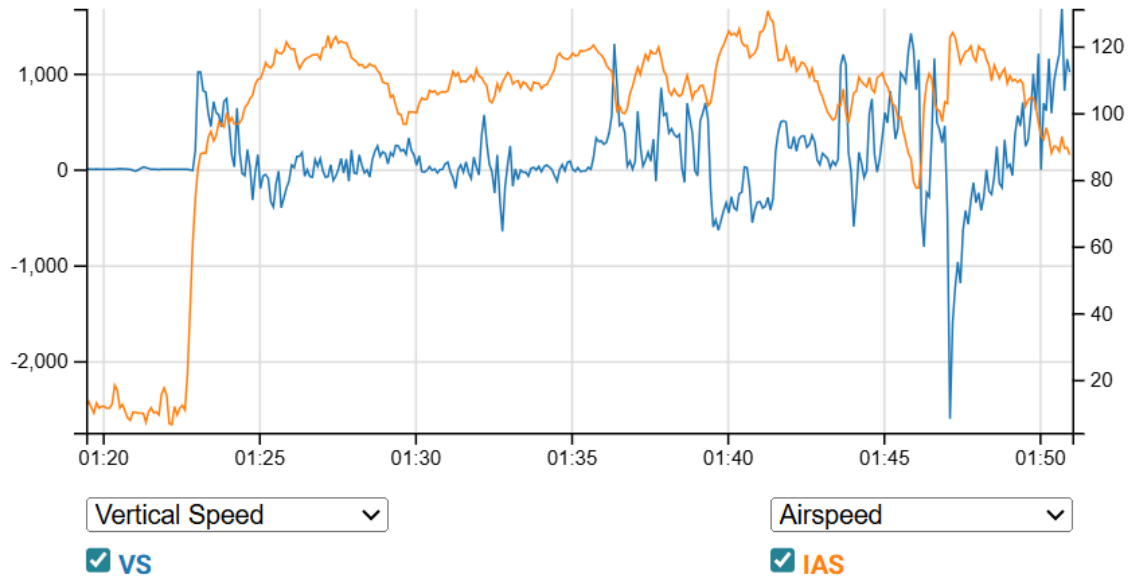
- 1.1.3 The aircraft was found destroyed and the pilot fatally injured.
- 1.1.4 According to the Global Positioning System (GPS) data recovered from the aircraft's navigation system, the aircraft was flown at an indicated airspeed of 87.9 knots (kts) at an altitude of 4 994ft above mean sea level (AMSL) and was climbing at a rate of 1 189ft per minute immediately before the recording stopped. The recording stopped 31 minutes into the flight. Data also indicated that the aircraft stayed between 3 500ft AMSL and 4 994ft AMSL in the last 3 minutes of the flight. It did not exceed 4 994ft AMSL for the duration of the recorded flight (see figures 2 and 3).

**Figure 2:** The GPS data shows the aircraft's vertical speed and airspeed before the recording stopped. (Source: Investigator)

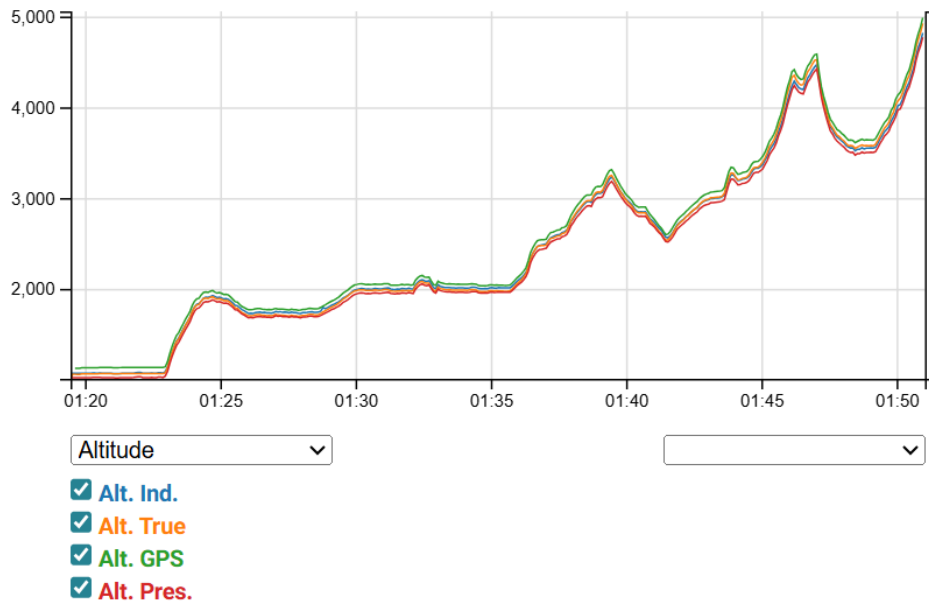
**Figure 3:** The GPS download shows the aircraft's altitude before the recording stopped. (Source: Investigator)

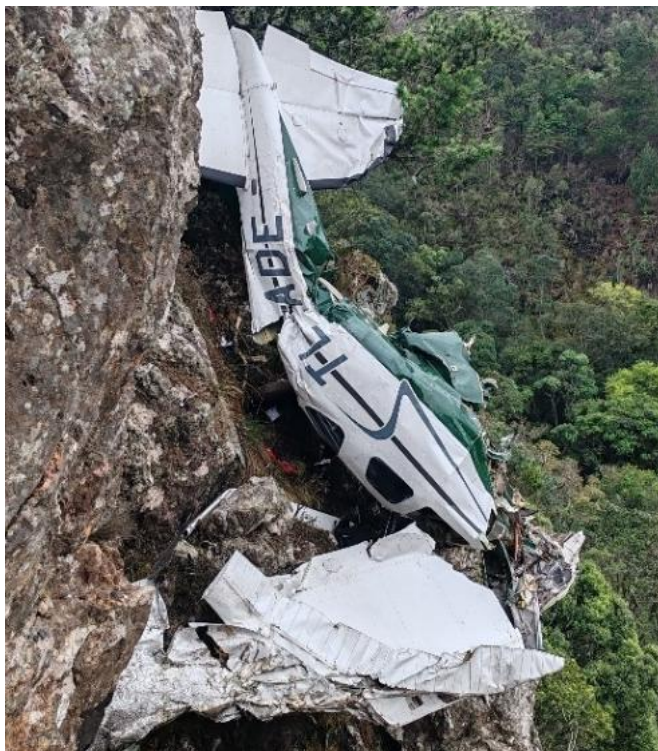
**Figure 5:** The wreckage at the scene of the accident. (Source: Investigator)

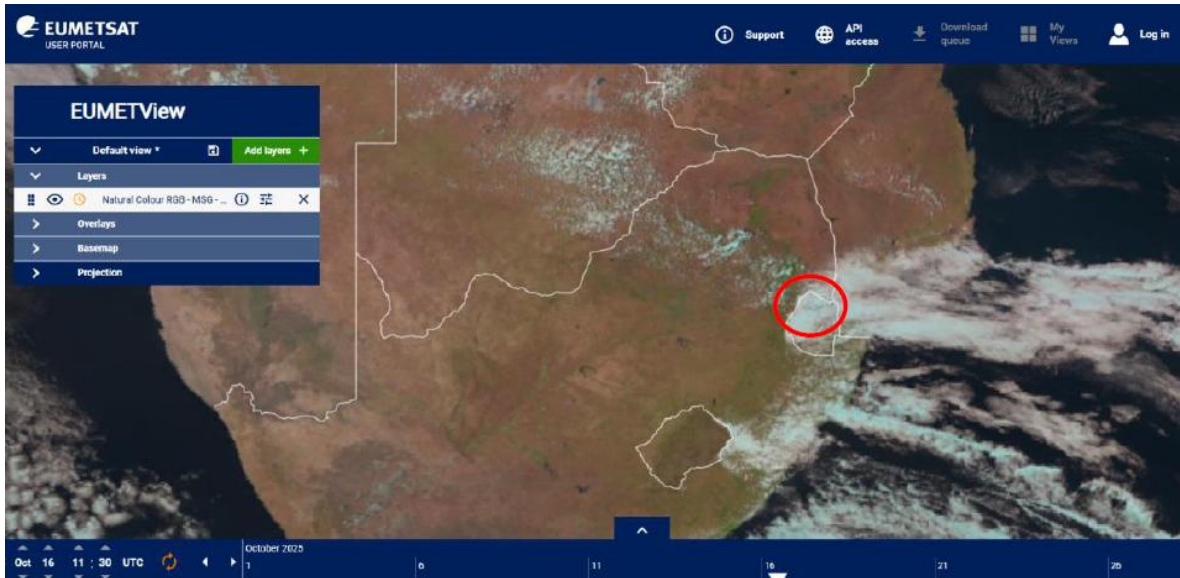
1.7.3 The satellite weather image for weather conditions observed on 16 October 2025, valid for 1130Z, which was closest to the time of the accident showed broken (BKN) to overcast (OVC) low cloud in the area (circled in red). This was in line with the reported conditions. These conditions posed a threat for VFR pilots especially in mountainous areas which could be obscured. The satellite images were retrieved from the European Organisation for the Exploitation of Meteorological Satellites (EUMETSAT) portal at <https://view.eumetsat.int/productviewer?v=default>

**Figure 7:** Satellite weather image for Barberton area on 16 October 2025 at 1130Z. (Source: SAWS)

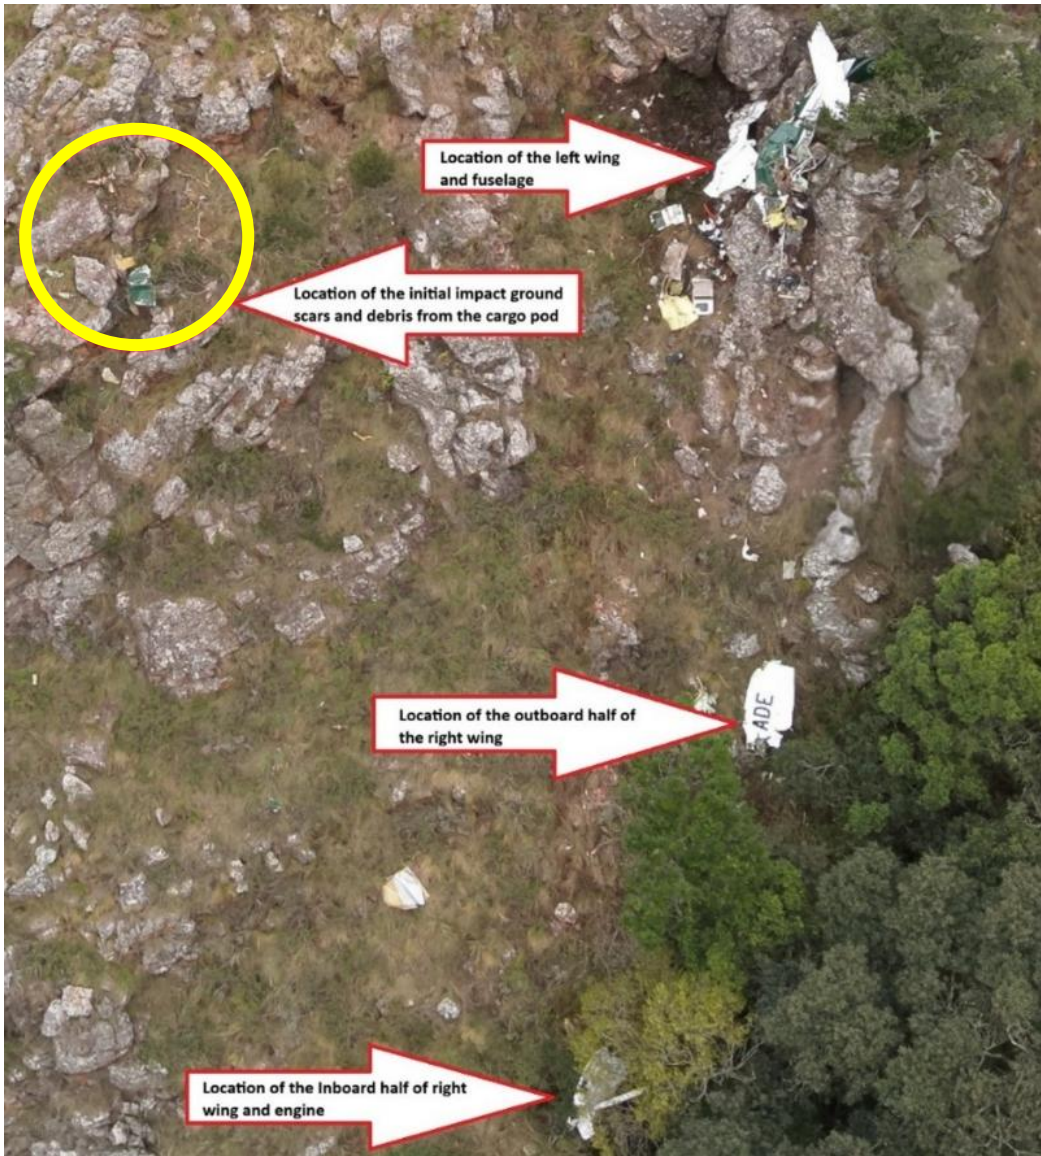
1.12.2 The left wing and fuselage remained on the cliff face suspended by the empennage that was wedged between the vegetation. The right wing and engine separated from the fuselage; the outboard half of the right wing was found 20m from the main wreckage, down the mountain side. The inboard half of the right wing and engine were found at the bottom of the valley approximately 50m from the main wreckage (see Figure 8).

**Figure 8:** The wreckage distribution. (Source: Investigator)

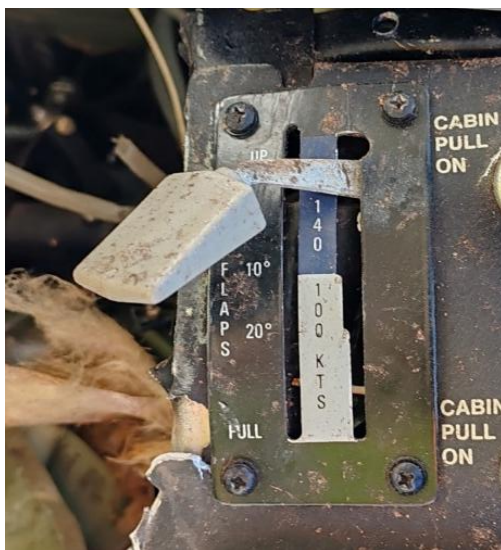
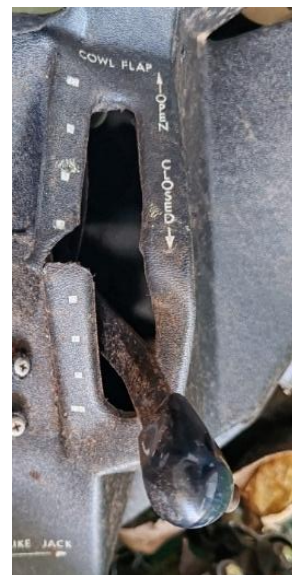
- The flap selector and control surfaces were in the retracted position (see Figure 8)
- The cowl flaps and cowl flap selector were in the closed position (see Figure 9)
- There was continuity in the flight control cables linking the flight control surfaces to the control column (see Figures 10 and 11)
- The engine throttle was depressed (in open position) (see Figure 12)
- The mixture control was extended to "lean mixture" position (see Figure 12)
- The propeller revolutions per minute (rpm) lever was depressed to "increase rpm" position (see Figure 12)
- The magneto switch was selected to "both" position (see Figure 13)
- The engine manifold pressure indicator indicated 20in Hg pressure (see Figure 14)
- The fuel flow indicator indicated a fuel flow of 20 gallons per hour (gal/hour) (see Figure 14)

**Figures 9 and 10:** Flap and cowl flap selectors. (Source: Investigator)

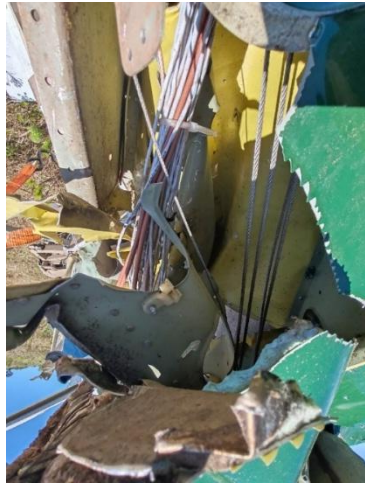
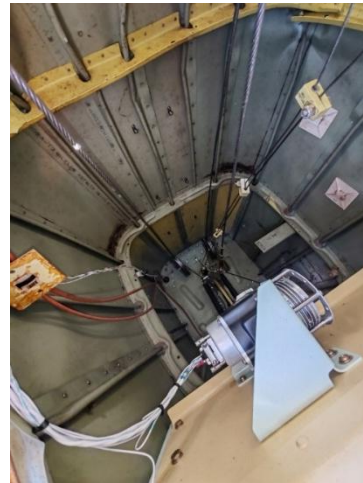
**Figures 11 and 12:** Flight control continuity through the fuselage. (Source: Investigator)

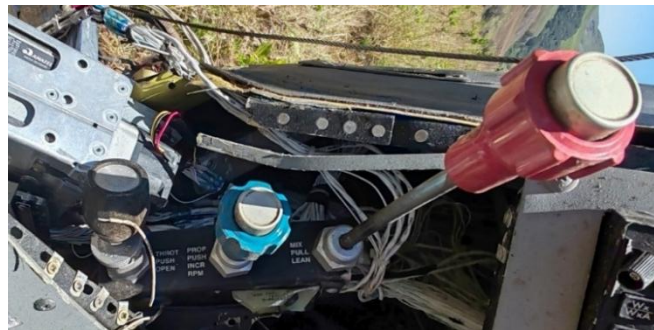
**Figure 13:** Throttle lever, propeller rpm lever and fuel mixture lever positions. (Source: Investigator)

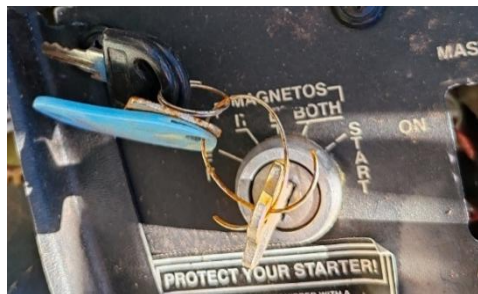
**Figure 14:** Magneto switch position. (Source: Investigator)

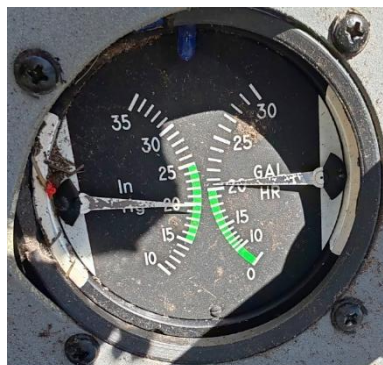
**Figure 15:** Manifold pressure and fuel flow dual indicator. (Source: Investigator)

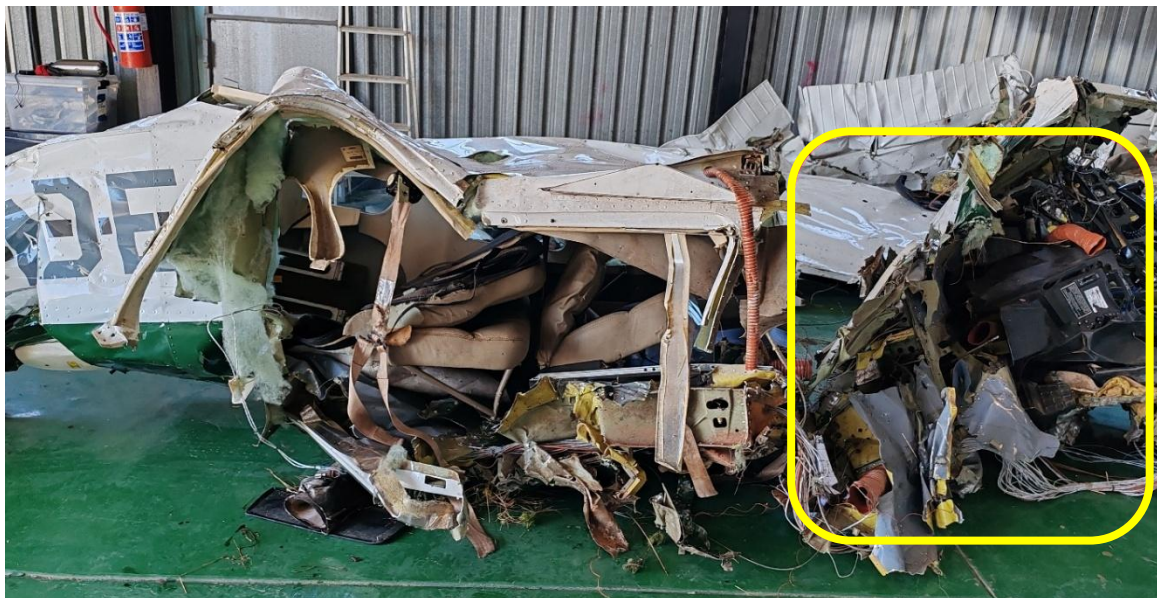
1.15.1 The accident was not considered survivable due to the extent of the damage sustained by the aircraft during the high-energy impact.

**Figure 16:** The cockpit was completely crushed during the accident sequence (yellow highlight).  
(Source: Investigator)
