AIRCRAFT ACCIDENT REPORT AND EXECUTIVE SUMMARY

Reference:		CA18/2/3/10614			
Helicopter Registration		ZS-DLF	Date of Accident		10 November 2025		Time of Accident	0545Z
Type of Helicopter		Robinson R22 Beta II		Type of Operation		Agricultural (Part 137)		
Pilot-in-command Licence Type		Commercial Pilot Licence (CPL) Helicopter		Age	43	Licence Valid	Yes	
Pilot-in-command Flying Experience		Total Flying Hours		473.3		Hours on Type	473.3	
Last Point of Departure		Patensie Farm Airstrip, Eastern Cape Province						
Next Point of Intended Landing		Patensie Farm Airstrip, Eastern Cape Province						
Damage to Helicopter		Destroyed						
Location of the accident site with reference to easily defined geographical points (GPS readings if possible)								
Roodegrond Citrus Farm near Patensie at Global Positioning System (GPS) co-ordinates determined to be 33°41'1" South 024°44'19" East, at an elevation of 192 feet (ft)								
Meteorological Information		Wind velocity: 020° at 3KT; Temperature: 26°C; Dew Point: 18°C; Visibility: ≥10000m; Cloud ceiling: FEW020; QNH: 1021 hPa

Reference Number : CA18/2/3/10614
Occurrence Category : Accident (Category 2)
Type of Operation : Agricultural Operat

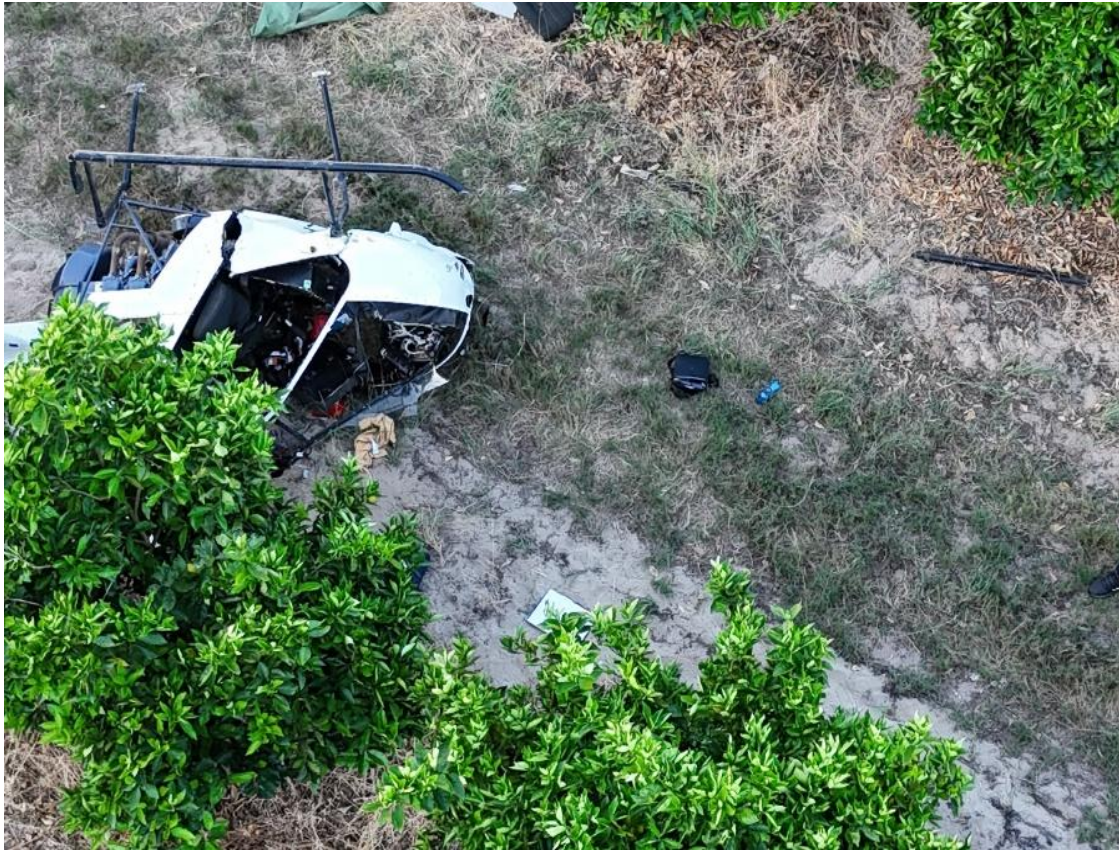
1.3.1. The helicopter was destroyed during the accident sequence.

Figure 2: An elevated view of the helicopter at the accident site.

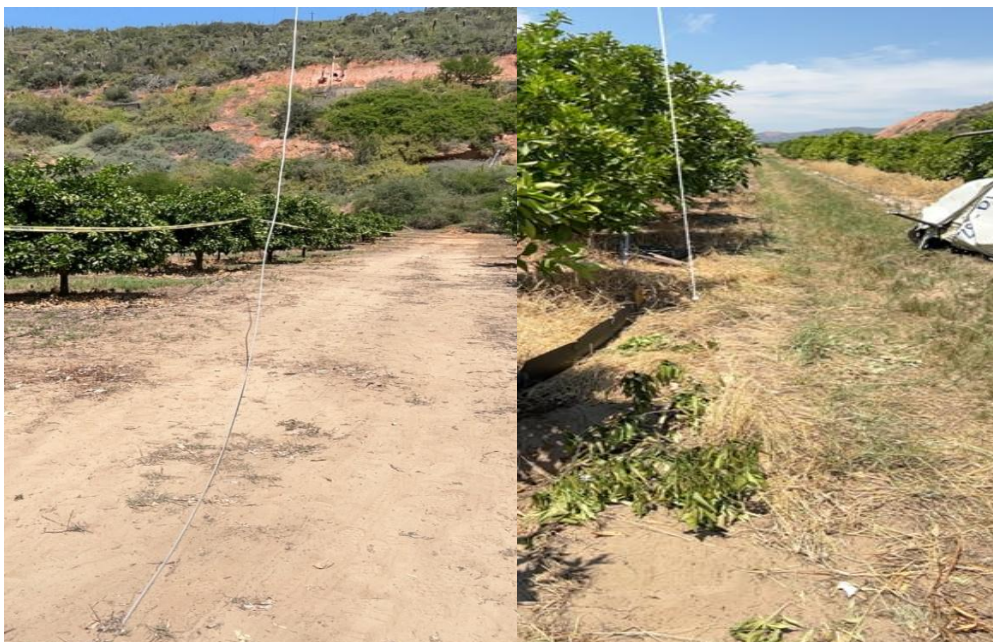
1.4.1. The privately owned 1 000-Volt overhead electrical powerline that was suspended approximately 7.2m above ground level sustained damage during the accident. The powerline supplied electric power to the water pumps which were installed at Patensie Citrus Farm.

Figures 3 and 4: The damaged powerline after the accident.

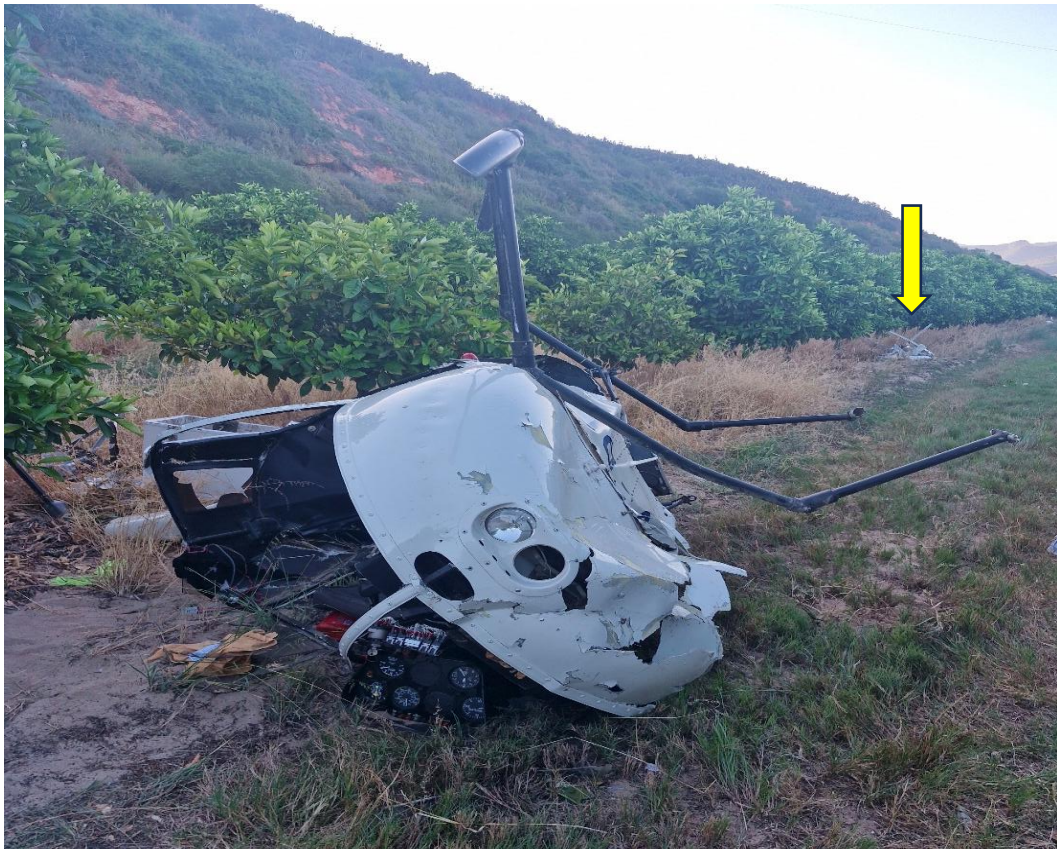
1.12.1. The helicopter's main rotor mast impacted the powerline whilst flying in a south-easterly direction. The main rotor severed the tail boom, and the two main rotor blades detached from the rotor hub. The helicopter crashed to the ground, left skid first; it came to rest on its right side between rows of citrus trees approximately 37m from the initial point of impact with the electric powerline.

Figure 5: A frontal view of the helicopter with the tail rotor section in the background (yellow arrow).

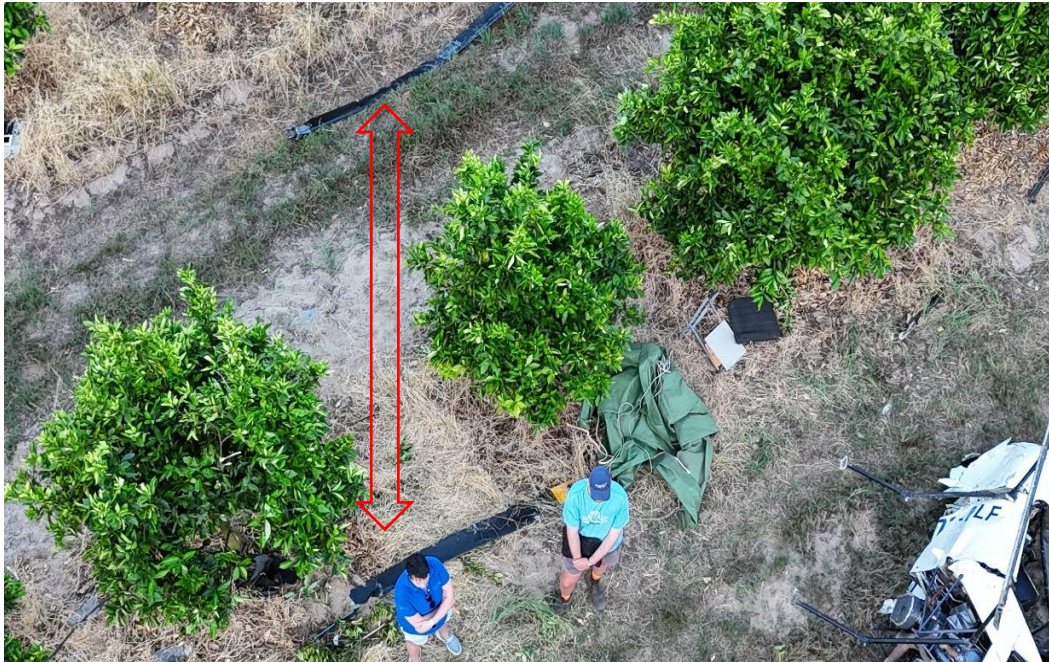
Figure 6: An elevated view of the accident site; the red arrow points to the main rotor blades.
