AIRCRAFT ACCIDENT REPORT AND EXECUTIVE SUMMARY

Reference:		CA18/2/3/10621	
Aircraft Registration	ZU-FWF	Date of Incident	30 November 2025		Time of Incident	0905Z	
Type of Aircraft	Sling 2 LSA			Type of Operation	Private (Part 94)		
Pilot-in-command Licence Type		National Pilot Licence (NPL)		Age	67	Licence Valid	Yes
Pilot-in-command Flying Experience		Total Flying Hours		1 862.2	Hours on Type	Unknown	
Last Point of Departure		Morningstar Airfield, Western Cape Province					
Next Point of Intended Landing		Morningstar Airfield, Western Cape Province					
Damage to Aircraft		Destroyed					
Location of the incident site with reference to easily defined geographical points (GPS readings if possible)							
Bush-type of terrain near Van Schoorsdrift Road, approximately 150 metres (m) south-east of Morningstar Airfield at Global Positioning System (GPS) co-ordinates determined to be 33°45'52" South 18°33'0" East.							
Meteorological Information		Surface wind: 180°/11kts; Temperature: 25°C; Dew point: 11°C; CAVOK

Loss of engine power during take-off from Runway 20 likely due to water-contaminated fuel and corrosion found in the carburettor float bowls; the aircraft crashed on a bush-t

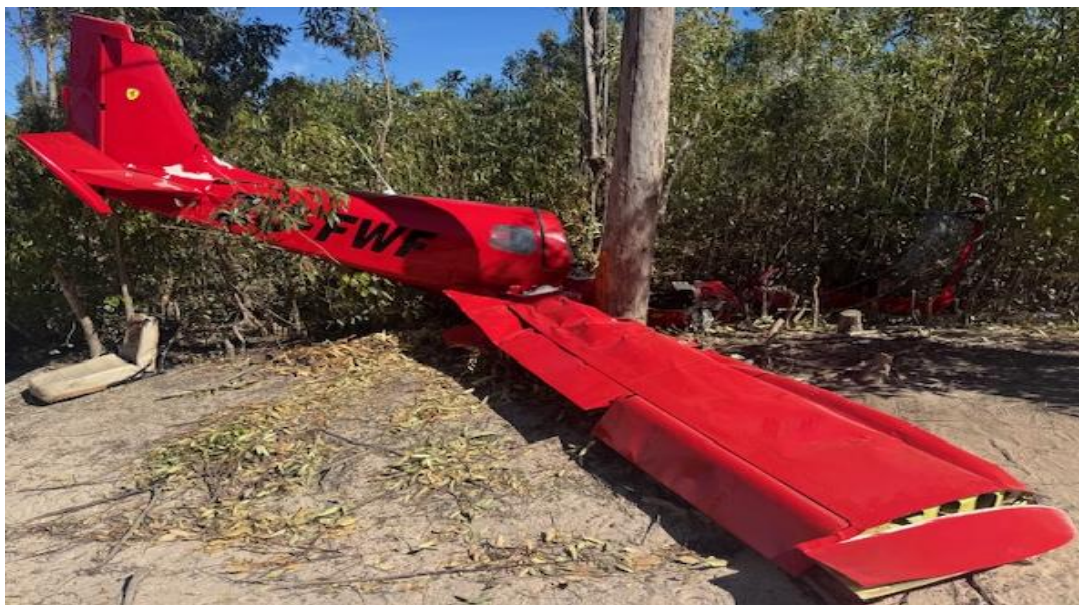
1.3.1. The aircraft was destroyed during the accident sequence.

Figure 2: The aircraft at the accident site.

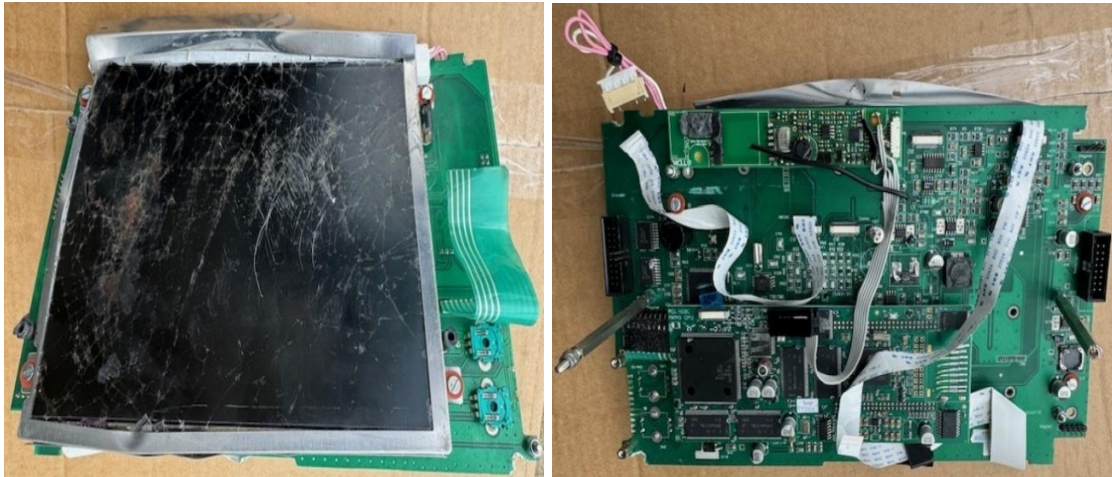
1.11.2. The aircraft was equipped with an old model MGL Avionics Stratomaster Voyager EFIS unit. The unit sustained impact damage during the accident sequence. The Secure Digital (SD) card was ejected during the accident; however, it was later found intact. The SD card that

was recovered from the aircraft did not contain data of last two flights that were conducted. The unit did not have internal data recording capabilities; it could only record on the external SD card that was set up and used by the pilot.

Figures 5 and 6: The EFIS unit (back and front) after it was removed from the cockpit.

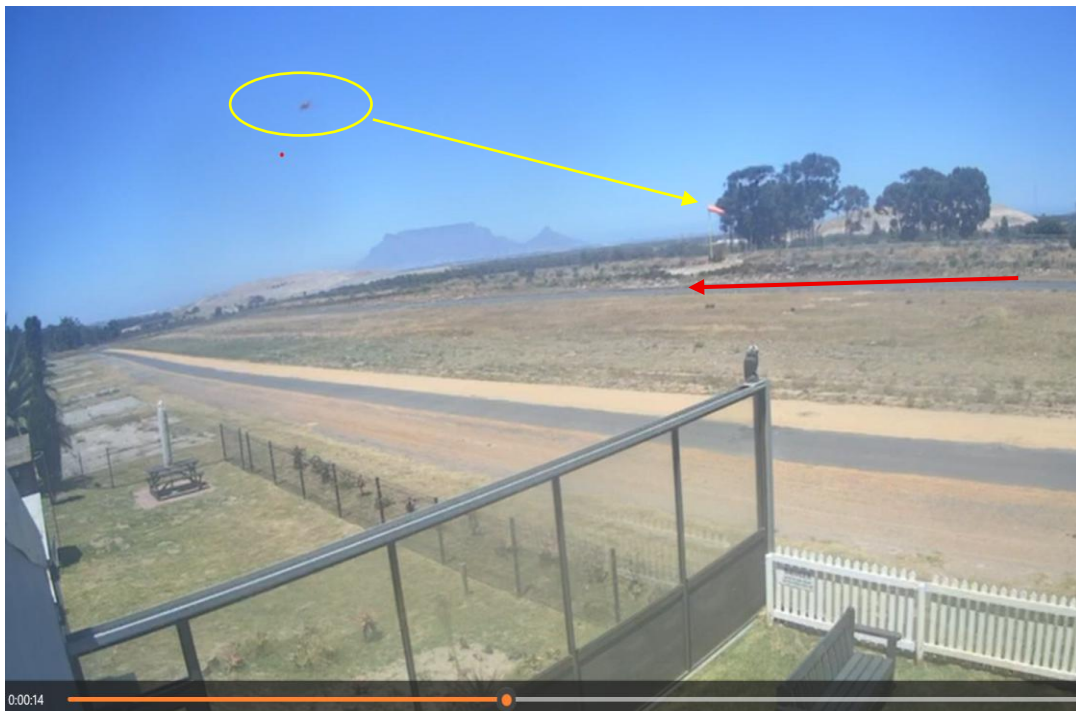
1.12.1. The video footage downloaded from the close circuit television (CCTV) camera mounted on the roof of the clubhouse at Morningstar Airfield showed the aircraft as it climbed in a southerly direction after take-off from Runway 20. The footage showed the windssock indicating a strong headwind.

Figure 7: The still video footage showing the runway used (red arrow), aircraft in a climb (yellow circle) and the windsock indicating a strong headwind (yellow arrow).

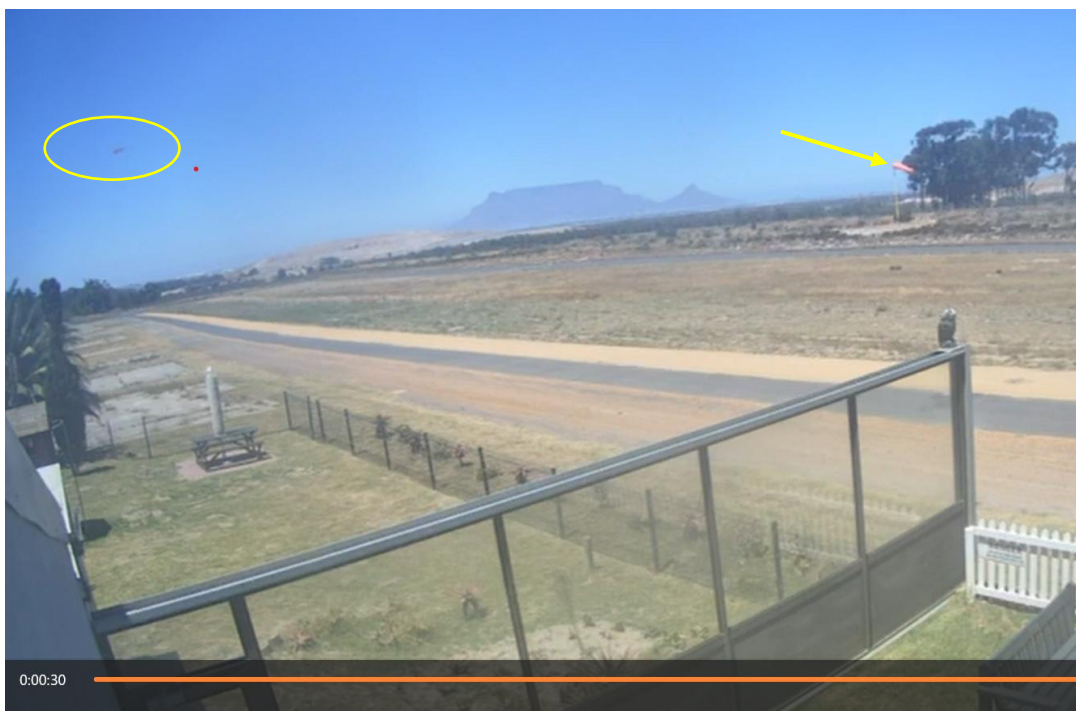
1.12.2. At approximately 250 AGL, the aircraft was observed executing a left turn, followed by a nose-down dive; it then disappeared from the CCTV coverage. It crashed on a bush-type terrain near Van Schoorsdrift Road, approximately 150m south-east of Morningstar Airfield.

Figure 8: The still video footage showing the aircraft executing a left turn (yellow circle).

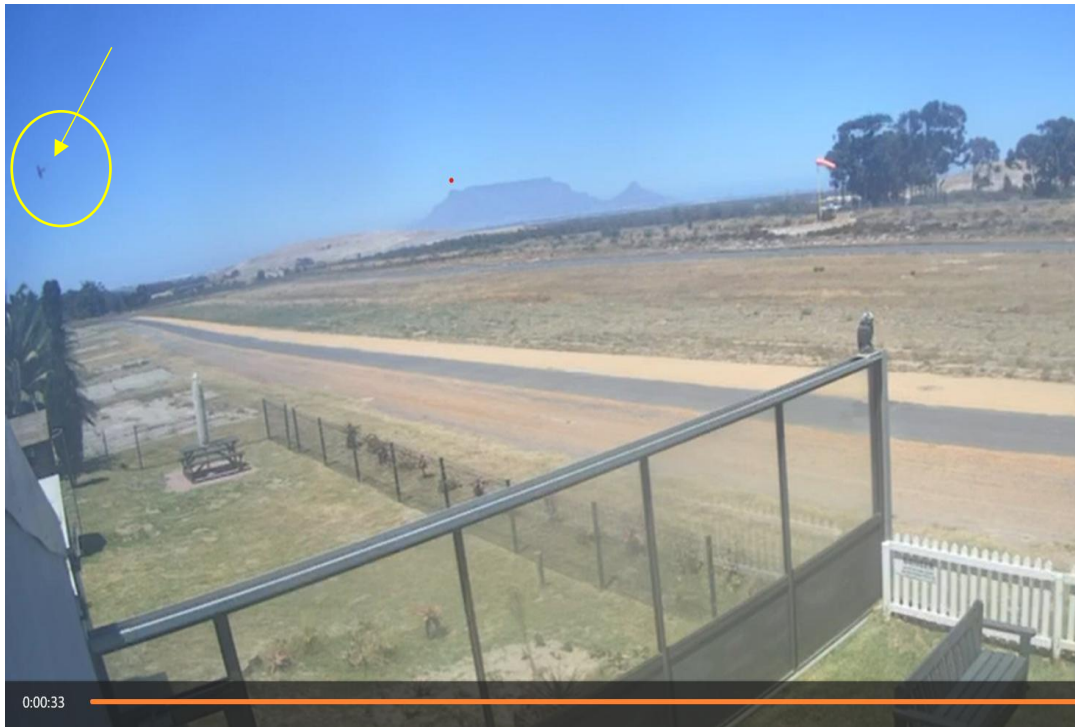
Figure 9: The still video footage showing the aircraft in a nose-down attitude.

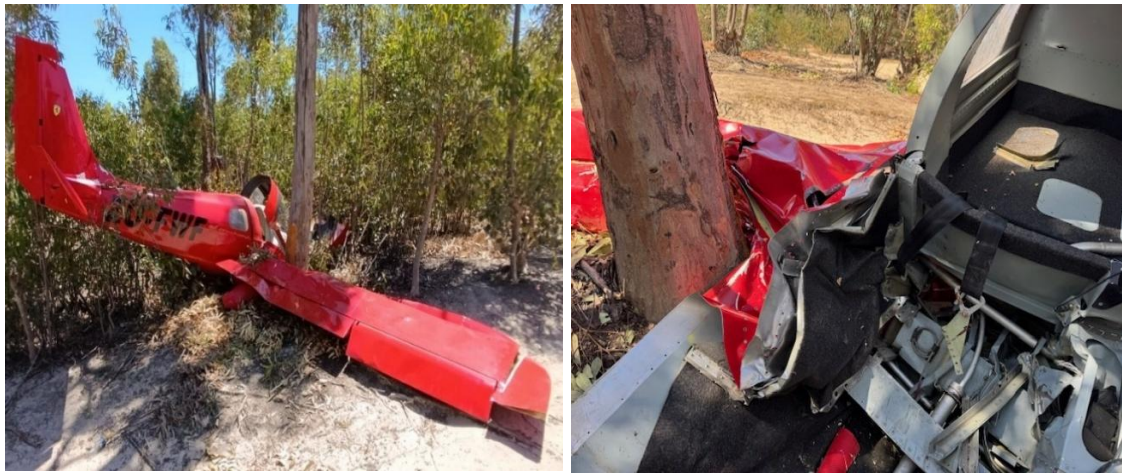
- 1.12.3. The aircraft was examined by the investigating team at the accident site; none of the components or flight controls was missing and no evidence of defective flight controls was observed. The aircraft's tail section showed compression marks due to rapid deceleration after impact with the tree. The estimated aircraft impact was 82° magnetic.

Figures 10 and 11: The aircraft's right-wing root against the tree stem.

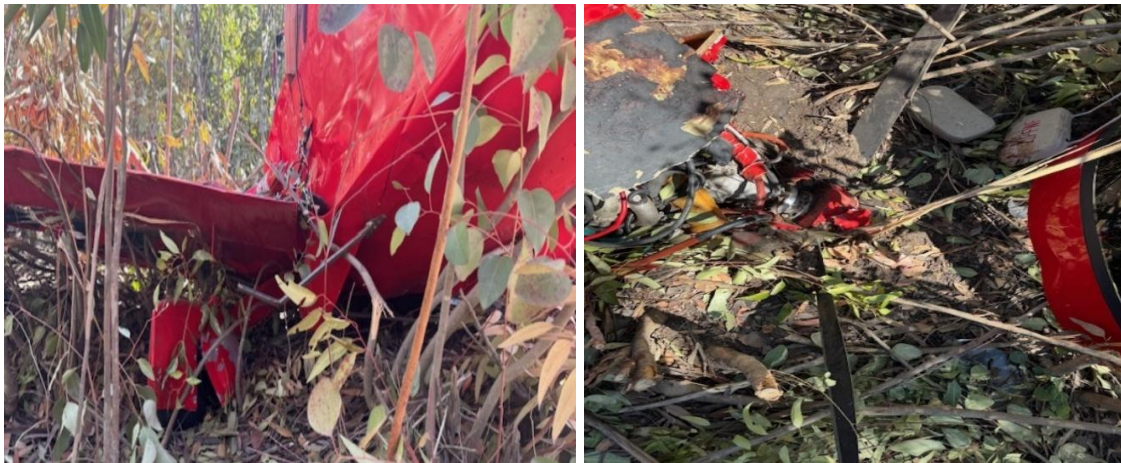
- 1.12.4. Evidence indicated that the aircraft was in a nose-down attitude and the flaps were retracted (up position) when it impacted the ground. Before impacting the ground, the right-wing root leading edge impacted the stem of a large tree which caused the wing tanks to rupture. The aircraft had an estimated Mogas of 57L in the tanks at the time of impact. There was a strong smell of fuel at the accident scene. The nose gear strut was found broken due to overload, and the spring-loaded main landing gear struts were stretched backward. The main wheel assemblies/tyres remained intact and inflated. The propeller had struck the soft ground and one of the blades had broken off. Examination of the remaining two composite blades indicated that the engine was not delivering power at the time of impact.

Figures 12 and 13: The left wing with the flaps retracted (UP position) and the left main gear strut that has stretched backward. The engine nose section is buried under the soft ground, and the remaining two blades are still intact.

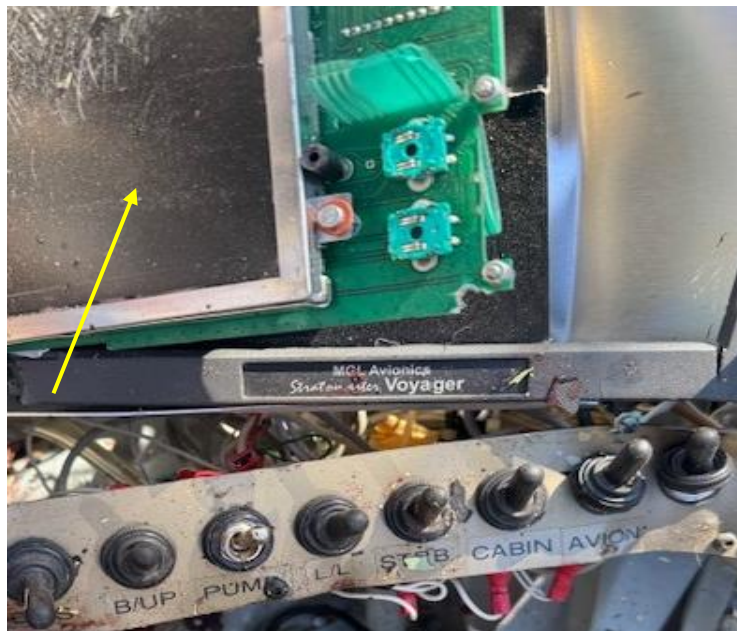
1.12.6. The EFIS screen was crushed and the SD card ejected. The circuit breakers (CBs) on the instrument panel were firmly secured to the mounting panel in the pressed (in) position, and all the switches including those of the fuel pumps were on.

Figure 14: An enlarged view of the EFIS (yellow arrow) unit in the cockpit with the switches in 'on' position.

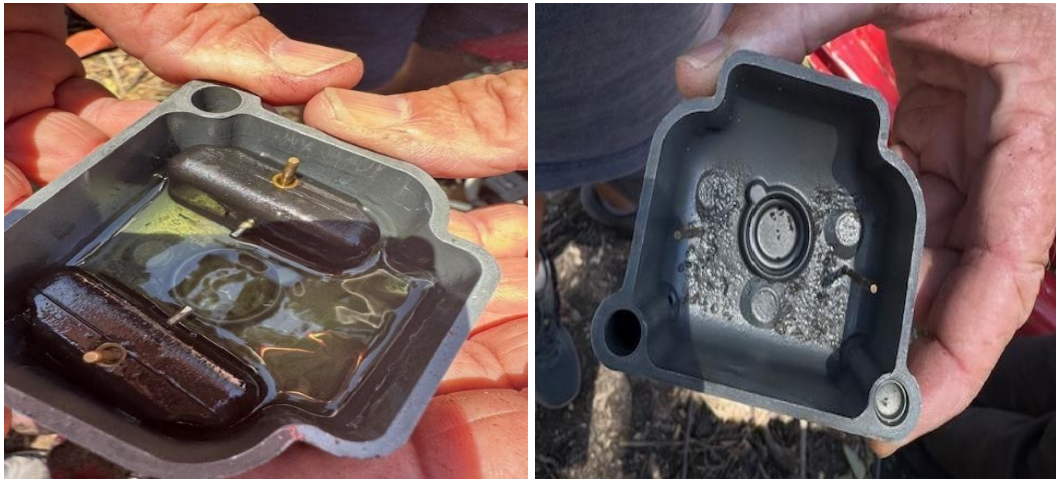
1.16.2. The engine was found undamaged with the carburettors, exhaust and propeller still attached. The propeller was rotated by hand to establish continuity, and compression was noted in all four cylinders. The position of the fuel selector could not be determined because of the cockpit console area that was destroyed by impact forces. The position of the power lever (throttle) and mixture could not be determined. The fuel tanks ruptured during the accident sequence and the fuel that remained in the tanks leaked out. No fuel was available for testing. The carburettor float bowls were examined for condition. Both the carburettor float bowls were in good condition. Both carburettor float bowls were removed; water contamination and corrosion were found on the bottom of the float bowls.

Figures 15 and 16: The left side carburettor showing water contaminated in the float bowl (left picture). Corrosion at the bottom of the right carburettor float bowl (right picture).

and there was no debris on the magnetic plug. All the engine major components were intact. The investigation discovered water-contaminated fuel and corrosion in the carburettor float bowls which likely caused the engine to lose power during take-off from Runway 20.

3.3.1 Loss of engine power during take-off from Runway 20 was likely caused by contaminated fuel and corrosion noted in the carburettor float bowls; the aircraft crashed on a bush-type terrain near Van Schoorsdrift Road, approximately 150m south-east of Morningstar Airfield.
