## AIRCRAFT ACCIDENT REPORT AND EXECUTIVE SUMMARY

| | | | | <b>Reference:</b> | | CA18/2/3/10629 | |
| <b>Aircraft Registration</b> | ZS-WEZ | <b>Date of Accident</b> | 2 January 2026 | | <b>Time of Accident</b> | 0812Z | |
| <b>Type of Aircraft</b> | Piper PA-22-160 Tri-Pacer | | | <b>Type of Operation</b> | Private (Part 91) | | |

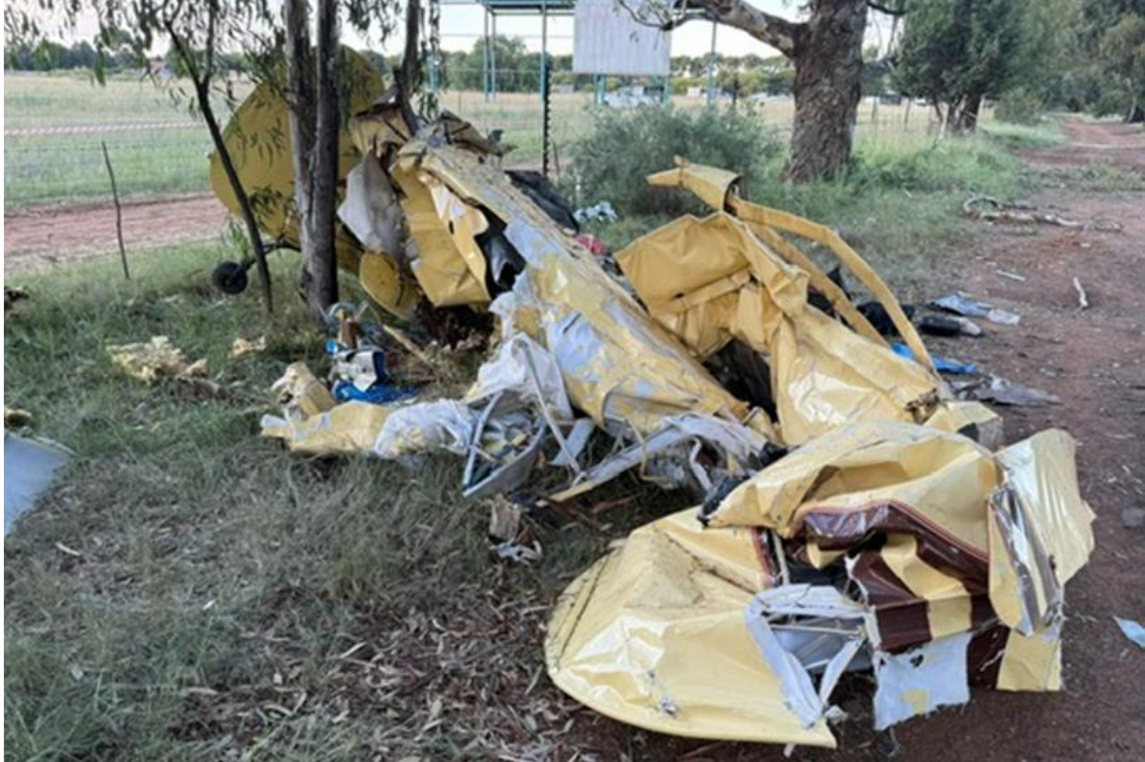
### 1.3.1. The aircraft was destroyed during the accident.

**Figure 2:** The wreckage at the accident site.

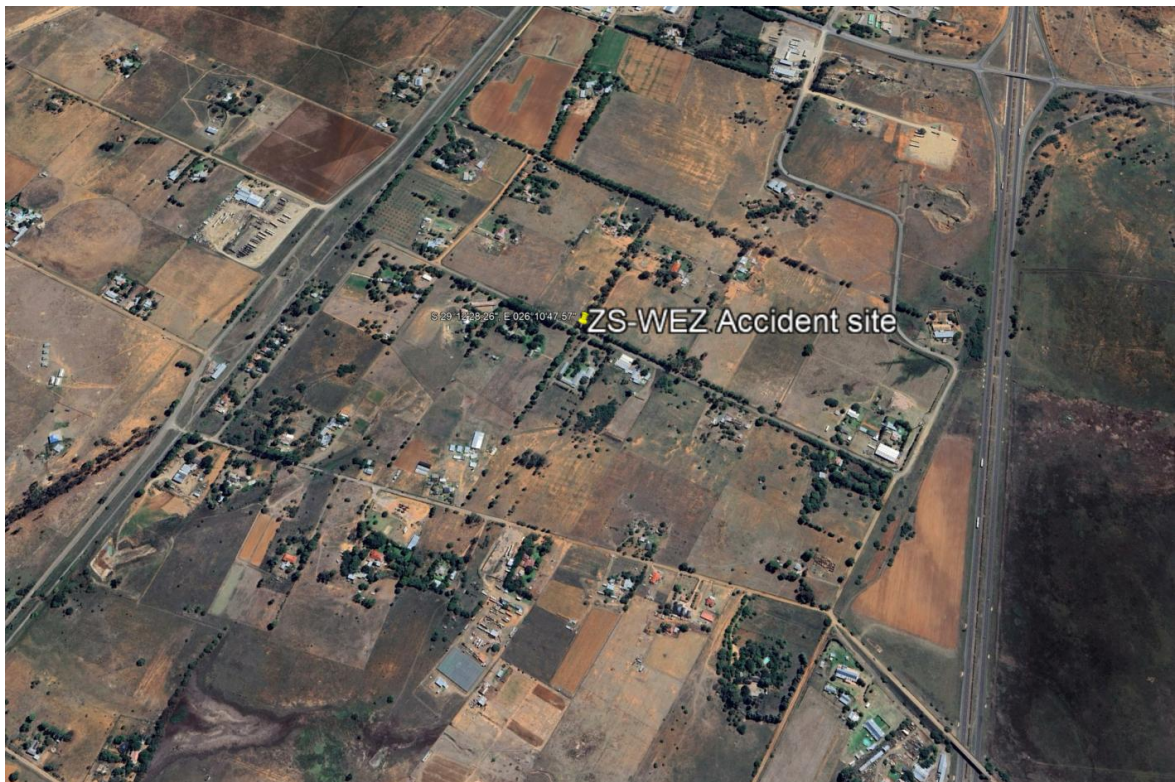
1.12.1. The accident occurred in a residential plot approximately 8nm south-south-west of FABL. The accident site had trees. The aircraft impacted the trees first before it hit the ground. This caused extensive damage. The fuselage was crushed and torn apart with major sections displaced and deformed. The airframe exhibited severe compression, buckling and tearing which was consistent with a high-energy impact.

**Figure 4:** The accident site. (Source: Google Earth)

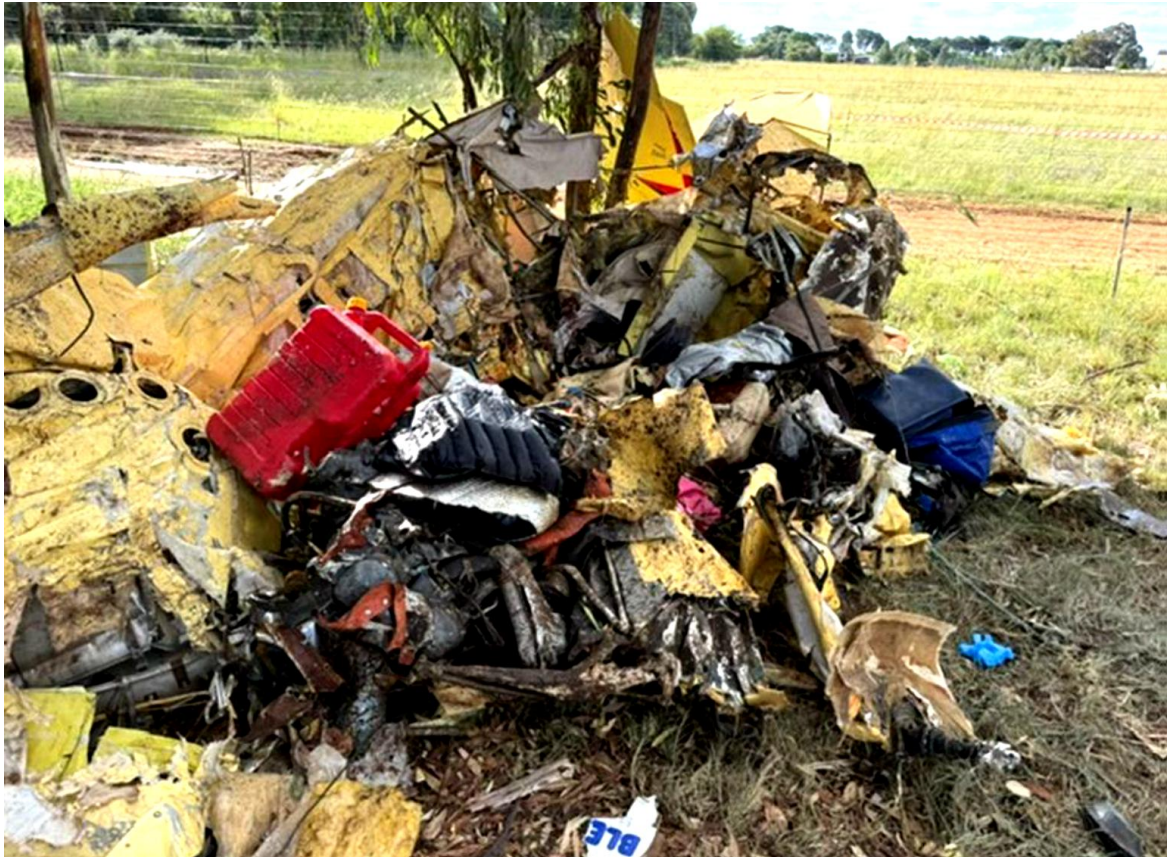
1.12.2. The wreckage was confined to a relatively small area which indicated little to no forward ground skidding after the initial impact. Three branches that snapped from the trees were found around the wreckage. Several fuselage panels and structural components were found folded inwards and in proximity to one another. Internal structure components were exposed, bent and fractured. The aircraft's skin panels were heavily crumpled and had separated from the primary structure in multiple areas. There was no evidence of in-flight breakup based on the concentrated nature of the wreckage distribution. The surrounding vegetation showed localised damage which was consistent with the wreckage distribution.

**Figure 5:** The wreckage after the accident.

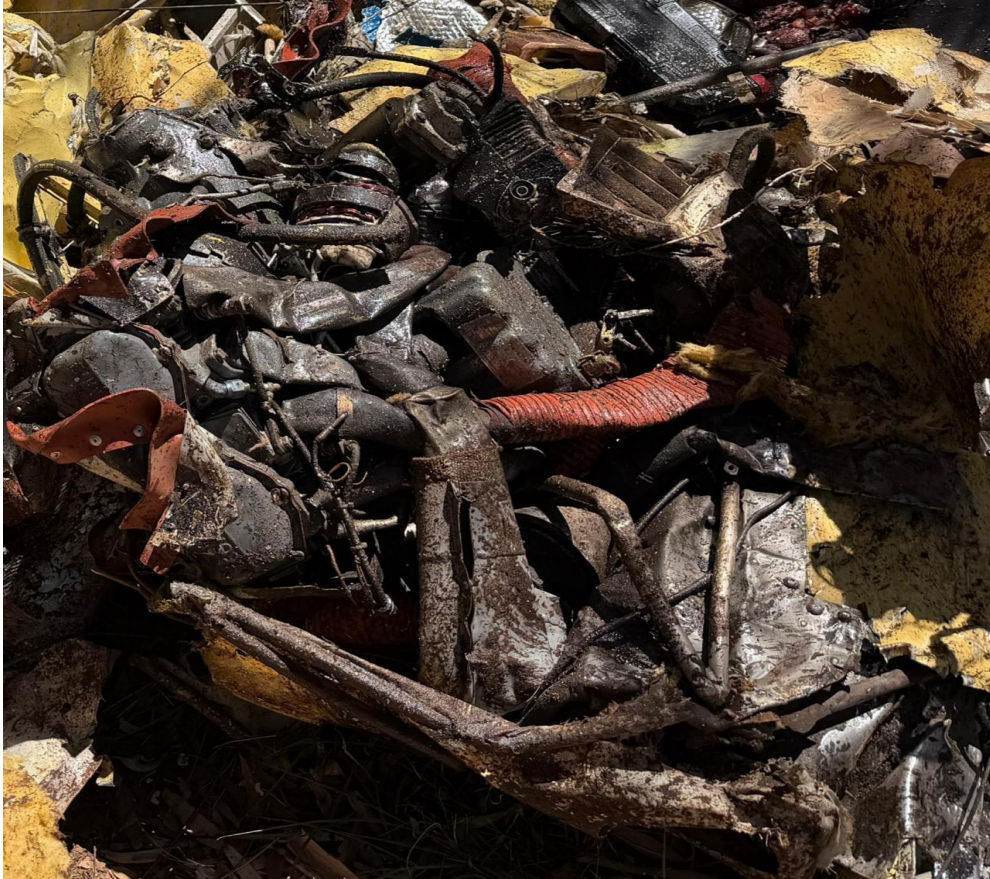
1.12.3. The engine sustained severe damage after ground impact. The engine casing was crushed, deformed and fractured, and several external components were broken, displaced or partially separated from their mountings. The engine mount structure was bent and fractured, and the associated accessories, lines, exhaust and ancillary components were distorted, fragmented and displaced. The damage pattern was consistent with high-impact forces. Due to the extent of the impact damage, the engine could not be taken for further inspection as critical components were destroyed and/or unsuitable for a meaningful examination. Consequently, a comprehensive technical assessment of the engine's pre-impact condition and functionality could not be performed.

**Figure 6:** The damaged engine.

- 1.16.1. The engine was not subjected to a teardown inspection due to the extent of damage sustained during the accident. The impact and post-impact damage resulted in significant structural deformation of the engine assembly, rendering the engine unsuitable to conduct a detailed examination.

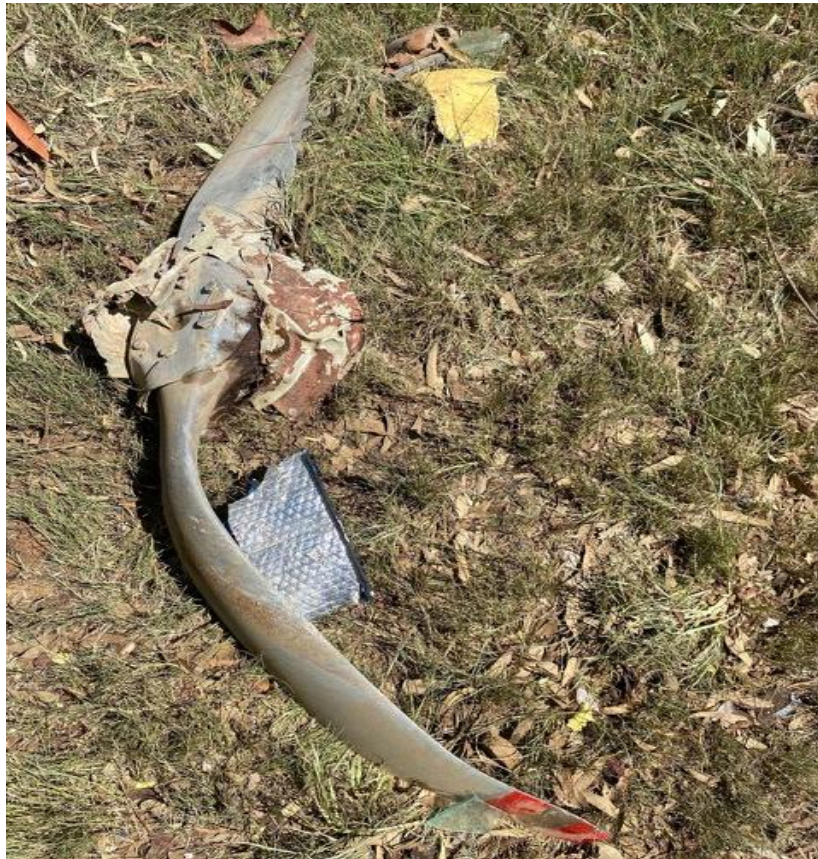
**Figure 7:** The propeller blades found approximately 3m from the engine.
